Effect of Compaction and Asphalt Temperature During Paving on Asphalt Lifespan

02/07/2019

Samuel Rutten
S1790099

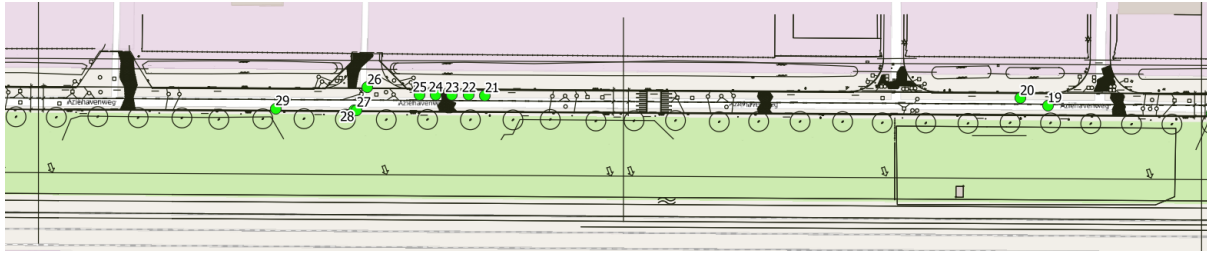
Figure 14: Damage Locations 2

Figure 14 shows the second third of the road. Points 19 and 26 are the locations of some light raveling. Points 20, 21, 22, 23, 24, and 25 are drill cores but do not display signs of damage. Finally, points 27 and 28 show the beginning and end of a longitudinal crack and point 29 is the location of a small transverse crack.

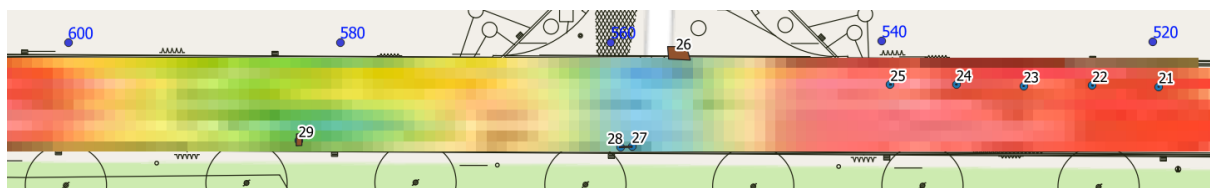
Figure 17: Temperature Contour Map (Method 1) Cold Spot with Distress

Another interesting area is pictured in Figure 17. Here a section of the temperature contour map created with method 1 that is significantly colder than the surrounding area can be seen at the 560-meter mark. The rapid temperature drop has a high likelihood to lead to segregation, and thus weaker asphalt. Therefore, visible distress would be expected here. Points 21 through 25 are drill cores and thus not relevant. Points 27, 28 and 29 show the location of two cracks, which are located exactly in spots where there was a significant temperature drop. This suggests that there may be a connection between the data. Lastly, point 26 signifies a patch of light raveling at the beginning of the bellmouth. Although it seems to correspond with the cold area, it is difficult to connect the two. This is because there is no data on the paving of the bellmouth. The fact that this data point is not located on the road in question makes it difficult to use.

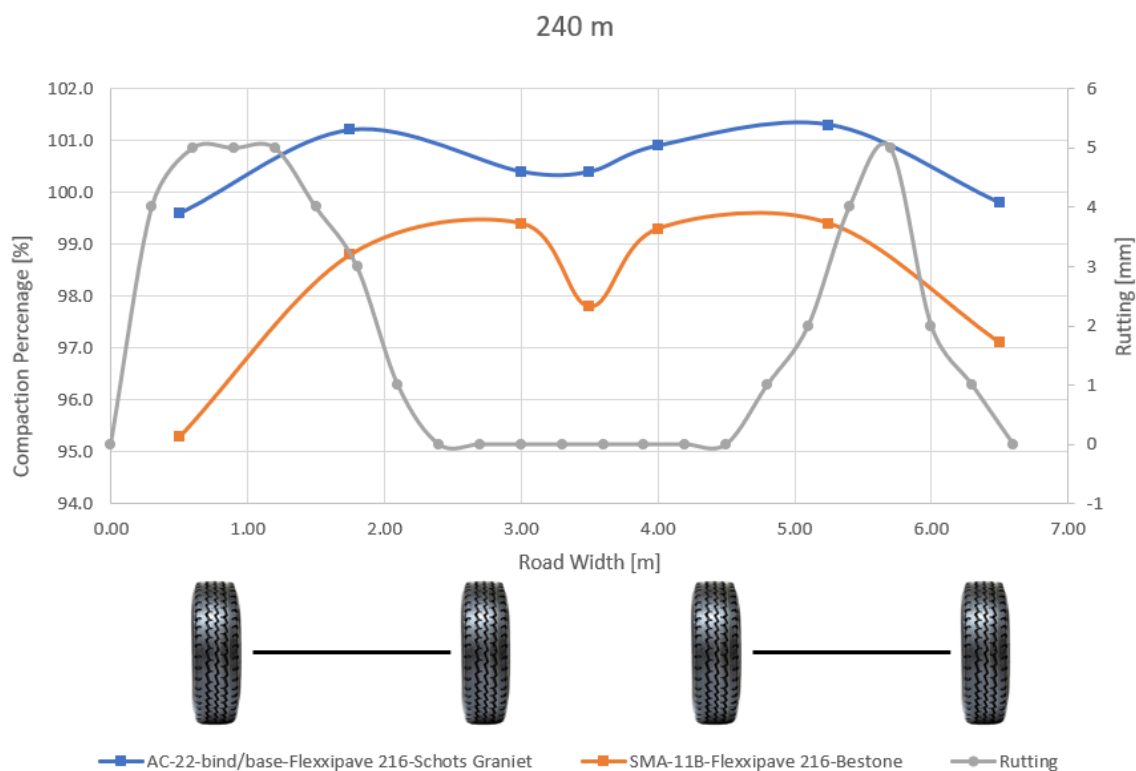
Figure 20: Compaction and Rutting vs. Road Width 240m

Over the years that the Aziëhavenweg has been in use it has seen a large amount of stresses. Based on personal observation when visiting the road, it was noticeable that predominantly large freight trucks used the road. These trucks are much larger and heavier than standard cars and therefore deliver a much higher force to the road. It is logical to expect some rutting to have accumulated over the years. In 2019 Erwin van de Jagt collected rutting data from three sample locations at 240, 360, and 740 meters from the paving starting point. This data has been compared to the compaction percentage. The following graphs (Figure 20, Figure 21 and Figure 22) were made by Marco Oosterveld and show the rutting compared to the compaction percentage of both the AC-22-bind/base-Plexxipave 216-schots Graniet (the STAB layer) and the SMA-11B-Flexxipave 216-bestone (the SMA layer). Below the X axis of these graphs the approximate wheel locations on the road are shown. This aids in analyzing what the actual cause of the rutting could be. This was based off of the average width that the wheels of freight trucks are apart.

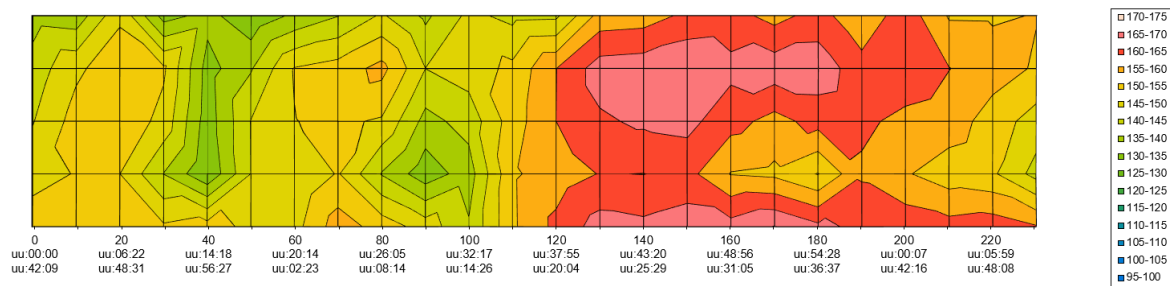
Figure 24: Temperature Contour Map Wednesday Lane 1

The temperature homogeneity of the asphalt mat laid on Wednesday night in the first lane can be seen in Figure 24. As can be observed, for the first 120 meters, the asphalt temperature is relatively homogeneous. The temperature stays around 140 to 150 °C and only dips to around 130 °C at two points (40 m and 90 m). From roughly 120 to 210 meters the temperature rises. The average temperature for that section lies somewhere between 160 and 170 °C. Towards the end of the asphalt mat, the temperature decreases again.

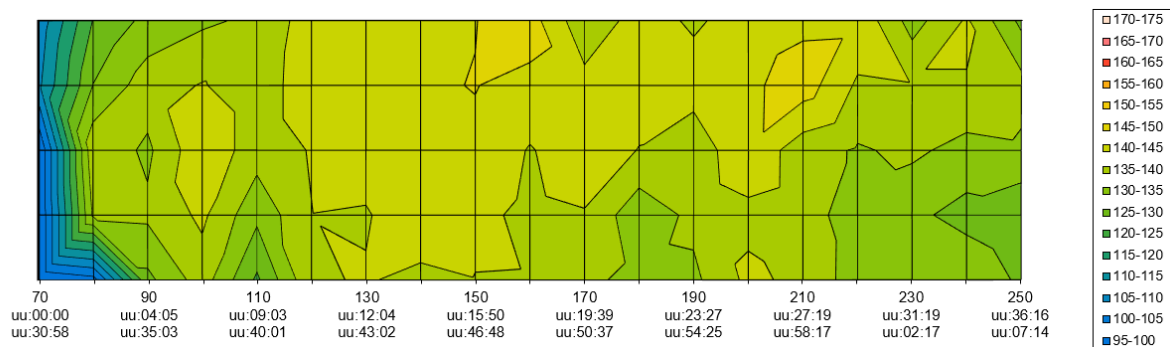
Figure 25: Temperature Contour Map Wednesday Lane 2

The temperature contour map for the second lane paved on Wednesday night can be seen in Figure 25. This map starts at 70 meters in because there is no data available from the first 70 meters. The start of the paving is very cold relative to the rest of the temperature contour map. The average temperature of the first 10 meters (70-80) is 95.8 °C. After this issue the temperature quickly rises to between 130 and 140 °C for the remainder of the entire section paved. Other than roughly the first 10 meters, the rest of the mat has a very good temperature homogeneity.

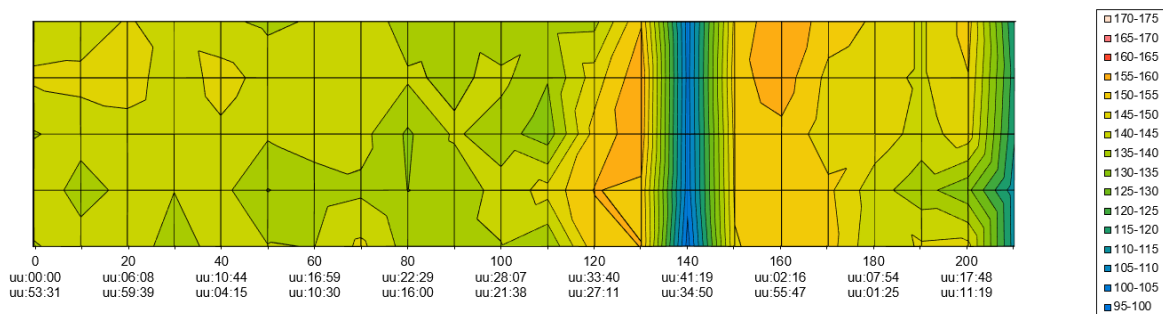
Figure 27: Temperature Contour Map Thursday Lane 1

In Figure 27 the temperature contour map for the first lane paved on Thursday night can be viewed. Roughly the first 110 meters shows very good temperature homogeneity with temperature ranging between 140 and 150 °C. At around the 120-meter mark a paver stop occurred. The temperature first rises slightly (to 156.2 °C at 130 meters) and then drops extremely quickly. At the 140-meter mark the temperature has dropped to only 101.4 °C. At 150 meter the temperature has risen again to 151.3 °C. After that, from about 150 to 200 meters, the temperature stays decently high and only fluctuates within a range of 10 °C. At the end of the paving operations the temperature drops rapidly again to 114.4 °C at 210 meters. Compared to other temperature contour maps, the temperature homogeneity is quite poor. The first section (0-110 meters) is good, but the large temperature dip at the 140-meter mark, and the smaller, but still significant, temperature dip at the 210-meter mark are negative.

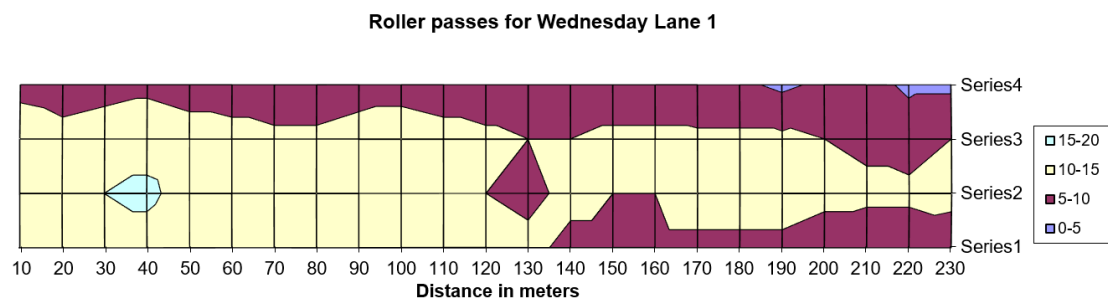
Figure 29: Roller Passes Map Wednesday Lane 1

The amount of roller passes over the asphalt mat laid on the first night in lane 1 can be seen in Figure 29. The majority of the asphalt mat was rolled between 10 and 15 times. There is one small section which was rolled slightly more (15 to 20 times) and there are two smaller areas which seem to have been largely forgotten since those areas only got rolled between 0 and 5 times. It is noticeable that the center of the lane was, on average, rolled more than the outside edges.

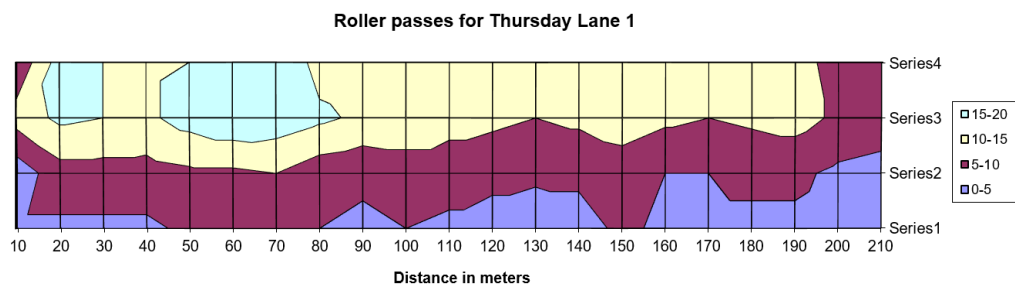
Figure 32: Roller Passes Map Thursday Lane 1

In Figure 32 the roller passes on the second part of lane 1 can be viewed. This roller passes map shows clearly that the bottom/southern side of the road was compacted considerably less than the opposite side. For much of the bottom half the asphalt mat has only been rolled 0 to 5 times or 5 to 10 times, whereas the top half is largely rolled 10 to 15 times and even has areas that were rolled 15 to 20 times. This shows neglect for even coverage of the entire road.

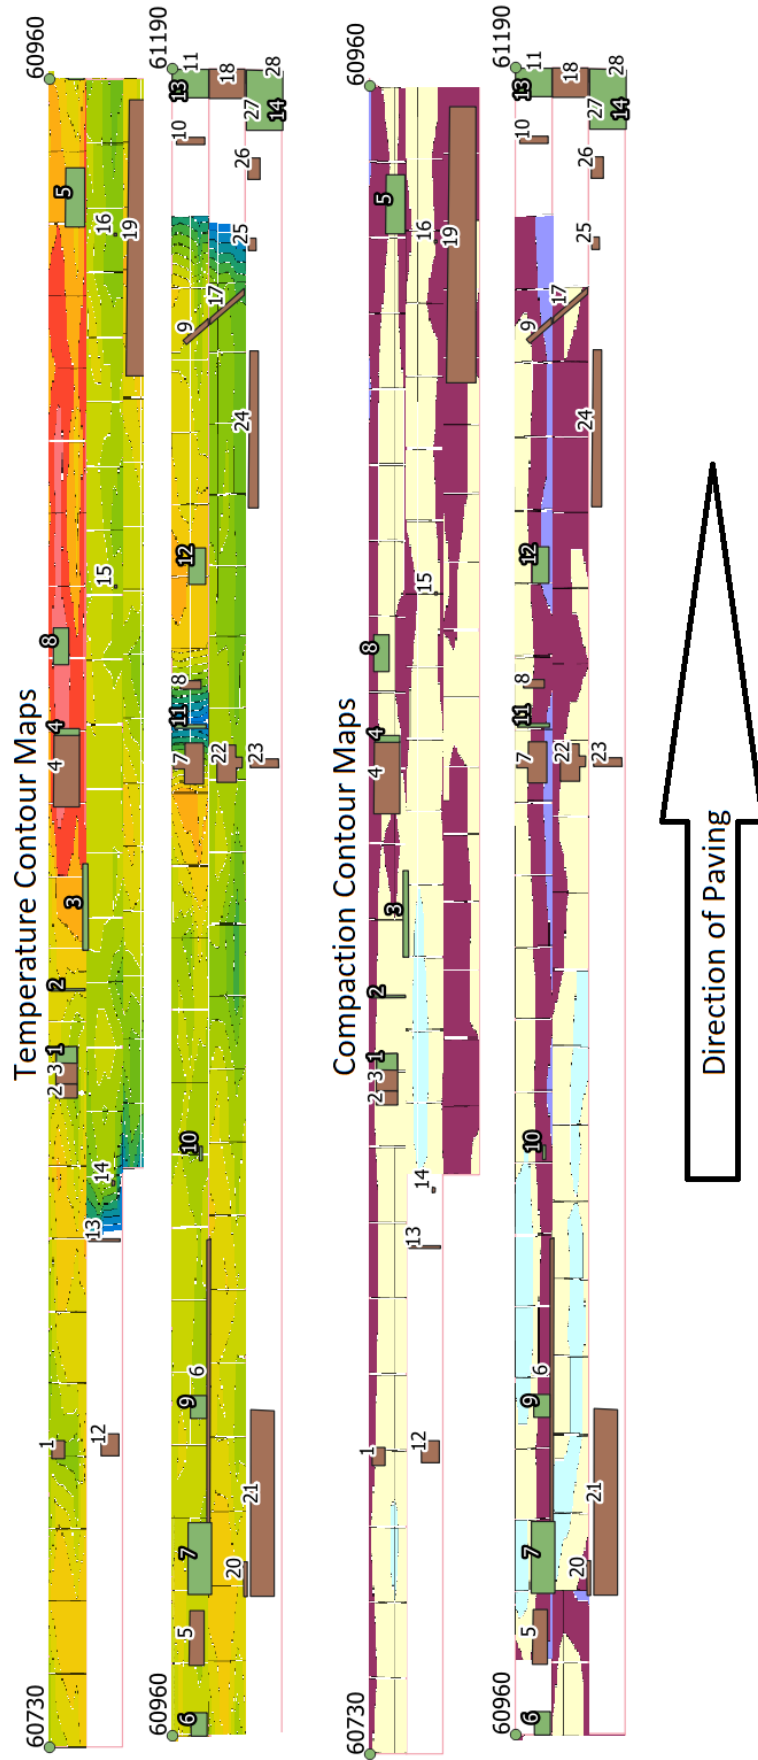
Figure 36: Temperature and Compaction Contour Maps Overlaid with Distress on A35

As can be seen in Table 5, there was quite a lot of data found; specifically, for the first lane (left lane). The visual inspection of the 2014 footage of the second lane (right driving lane) showed less distress and it was not possible to gather distress data from 2017 for that lane since at that point the entirety of that lane had been repaved. The third lane (the emergency lane) also showed less distress. Also, the second half of that lane has no available paving data (both temperature homogeneity and compaction) which made analysis impossible.

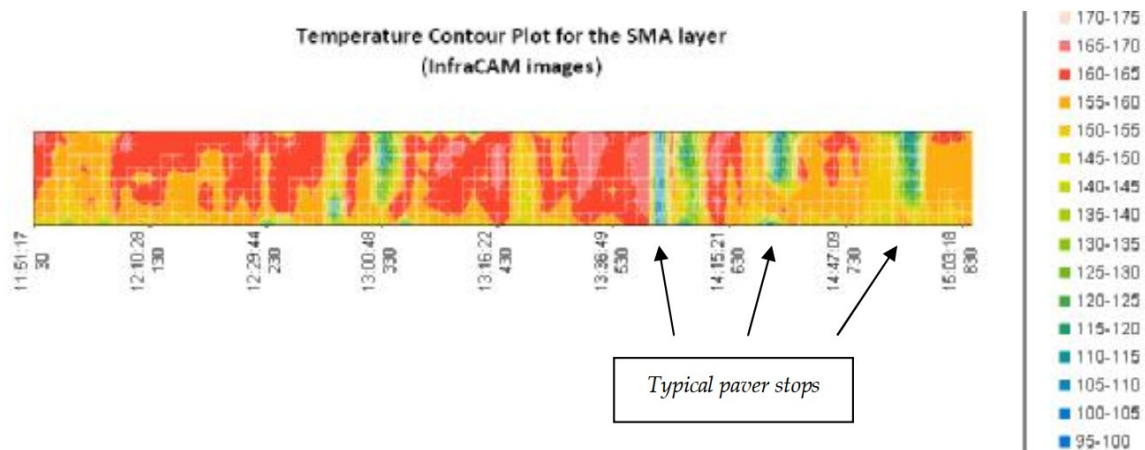
Figure 38: Temperature Contour Map Aziëhavenweg Method 1

The image above (Figure 38) displays the temperature contour map made of the Aziëhavenweg using the first method discussed. It is clear that a large majority of the asphalt mat had temperatures between 150 and 170 °C. There are smaller areas which deviate slightly and a couple of areas which deviate greatly. An example of the slightly deviating areas is that some of the dark red areas also have light pink areas which are above 170 °C. The areas which will be most likely to cause problems are the area which have very different temperatures than the rest of the asphalt mat. Refer to the section on Asphalt Temperature for an understanding as to why this is such an issue. The areas that might pose a problem are the paver stops. When the paver stops that area of the asphalt mat cools down. There are three stops clearly visible at roughly 570 meters, 670 meters, and 790 meters. These have also been pointed out in the image. Additionally, there are cold spots at roughly 280 and 340 meters. The temperature drops of the asphalt mat can be seen clearly in Figure 39. From this image it can be clearly seen that most of the cold spots have a similar low temperature; around the low 130's and 120's °C. However, the cooler area which is also most visible in the temperature contour map, is much cooler. That area had a low temperature of just below 100 °C.

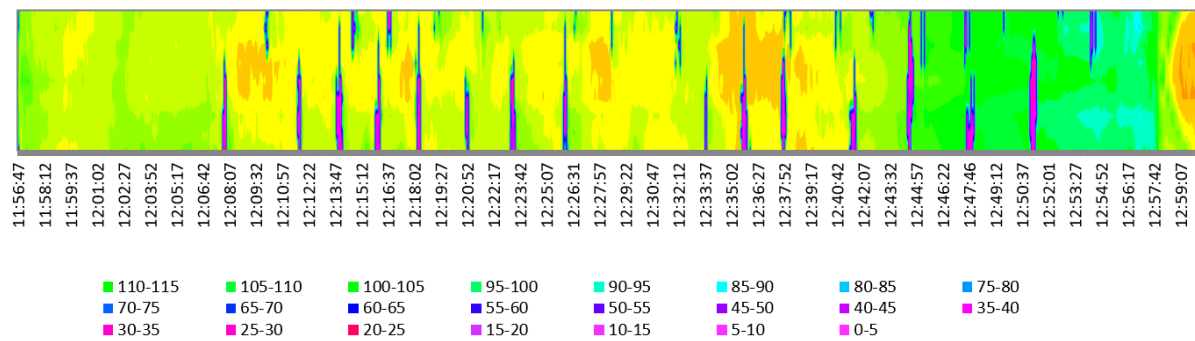
Figure 40: Temperature Contour Map Aziëhavenweg Method 2 hour 1

The larger part of the first hour (Figure 40) shows good temperature homogeneity. The temperature is shown to be roughly between 130 and 150 °C. At 12:41 a stop was needed which caused the temperature to drop to slightly below 100 °C. At the end of this hour the quick change in temperature after the stop can be observed. After the paving resumes, the temperature rises quickly back to between 135 and 155 °C.

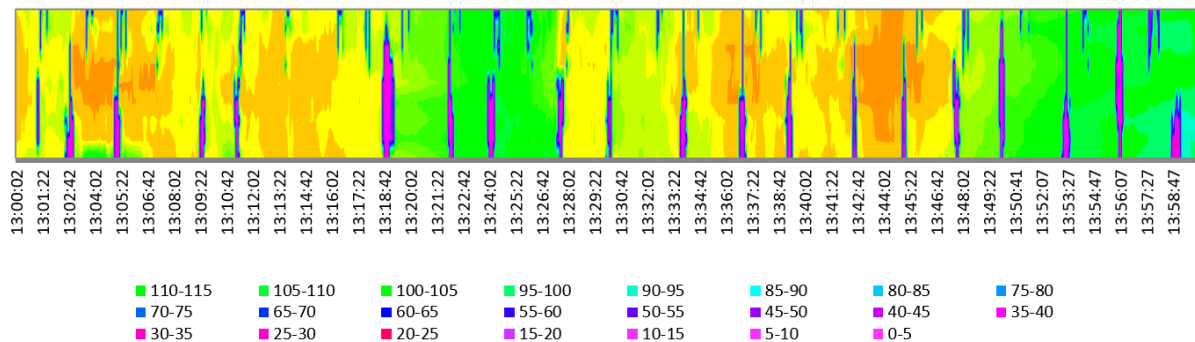
Figure 41: Temperature Contour Map Aziëhavenweg Method 2 Hour 2

The temperature stays within this range achieved at the end of the first hour for the majority of the second hour (Figure 41) except for one stop halfway and one stop at the end. The stop halfway starts at 13:18 because of a break for the workers. The temperature then seems to drop to around 100 °C. The final stop in the hour starts at 13:45 and, again, causes the temperature of the asphalt mat to drop considerably a few minutes after.

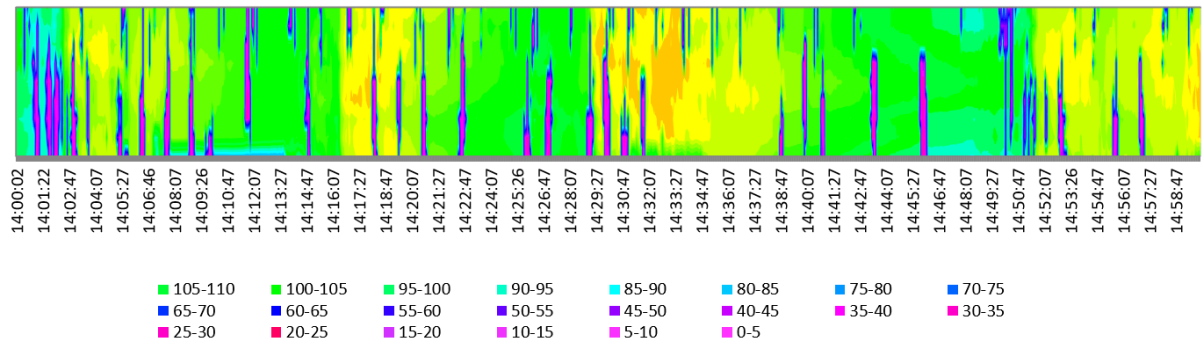
Figure 42: Temperature Contour Map Aziëhavenweg Method 2 Hour 3

The third hour of paving (Figure 42) sees four cold patches. The first stop witnessed began in the second hour. After that, three additional stops take place at 14:07, 14:19, and 14:37. During these three stops the temperature dropped to around 100 °C. In between the stops the temperature was roughly between 125 and 150 °C.

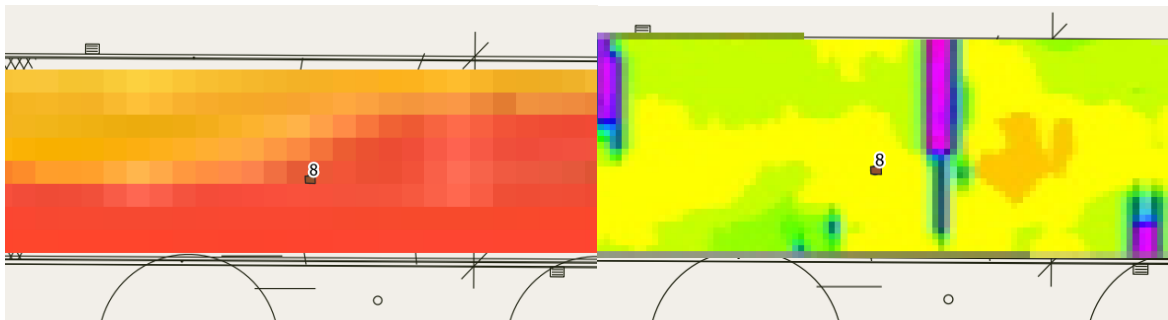
Figure 53: Point 8 TCM Method 1

- Point 8: light raveling

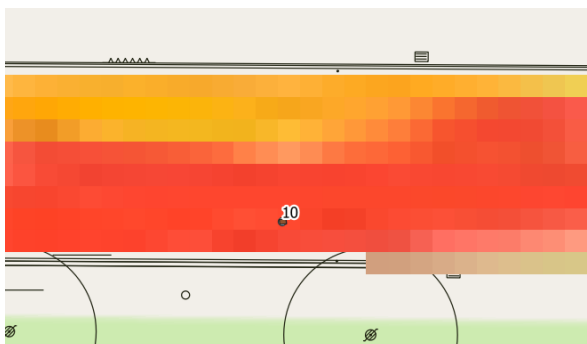
Figure 56: Point 10 TCM Method 1

- Point 10: light raveling
