MAINTENANCE LAYER ANALYSIS FOR A LEVEE STRENGTHENING USING SANDY SHORES IN A NON-TIDAL ENVIRONMENT

Author: Loek Hahn

Civil Engineering department, University of Twente. Internship at Rijkswaterstaat. University of Twente supervisor: Dr. ir. G.H.P Campmans. Rijkswaterstaat supervisors: Ir. R.J.A Wilmink and Dr. E. Brand. Date: 17-11-2020

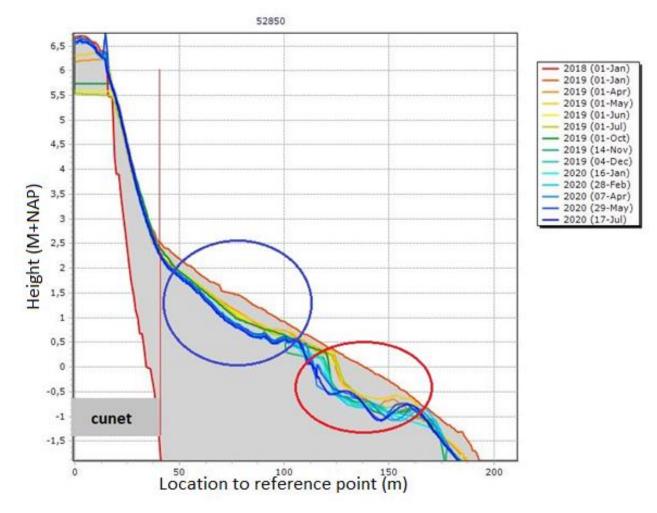
Data above NAP +0,5 m and at least 40 m from the dike was used to investigated subsidence. This has to do with for example the supportive presence of a cunet. This cunet causes the first 40 meters from the reference point (centre of the road on the Houtribdijk) to barely have any subsidence in this "cunet supported zone" (left of the vertical red line in figure 11). Furthermore, the area where waves start to impact the sand surface profile between NAP+0,5m and NAP-0,5m (the morphological zone, red circle figure 11) must be excluded. This leaves only a small area where the sand profile (mostly) subsides due to compaction of the subsoils (blue circle figure 11).

These areas differ for both sides of the Houtribdijk. For the IJsselmeer side this location is on average between meters 40 until 75 from the reference point (blue circle figure 11). For the Markermeer side of the Houtribdijk this section is between 30 until meter 100 from the reference point on the Houtribdijk.

Figure 11 "Cunet supported zone" (left of the red vertical line), subsidence analysis zone (blue circle) and morphological zone (red circle).

Visually figure 11 shows how the platform appears to have an equilibrium at around NAP -0,7m. However, when looking at the shoreline (red circle figure 11 and red circle figure 12) this seems to move fairly linearly land inwards. By the use of MorphAn and the converted data in Matlab a relation in how the shoreline moves over time can be found and what results this has for the morphology of the maintenance layer.

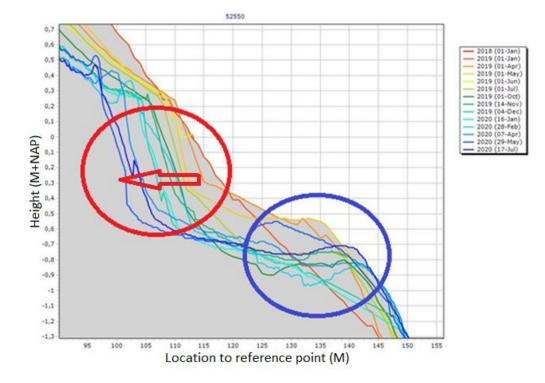
• There is a loss of volume in the morphological zone (red circle figure 12) whereas there appears to be a volume increase in a lower lying location (blue circle figure 12).

• The rapid change in shore-line movement (red circle in figure 12).

Figure 12 "Morphological zone" from the sandy shores at the Houtribdijk (red circle shore line movement), (blue circle platform equilibrium).

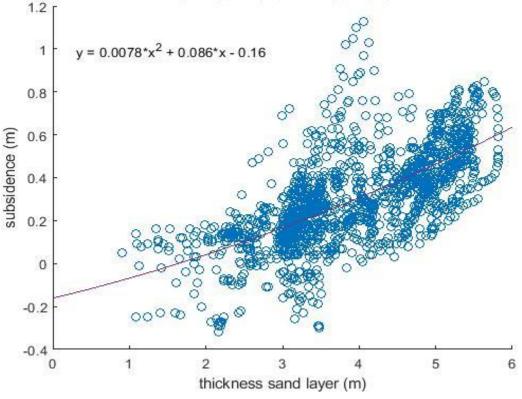
Figure 13 shows a scatter plot for all the measurements from 01 January 2019 until the most recent measurement 17 July 2020 for the IJsselmeer side of the Houtribdijk. This scatterplot shows a relationship between the subsidence with the thickness of the sand layer. The trendline, a second order polynomial, is weakly quadratic. There are certain outliers in the scatterplot, these can be explained by for example morphological changes that are not taken into account in this plot. In general, the trendline corresponds well with most of the data points.

(01-1-2019 until 01-6-2019 and 16-1-2020 until 17-7-2020) in which data at the IJsselmeer side was collected. Based on figures 13 and 14 it can already be stated that when looking at the y-axis the sand layer subsides substantially more in the beginning stage after construction compared to a later stage. This complies with the logic of a gradually slower subsidence since the sand layer gets more compact over time. As shown in figure 15, the data shows that the sand layer has settled for the most part and that there are minimal differences even over a 6-month period. The data show that the subsidence is substantially larger in the first few months after construction in comparison with a later stage.

Figure 13 Subsidence scatterplot IJsselmeer side 1-Jan-2019 until 17-Jul-2020

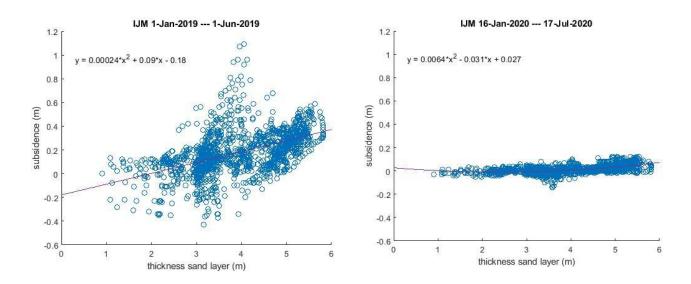
Figure 14 (left) and 15 (right) Subsidence scatterplot IJsselmeer side 1-Jan-2019 until 1-Jun-2019 (month 1-6 after construction) and 16-Jan-2020 until 17-Jul-2020 (month 12-18 after construction)

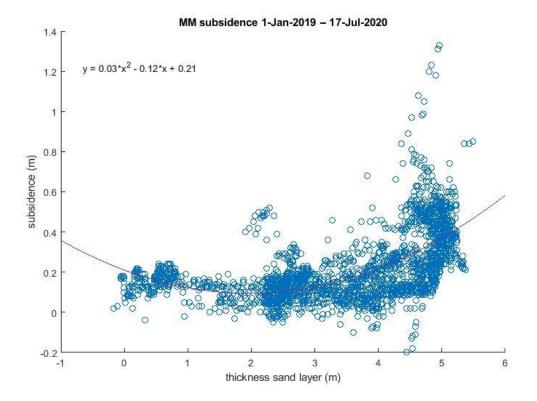
Analysing the results for the Subsidence scatterplot of the full dataset from 1-Jan-2019 until 17-Jul-2020, the results are shown in figure 16 and seem fairly similar to the scatterplots at the IJsselmeer side. As expected just like the IJsselmeer side of the Houtribdijk the sandy shores on the Markermeer side of the Houtribdijk seem to have a similar relation for the subsidence compared to the thickness of the layer. There seems to be a slight exponential relation for when the sand layer gets thicker, the subsidence increased exponentially.

Figure 16 Subsidence scatterplot Markermeer side 1-Jan-2019 until 17-Jul-2020

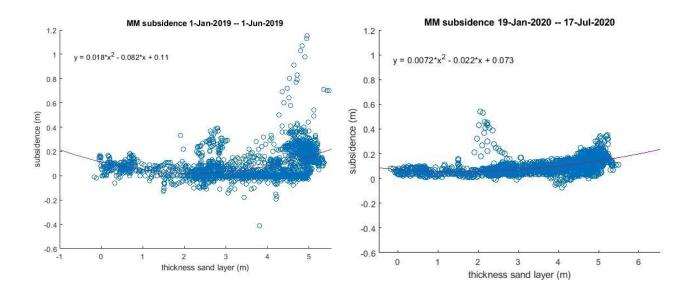
Comparing figure 17 and figure 18 which represent the first stage of the sand layer after construction and a layer stage as comparison, the figures differ from those of the IJsselmeer side. The subsidence for the first 5 months after construction shows subsidence up to 0,4m which is slightly less but comparable to the values at the IJsselmeer side of the Houtribdijk. Furthermore, the last 6 months show for the Markermeer side a decrease in subsidence. When comparing figure 17 and 14 and figures 18 and 15 which show the same time frames but at the other side of the Houtribdijk it can be said that the figures show very similar x-y relations and it can be stated that the sandy shores subside more in the first stage after construction in comparison with a later stage.

Figure 15 (left) and 18 (right) Subsidence scatterplot Markermeer side 1-Jan-2019 until 1-Jun-2019 (month 1-6 after construction), and 19-Jan-2020 until 17-Jul-2020 (months 12-18 after construction)

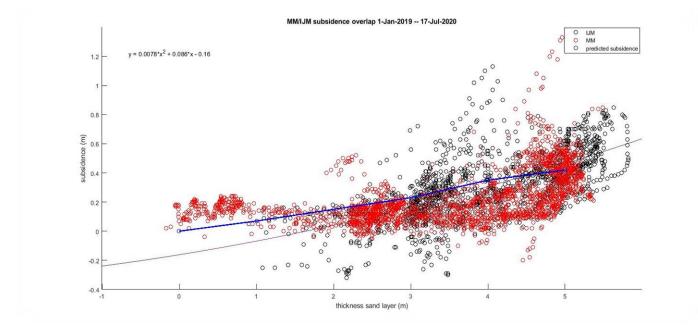
Figure 19 Subsidence combination scatterplot Markermeer/IJsselmeer 1-Jan-2019 until 17-Jul-2020, required 2-year subsidence compensation (blue line) compared to the 1,5-year observed subsidence (purple line).

Figure 19 shows a scatterplot for the subsidence measurements from both the IJsselmeer and Markermeer side. The subsidence shows a clear exponential relation with the thickness of the sand layer and taking an average over all these data points the exponential trendline clearly shows this relationship. Reflecting this trendline back to figure 10, one can see that the prediction for the subsidence compensation over a 2-year period (blue line figure 19) corresponds pretty well with the trendline prediction in figure 10. When for example looking at a 5m sand layer thickness it can be seen that this layer on average subsides 0,4m over an 18-month period.

For figure 19 it has to be noted that the data in this scatterplot Is for a 1,5-year period whilst the blue line in figure 10 is for a 2-year period (Arcadis, 2019). Considering this fact, it can be explained why the blue line seems to be on the high side compared to the plotted trendline in figure 19. In half a year (when the 2-year period is complete), the blue line will very likely be more in the centre of the scatterplot which would confirm a good prediction for the required subsidence compensation. Having concluded that the gross part of the subsidence takes place in the first few months after construction, the measurements for the exact 2 year period (measurements that will be taken in January 2021) are expected to correspond with those predicted by the blue line in figure 10.

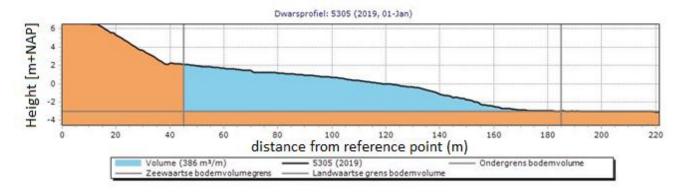
Having performed multiple volume analyses for different locations at the Houtribdijk, there appears to be a trend in how the sand profile evolves and the volume loss/gains in cross shore direction. Figure 20 shows an example what the sand profile looks like right after the construction of the sandy shores. The sandy shores have a smooth slope over 140 meters in cross shore location. The volume for this specific alongshore location is 386 m³/m. This volume has its boundaries in height and cross shore location. The boundaries used for this analysis are in height: NAP -3m and in cross shore direction 45m from the reference point.

Figure 16 Sand volume and profile in cross-shore direction right after the creation of the sandy shore (1-Jan-2019).

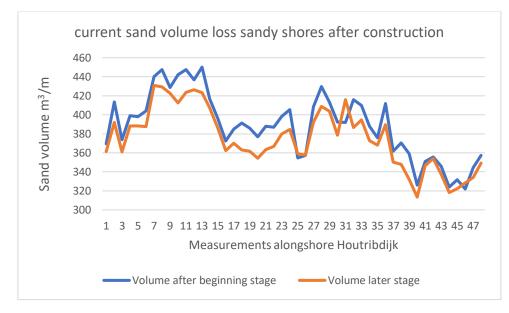
there seems to be a net volume loss between 0 m^3/m and 30 m^3/m over all alongshore locations (X-axis showing the amount of transects this calculation has been performed at) shown in figure 22.

Figure 22 Current sand volume loss sandy shores after construction (18-month period from 01-1-2019 until 17-7-2020).

On average there has been a loss of $25m^3/m$ in alongshore direction. This average is decided by taking all detail locations and comparing their total volumes bounded by 40m from the reference point and NAP -3m. The total volumes to get to this average volume loss value can be found in appendix 8.1. The volume calculations where done for a stretch of 140 meters in cross-shore direction on sand profiles that have an average sand thickness of 3 meters in cross-shore direction. Reflection this back to the subsidence results an estimation can be made on how much of this sand volume loss is due to subsidence: On average a sand thickness of 3 meters shows an average subsidence of 0,15 meter (with the assumption that sand under water subsides the same way as it does above water) from the moment of construction until the last measurement (17-jul-2020). In the full cross shore direction this results in $21m^3$ sand loss. This means on average an alongshore sand loss of $21m^3/m$. This shows that the gross part of the volume loss is due to subsidence and only a small part due to morphological developments.

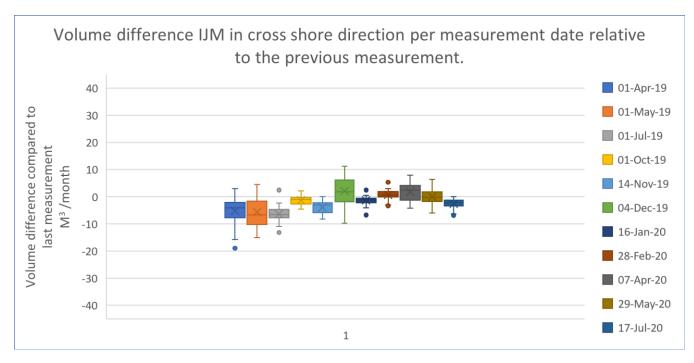
Figure 23 IJsselmeer volume loss M³ /month difference per measurement date.

Figures 23 and figure 24 show the volume differences for each measurement date compared to its previous measurement on every location at the Markermeer and IJsselmeer side. There seems to be strong decrease in sand volume for the first few months for most alongshore locations. In figures 23 and figure 24 there appears to be forming an equilibrium in sand volume for a later stage of the Houtribdijk.

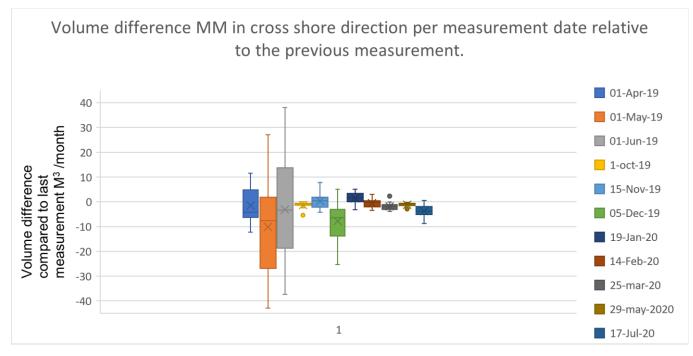
Figure 24 Markermeer volume loss M³ /month difference per measurement date.

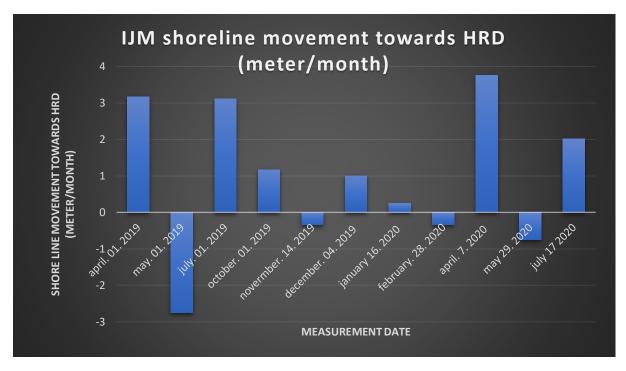
An interesting observation since the periodic monitoring is the shoreline movement (which lies between -0,3m NAP and -0,5m NAP). Although the evolution of the "plateau" in the sand profile (Ton, 2019) seems to find a relatively fast equilibrium, the land inwards shore line movement seems to continue on longer. Figure 25 and figure 26 shows a plot where the shoreline from all periodic measurements for both the Markermeer and IJsselmeer side at all measurement locations have been analysed and compared with its previous periodic measurement. Due to the time in between measurement dates not being consistent, the values are converted in shoreline movement per month. The trend over these measurements show a land inwards shoreline movement for the IJsselmeer side (figure 25). But when looking at the Markermeer side this trend is strongly decreasing over time (figure 26). The difference has to do with the peak for the IJsselmeer side at April-7-2020 and another in july-17-2020. These peaks in shoreline movement cannot be explained by the potential occurrence of any strong storms and remains a questionable observation.

Figure 25 Shore line movement at the IJsselmeer side.

This movement of land inwards shoreline show the natural variability between the two sides of the Houtribdijk. Figures 25 and 26 can help in the prediction when the set intervention line (BOL) will be exceeded. When the shoreline exceeds this line, maintenance to the Houtribdijk is required to stay within the safety regulations that are set for the sandy shores. Looking at figures 25 and 26 it shows that the shoreline at the IJsselmeer side moves faster compared to the Markermeer side. Due to aspect like the angle in which waves hit the sand body, stronger periods of wind and other morphological aspect the differences between the Markermeer and IJsselmeer side could possibly be explained. However, these aspects are not taking into account due to limitation of time for this research. Eliminating the initial subsidence for the first half year and looking at the trend and the values from figures 25 and 26, the BOL will most likely be exceeded in 5 to 6 years for the IJsselmeer side considering my research results.

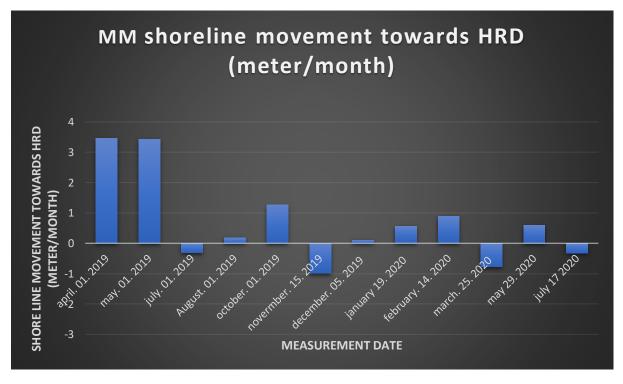
Figure 26 Shore line movement at the Markermeer side
