Impact of animal burrows on the stability of Dutch dikes

A sensitivity analysis of the effect of relevant animal species on failure mechanisms GEKB and STBI at the IJssel dike

L. H. (Leon) Sloopman

This document contains the findings of my Bachelor thesis “Impact of animal burrows on the stability of Dutch dikes”. This thesis is the final part of my Civil Engineering Bachelor program at the University of Twente and has been performed in collaboration with Witteveen+Bos.

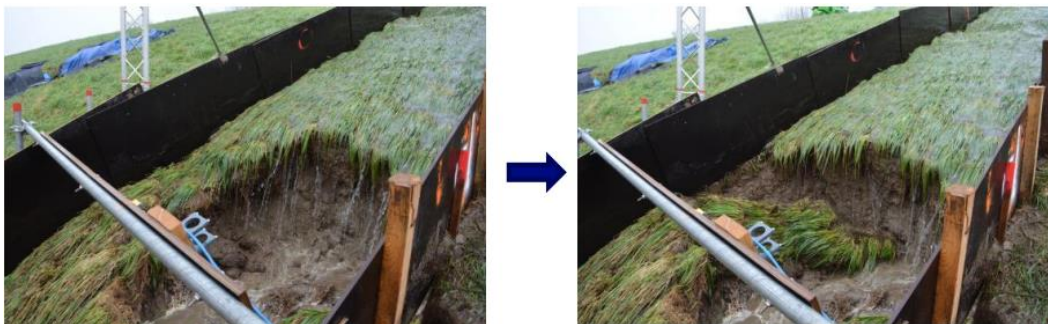
Burrows located in the slope can lead to erosion of the revetment layer of a dike. The burrows create weak points within the revetment layer, making it easier for hydraulic and other loads to damage the revetment. When these damages are not properly monitored and addressed, they can lead to failure of the revetment layer. A figure showing an advanced stage of this type of erosion is visible in Figure 6.

Figure 6: Erosion of the revetment layer (and the slope beneath) in an advanced stage (Deltares, 2023a).

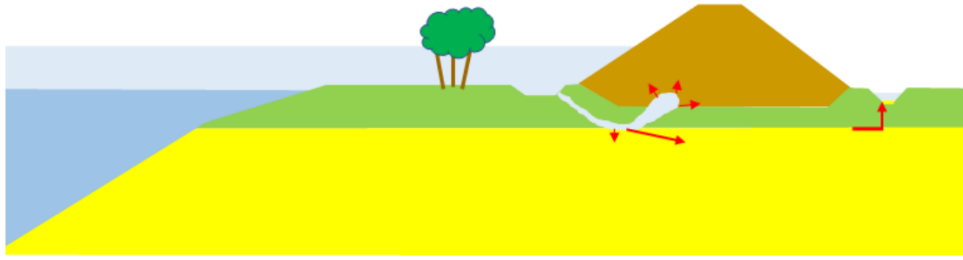
An animal burrow on the inner or outer slope of a dike can create contact between the water body and the sand layer or it can shorten the seepage length, if the layer above the sand layer is completely penetrated. This is only possible for species that can dig deep enough. This means that species such as the beaver, badger, nutria and muskrat form a potential risk. A schematisation of an animal burrow reaching the sand layer is visible in Figure 7.

Figure 7: How a burrow can shorten the seepage length, increasing the risk of piping (Deltares, 2023a).

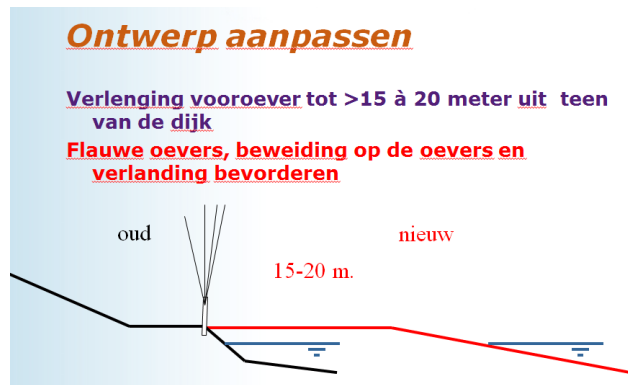
Extending the foreshore is another measure to mitigate the effects of animal burrows. This measure does not prevent animals from digging burrows, but instead moves the shore away from the dike. This makes the slope of the dike an unattractive area for most burrow digging animals, as most prefer to dig close to the water level. This measure moves their preferred habitat to an area where the animals can safely dig without impacting the dike. An example of such an extension is visible in Figure 9 (Waterschap Rivierenland, 2016).

Figure 9: Extending the foreshore as a mitigative measure against animal burrows (Waterschap Rivierenland, 2016).

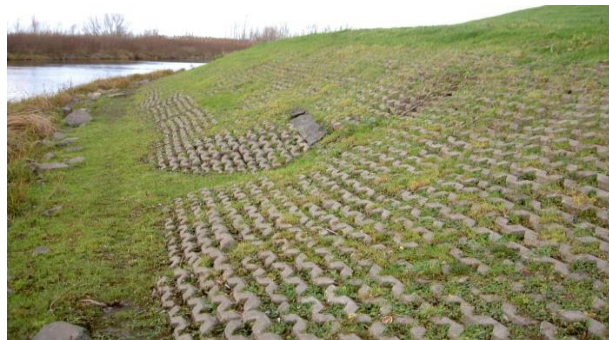
A straightforward way to prevent burrows is installing physical obstructions to make digging impossible. Water board Rivierenland has investigated several of these. Installing hard materials such as basalt blocks, rubble, or asphalt on the slope prevents burrows from taking place. An example is the grass paving revetment that was installed at the Erlecomsedam on the Waal river for this purpose. This is visible in Figure 10.

Figure 10: Grass paving revetment to prevent animal burrows at the Erlecomsedam (Waterschap Rivierenland, 2016).

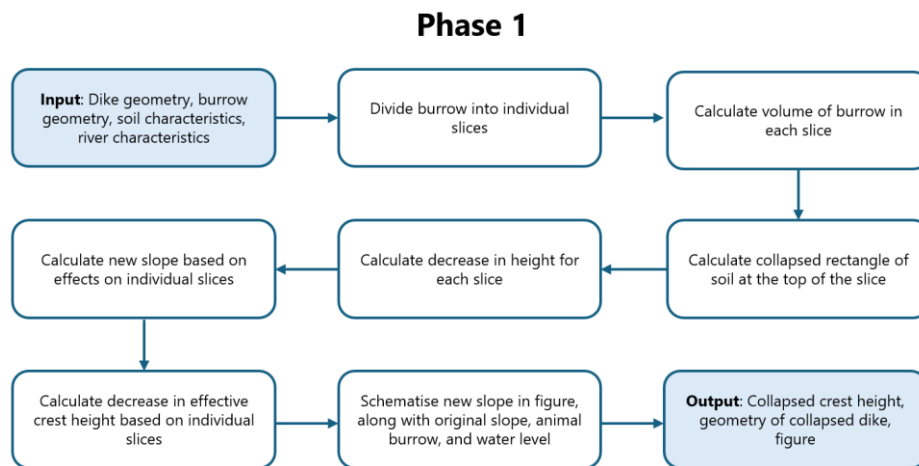
In the first phase, the decrease in effective crest height is calculated. Figure 13 shows an overview of the steps taken in phase 1.

Figure 13: Schematisation of phase 1 of the burrow collapse model

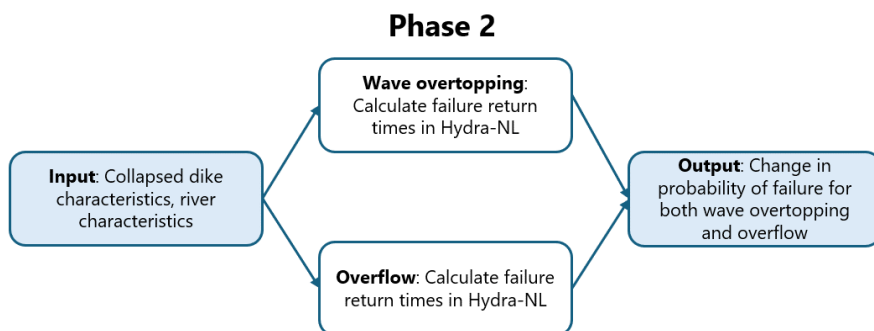
In phase 2 of the GEKB model, the characteristics of the dike and the river are used to calculate the probability of overflow and the wave overtopping. This is done in the program Hydra-NL. Hydra-NL is a programme that calculates the statistics that result from hydraulic loads, for the assessment of primary dikes in the Netherlands. Hydra-NL takes the collapsed crest heights that result from phase 1 along with river characteristic. It uses this data to calculate the failure return rate for both wave overtopping and overflow. These are done separately. A schematization of this is visible in Figure 18.

Figure 18: Schematisation of phase 2 of the burrow collapse model

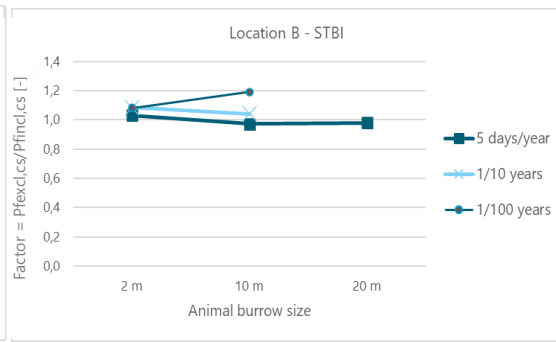
Figure 33: Relative failure rate increase at location B

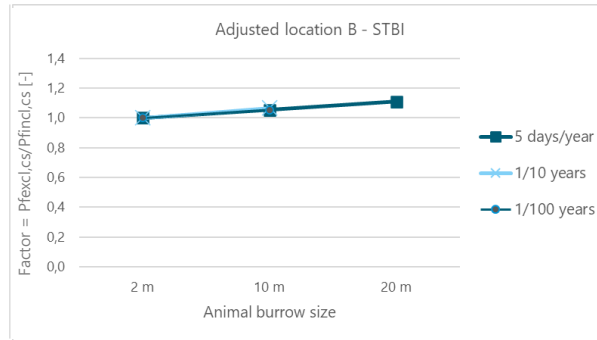
Figure 34: Relative failure rate increase at adjusted location B

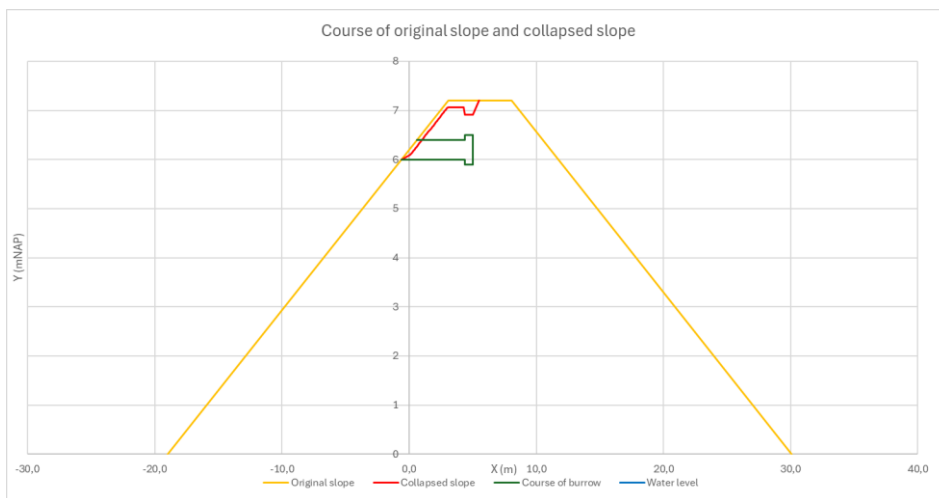
The greatest amount of settlement took place in case of badger burrow 5 at location B. This is visible in Figure 38. While a section of the burrow is left unaffected, this section is smaller than three meters, meaning that entire crest is considered to have collapsed. The burrow is located very high in the slope, as the badger digs its burrow high above the water level and the phreatic line, in unsaturated soil.

Figure 38: Simulation of badger burrow 5 in location B
