A Technical End-of-Life Assessment Approach for Steel Bridges

*Construction Management track,
Civil Engineering & Management, University of Twente*

Master's Thesis

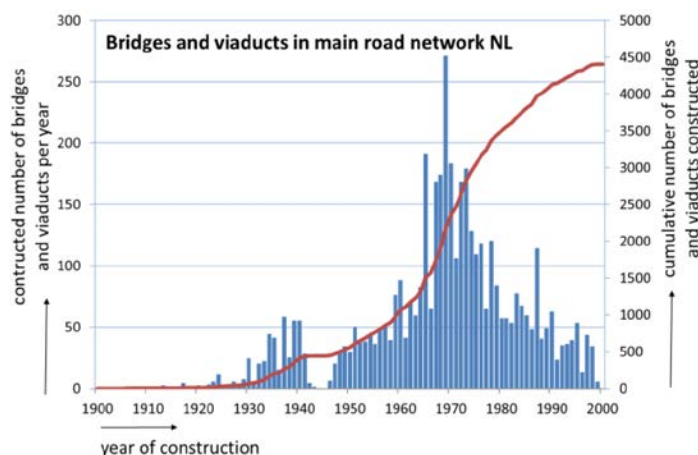
FIGURE 1: NUMBER OF BRIDGES AND VIADUCTS CONSTRUCTED PER YEAR, AND CUMULATIVE NUMBER OF BRIDGES AND VIADUCTS IN THE NETHERLANDS (BASED ON RWS DATABASE) (ABSPOEL - BUKMAN ET AL., 2023).

After the devastation caused by World War II, numerous European countries began a phase of heavy construction to rebuild the continent. Between 1950 and 1975, the Netherlands saw economic growth that had a bidirectional link to the infrastructure transportation networks within the country; as a result, there was a boost in the construction of bridges and viaducts (Xie et al., 2018). Within the Dutch territory, there is an extensive network of approximately 85,000 bridges and viaducts (Bleijenberg, 2021) (Figure 1).

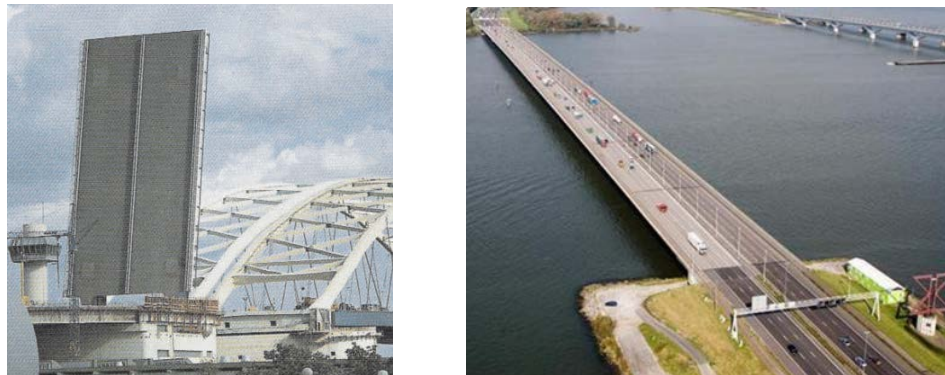
FIGURE 2: (LEFT SIDE) MOVABLE BRIDGE – VAN BRIENOORD BASCULE BRIDGE AND (RIGHT SIDE) FIXED BRIDGE – MOERDIJK BRIDGE A BOX GIRDER BRIDGE (ROMEIJN, 2006) AND RIJKSWATERSTAAT.

Bridges, both fixed or movable (Figure 2), stand out as indispensable structures that drive the economic and social growth of nations (Hartmann & Bakker, 2023). Due to their importance, understanding the risks related to aging, safety, and environmental dangers associated with the physical integrity of these structures became crucial (Chang et al., 2003).

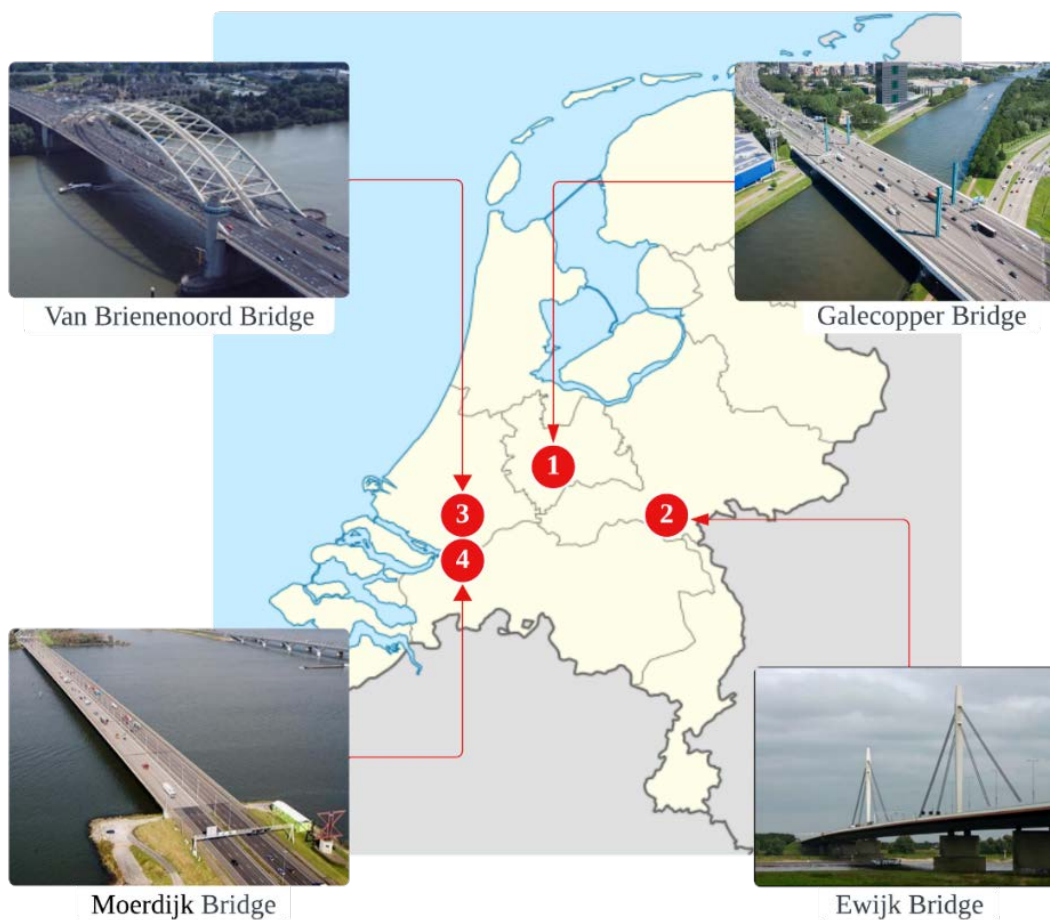
Figure 29: Overview of the selected case studies.

This sub-chapter illustrates and analyses real-world examples of steel bridges that are currently under the research program set up by RWS called Replacement and Renovation (V&R), bridges that already underwent a major intervention or that are planned to have a major intervention. Each of the analysed bridges will exhibit a brief description, images of the civil infrastructure asset, geometrical data, the TEoL framework, and an extensive analysis of the damages and defects discovered. Figure 29, indicates the selected case studies and their location within the Netherlands:

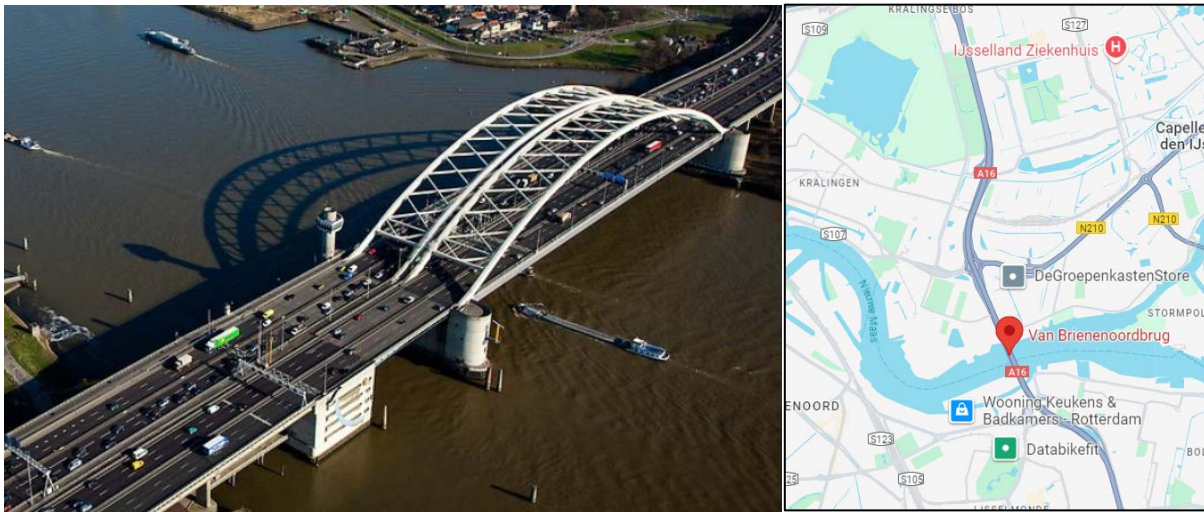
The Van Brienoord bridges are a set of movable steel bridges that are composed of an arch bridge section and a bascule bridge (Figure 41). Each bridge has a total length of 1320m; 300m is part of the arch bridge, and 60m for the bascule bridge. These infrastructure assets are located within the national highway A16 in the municipality of Rotterdam and over the new mass river. The Van Brienoord bridges comprise 12 lanes that carry about 230,000 vehicles daily and 120,000 ships per year, making it one of the busiest bridges in the Netherlands (Acosta et al., 2023) (Structurae.net, 2023b).

FIGURE 41: THE VAN BRIENOORD BRIDGE BY MEGACONSTRUCCIONES.NET, AND GOOGLE MAPS.

The Van Brienoord bridges were constructed between 1965 (I) and 1990 (II). In 1965, the western arch was first constructed, and in 1990, the eastern arch was incorporated. The arches have a high approximately of 40m and a width of 25m (old) and 27m (new) (Acosta et al., 2023).

During visual inspection in 1997, signs of fatigue cracks were detected within the OSD of the bascule bridge (Maljaars et al., 2012). Based on these defects and the noticeable increase in traffic intensity and load over the years, a major intervention is planned for 2025. This major intervention aims to strengthen the plate stiffeners to the main girders, and the arches, and add a new deck (Acosta et al., 2023).

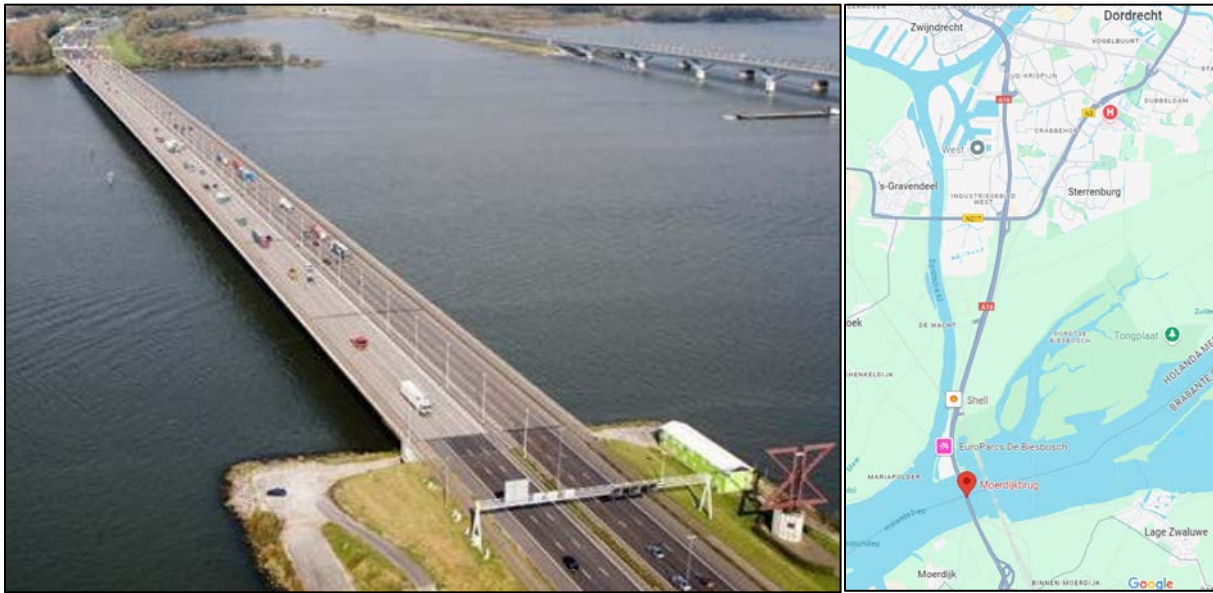
Standing as one of the major land connections in the country (>120,000 vehicles a day), the Moerdijk is a steel box girder bridge located at the crossing of the Hollands Diep within the municipality of Dordrecht and Moerdijk (Figure 47). Following the devastations of the Second World War and faced with escalating traffic demands, this infrastructure asset underwent multiple major interventions. The original structure became inadequate for increasing traffic needs, leading to the inauguration of a new, twice-as-wide bridge in 1976 to enhance the vehicle capacity. The bridge's deck is composed of ten spans of 100m each over a total length of 1,000m. The deck has a construction height of 3.5 meters and supports three lanes of traffic on each side (42.9 m wide in total) (Buitelaar & Braam, 2008).

FIGURE 47: THE MOERDIJK BRIDGE BY RIJKSWATERSTAAT, AND GOOGLE MAPS.

After the replacement in 1976, the original piers and foundation were retained. The replacement strategy involved utilizing a lighter deck composition (OSD), which allowed the deck to be widened to meet new traffic demands while keeping the dead load on the piers and foundation approximately the same. Despite these efforts, the Moerdijk Bridge has suffered from fatigue cracks throughout most of its lifespan, resulting in repairs every four to six years (Buitelaar & Braam, 2008).

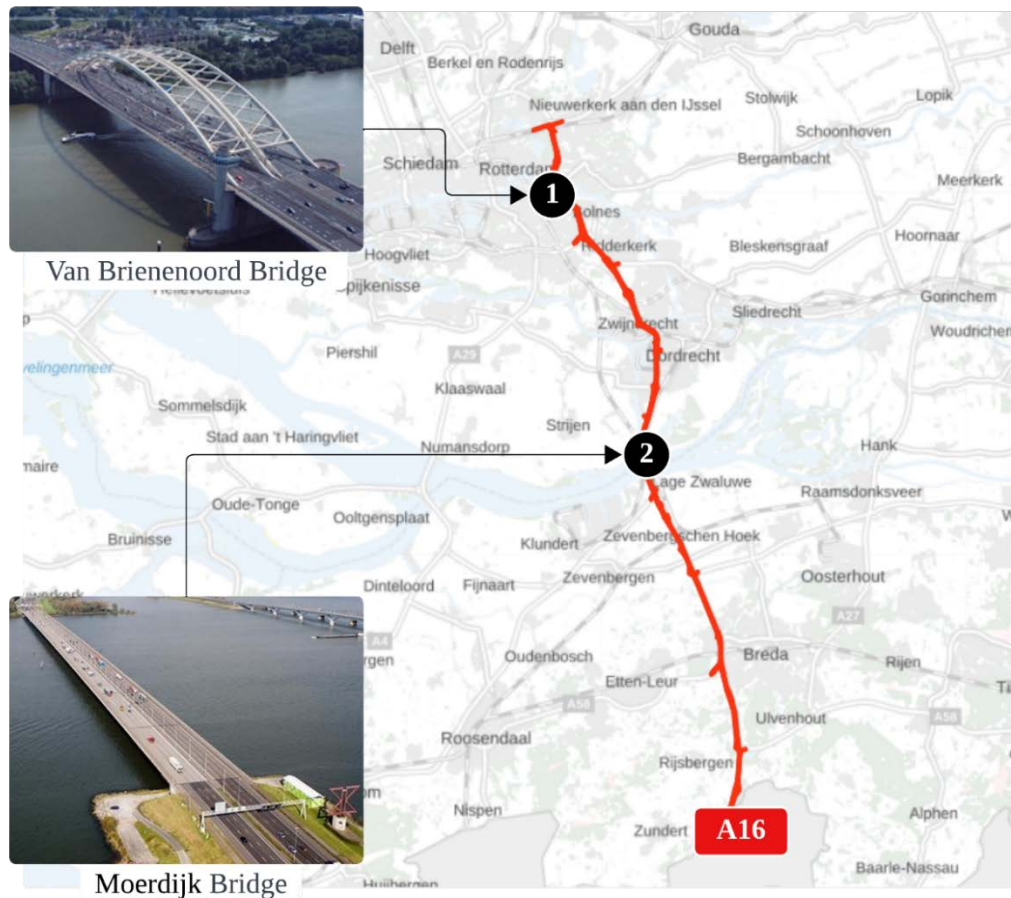
Figure 50, illustrates the Van Brienoord and the Moerdijk steel bridges within the national highway A16. Both of these bridges had similar problems with fatigue cracks. Based on the analysis within previous chapters, it was concluded that both had a deck plate of 12mm and attributed the fatigue cracks due to heavy traffic. Therefore, an area data, system part criterion was proposed based on Table 5. By analysing the variable heavy traffic intensity within the highway, other bridges within the same network can be assessed.

FIGURE 50: BRIDGES IN THE MOTORWAY A16 (GEO.RIJKSWATERSTAAT.NL, 2024)

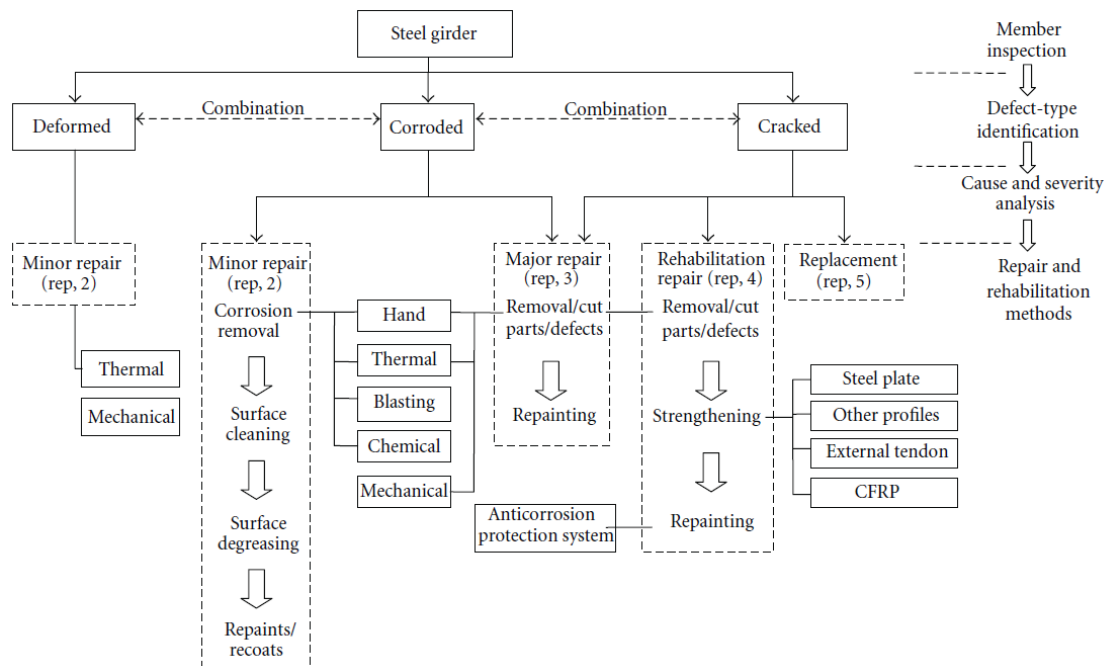
FIGURE 51: REPLACEMENT AND REHABILITATION METHODS FOR CONVENTIONAL STEEL GIRDER (SO ET AL., 2012).
