# LIFETIME AND DEGRADATION BEHAVIOUR OF PTFE COOLANT HOSES

## MASTER THESIS

**Chris-Jan Bolks**

**Faculty of Engineering Technology, Mechanical Engineering**

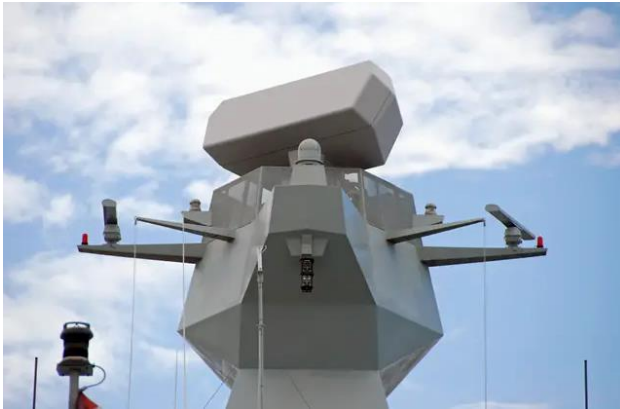
Figure 3: SMART-S Mk2 on a navy frigate

Returning to the radar products of Thales and highlighting the SMART-S Mk2. This radar is part of the Surveillance & multi-mission radar product line. SMART-S Mk2 is the naval 3D air and surface surveillance radar operating in S-band frequency. The multi-beam concept creates a long time-on-target resulting in excellent performance over the whole coverage. The system has two operating modes: medium range up to 150 km (81 nmi) at 27 RPM and long range up to 250 km (130 nmi) at 13.5 RPM [3]. Figure 3 and Figure 4 show an example of the SMART-S Mk2 radar positioned on a navy frigate and a detailed photo of the radar respectively.

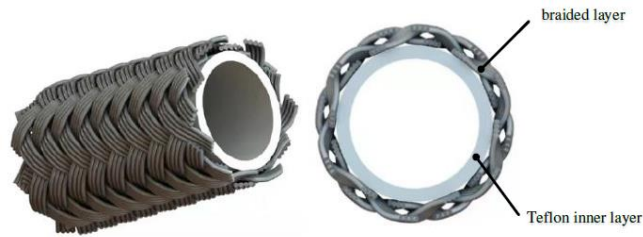
Figure 5: 3D model of a general PTFE hose construction

After studying the cooling liquid circuit it was noticed that different hoses are used between the equipment. The main differences are in terms of diameter, length and material used. The most commonly used coolant hose that was found, consists of a Polytetrafluorethylene (PTFE) inner core with aramid or stainless steel (SS) braided outer core. Figure 5 shows a schematic example of how these hoses are generally constructed.

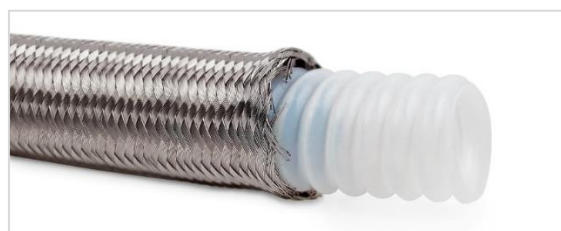
**Figure 14: PTFE hose with Stainless Steel outer braiding**

Operational performance of naval radar systems has increased in recent years due to advances in radar technology, data processing capabilities and much more. Thus, so too have the demands placed upon the systems. In particular, coolant systems must be capable of transporting fluid in extreme marine environments. As a result conventional plastic hoses (e.g. PE, PVC) and rubber hose assemblies have been developed to the limit of their operational capabilities. Recognition of the limitations of these conventional hose sparked the interested to seek an alternative hose lining and construction [22]. In this case, PTFE hoses offer an excellent alternative. An example of a PTFE hose with stainless steel braiding can be seen in Figure 14.

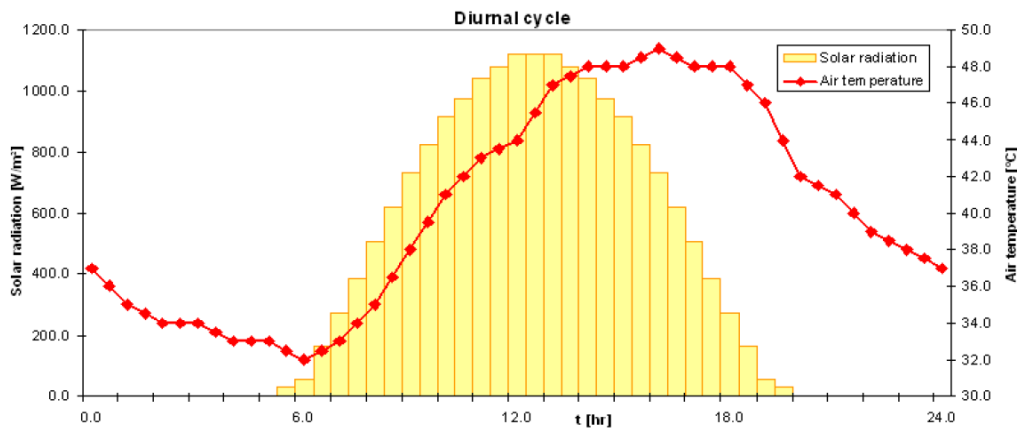
Figure 15: Diurnal cycle in hot environment

Laan [68] describes the temperature extremes across the globe for marine environments. It shows that a maximum of 49 °C could occur combined with 1120 W/m<sup>2</sup> solar radiation (Figure 15) and a minimum of -40 °C in cold environments.

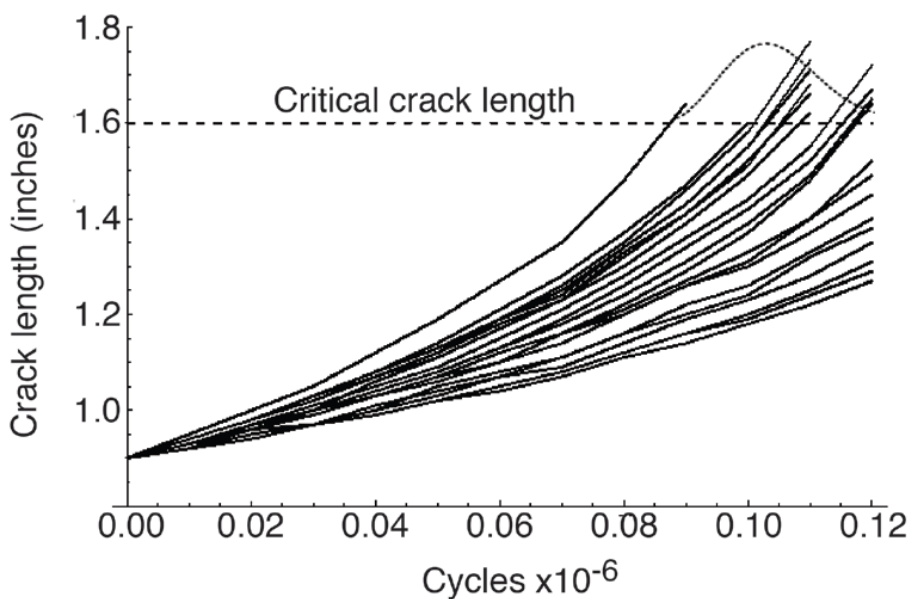
Figure 20: ADT approach; measuring crack length [52]

For highly reliable materials like PTFE, ADT offers an alternative approach by monitoring degradation over time instead of waiting for complete failure. Collins [52] suggests that this method is effective for materials that exhibit a gradual decline in properties, such as hardness, tensile strength, or elasticity. For PTFE coolant hoses used in naval radar systems, ADT may be especially useful due to the high durability of the material. By tracking performance degradation metrics (e.g., flexibility, tensile strength, or microcrack formation), researchers can predict hose lifespan without waiting for catastrophic failure. An example can be seen in Figure 20 in which the progression of crack length in a material is shown as a function of loading cycles. The individual curves represent different tests, all showing a gradual increase in crack length until reaching the critical crack length, after which catastrophic failure occurs. For highly reliable materials like PTFE, such data from ADT can be used to model microcrack growth and predict the service life before reaching the critical crack size.

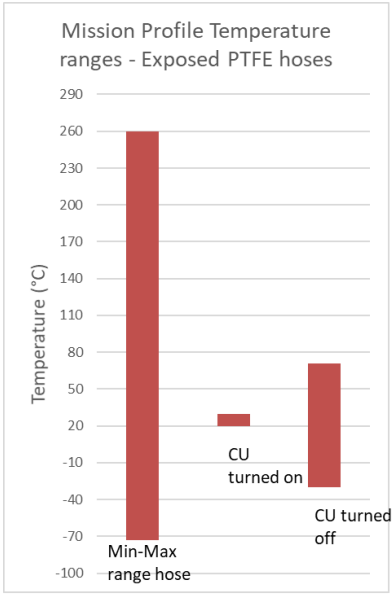
**Figure 26: Mission profile - Temperature loads on: exposed hoses,**

Next, the operational temperature loads and pressure loads were compared to the specifications of the hoses provided by the data sheets from Goodridge (Table 1). A mission profile graph is created to visualize the differences. Figure 30 presents the temperature range for the exposed PTFE hoses, highlighting the differences when the cooling unit (CU) is turned on and off. Figure 31 shows the similar thing for the sheltered PTFE hoses. Finally, Figure 32 compares the maximum burst pressure and operational pressure of both exposed and sheltered hoses, demonstrating the extreme differences between operational and burst pressures.

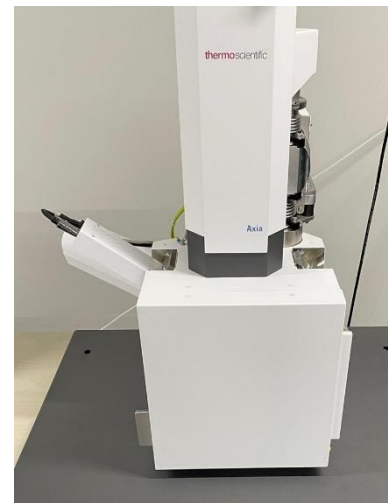
Figure 32: Microscopic SEM analysis machine: Thermoscientific Axia

The microscopic analysis were executed under room-temperature environments and data was collected by scanning the PTFE samples manually and searching for cracks, or discontinuities etcetera. After that, a High-Definition photo was taken and saved on the computer. Three most suitable enlargements have been chosen to use for each sample: 50x, 400x and 1600x. One PTFE sample per specific aging temperature and duration was analyzed. Samples were cut from the region in which the smallest radial bend took place. This ensures a region that contains the highest chance of observable cracks/degradation. The SEM analysis was outsourced to partner company DEON. Figure 32 shows the SEM machine used from Thermoscientific Axia.

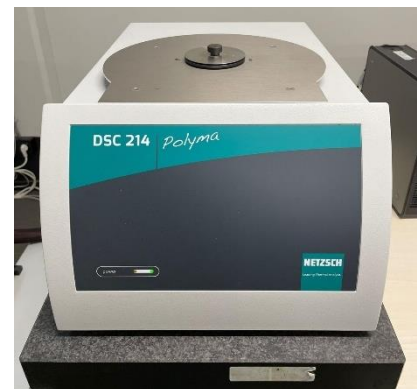
Figure 33: DSC machine: Netzsch

The analysis were executed under room-temperature environments and data was collected by turning on the DSC to let it start the heating and cooling cycle. After that, a plot has been generated and saved on the computer. One PTFE sample per specific aging temperature and duration was analyzed. Samples were cut from random locations of the hose as they should not interfere with the DSC results. The DSC analysis was outsourced to partner company DEON. Figure 33 shows the DSC machine used from Netzsch.

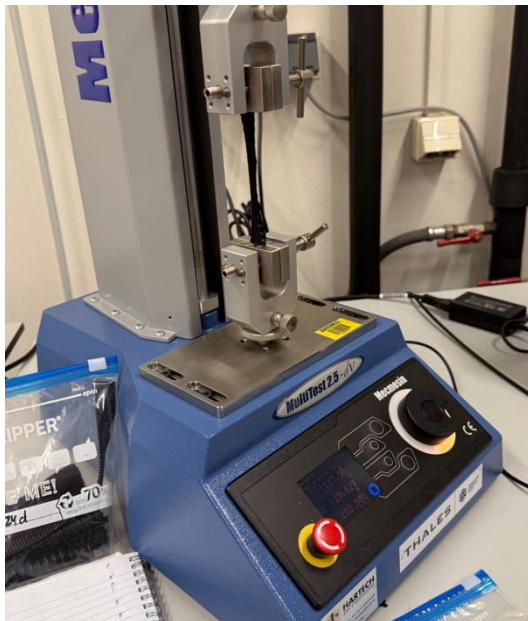
Figure 34: Tensile test setup

Dumbbell shaped hose samples were cut and tested in a small tensile test bench that was available at Thales. Each test run contained at least five hose samples tested in the tensile test. The displacement rate of the test bench was set to 200 mm/min. The samples were clamped tight using hand force so that they did not show signs of slip. The distance between the tensile clamps was set at 70 mm. Before the test was started, each sample was measured using a calliper on smallest width and length. All samples failed in the rejuvenated area of the sample, that is where the width of the sample is the smallest. The test bench used is the Mecmesin Multitest 2,5 dv, depicted in Figure 34 and contains a maximum tensile force of 2500 N. Figure 35 shows an example of how the hose samples were clamped during setup.

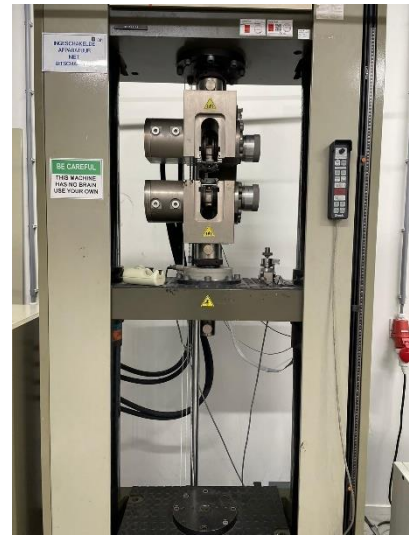
**Figure 36: Tensile test setup; heavy**

In this test, a full diameter hose has been tested by outsourcing it at partner company DEON. This test was set up in order to compare tensile results the dumbbell cut PTFE samples. A special clamping tool was designed and used in order to prevent the functional hose from slipping. A clamping force of 50 bar was used and a strain rate of 203 mm/min. The test bench used is depicted in Figure 36.

The two types of tensile tests were executed under room-temperature environments. Data was collected by sampling data points of the test bench in Force vs. Displacement values. This raw data was later translated to Stress vs. Strain pots.

The parameter(s) to be monitored, before and after accelerated aging, using the tensile test are: plastic modulus, maximum stress, maximum elongation.

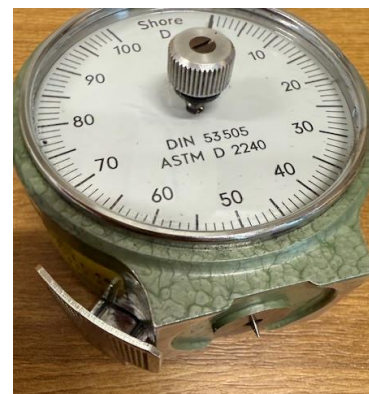
**Figure 37: Hardness measurement device**

The analysis were executed under room-temperature environments and data was collected by writing down the hardness values for the specific aging setpoint samples. Results showed an average error of +- 1 Shore D for basically all tested samples.

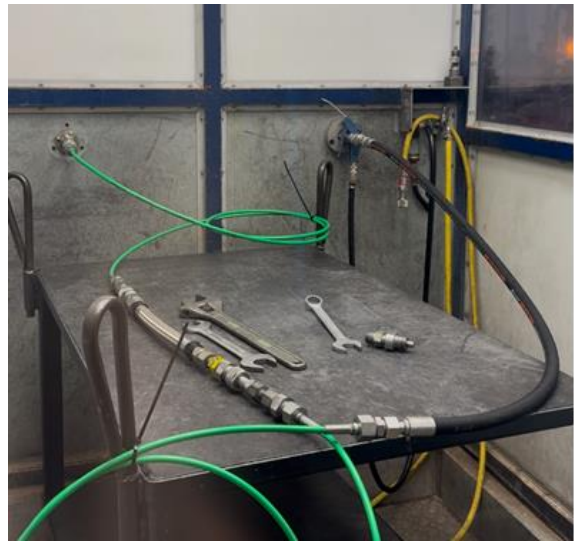
**Figure 39: Burst pressure test setup**

The burst pressure for these hoses is specified by Goodridge to be 315 bar. Consequently, the test was designed to reach 500 bar with a buildup pressure of 2,5 bar per second. The hoses were connected with the applicable torque settings specified by HSV-P-6031. Each hose was tested individually and put inside the protected burst test room. Figure 38 and Figure 39 shows the test room and the connected hose setup respectively.

The parameter(s) to be monitored, before- and after accelerated aging, using the burst test are: Leak pressure and burst pressure.

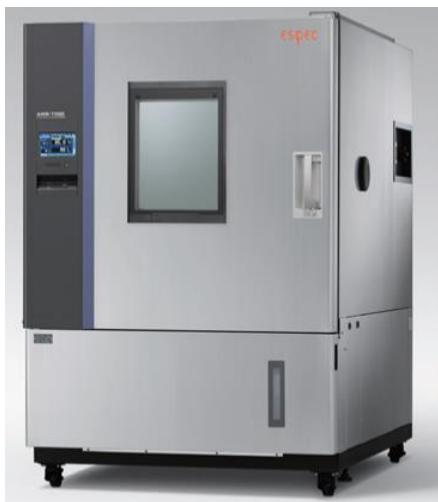
**Figure 40: Temperature & humidity chamber**

The temperature & humidity chamber depicted in Figure 40 was used to induce temperature cycling for test 1. Classified as the Espec ARG 860, containing a temperature range of -75 °C to + 180 °C, heat up rate of 6.0 K/min, allowable heat load of 4500 W and a capacity of 680 L. Maximum measurement uncertainty of this equipment is 1,02 °C

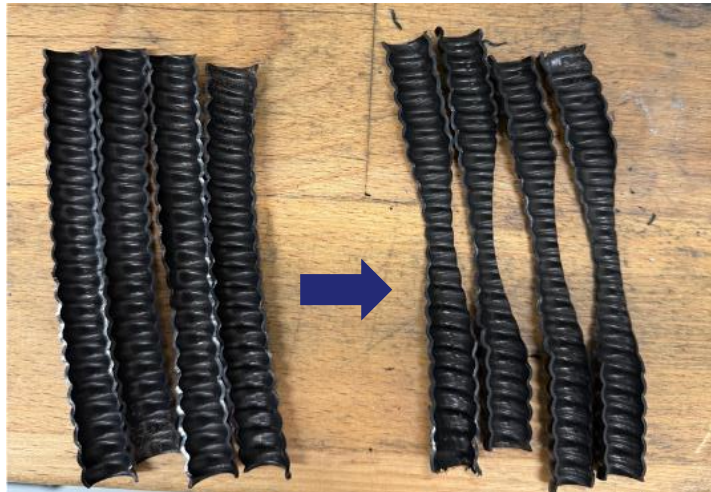
**Figure 43: Sample preparation - cutting for tensile tests**

Since four different analysis methods were employed, various types of samples had to be prepared accordingly. The preparation of PTFE hose samples began with the careful removal of the outer braiding without damaging the PTFE inner liner. The stainless steel braiding was required more effort to remove compared to the aramid braiding. Once the braiding was removed, the inner PTFE liner was isolated for further sample preparation. For the tensile test, cutting the PTFE liner lengthwise into rejuvenated/dumbbell shaped test specimens was necessary to ensure that the samples failed in the middle of the sample. Cutting these rejuvenated tensile samples proved to be the most difficult step due to the precision needed and the use of a surgical knife. This process often resulted in inconsistent sample widths, affecting the uniformity of the tensile test specimens. An example of the before and after cutting of the hose samples can be seen in Figure 43.

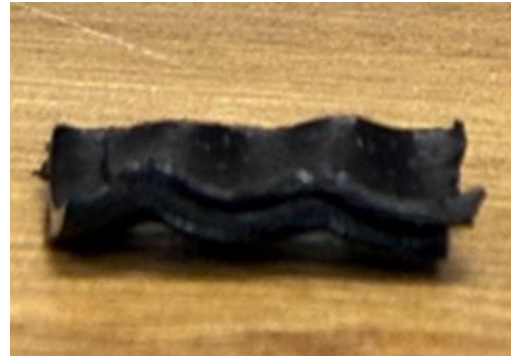
Figure 45: Sample setup for hardness measurements

For SEM, DSC, and hardness testing, smaller samples were required. Samples for the SEM analysis were cut into 10x10 mm shapes to meet the requirements of the respective tests. Figure 44 shows an example of the hose samples pasted on mounting pads for SEM analysis. DSC samples needed to be cut in a similar way compared to the SEM samples, but now with a dimension of roughly 2x2 mm. Lastly, the hardness samples did not require a maximum dimension except for the thickness. The ASTM D2440 requires a minimal sample thickness of 3 mm. Therefore, two hose sample thicknesses needed to be placed on top of each other in order to guarantee proper measurement values. Figure 45 shows the stacking of the two samples.

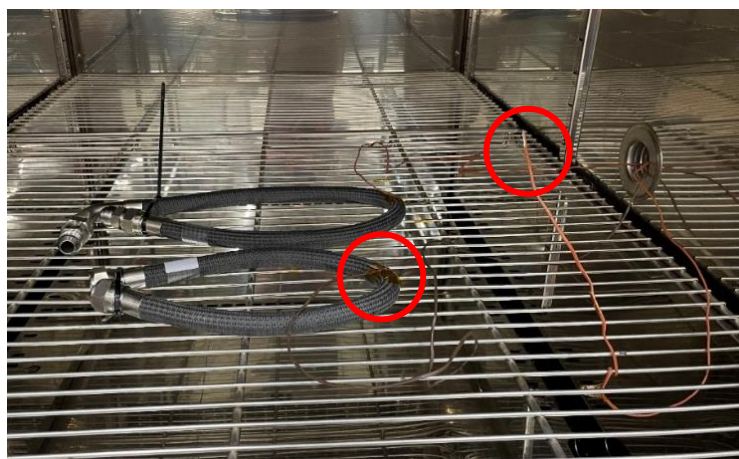
**Figure 46: Temperature cycling test setup; hoses placed inside**

The temperature cycling test was designed using three Goodridge G-Flex 711 PTFE hoses. These hoses, positioned within the radar antenna system, are categorized as sheltered components. Other parameters that were defined for the test design include a general consideration for the heating and cooling rate, set at 15°C per minute, and a 2-hour soak period at both the hot and cold setpoints. This configuration results in a total duration of 39 hours for the total test. The hoses were put in a fixed position inside the temperature cabinet with the help of a tie wrap so that a minimum outer bend radius is achieved in the middle of the hose. This creates a region that can be analyzed for potential cracks. Figure 46 shows the two hoses inside the chamber with the addition of thermocouples to monitor the temperature of the hose wall and of the environment.

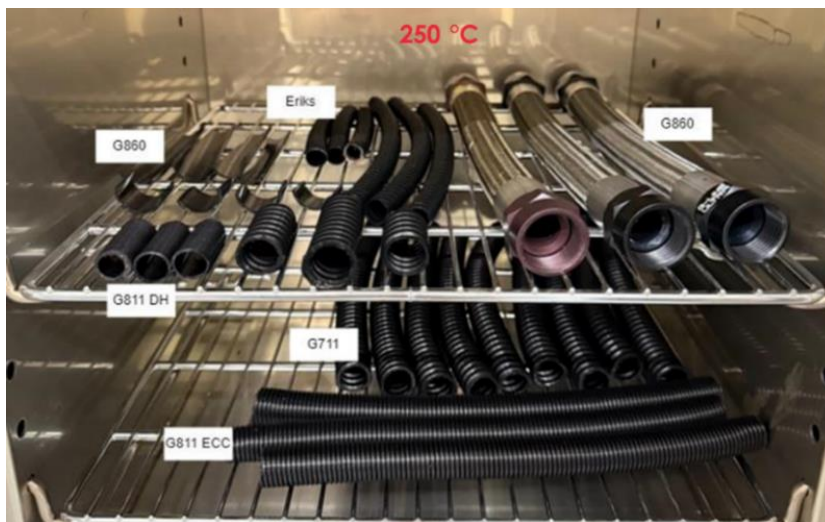
**Figure 49: Test #2 aging setup inside the Thales oven**

Figure 49 shows the inside of the small oven during aging at 250 °C, with different hose samples inside. Next to the stripped PTFE inner liner samples, the three fully functional G860 hoses were placed inside (including braiding and crimped fittings). These were utilized during the burst pressure test at Eriks Roermond. In the end, the constant temperature test took a total of 48 days to complete.

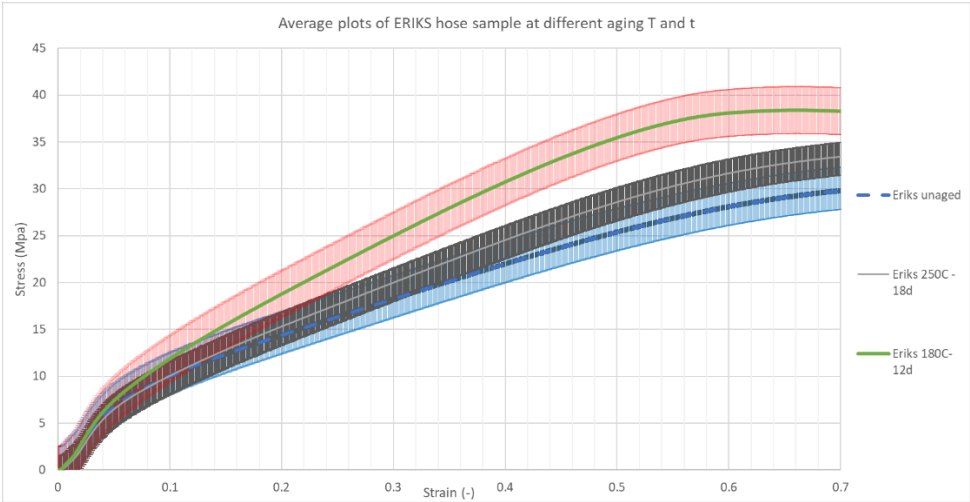
**Figure 53: Error bandwidth plot of ERIKS hose samples unaged vs. 180 °C-12d**

To verify this statement regarding an increase in stiffness in the plastic region, the error bandwidth of the average lines are plotted (see Figure 53 for example). If error bandwidths are clearly separated, then this indicates a statistically significant difference between the stress-strain behavior of the two conditions. In this case, the shift in the plastic modulus or the overall stiffness of the material can be confidently attributed to the aging effects (e.g., temperature, duration) rather than sample-to-sample variability or experimental error.
