Examining the geomorphic effects of the Canterbury earthquakes on the Hororata River

Research report

Michiel Pezij (s1109278)
Bachelor's final assignment

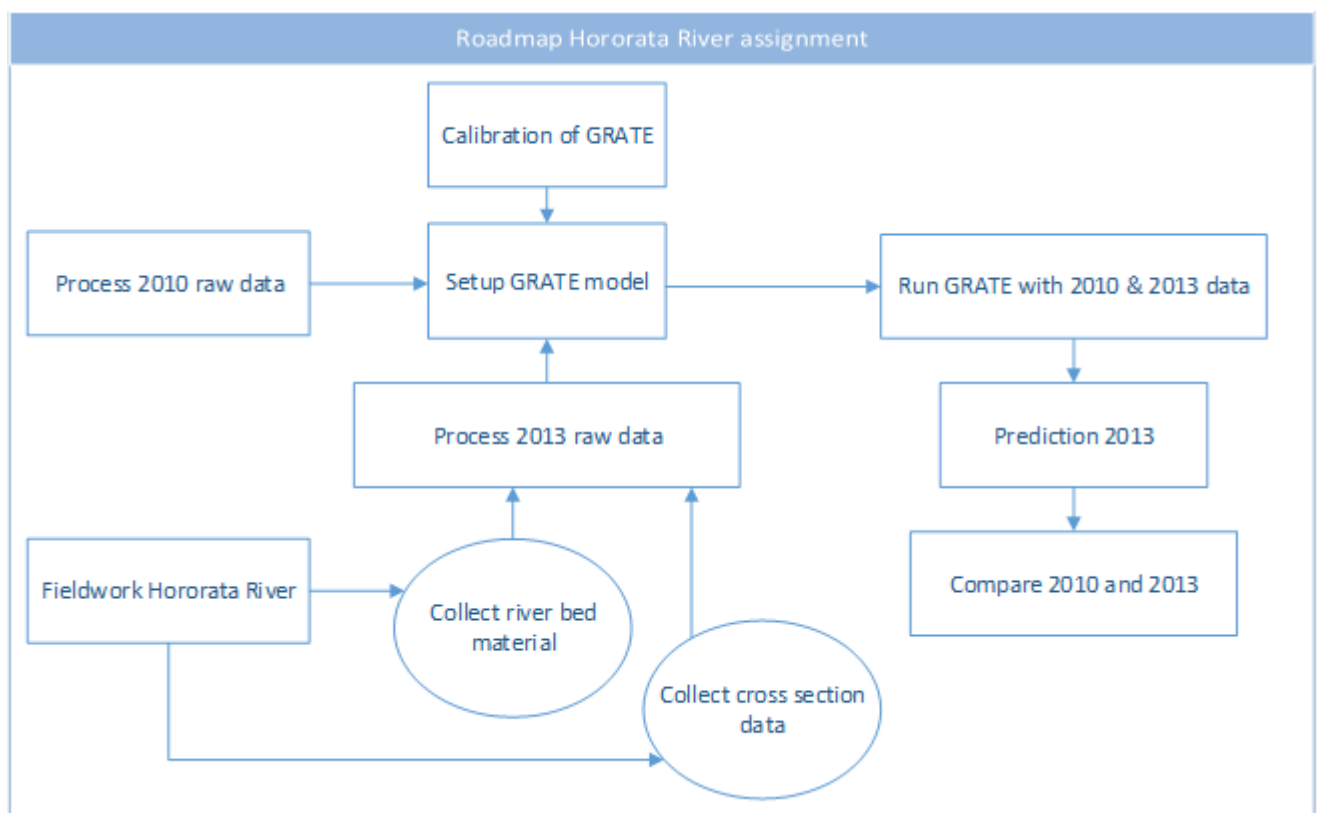
Figure 3 - Methodology

The first step is processing the 2013 raw survey data in order to setup the GRATE model. This setup is complemented by processing 2010 raw survey data. This data, river bed material and cross section data, is collected during fieldwork in May/June 2013. After the initial setup of the model, GRATE is calibrated. The next step is running the model with the available data, which results in a prediction of river adjustments in 2013. This prediction is then compared with validation data, in order to check the appropriateness of the use of GRATE for this project.

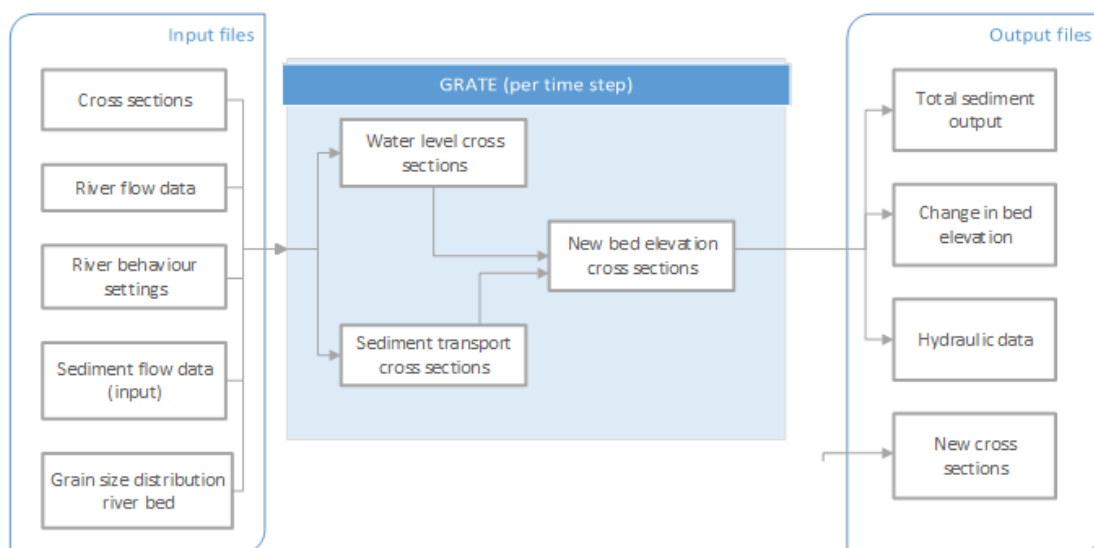
The structure of GRATE can be seen in Figure 5. The required input includes cross section data (river profiles), river flow data (discharge), river behaviour settings (like initial values for thickness of storage and active bed layer and initial water surface elevation approximation), sediment inflow data and grain size distributions of the river bed and subsurface. During a model run, water levels, sediment transport and the new bed elevations are stored and used for each time step. The output files include (total) sediment output, total change in bed elevation, hydraulic data (like Froude numbers) and the new cross sections profiles.

Figure 5 - Structure GRATE

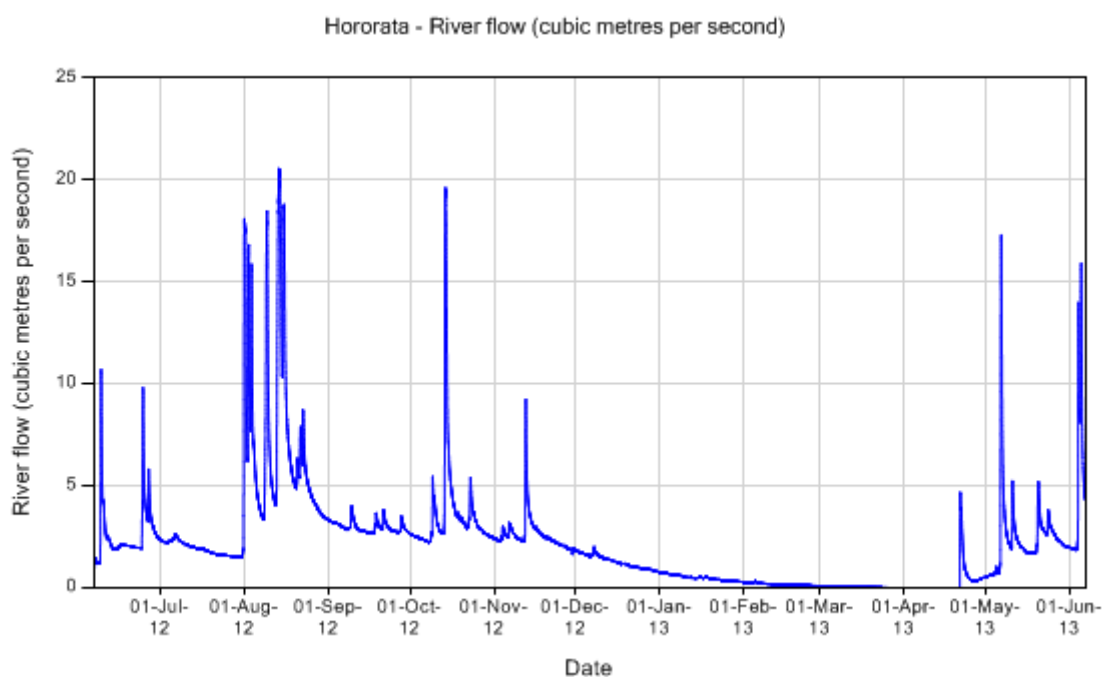
Figure 6 - Flow rates during period July 2012/June 2013

Canterbury Regional Council (previously known as Environment Canterbury) provided river flow data for the period between September 2010 and April 2013 (Environment Canterbury, 2013), see Figure 6 for an example and Appendix I for the full time series. The river flow recorder is situated a kilometer upstream of the study area. This means that the flow recorder data should be consistent with the flow in the study area.

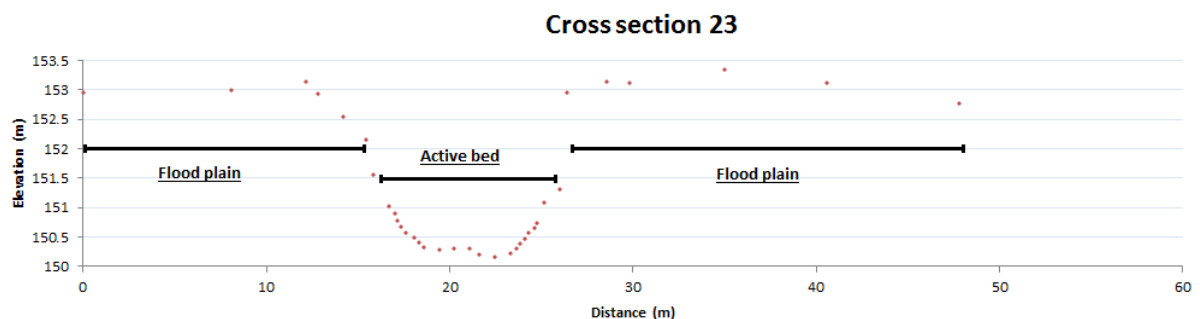
The cross section profiles in GRATE are represented as points, see Figure 7. The input cross sections consist of 2010 survey data. The active bed is distinguished from the left and right banks by flags. By doing this, GRATE will only calculate sediment transport for the active bed.

Figure 7 - Visualization of cross section

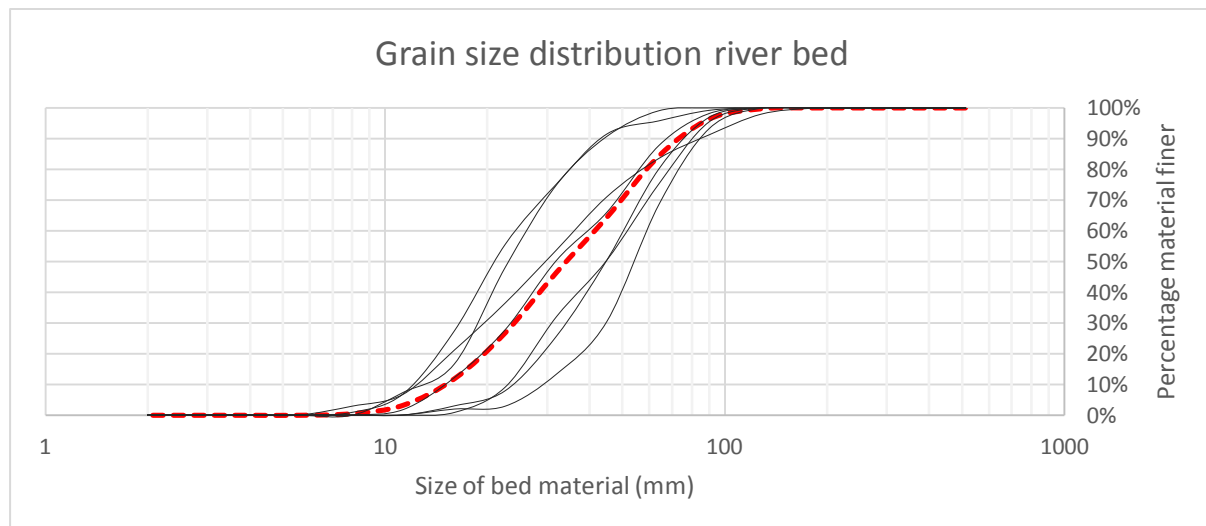
Figure 8 - River bed surface grain size distributions

surface grain size distribution using this data. Seven sites were used for Wolman sampling, namely cross sections 1, 8, 12, 16, 19, 24 and 34. At least 100 random clasts were collected at each site. Wolman sampling was used to get the average grain size distribution of the river bed surface layer, the red dashed line in Figure 8. This grain size distribution is an average of the samples collected at the seven sites. These samples are presented in Appendix II. The 2013 grain size distribution are assumed to represent the 2010 distributions in an acceptable way. However, the different Wolman samples vary somewhat, so the average distribution does not cover the entire study area. The simulated values are therefore probably under- or overestimated.

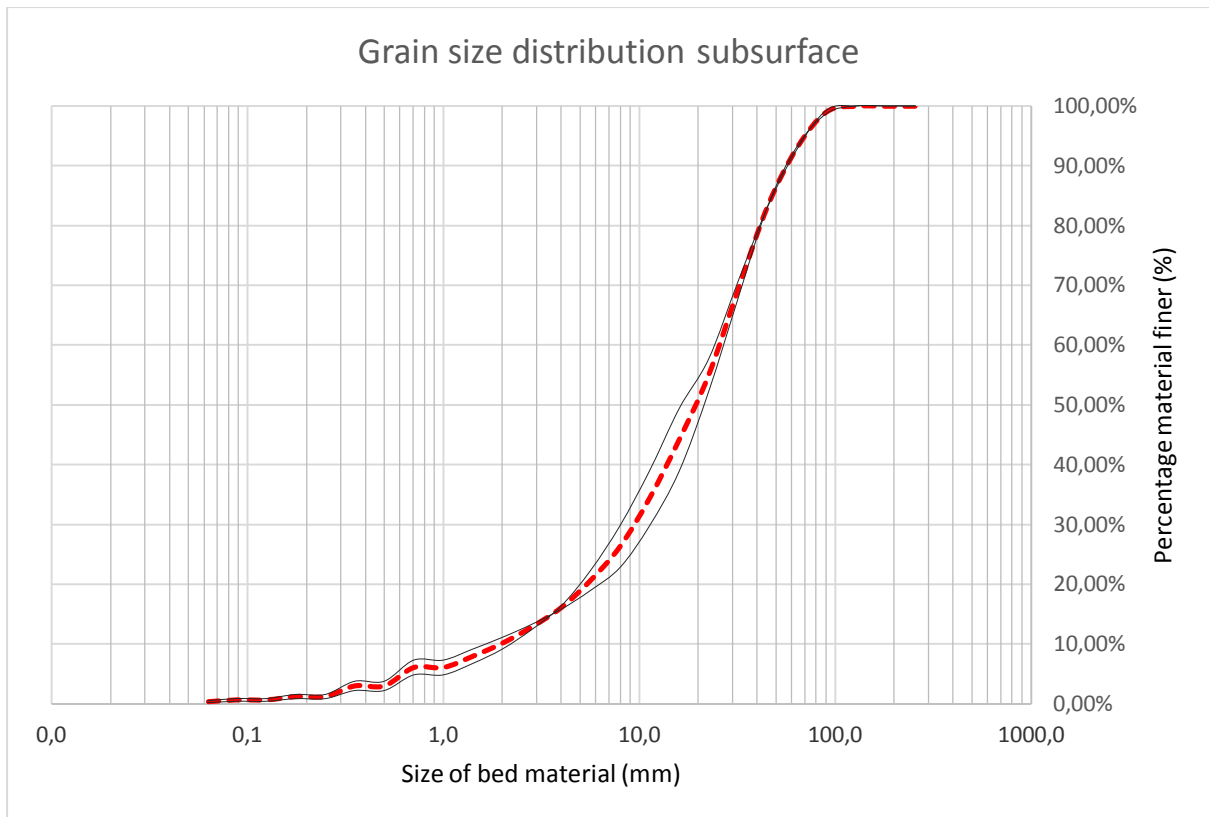
Figure 9 - River subsurface grain size distribution

Bulk sampling was used to collect material below the level of the largest surface class and from within one layer (NIWA, 2011). With this information, the average grain size distribution of the subsurface of the river was determined, the red dashed line in Figure 9. This average distribution is an average of the distributions of two samples (sediment calibration). The distribution for these specific sections can be found in Appendix II. Two sites are used for bulk sampling, namely cross section 16 and 24. Samples of at least 100 times the weight of the largest class visible on the surface layer were collected and sieved in the field. To collect information about the grain sizes smaller than 8 mm, samples were brought to NIWA to sieve them in a laboratory. This had to be done in order to get information about the smaller grain size clasts.

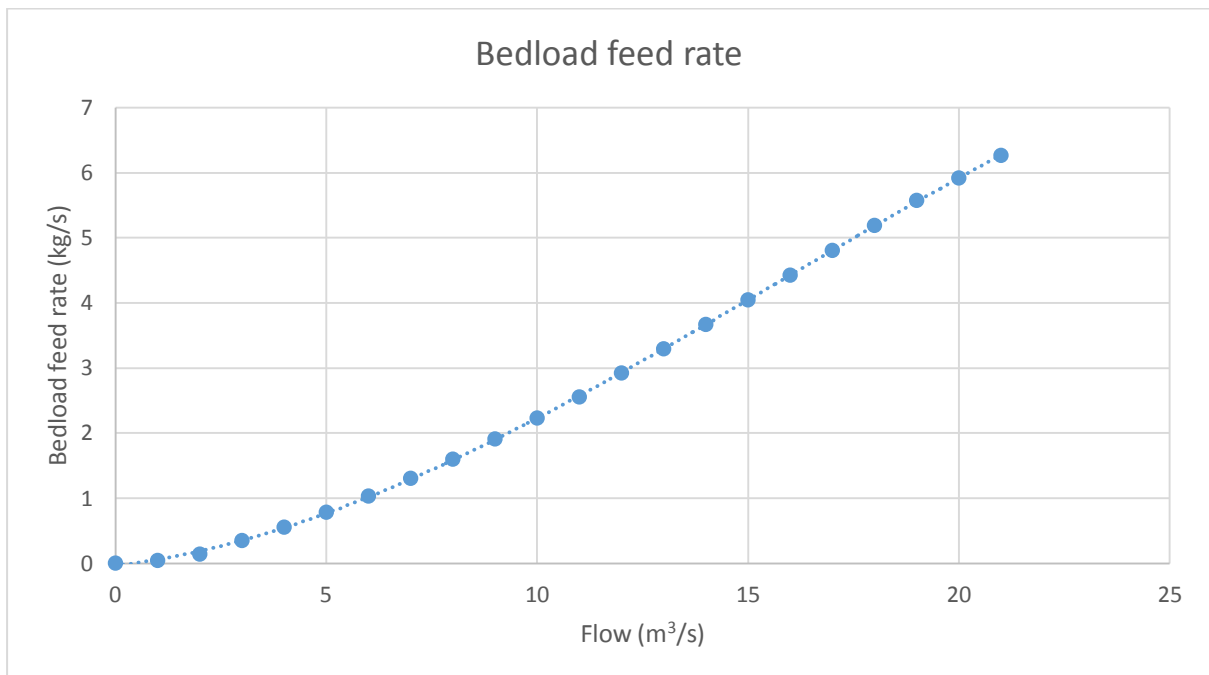
Figure 10 - Bedload feed rate

The Wolman samples are also used to feed the model at the upstream end. The bedload feed rate for a specific discharge was calculated with the Wilcock-Crowe formula (2003). The samples are used to extrapolate the bedload feed rate to every possible flow in the river, see Figure 10. The R^2 of the interpolated values is 0.999, which is very good. The values used for extrapolating can be found in Appendix III. These values were obtained after sediment calibration using an Excel macro of NIWA to calculate the bedload feed rate for different discharges.

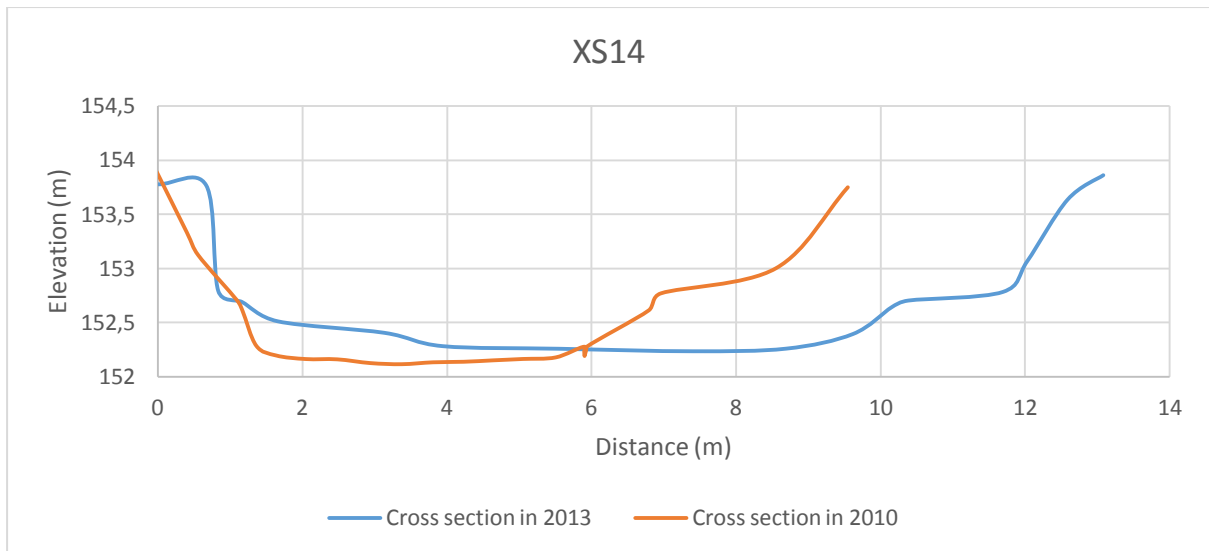
Figure 11 - Cross section 14 mainly adjusted in its width

The average bed level change was calculated by calculating the area in for example Figure 11 between the 2010 & 2013 survey bed elevations and the 2010 & 2013 model run bed elevation. The area divided by the width of the cross section gives you the average change in bed elevation between the 2010-2013 surveys and the 2010 survey & 2013 model run. These average changes are consistent with each other and can then be used to compare the model run with the 2013 survey data.

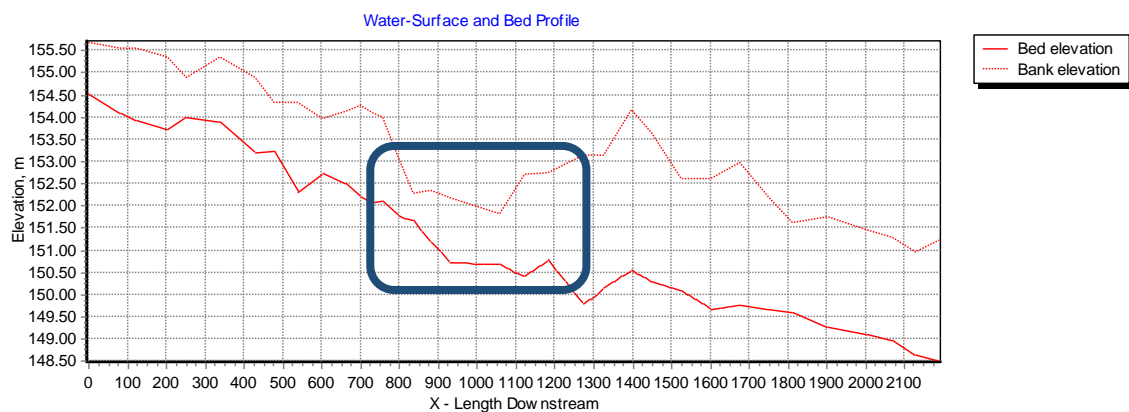
Figure 13 - Initial geological situation of river

In Figure 13, the situation of the bed level and top of bank elevation directly after the quake and the digging is visualised. The bank elevation is an approximate value of the highest point of both banks, but is not very accurate. The bank elevations are derived from the 2010 cross section profiles. Almost 300

The average drop of bed elevation is around 1.5 meters. The original slope of the river bed is 0.0028. This is an average as there are always natural variations in the channel. However, the section of the river immediately downstream of the fault (around river distance 800 meters, Figure 13) has a slope of 0.0065, which is very high. The elevation of the 'top of the banks' increased after the fault line, due to the human interventions. The cause of this increase is discussed in the 'human intervention' section below. This bed elevation profile is used as the start situation in GRATE.

Also, because of the drop in top of bank elevation in the bend, the surrounding land flooded quicker at lower discharges than before. The difference between the bank elevations within and outside the meandering bend are relatively large, see Figure 13.

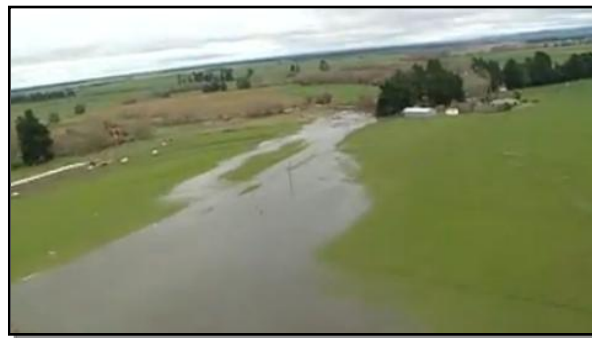
Figure 14 - River flooding (meander is near the trees in the middle of the picture)

Because half of the meandering bend dropped down, the water could not continue its course in the original channel. It spilled over the left bank, creating a large flood, see Figure 14. Also, water escaping from the river upstream of the study area flowed overland and re-joined the river within the study area between cross sections 16 and 17 from the northwest. This increased the magnitude of the flood, because more water was delivered to the river than it could handle. At the location of the meander, a lake of approximately 400 meters wide was formed.

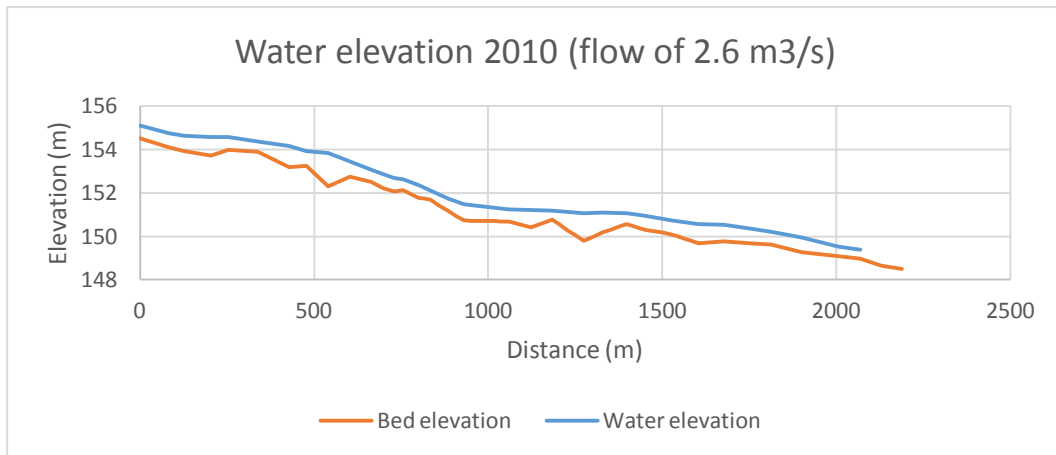
Figure 15 - Water elevation 2010, initial setup GRATE

Also within the river channel some changes were visible. At the locations where the fault cut the river, small 'waterfalls' occurred. The geomorphic term for these in this situation are 'nickpoints'. The river bed slope was relatively very steep, resulting in flows that were supercritical. After the human intervention, the river returned to its original course. The 2010 survey (after the human intervention) was done during a discharge of $2.6 \text{ m}^3/\text{s}$. The water elevation for the surveyed length at this specific flow is shown in Figure 15. The slope of the water elevation shows a drop at 800 meters downstream. Probably, this is attributable to the change in river bed elevation/slope.

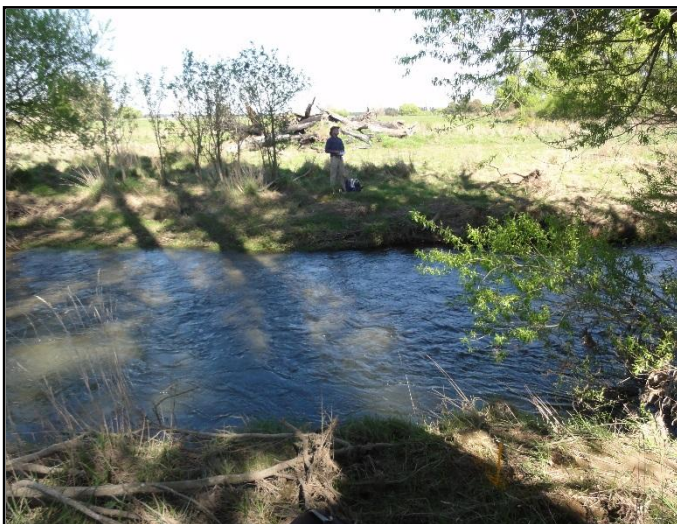
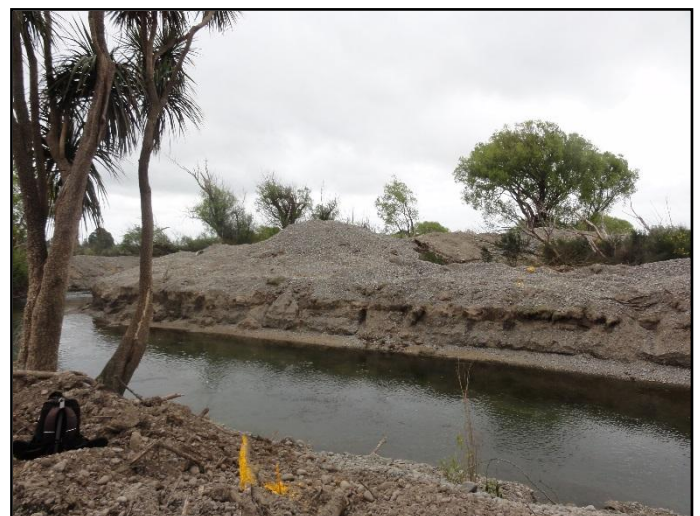
Figure 16 - Channel upstream (left) and downstream (right) of fault & drop

Downstream from the meandering bend, a farmer living next to the river dug out the channel to allow the water in the original channel again. He used a digger to dig out the river bed and banks, depositing the excavated material on the sides of the river, raising the height of the banks. The width of the river was fixed, following the original channel. Compared with the original channel, the new banks are very steep, see Figure 16. The section of the river that was modified by the farmer starts at cross section 20 and ends at the end of the survey length, cross section 35. This section is about 800 meters long. The effect of the digging was that the flood levels in the paddocks quickly reduced to 5 cm (The New Zealand Herald, 2010). All the vegetation was removed from the river bed and banks, this resulted in a different roughness coefficient in these sections. See Figure 1 for the location of the dug out area.

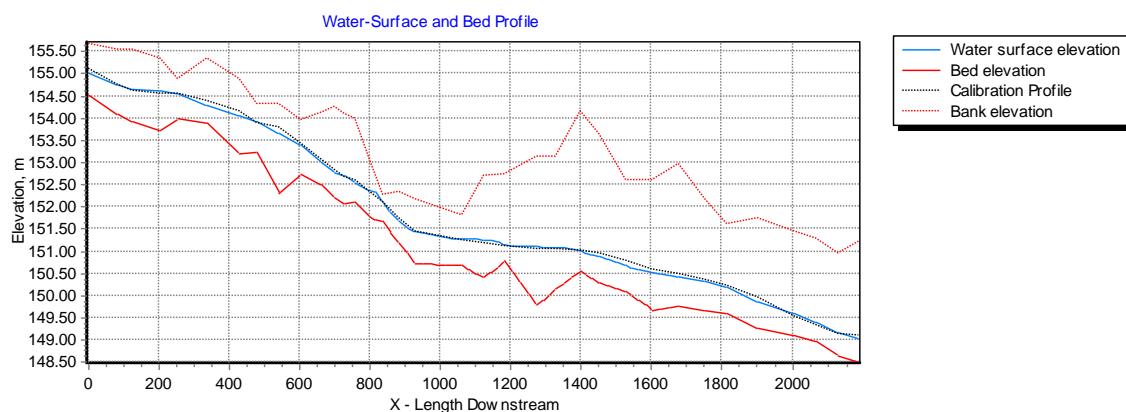
Figure 17 - Calibration profile 2010

Manning's n values vary in the range of 0.02-0.045 with an average value of 0.0303, resulting in a good fit, according to Figure 17. According to Hicks & Mason (1998), these are typical values for a natural stream with a gravelly river bed. The coefficient in the manually excavated channel is lower and before the fault line slightly higher than the average value. The Nash-Sutcliffe coefficient (NS-value) and the Relative Volume Error (RVE) were used as they are good indicators for hydrological model simulation and behaviour. The calibrated cross sections have a NS-value of 0.857 and a RVE value of -3.04%. NS-values between 0 and 1 are acceptable, indicating good model performance (Moriassi, et al., 2007); the values of the RVE should be between -5 % and +5% (Gumindoga, 2010).

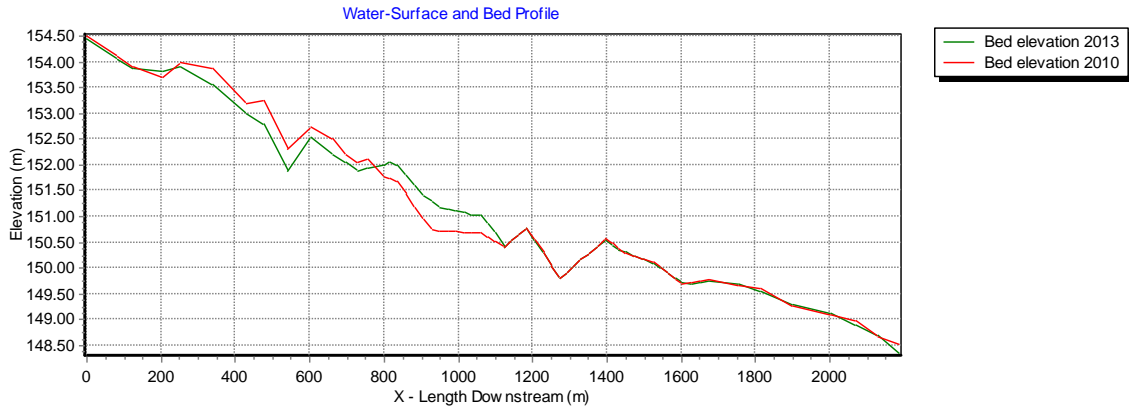
Figure 18 - River bed elevation change

The model predicts that there will be only changes around the fault line, from 200 meters to 1100 meters river distance. The sections consist of cross sections 4-19. The model predicts that the part of the channel that was manually adjusted will not change very much. The bed level upstream of the fault line will

The output of the model GRATE is presented in these sections. The results of the model run in terms of predicted bed elevation change are shown in Figure 18. A prediction for individual cross sections is presented in Appendix V.

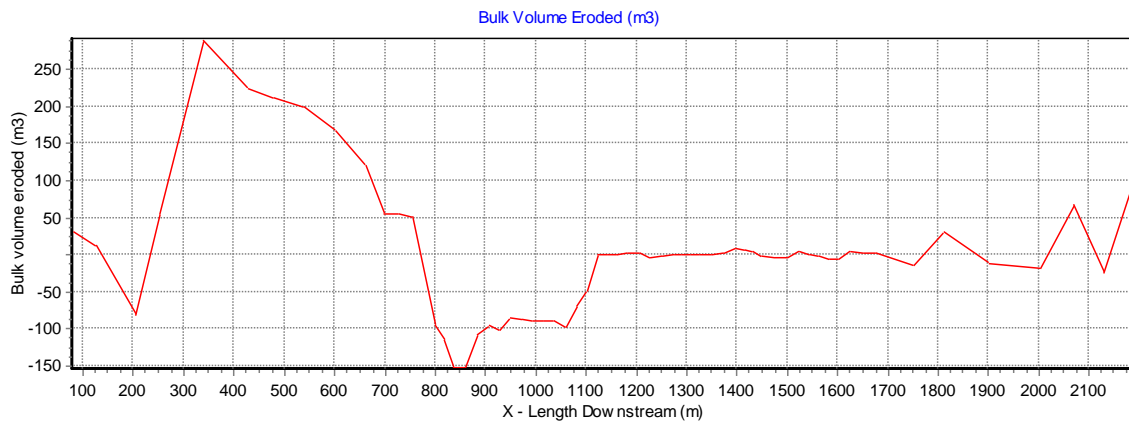
Figure 19 - Eroded volume (m3) for period 2010-2013

mainly degrade and the bed level between the fault line and the start of the newly excavated channel will aggrade. Note that these elevations represent the lowest points in the cross sections from the 2010 survey data. The slope of the river should be restored to normal levels according to the model.

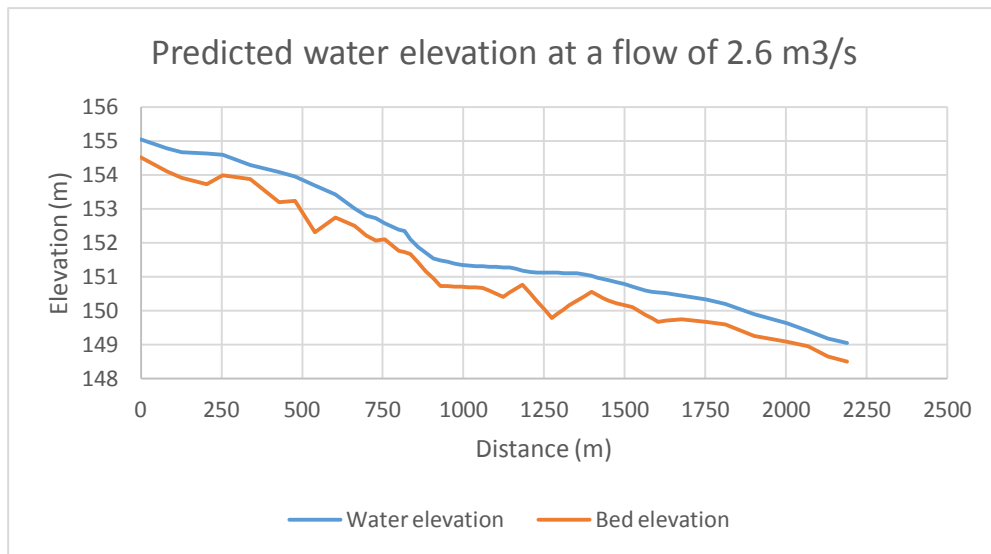
The water elevation at a discharge of $2.6 \text{ m}^3/\text{s}$ is visible in Figure 20. Note that at some sections, the elevation is a bit rough, for example 800 meters. This is due to the quasi-steady flow simulation. A fully dynamic flow simulation would have shown a smooth water elevation. For the calculation of sediment transport however, this is not a problem.

Figure 20 - Water elevation 2013 as predicted by GRATE

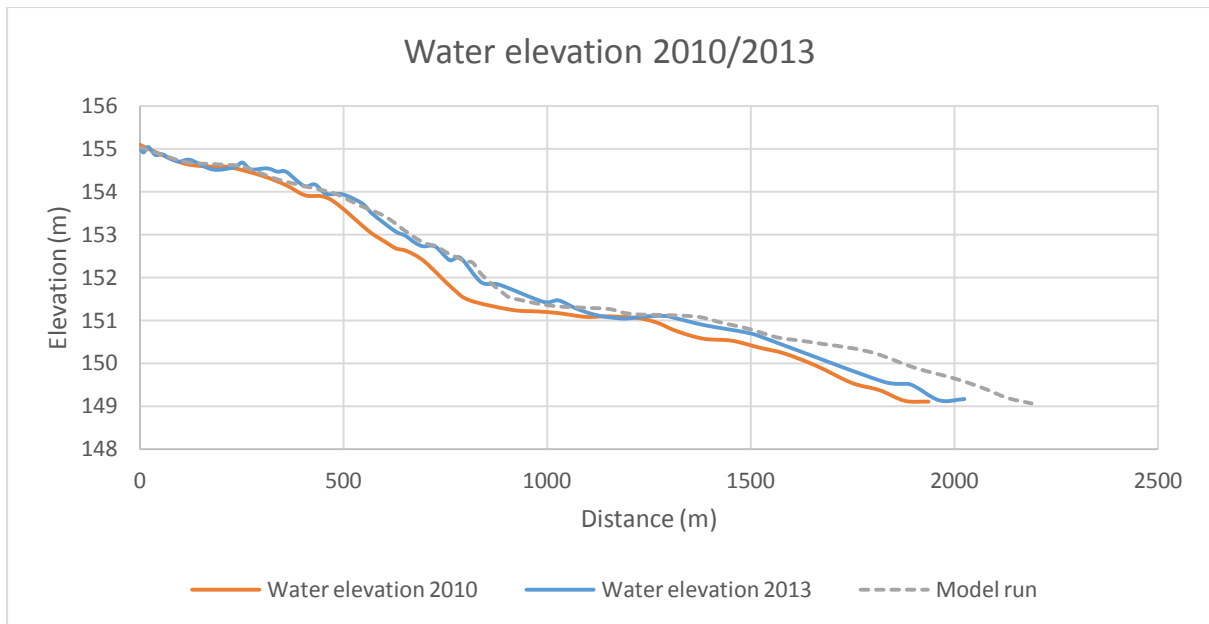
Figure 21 - Water levels

The model run results are also visible in Figure 21 (grey line). A first sight, the model seems to predict quite well how the water elevation changes. Linked to this is a good simulation of the change of river bed.

A direct comparison between the measured water elevations of 2010 and 2013 can be made due to fieldwork surveying. The surveying was done during the same discharge in both years. In Figure 21, the lines represent these elevations. The water level has slightly risen in 2013 in both the measured and model predicted results. Also, it looks like the water level drop ('nickpoints) at distance 800 meters has faded out, since the line (slope) of 2013 is not as steep as the 2010 one. However, the river slope is still locally steepened, which will likely result in further adjustments, as discussed in section 3.6. Also remarkable is that the adjustments only occur over a 500 meter reach around the drop location. Beyond this 500 meter reach, upstream and downstream of the drop there are no significant changes visible, except for last sections of the downstream part. But, this predicted deviation at the downstream end of the reach is due to a model error rather than real adjustments in the field. Namely, the water elevations for the sections 1500-2000 meter downstream of the 2010 and 2013 surveys show that the adjustments are not as big as predicted by the model. The cause of these deviation is, as previously explained, the man-made adjustments.

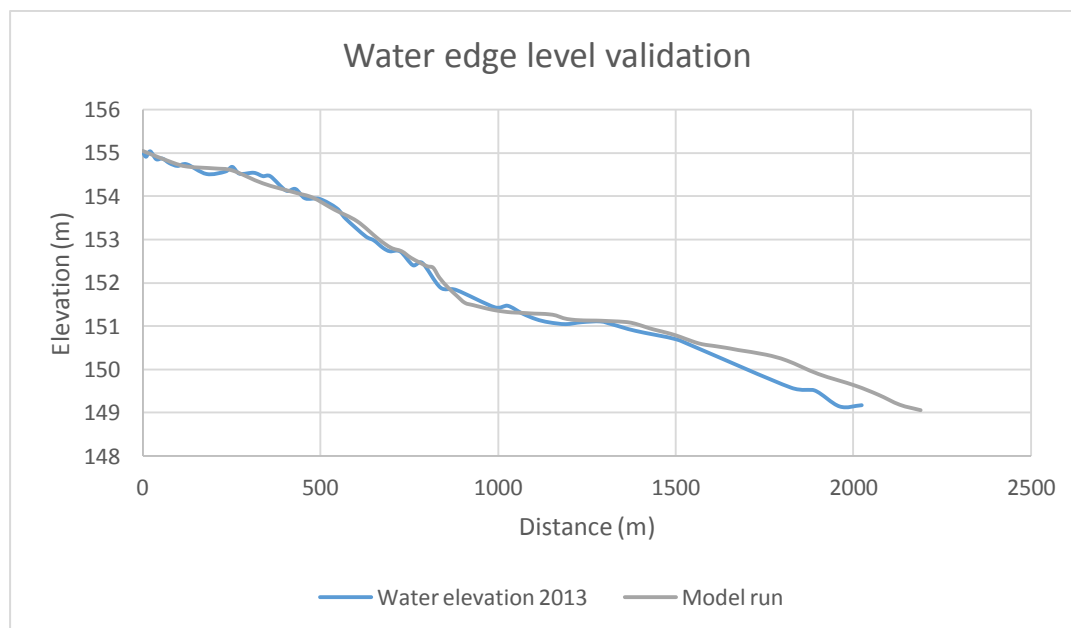
Figure 22 - Validation of water levels

Generally, the two water elevations fit closely together. Except for the last 500 meters of surveyed length, the slope and value of the simulated water elevation fits the observed slope and values. However, there is a large deviation at the end of the surveyed length. This can be explained; the river has recently been manually deepened here to protect a bridge at the end of the study area. The farmer dug out the channel locally (~1200-2000 meters downstream from the start of the study area), as stated before. Also, due to the recent digging, there was no vegetation on the river bed and banks. The roughness coefficient of the river in these sections is lower than used as input for the model. Therefore, the model overestimates the water levels.

To validate the results of the model, the water elevations were measured during the two surveys. The water elevation obtained after the model run is subsequently compared with the 2013 water elevation data. There were obstacles in the water in 2013, so the last 165 meter was not measured. That is why the blue and grey lines are not of the same length in Figure 22.
