Final Report

Workzone Safety at the Gauteng Freeway Improvement Project

Author: Arjan Apperlo (s0098337)
Subject: Civil Engineering Bachelor Thesis at Twente University
Date: October 16, 2009
To: The South African Road Federation (SARF)

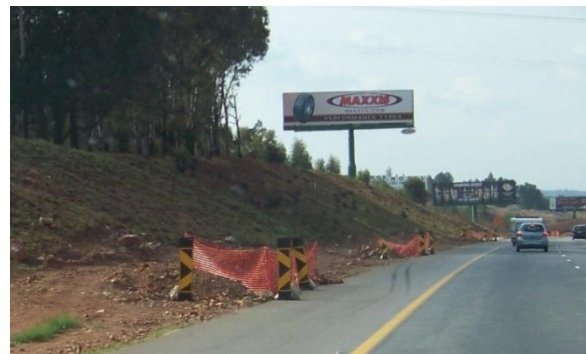
Figure 3: Unprotected workzone

The information area is the first and one of the most important safety areas at a workzone. It is important to inform the road users of the road works ahead. At all the visited work packages the dimensions of the information area were sufficient. The transition area was sufficient most of the visited sites, at one site the transition area was much too short and at one other site the transition area was a bit short. At all but one of the sites the buffer area was of the right dimensions. At one site the buffer area was too small. A problem in the buffer area at one of the sites was that there were both persons and vehicles in the safety area. This caused a safety liability. All workzones should be ended with a termination area. In this area the original state of the road will be restored. At all but one site the termination area was of the right dimensions.

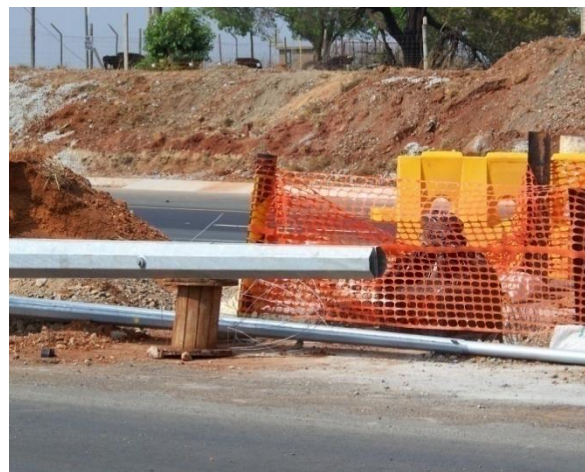
Figure 4: Lightpost at roadside

For the obvious safety reasons the workzone should be closed off from traffic properly. This means that vehicles can't penetrate the workzone and that all plant and vehicles that are on the road are protected. At multiple sites this was not done properly. At one of the sites there were holes and piles of soil at the side of the road (Figure 3), at another site there were 2m deep holes that were not protected. These holes were meant for the foundations of light posts. The light posts were lying unprotected next to the holes (Figure 4). This caused a very dangerous situation where if a vehicle would hit the light post it would be speared. At another site the assembly of a guardrail was taking place, this was not happening behind protection also warning vehicles were missing.

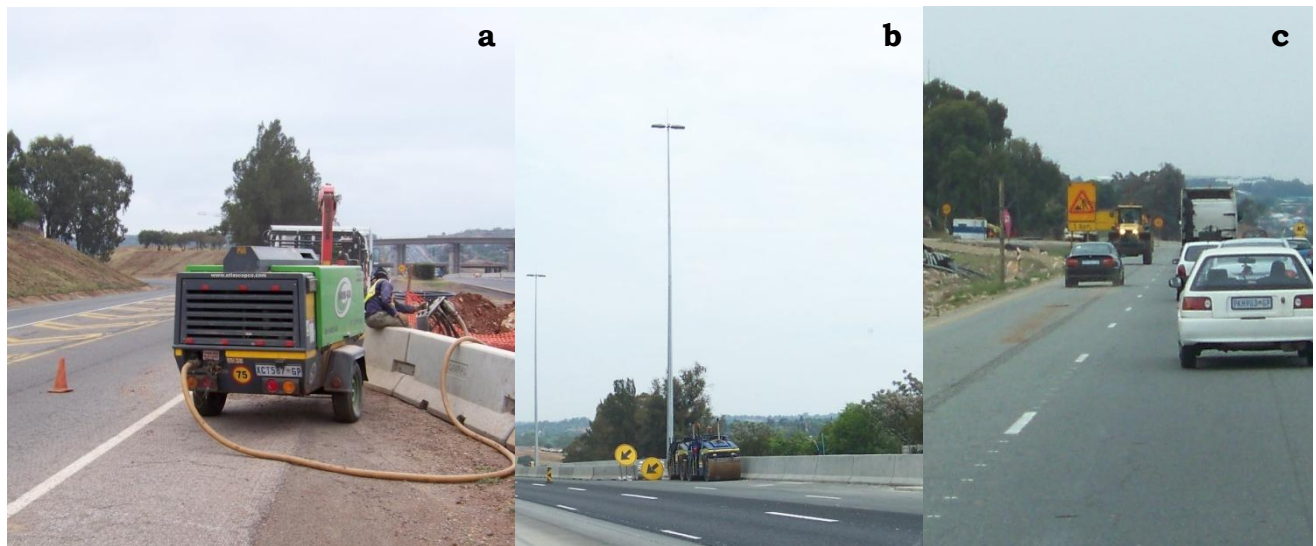
Figure 5: Unprotected plant

At multiple times slow construction vehicles were standing or driving in traffic without protective or warning vehicles (Figure 5b and 5c). A lot of the times there were safety vehicles with TMS's at site but the TMA wasn't in use. At one site a generator was standing at an off ramp without any protection (Figure 5a).

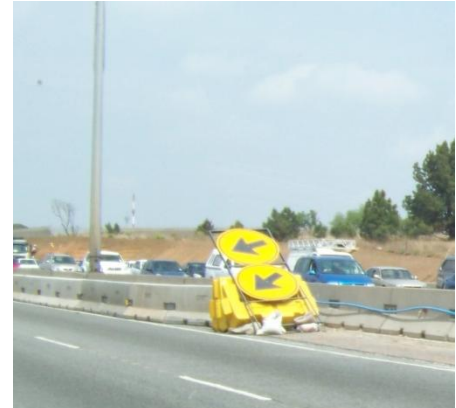
Figure 6: Sign fallen over

At most workzones the signing was according to the requirements. The message of the signs was clear and visible and the signs were placed correctly. The correct signs had been used and unnecessary signs were removed from site at most workzones. At one site a sign had fallen over and therefore wasn't very visible (Figure 6). At another sites signs that were not in use at that moment were made invisible (Figure 7) the problem that because this was not done properly, these signs made the message unclear and caused major confusion at this site. At some of the sites signs were very dirty and therefore not very reflective, at time of the inspection, during the day, this did not really cause a problem, but at night reflection is one of the most important aspects in visibility of signs.

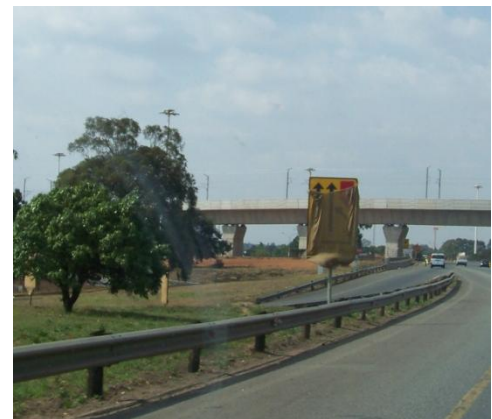
Figure 7: Sign made invisible

To make travelling public more alert to a workzone a lot of different warning devices can and should be used at the workzones. At the workzones of the GFIP there was a lot of difference in how well warning devices were used. At a lot of sites the flickering warning lights were missing. At some sites the flashing arrow light was not flashing, at another site it was pointing in the wrong direction. Nevertheless at a reasonable part of the workzones the warning devices were used accordingly and in the right combinations. A lot of them had a flashing arrow board and flicker lights to indicate closures and lane diversions. Almost all sites had a VMS at the beginning of site warning for the roadworks and giving instructions.

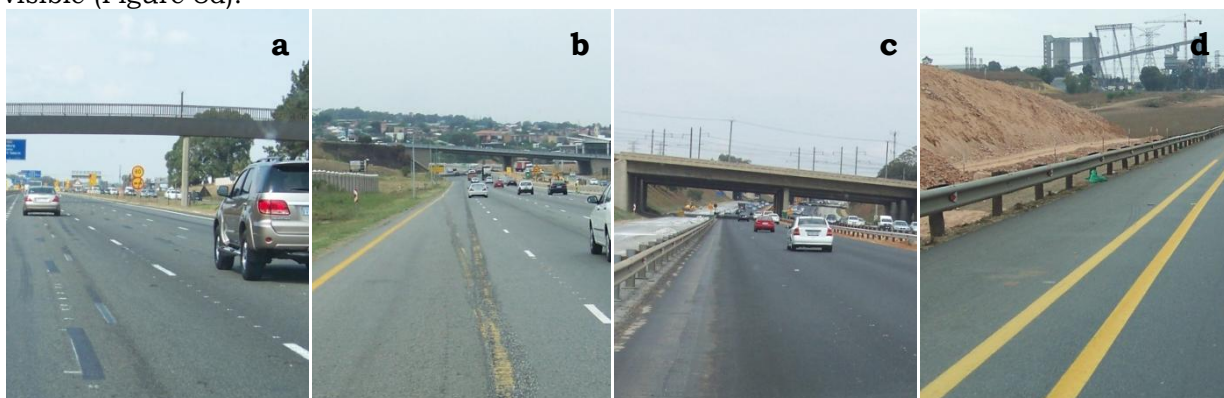
Figure 8: Different states of marking

The quality of the markings at different sites was not very similar, a lot of sites did not have clear temporary markings (Figure 8c), and at a lot of sites the old marking wasn't removed properly (Figure 8a and 8b). At some of the sites (temporary) markings were very clear and visible (Figure 8d).

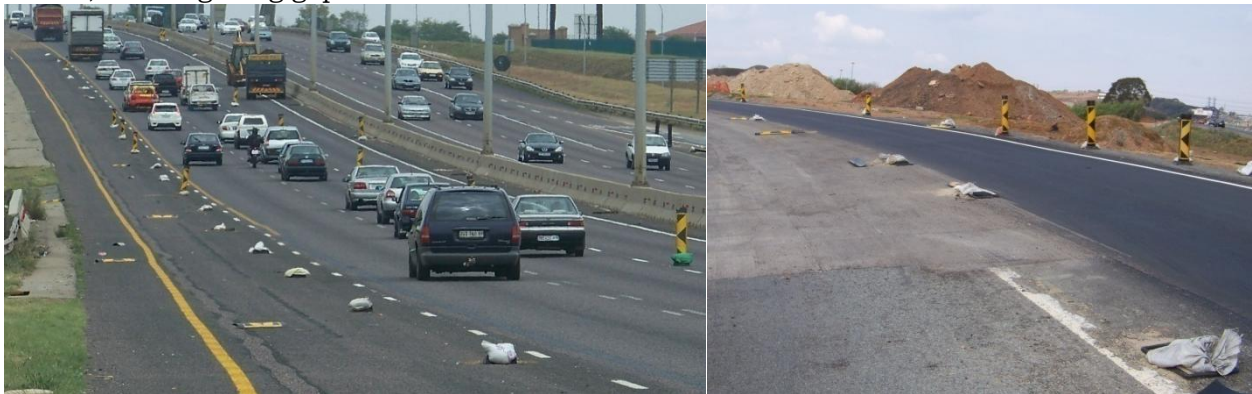
Figure 9: Damaged delineators

At most sites cones and delineators were used for delineation. The cones and delineators that were used complied with the regulations. A big problem at most of the sites was that a lot of delineators were damaged (Figure 9), trucks seem to make a game out of running over as much delineators as possible and that makes it almost impossible for a contractor to keep replacing the broken ones. Also a lot of delineators were not supported properly with sandbags, this means they fall over when a truck drives past or when there are hard winds. If sandbags are supporting the delineator a lot of the times they block part of the reflective section of the delineator, this makes the delineator less visible. A solution to this problem is to use taller delineators so they are visible in combination with the sandbags supporting them. The alignment of delineators could have been a lot better, most of the time it was not straight. The spacing of the delineators was good at some of the sites but at other sites the delineators were too far, allowing a big gap in the delineation.

But the biggest problems are broken and damaged delineation devices. Trucks seem to make a game out of running them over therefore a contractor has to replace a lot of delineators. Also the stabilisation of the delineators isn't as it should be so a lot of delineators are blown over by the wind.

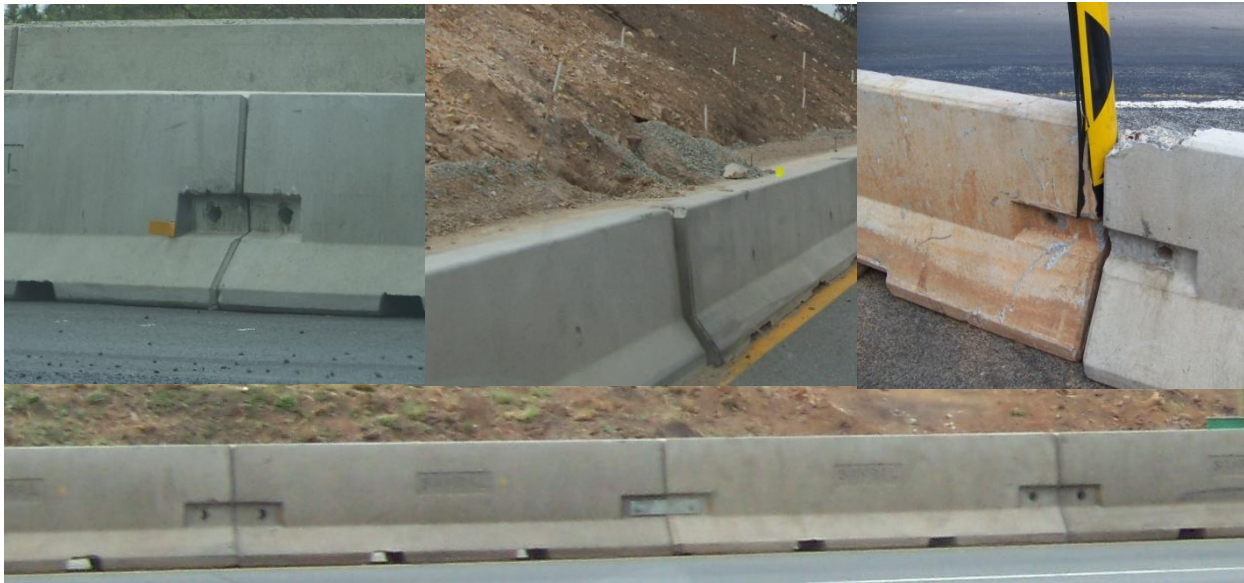
Figure 10: Non joined barrier systems

But before being able to say that a system complies or not it's important to look at the installation and state of different barrier systems. Because a system only complies with the approved test level when it is installed according to manufacturer's standards. At the worksites if the GFIP a lot of barriers were not installed properly and therefore not complying with the contract requirements. At a lot of sites several barriers were not joined (Figure 10) or gaps in the barrier systems were found, different kinds of barrier systems were not joined together as well. Also quite a lot of barriers were severely damaged (Figure 11), this damage lowers the system's ability to redirect a vehicle.

An even bigger problem than the compliance of these barrier systems is the installation. These systems are only effective as they are installed properly because the different barriers work together to absorb kinetic energy at an impact. If barriers for example are not joined properly the effect of the system is gone and the results at impact will not be safe. At a lot of the sites the installation of the different systems was not according to manufacturers standards. This caused a major safety problem. There were installation had been executed according to standards the positive effects could be seen. A lot of impacted locations have been spotted during site inspections and where the installation was good penetration of the workzone hardly occurred, even with non complying barrier systems.

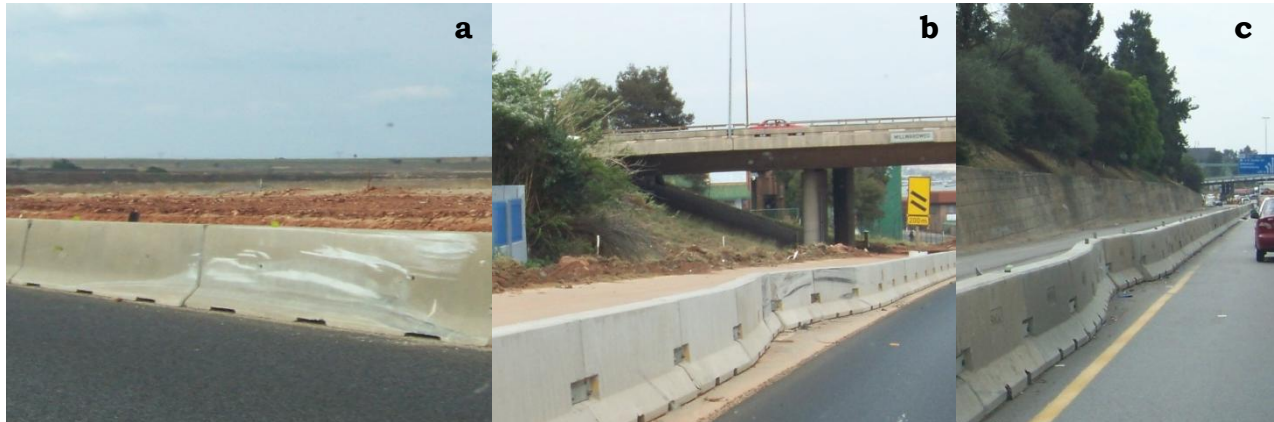
Figure 12: Impacted barrier systems

When looking at actual workzone safety it can be concluded that barrier systems, when installed accordingly, do prevent a lot of workzone penetrations by vehicles. A lot of barrier impacts have been seen at site and at most times the vehicle did not penetrate the workzone. This regards both SANRAL (Figure 12b and 12c) and DeltaBloc barrier systems (Figure 12a). **A big difference between the both systems is that the SANRAL system moves quite far at impact (Figure 12b and 12c) where the DeltaBloc system hardly moves at all (Figure 12a). Another big problem is that in workzones where contra-flow occurs the delineation of the barriers is not restored and this causes severe danger to traffic in both directions.**

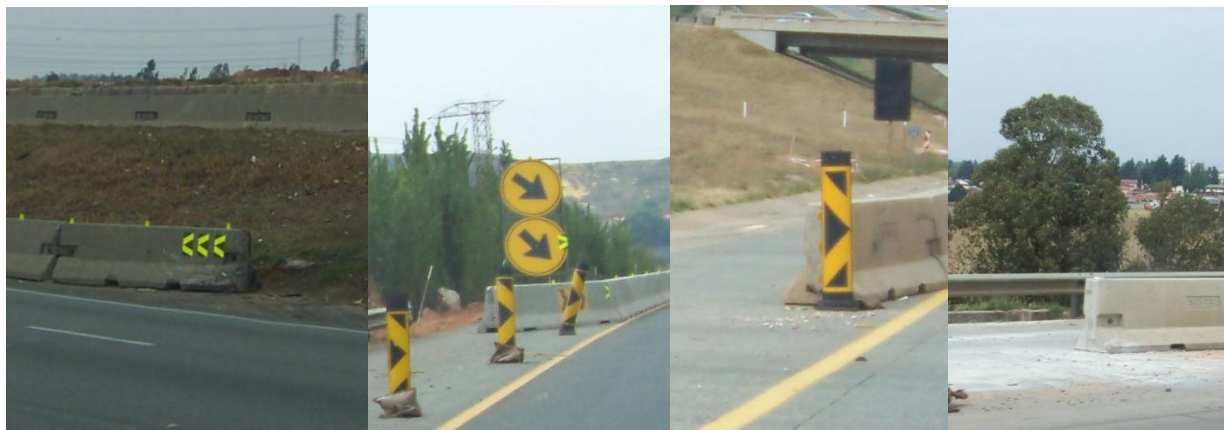
Figure 13: Unprotected barrier ends

Barrier ends and objects should be protected with crash absorbers or attenuators. At most sites sandbags (Figure 14b), plastic (water filled) barriers or plastic (water filled) watertanks (Figure 14a) were used as a crash absorber, but in a lot of cases barrier ends were not protected (Figure 13). In one situation an approved crash absorber was used. But the installation of this device was not according to standards; it should have been anchored to the surface which was not the case (Figure 15).

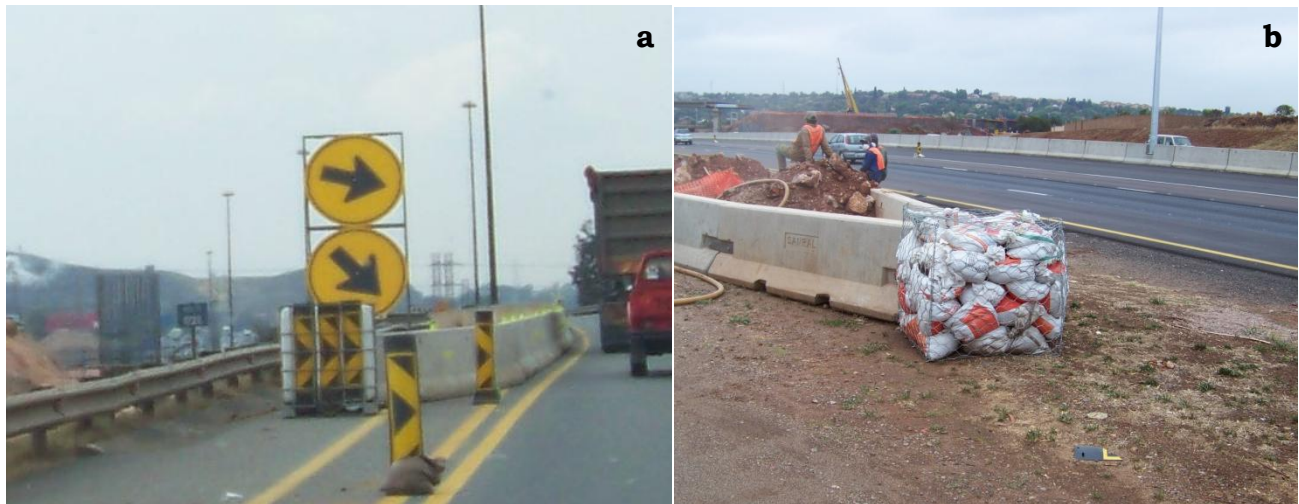
Figure 14: Watertank and sandbags used as crash absorber

The last component of this category is the crash absorbers. A lot of non complying systems like, water filled plastic barriers, filled plastic water tanks and heaps of sandbags were used. These do not comply with international standards for crash absorbers. One complying crash absorbing system was found at site but this system was not installed properly and therefore not safe.

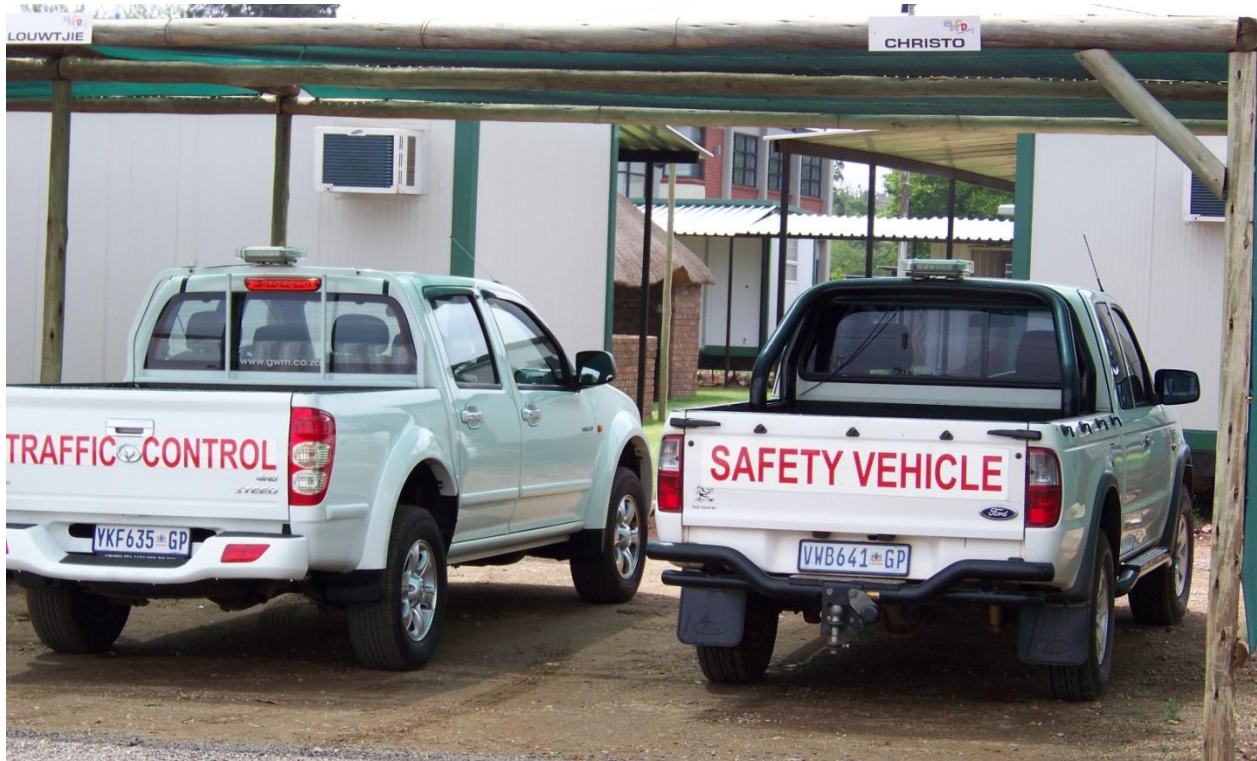
Figure 16: Traffic safety vehicle

At the sites where the researcher was shown around by the contractor the TSO was present at site and so were the required safety vehicles (Figure 16). At other sites safety vehicles have been spotted. At one site the TSO left his vehicle without using reflective clothing and at another site the safety vehicle was used for transport purposes.
