Internship

at the Royal Grolsch

Internship for the master program mechanical engineering at the University of Twente. Working in the maintenance department of the packaging division at the Grolsch brewery. Improving efficiency on the non-return bottle filling line.

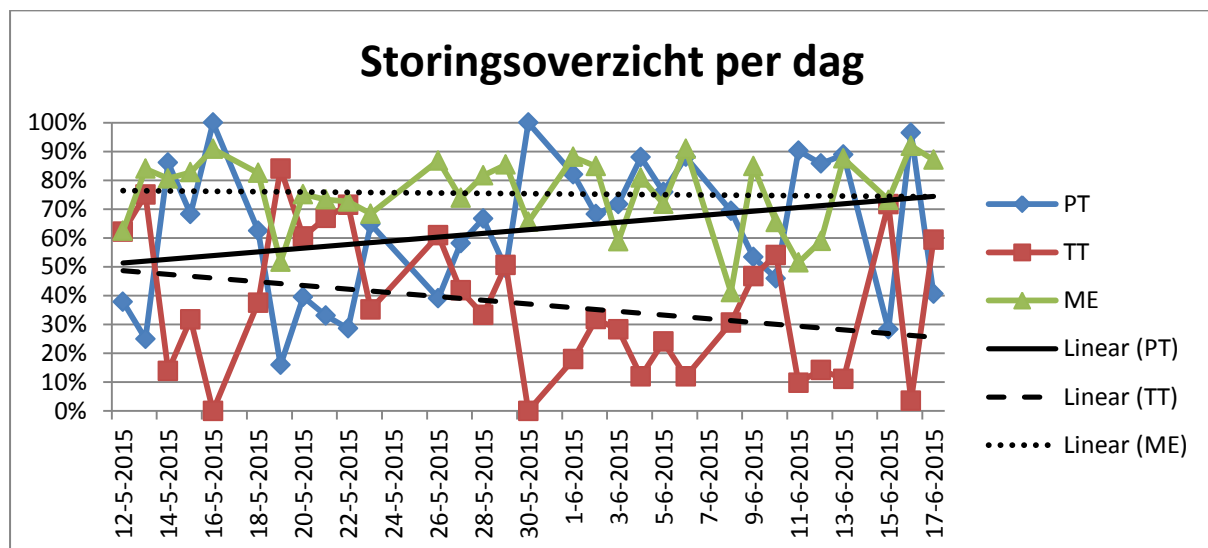
Figure 6: Analysis of types of downtime and ME.

The excel sheet was adjusted including all the visual basic macro’s. Also an analysis file was added to monitor the ratio of these malfunctions over time. This file automatically gathers its data from the database and plots it in a graph. The ME is also included in this graph (Figure 6) so one can get an overview which kind of downtime influences the ME the most.

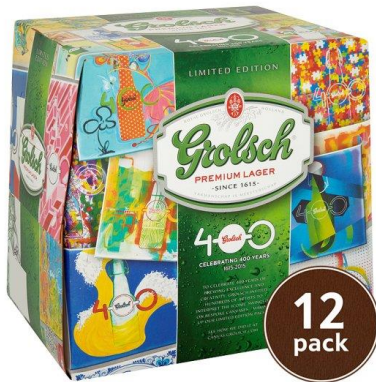
Figure 7: Left: Multipacker 12-pack.

Next in line is the multipacker Jones. This machine is accountable for 11% or 6748 minutes of downtime. This machine unfolds and glues the 12-, 20- and other specific packs (Figure 7). It also places the bottles of beer in the packs and closes them. When using regular cardboard boxes, these steps are done by several different machines (dozenopzetter, robot, dozensluiter). This machine is a machine with lots of problems regarding the set up for a new product. The list of adjustments points is very high and therefore the machine is hard to understand for the operators working with it. Several people are working or have been working on this machine to improve this. Next to this there are many problems with quality of the material used (cardboard). This is not a thing that can be solved on a technical perspective but has to be done by the purchasing department. Therefore this will not be the main focus. Furthermore this machine is not used all the time. Only about 20% of production is done using this machine.

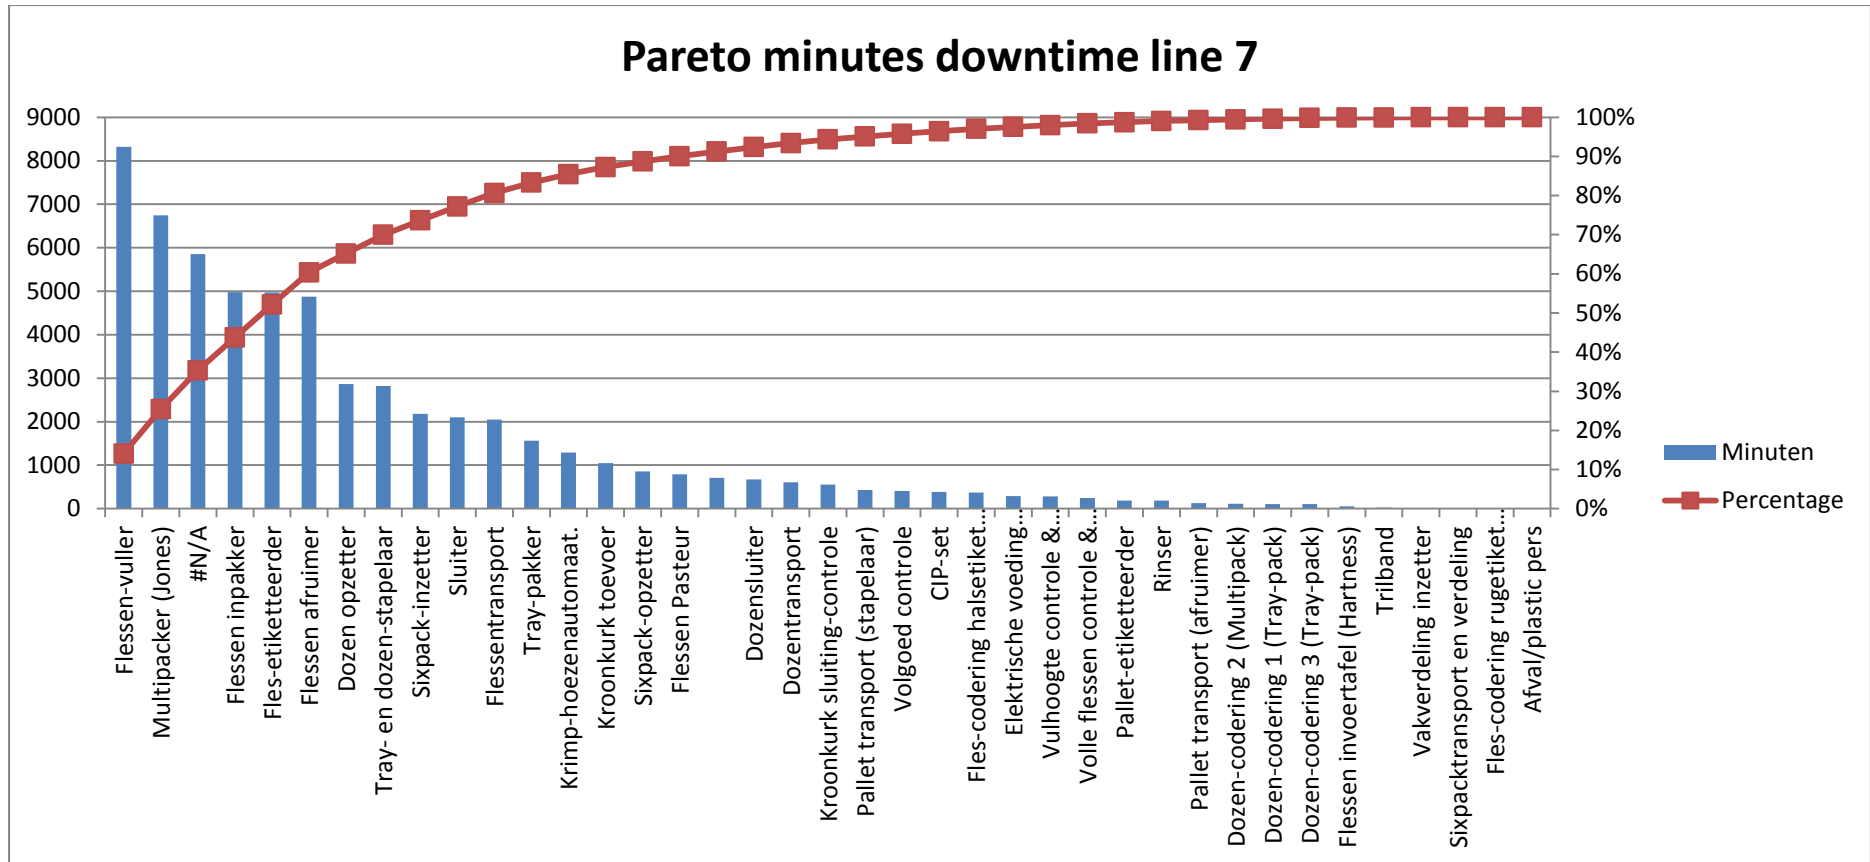
Figure 8: Pareto of the downtime on line 7

In Figure 8 the pareto graph of the downtime of line 7 of book year F15 is displayed (apr-2014 till apr-2015). The first five records make up more than half of the downtime.

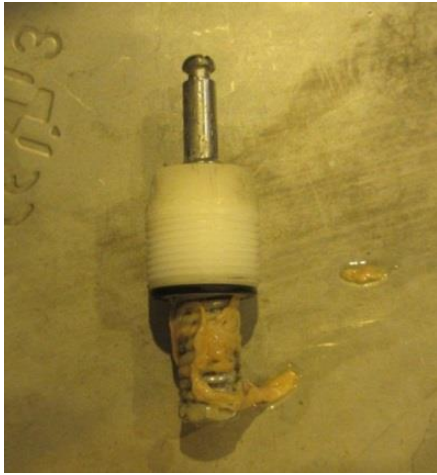
Figure 13: Dirty inside of a nozzle

In this study can be read that lubrication is a key factor in solving this problem. The nozzles which spray on the conveyors need to be cleaned and adjusted on a regular basis (

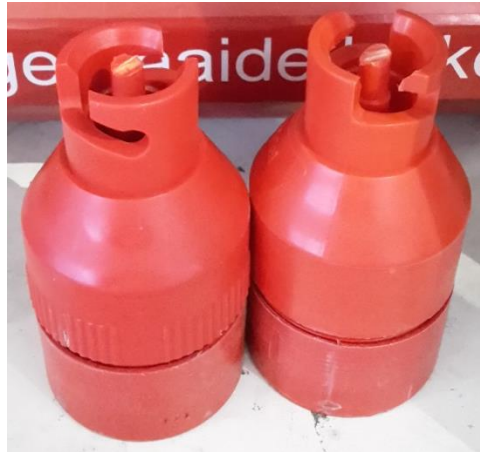
Figure 14: Tulips

These tulips sometimes are not functioning anymore and need to be replaced. The third issue is adjustment and fine-tuning after setup for a new product.

To reduce the time of problems with the tulips it is investigated what caused the most downtime. It seemed that waiting on a new part was the biggest problem. Next to the machine there is a cabinet with spare parts in which ten spare tulips should be present. It happened quite some times that the cabinet was empty. To make sure there are always new tulips, two containers have been placed in the cabinet. When the first one is empty an operator has to refill this from the central warehouse immediately. The second problem is the use of standard and modified (narrower) tulips. Some operators use the wrong tulip while replacing a broken one. These narrower tulips however can be used in all the different robot heads. Therefore it is decided to modify all available tulips. This can be done at the in-house technical department using a lathe.

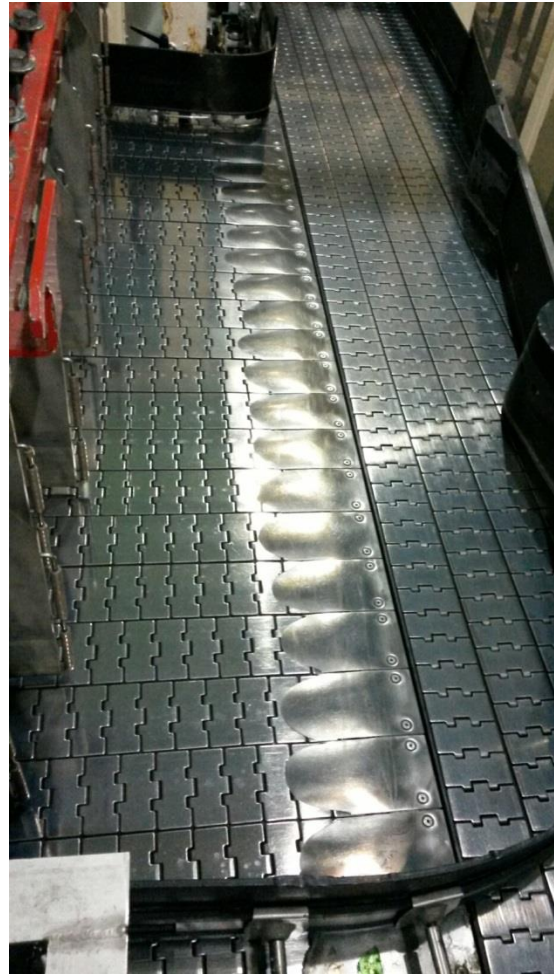
Figure 16: Overview of the bottle table, old fingers still present

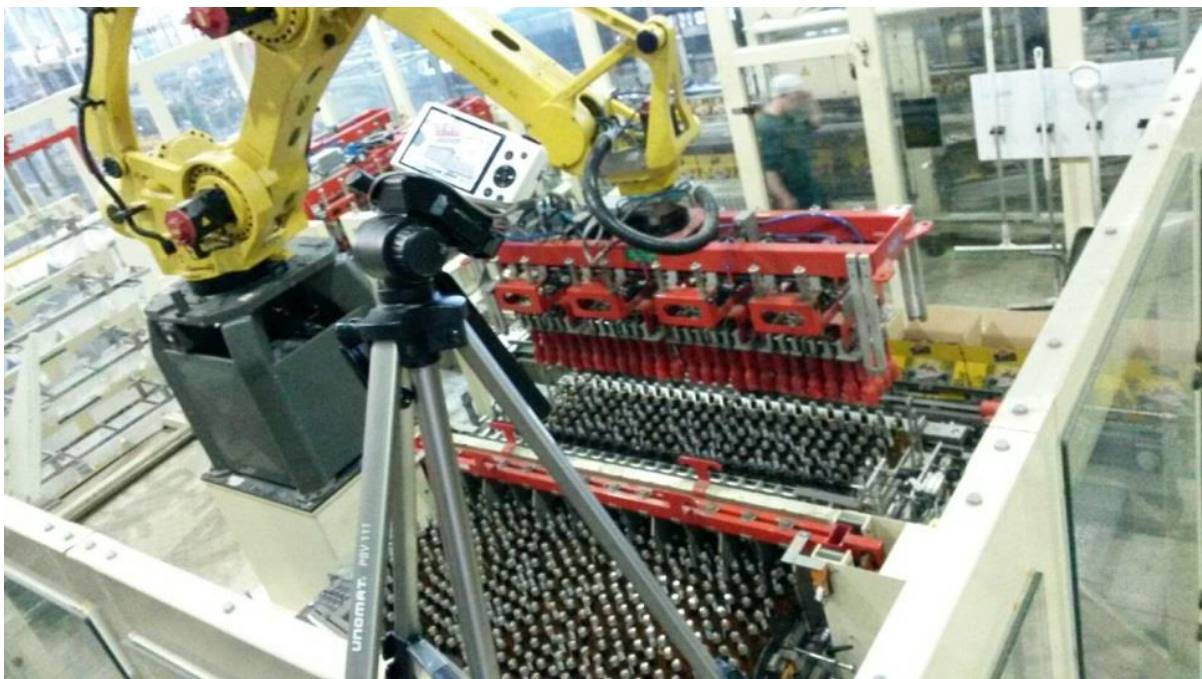
Figure 18: Shooting video of the robot. The robot head with the (red) tulips can be seen.

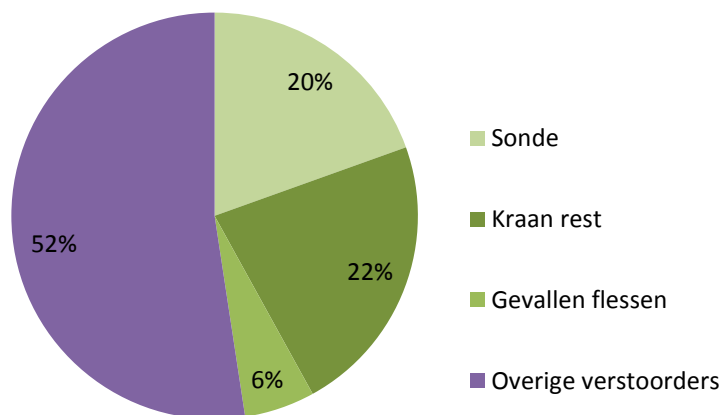
Figure 22: overview downtime root causes of the filler

From this analysis is found that the filler was responsible for 5% of the total downtime of the line. To get an improvement of 2% on the entire line we have to solve 40% of the filler specific downtime. A big problem last year has been the High Pressure Injector (HDI). This was a technical malfunction that has already been solved. This leaves us with 4% on the entire line from which we need to solve 2%. This means 50% of the filler specific problems. The top 3 problems, combined accountable for 48% of the downtime (Figure 22), are selected. The first one is the probes (sondes). The second is the filler valves (kranen) and the last is tipped over bottles at the inliner.

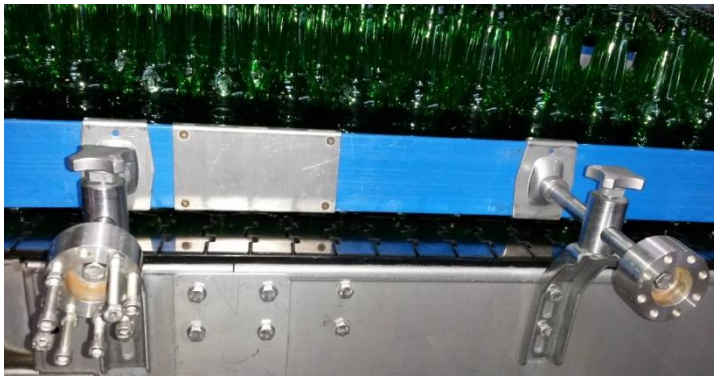
Figure 25: Left: old adjustment tools for the side barrier.

Right: current status of adjustment tool

The second problem is the adjustment of the side barriers. When the bottles are stacked ten next to each other like in Figure 32 and they need to speed up and get in a single line it is every critical that the side barrier is in the right width. For every different bottle type this barrier needs to be adjusted. A long time ago someone made an adjustment tool on these barriers. These tools are no longer in use. It is decided to take them back in use after making an improvement. The old state of the tools can be seen in Figure 25. The tools are mounted backwards, the right one is even incomplete. The idea behind the tool is that the bolts sticking out of the revolver are of different lengths. Each length is for a different bottle type. The side barrier distance can be measured using this revolver. The distance was measured against a round bar. This bar is flattened to make a clear adjustment point. Furthermore new lengths of the bolts are to be determined. The bolts are then secured using Loctite to prevent them from unwanted adjustments. Finally, every bolt is given a color corresponding with the color of the parts in the filler belonging to this bottle size.

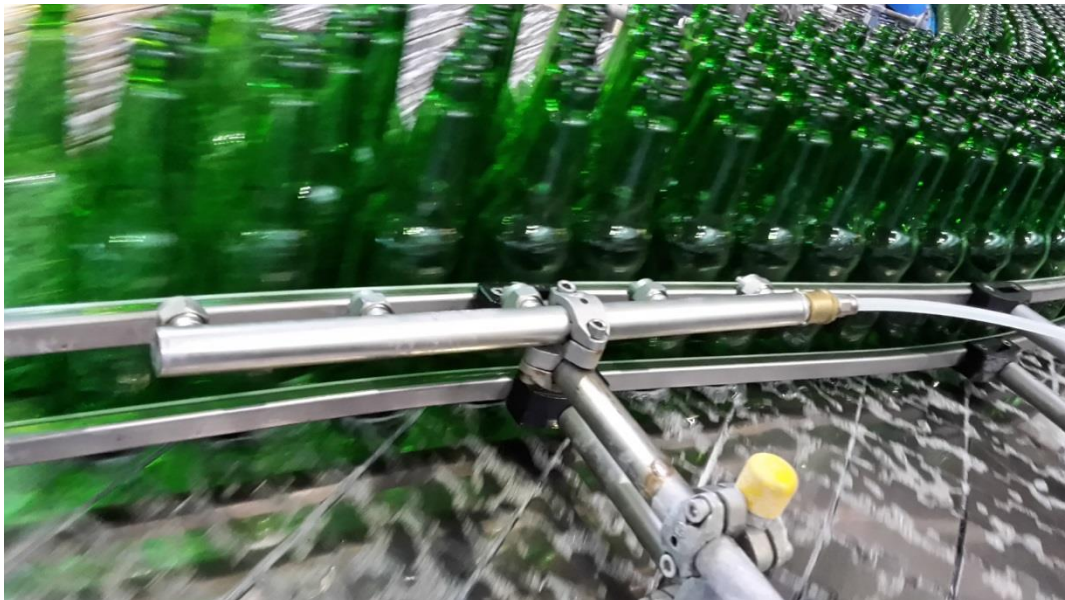
Figure 26: New spray nozzles

When the bottles are lined up from the “afruimer” they are waiting about a half hour before production starts. At this moment the conveyor is on hold and thus not lubricated. This conveyor runs at a very high speed as the bottles are not transported ten next to each other but are lined up individually to enter the filler. When the conveyor then starts the bottles will tip over due to lack on lubrication. To prevent this extra spray nozzles are mounted which spray the bottles on this location with extra soap solution to keep them from tipping over (Figure 26).

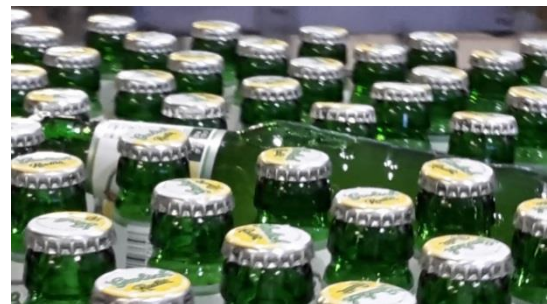
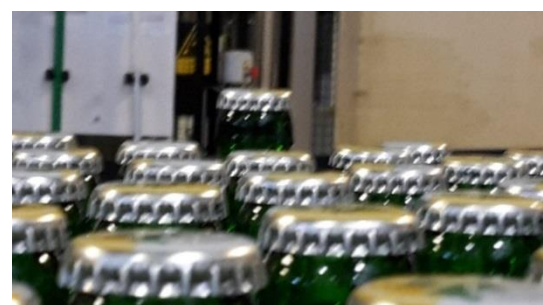
Figure 31: Grolsch Apollo bottles pop up

Lubrication of the conveyors is an important factor. The conveyors have a stainless steel surface which is lubricated with a soap water solution. This solution is sprayed on the conveyors every 50 seconds by a nozzle. If the conveyor is too rough the bottles will tip over. This roughness will also cause pressure on the bottle as the conveyor is running underneath the bottles as the conveyor is filled. The conveyor is designed in such way that it will not stop directly as the conveyor is filled. This pressure generated on the bottles will cause the bottles to pop up (Figure 31).

The new Grolsch "Apollo" 30cl bottle has another problem. This bottle tends to pop up if the pressure on the conveyor is too high (Figure 31). This is caused by the shape of the bottle. The standard 30cl BNR bottle has a straight side. The Apollo bottle has a relief surface. This causes the bottle to only make a two point contact with the other bottles. Therefore there is less friction between the bottles and they are popped out easier. Furthermore the Apollo bottle is just a bit tapered which also makes it easier to pop up.
