# Internship Report

Condition monitoring and testing of piezo elements for the activation of guided Lamb waves & damage identification using ultrasound scanning

Location: Centre for Advanced Composite Materials (CACM), University of Auckland

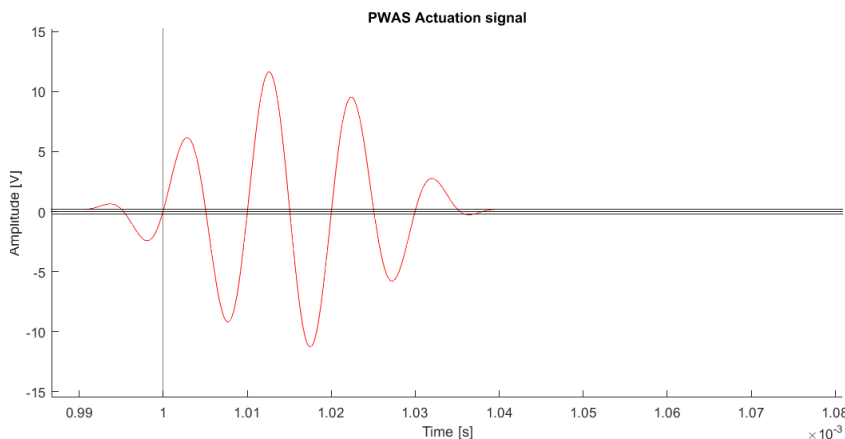
Figure 7: Actuation signal (burst)

The signal sent to the PWAS element is an electrical burst shaped signal (Figure 7) of a single frequency and maximum voltage output of 10V. This electrical signal is converted into a vibration by the PWAS element which triggers the guided Lamb wave. The Lamb waves arriving at the PWAS elements at the other end, cause an electric output. The electric output is recorded by the handyscope and sent the external PC for further analyses. To reduce the influence of external vibrations, the sensor data is averaged over 10 experiments.

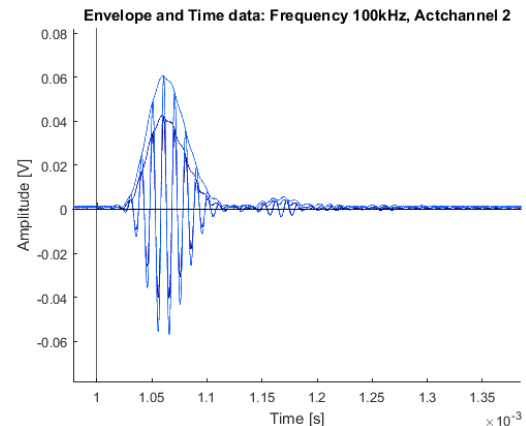
Figure 8: Envelope plot 100kHz

The measured sensor data, is the time domain data as shown in figure 8, in this case the two receiving elements are number 1, 4. Figure 8 shows both the envelope plots, for the particular case of 100 kHz and actuator element 2. In the figure the light blue line indicates the sensor signal from big piezo, the darker line is the sensor signal corresponding to the smaller piezo. Although the boundaries taped, there is still a small reflection from the free boundary visible. At lower frequencies (70 kHz), the  $A_0$  mode is significantly higher. At higher frequencies the S mode is dominant. Also interesting is that for higher frequencies, about 100 kHz, the  $S_0$  and  $A_0$  mode arrive at the same time. Increasing the mutual distance should lead to a clear separation of the wave modes, since the A mode is supposed to have a lower wave velocity. Only the strip is too short to test for increasing distance.

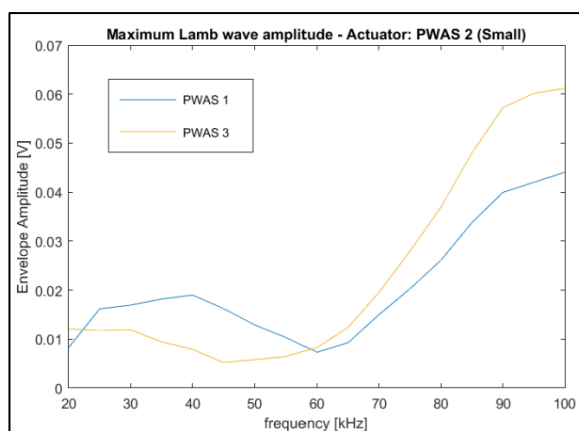
Figure 9: Envelope Amplitude, Actuator element 2 (small)

The maximum amplitude for each frequency is shown in figure 9 and 10. In the left figure, the lamb waves are activated by a small PWAS element (14mm). It shows that for higher frequencies, the lamb waves have a higher amplitude.

It can be concluded that smaller piezo elements perform better for the activation of Lamb waves on this CFRP strip, with a maximum voltage of 10V. An increase in PWAS element diameter deteriorates the sensibility of high frequency Lamb waves.

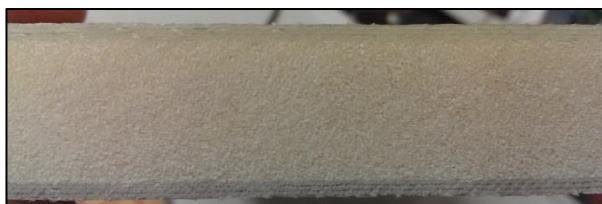
Figure 13: Sandwich specimen: two glass fibre skin and foam core

The third specimen is a sandwich material consisting of two glass fibre skin panels and a stiff foam structure core. 3 PWAS elements are placed on the top skin and 1 on the bottom skin to check if the Lamb wave is propagating through the material thickness. On the top skin the mutual distance varies between 30 to 50 mm.

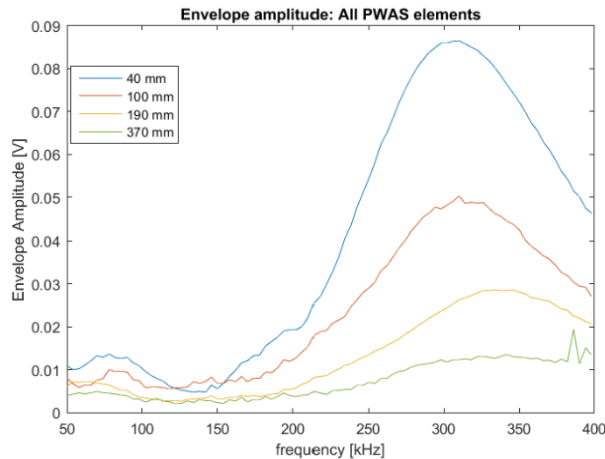
Figure 14: CFRP flat panel

The 6.2 mm panel is tested for the frequencies 50 kHz up to 500 kHz, the graph (figure 14) shows two peaks, a small peak at 70 kHz and one around 300 kHz. Plotting the time domain showed that for low frequencies (50-100 kHz) the A-mode is most active. However, at high frequencies it is different. Especially around 300 kHz (figure 15) a strong S-mode is followed by a strong A-mode. Two strong modes have a great potential for damage detection.

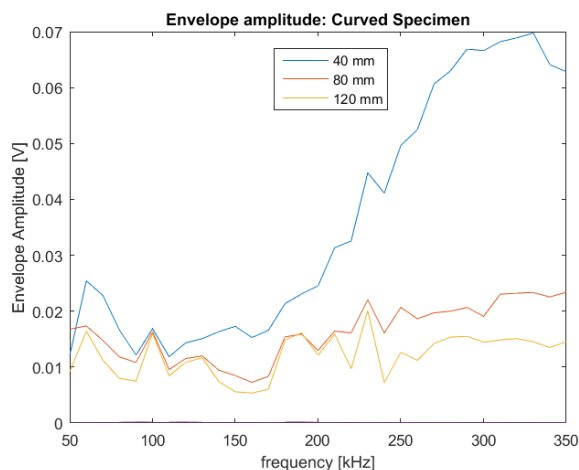
Figure 16: Curved specimen (mast section)

Figure 16 shows that the wave propagation in the curved specimen is more attenuated. Sensor 2 at 40 mm, positioned before the curvature, shows a significantly stronger peak as sensor 3 at 80 mm after the corner section (figure 12). Thus, the non-linear section has a high attenuation ratio. This is in contrast to the flat panel case where the attenuation is approximately linear over the distance. The time domain graphs made clear that the S-mode is mostly attenuated by passing the corner section, while the A-mode is less affected.

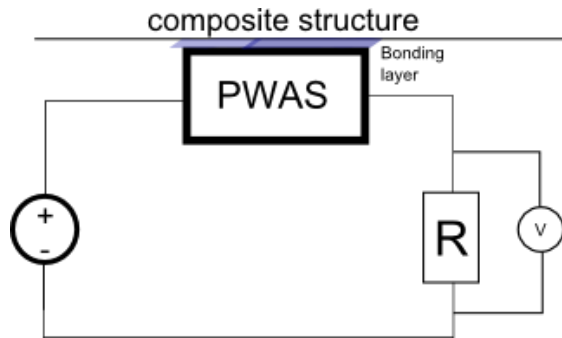
Figure 19: Electric circuit

The impedance measurement is obtained by applying a frequency sweep in the range of 0.1 - 1MHz with a maximum voltage amplitude of 10V. A small electrical circuit (figure 19) is used to determine the voltage and the current over the piezo element, these are needed to acquire the impedance value. The power source, the PWAS element and the resistor are in series, hence the voltage over the PWAS element is determined by subtracting the power source voltage by the resistor voltage. The current is acquired by measuring the voltage over a low ohm path, a composition resistor of 20 Ohm's is used in the experiment. The resistor has a low value such that the voltage drop at the resistor is minimal.

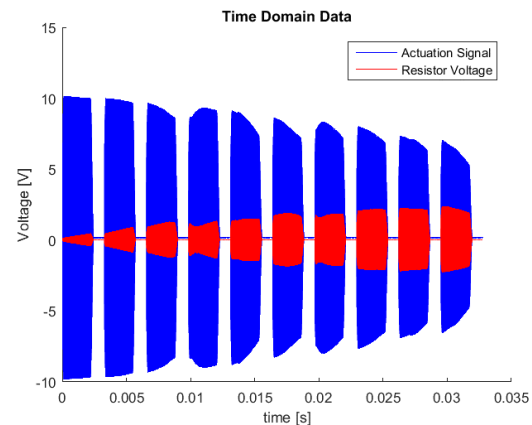
Figure 20: Time data frequency sweep

The time domain data is the direct result of the experiment (Figure 20). In the figure the actuation signal (blue) and the resistor voltage (red) is shown. Due to a small storage capacity in the Handyscope, 10 different sweeps are applied in sequence, each activating a different frequency range. When all the sweeps are conducted and the time domain is converted into the frequency domain by a fast Fourier transform, the data is merged together. Finally one data set is left containing all relevant data over the entire frequency range. The same handyscope system as in previous experiments is used, only is now connected to the electrical circuit to measure the resistor and power source voltage. The burst signal is replaced by the frequency sweep signal as shown in the figure.

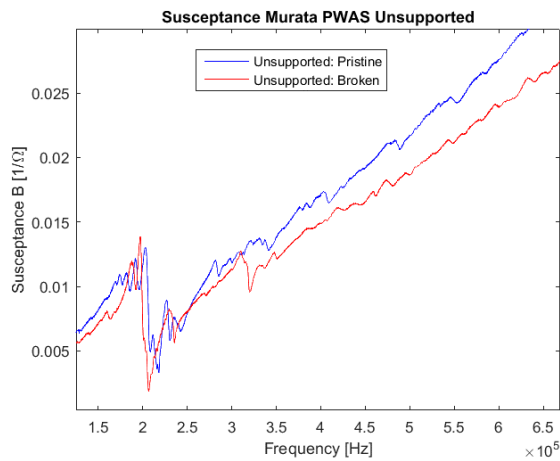
Figure 22: Pristine and broken PWAS element susceptance analyses

The breakage scenario is tested with two unsupported piezo elements, one pristine and one broken, resulting in a different gradient. In figure 22, the two cases are plotted. Note that the broken piezo has a lower gradient. This corresponds to the literature [11], a broken piezo has a lower capacitance and this leads to a decrease in slope.

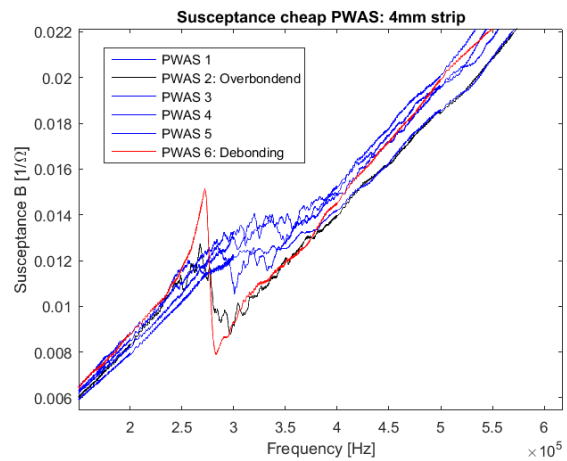
Figure 23: 4.2 mm strip susceptance analyses

For the sensor bonding failure two different scenarios are tested, the over bonding and lose bonding case. These scenarios are compared with 4 properly bonded piezo elements. The susceptance curves of all elements are plotted in figure 23. The effect of changing bonding layers, tends to show a change at the resonance frequency. In case of loose bonding (red line), there is strong anti-resonance peak to be recognized, as can be seen in the figure. The element covered in a thicker layer of glue (black line) did not change much, only a slightly stronger peak at the resonance frequency, but no anti resonance peak.

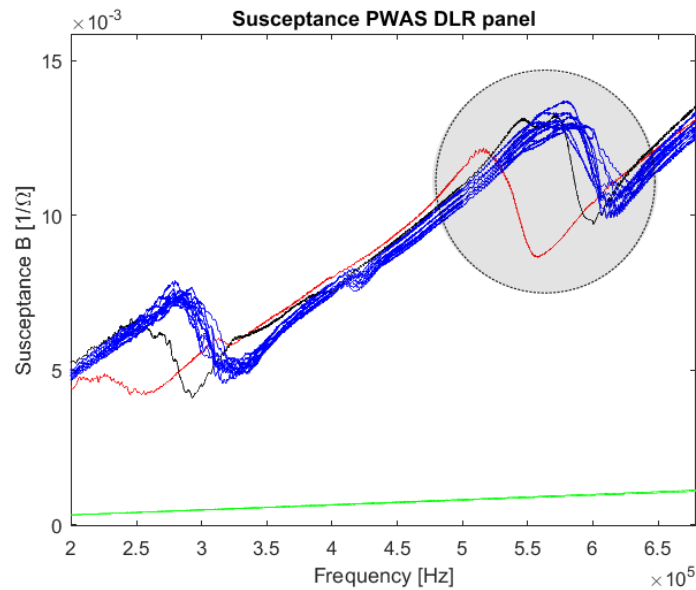
Figure 24: PWAS susceptance DLR panel

The integrated sensors in the aircraft panel are tested after the impact damage application, no data was measured prior to the impact. The susceptance graphs are presented in figure 24. Apparently, most of the PWAS elements have a high correlation. Some PWAS elements on the aircraft panel show slightly different behaviour. Especially PWAS 5, 12 which are presented by green lines in the bottom of the figure. These PWAS are not properly connected and are excluded from further analyses. The peaks according to PWAS 2 (red) and 9 (black) are at different frequencies. These results correspond to the susceptance characteristics found in the damage scenario analyses. In figure 24, the encircled area shows the susceptance change most clearly. A small change in resonance frequency and the presence of a tiny resonance peak indicates that PWAS 2 and PWAS 9 are debonded/loose bonded from the panel surface.

Monitoring the state and condition of the PWAS elements based on susceptance is proven to be a simple and reliable method with much potential. This method indicated the debonding or lack of adhesive layer at PWAS 2 & 9, which could have affected the results found in the external research done by Loendersloot. The effect of debonding on the wave generation and sensibility is not investigated. One disadvantage of monitoring the susceptance is the need for an external electrical circuit, since it would be ideal to ultimately integrate the PWAS elements into the structure. The next step is to test this method on a larger scale, involving much more elements and in changing environmental conditions.

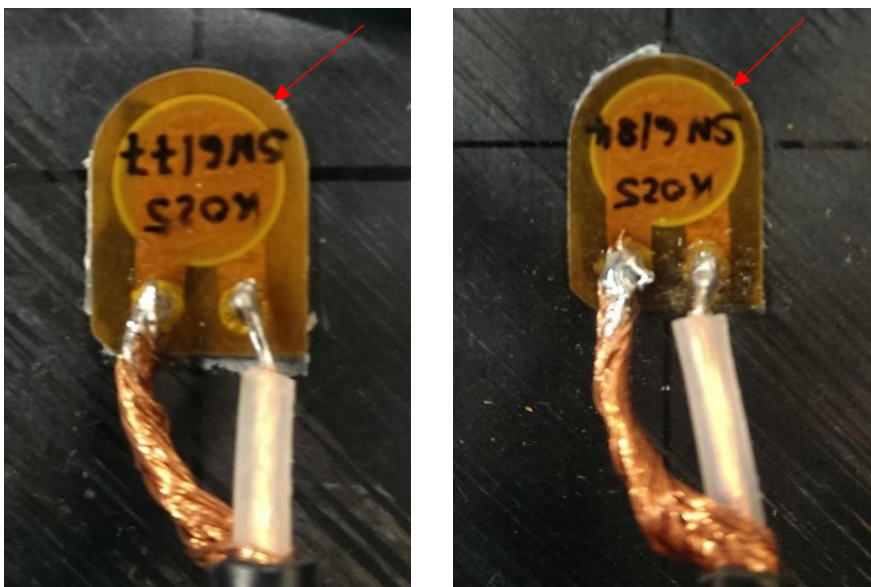
Figure 25: Aircraft panel PWAS 2 (left) & 9 (right)

A closer look at the PWAS element bonding layer on the aircraft panel reveals the potential problem. Sensor 2, shown in the left image has a different orange tint along the edges as the healthy PWAS element shown in the right figure. This colour change at the edges probably indicates less adhesive material (glue), resulting in debonding. PWAS 9 has similar appearances.

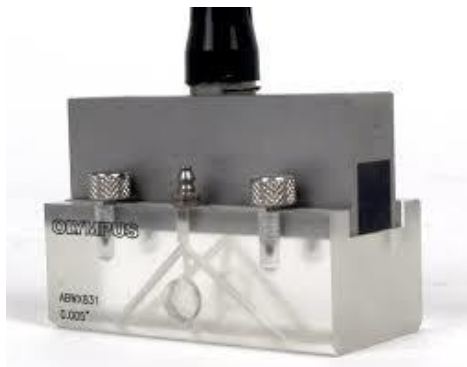
Figure 30: Probe & Wedge

The device used for the ultrasound scan of the aircraft panel is the Olympus OmniScan MX2 created by Olympus. As mentioned before, a probe wedge (Figure 30) is used to increase the time of flight of the wave. This increases the accuracy of the scan. The device specifications, probe type and wedge are listed below.

**Device:** Olympus OmniScan phased array (64 probe; 3.5L64-NW1)  
**Frequency:** 3.5 MHz  
**Wedge:** SNW1-0L-IHC-C Rev-C wedge (20 mm)

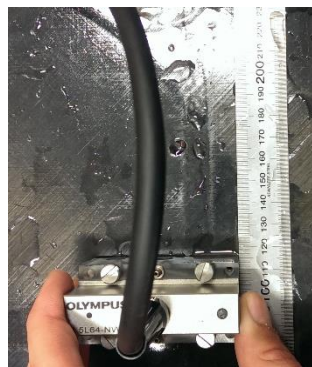
Figure 31: Manual C-scanning

In order to acquire knowledge about the system and to gain experience, first the manual created by Cartier [15] is used. This manual includes two test specimen, one calibration panel and one with artificial defects. The artificial defects are made by integrated layers of backing film in between the composite layers. The user manual is useful for a first experience with the ultrasound scanner. This manual shows how to setup a first test and which settings are influencing the quality of the image. The effect of most settings are already discussed by Cartier. However, most settings are mainly focussed on scanning of thick panels. Secondly, the correctness of these settings is judged on the defect depth error and the defect size error for a thick specimen. The echo intensity and noise are not taken into account. Therefore the settings are evaluated and optimized for the functionality of scanning the aircraft panel. In appendix a: olympus omniscan settings, all settings are briefly discussed and optimized. Since there was no encoder present, the C-scanning is done manually as shown in figure 31. More details about manual scanning can also be found in the appendix.
