The use of unmanned aerial vehicles to inspect bridges for Rijkswaterstaat

Title:	The use of unmanned aerial vehicles to inspect bridges for Rijkswaterstaat
Educational institution:	University of Twente Faculty of Engineering Technology Civil Engineering Postbus 217 7500 AE Enschede www.utwente.nl/en/ce/
Author:	Alexander Jongerius alexander.jongerius@gmail.com
Supervisors:	Dr. A. Hartmann University of Twente Faculty of Engineering Technology Arie van Kersen Rijkswaterstaat Grote projecten en onderhoud Dr.ir. Martijn J. Booij University of Twente Water Engineering and Management
Place:	Enschede
Date:	March 25, 2018

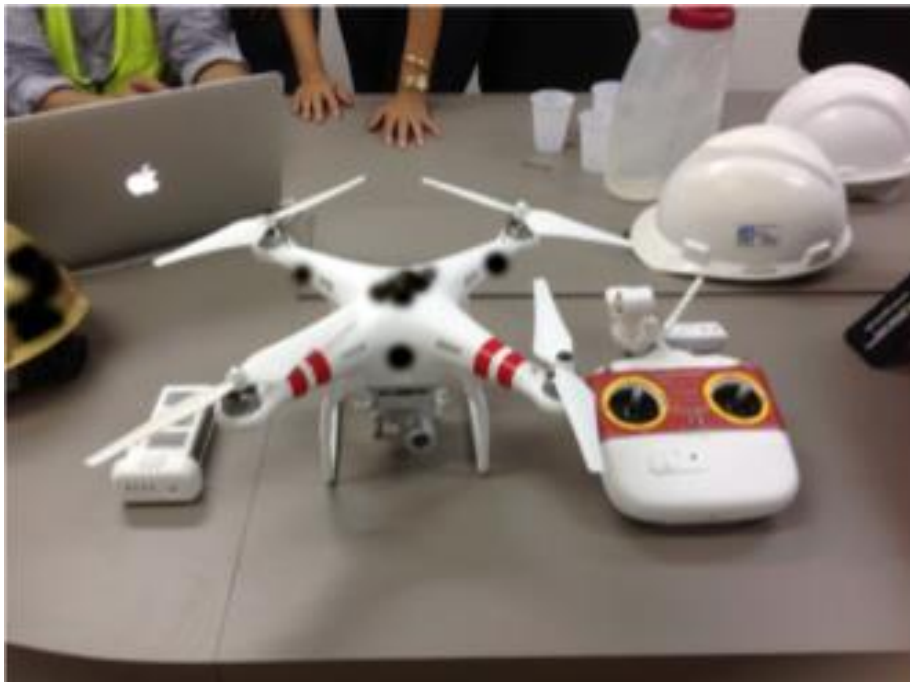
figure 2 - Example of simple multi-copter platform, DJI Phantom 2 (Irizarry & Costa, 2016)

The most common system used for civil purposes is the multi-copter platform, consisting of four or more brushless motors. The advantage of these multi-copters is the capability of vertical take-off and landing. The improved manoeuvrability of UAV technology allows flights to be conducted in difficult-to-access areas as well as indoors. (Jordan et al., 2018)

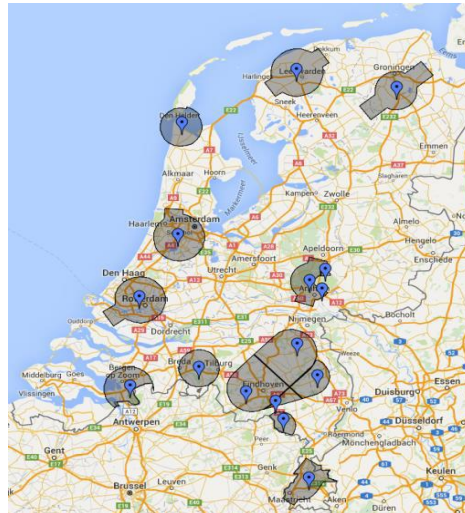
figure 4 - No-fly zones in the Netherlands

Within the Netherlands, there are currently some limitations in legislation regarding the professional deployment of UAVs. Figure 4 depicts the no-fly zones within the Netherlands. It is not allowed to deploy UAVs without a transponder (which communicates with local air traffic control) in these areas. Besides these no-fly zones, the following rules must be observed when it comes to inspecting large infrastructural objects (Keesmaat, 2017):

1. A minimum distance of 150 meters between human beings (in all three dimensions).
2. Altitude limitation of 120 meters.
3. No flying within three kilometres of airports.
4. No flying above roads (speed limit 60km/h or higher) and a minimum distance of 150 meters to these roads.
5. Roads with a speed limit beneath 60km/h have a minimum flying distance of 50 meters.
6. No flying within 150 meters of railway lines.

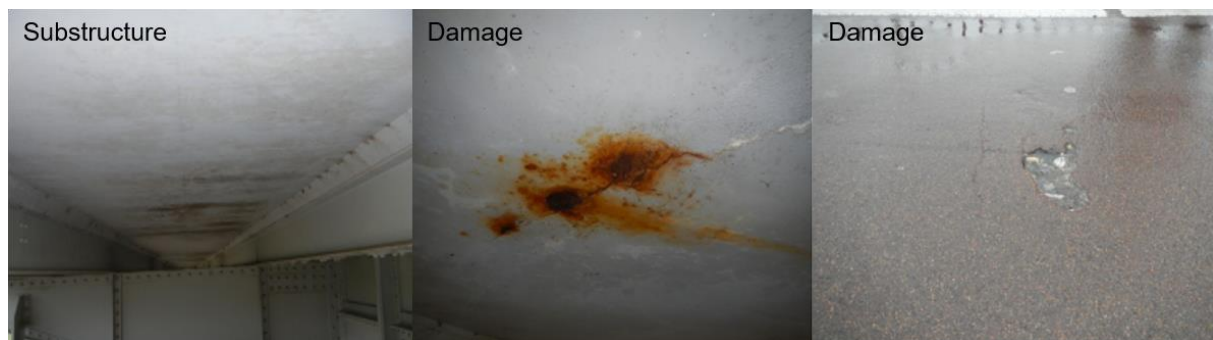
figure 11 - one damage type to the main bearing construction concrete

During the conventional visual inspection of the main concrete construction six different damages have been found. The severity of each of these damages varies from low to high. The severest damage is to the concrete construction of the underside of the concrete slabs that support the bridge deck. In figure 11 an example of one of the damages is given. In this case two to four small cracks have been found in the underside of the bridge deck with a width that is smaller than 0,2mm (middle photo). Another six cracks have been found on the bridge deck, with width varying between 2-3mm (right photo). Both observed cracks are placed within the "cracks in the main construction concrete" group.

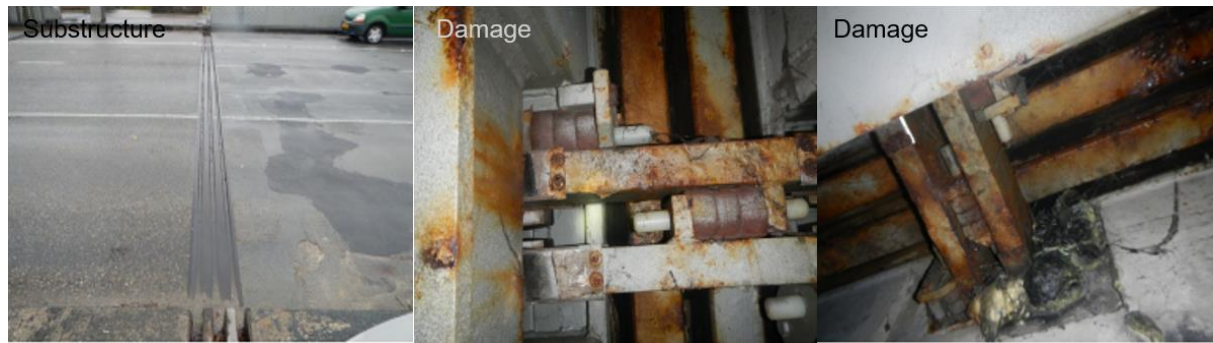
figure 12 - one damage type to the expansion junction

Apart from damages on the main concrete construction, the visual inspection reported failures on all other substructures except the handrail. Another example of one of these damages is corrosion cracking (fatigue) due to the thermal expansion/closure of joints. This process will result in material decay over time. The corrosion damage photos can be found in figure 12. Again, the overview photo of the substructure is on the left and two photos of the damages on the right. No measurements have been made on this damage type.

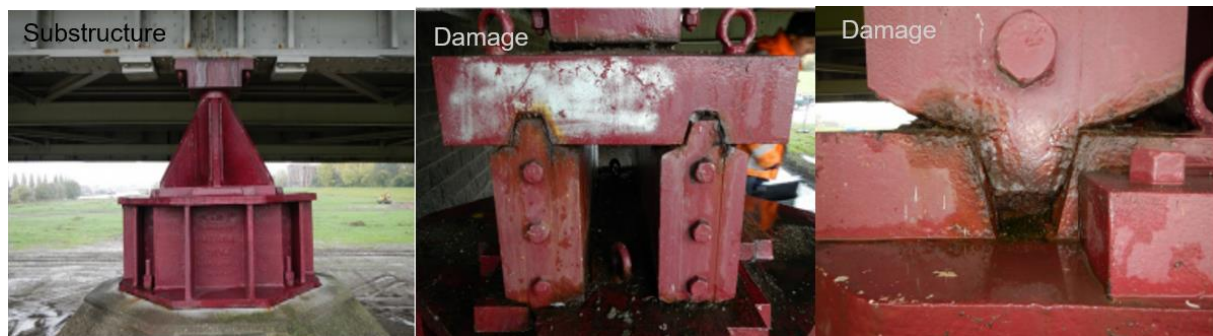
figure 13 - one damage type to the supports

The last example of a found damage is to the supports, this is the only damage type that is found during inspection. In this case the supports show signs of corrosion, mostly showing on the points of contact. The overview photo (left) and the damages (right) can be found in figure 13. The damage has been classified as normal considering the age of the structure.

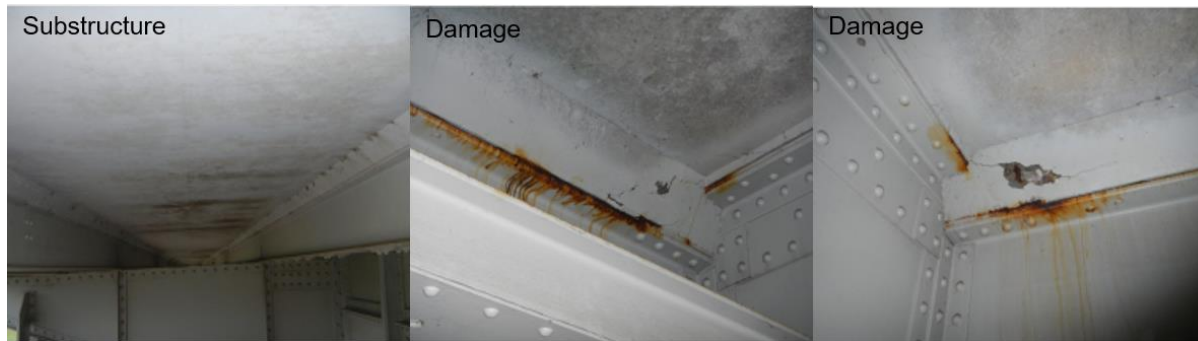
Underside of the road bearing concrete slabs show rupture/broken off concrete, damage is of around 0,5 meter.

Severity: severe damage.

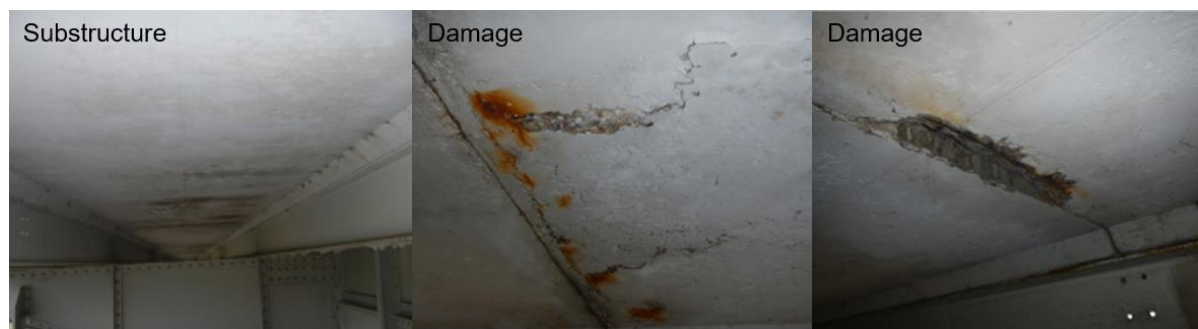
Corrosion areas on the concrete slabs with exposed reinforcement. About 20 locations along the outer side of the bridge deck. Coverage on reinforcement is 1,5-2cm came forward from additional research.

Severity: severe damage.

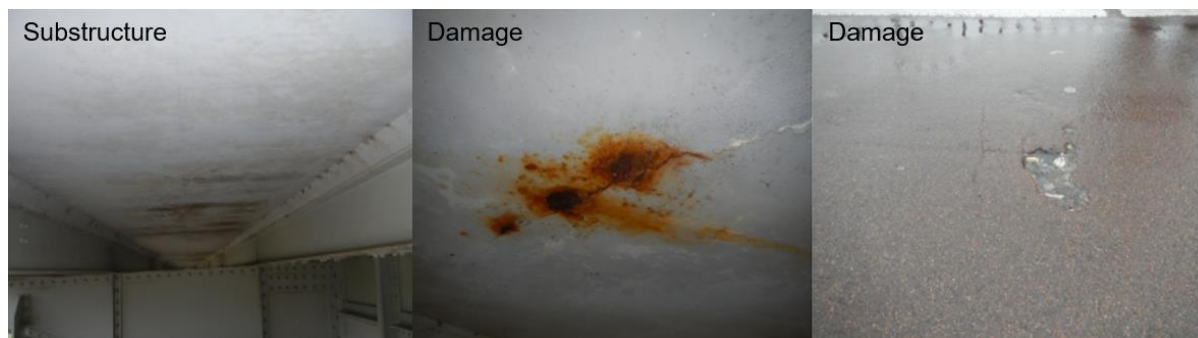
Rips in concrete slabs (underneath) in width direction of the bridge, about 2-4 cracks. The width of these cracks is very small ($<0,2\text{mm}$). Also on the bridge surface detected 6 cracks with a width of 2-3mm.

Severity: severe damage

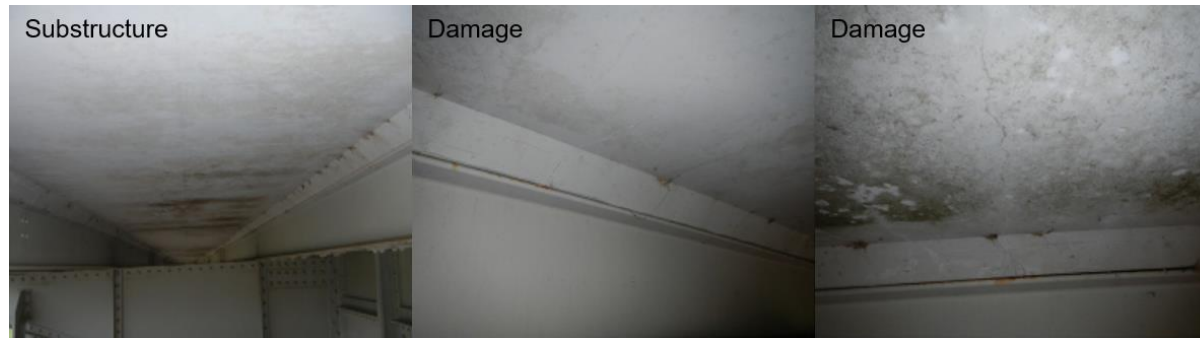
Concrete slabs for the bicycle lane have little thickness (8cm), in combinations with the damages the slabs lose structural safety.

Severity: severe damages

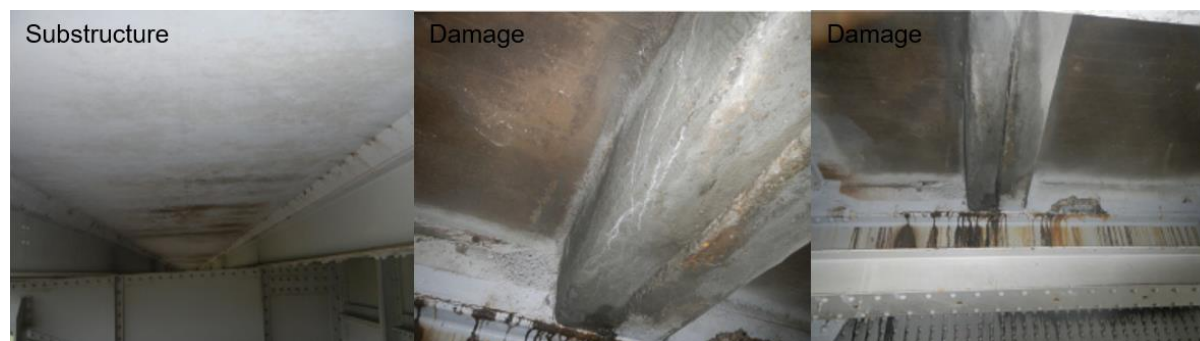
Transversal rips in concrete slabs, with shows of calcium spout at about 8 locations. Width of the cracks is <2mm.

Severity: minor damage

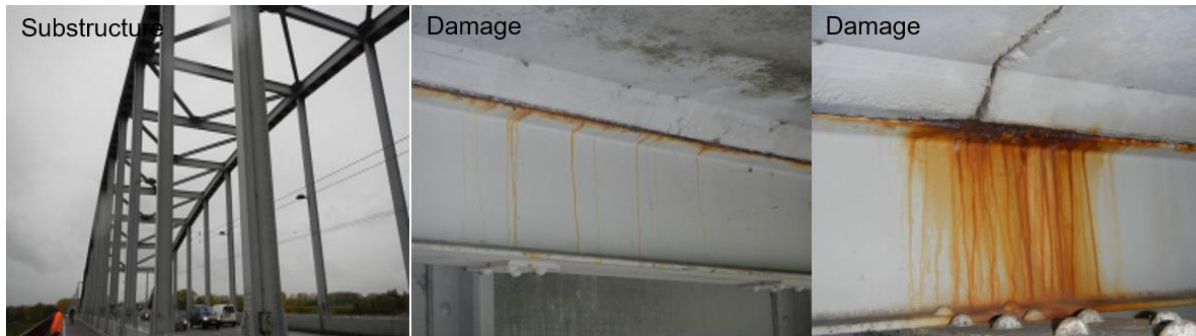
Longitudinal beams show local corrosion on connection with concrete slabs.

Severity: minor damage

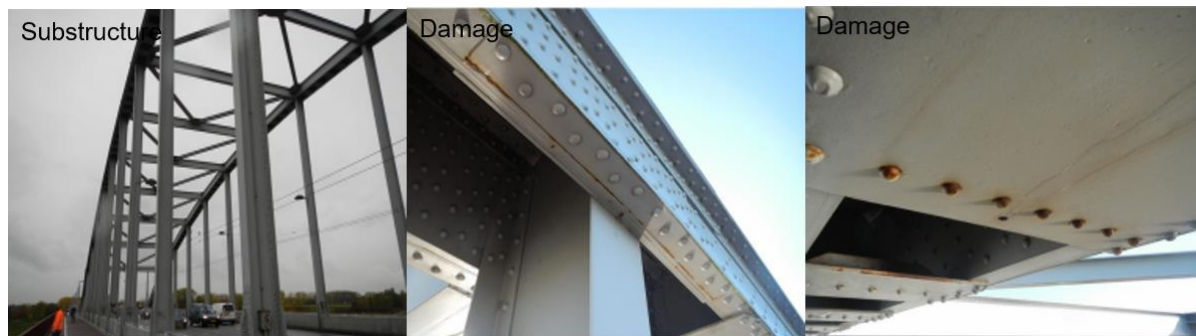
Arch shows corrosion on connection areas and some rivets are corroded (about 30). On about 5 locations there is material decay and slight compression (0,5-1mm)

Severity: minor damage

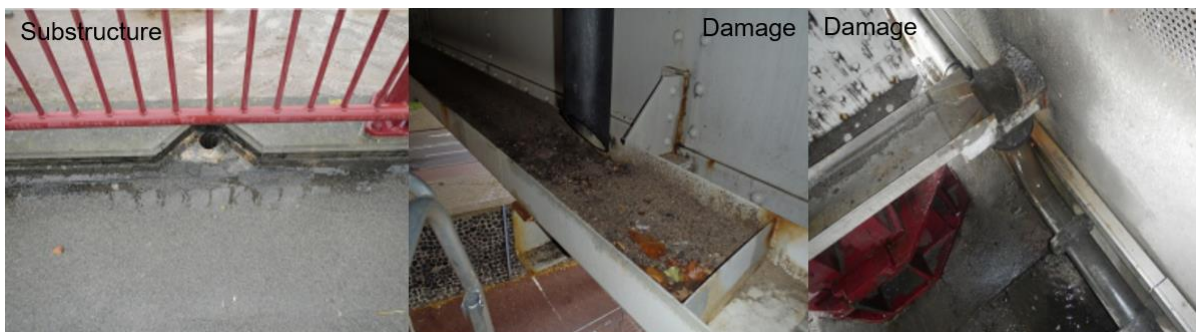
Drains are block, causing water to reach the supports.

Severity: minor damage

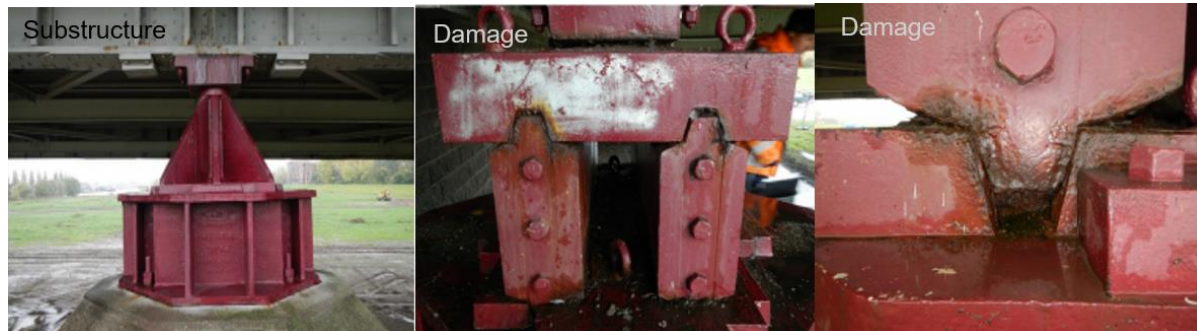
All supports show signs of corrosion, mostly showing on the points of contact.

Severity: minor damage

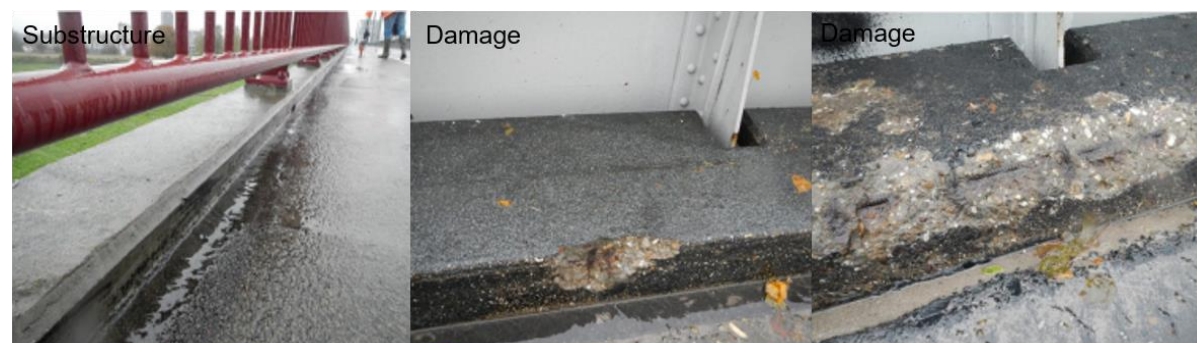
Damages on Road sides at about 40 locations with a total length of 50 meters.

Severity: minor damage

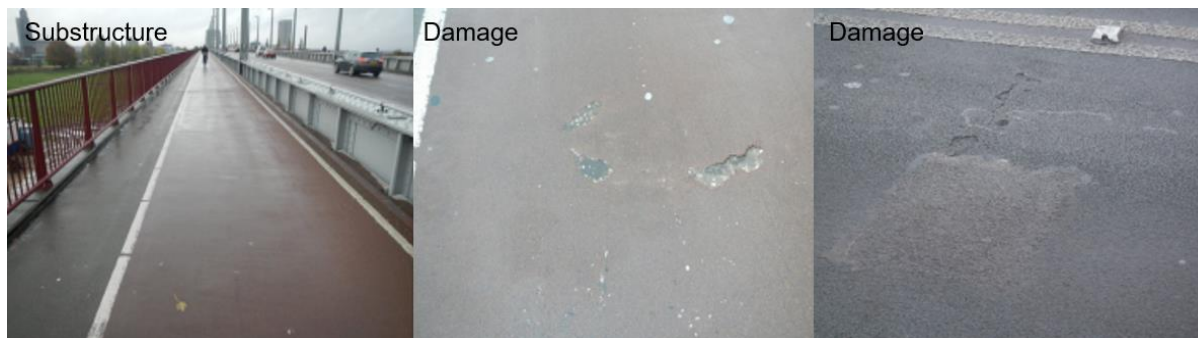
Wear layer shows several different types of damages at an area of about 10 square meters.

Severity: severe damage

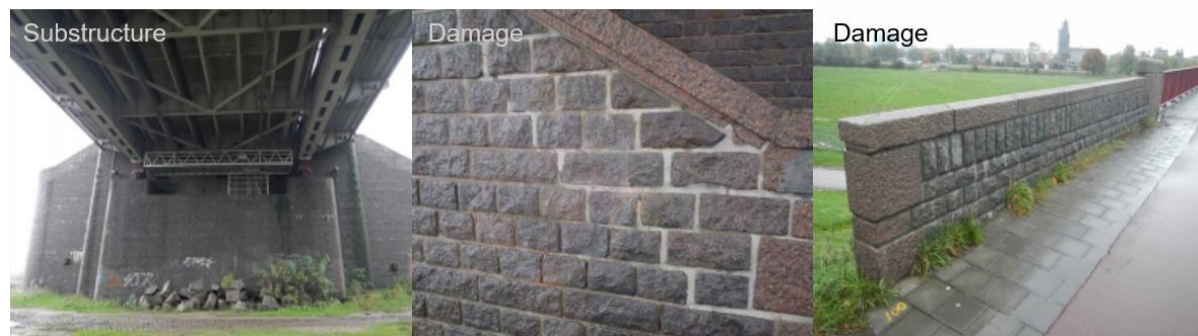
Natural stone on the upper side of the pillars show silted up mortar at about 125 natural stones.

Severity: minor damage

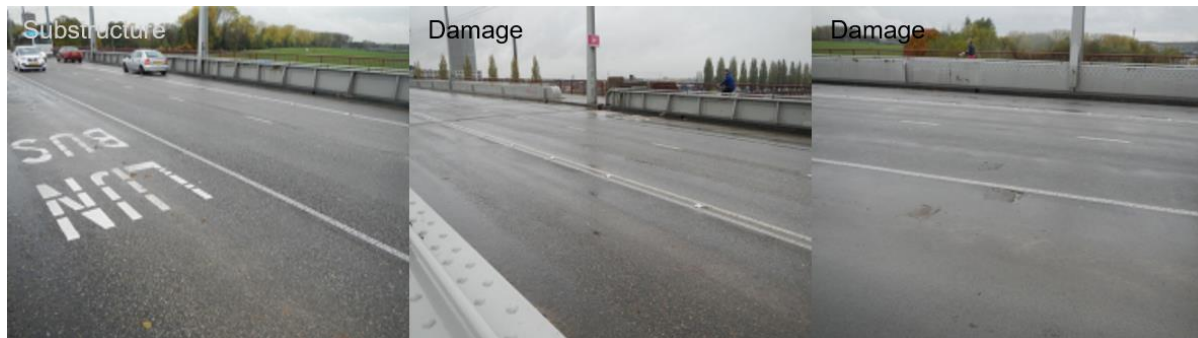
Asphalt shows several different types of damages at an area of about 12 square meters. There is also rut formation on the complete deck with a depth of about 1cm.

Severity: minor damage

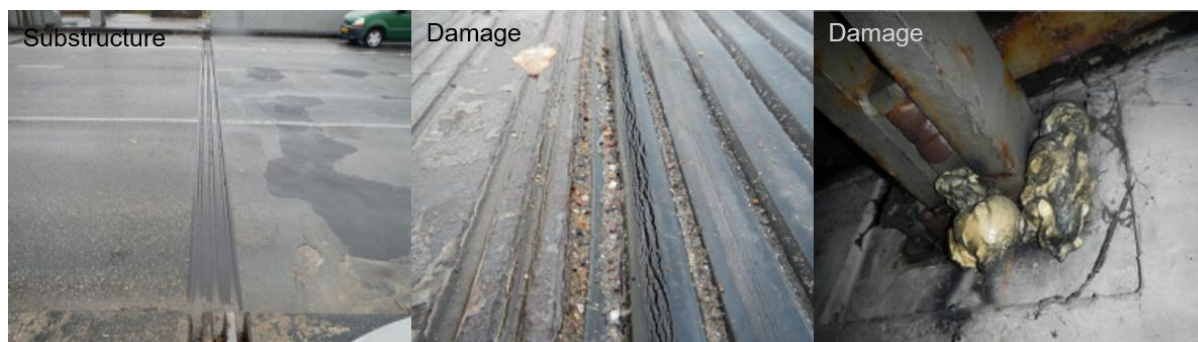
Tearing of rubber of junctions, besides slight settlement in the middle of around 0,5 cm.

Severity: minor damage
