**DEVELOPMENT OF A RAPID
EVALUATION METHOD FOR
MULTI-HAZARD ASSESSMENT
ALONG ROADS:
A CASE STUDY FROM CHINA**

Thesis submitted to the Faculty of Geo-Information Science and Earth Observation of the University of Twente in partial fulfilment of the requirements for the degree of Master of Science in Geo-information Science and Earth Observation.

Specialization: Applied Earth Sciences: Natural Hazards, Risk and Engineering

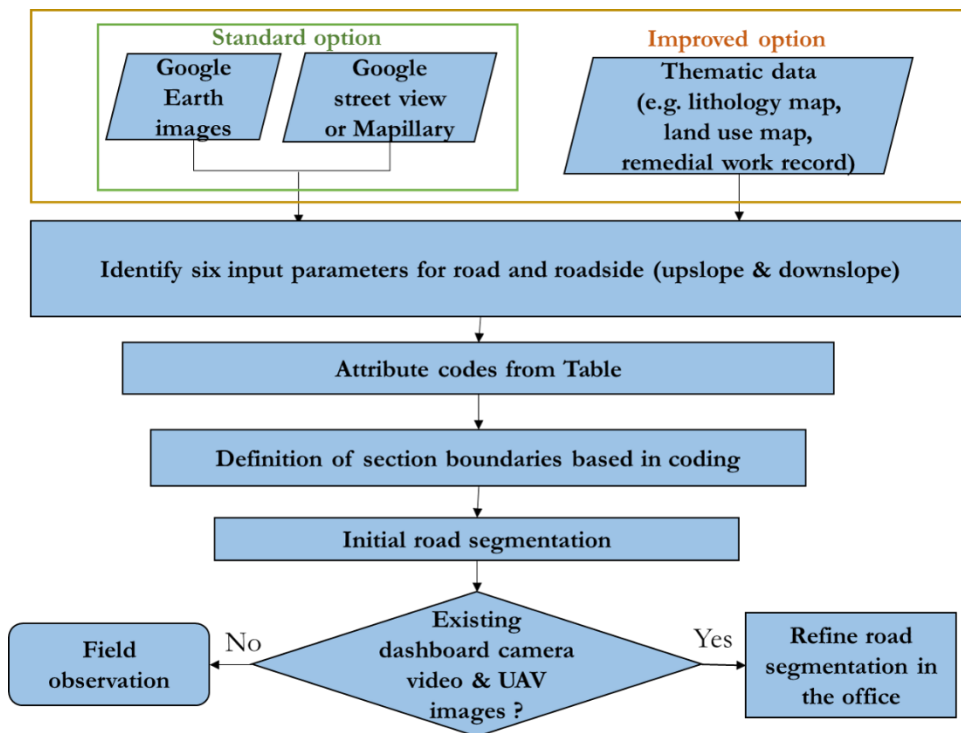
Figure 4.2. The flowchart shows the process of road segmentation

The process for the homogenous road segmentation is not a standard method because the six input parameters can be obtained in different ways. The first step contains two options (standard and improved options shown in the Figure 4.2), it depends on which data is available. The standard option is only based on free software and data (mainly focusing on Google Earth data) to identify the six input parameters. The improved option indicates there are more available data can be used to observe the parameters. It is worth mentioning that these optional procedures are not independent, they can be combined with each other based on existing data. The standard option and the improved option are determined manually. Moreover, there are opportunities to automate it. These possible automatic or semi-automatic procedures were discussed more in the last chapter.

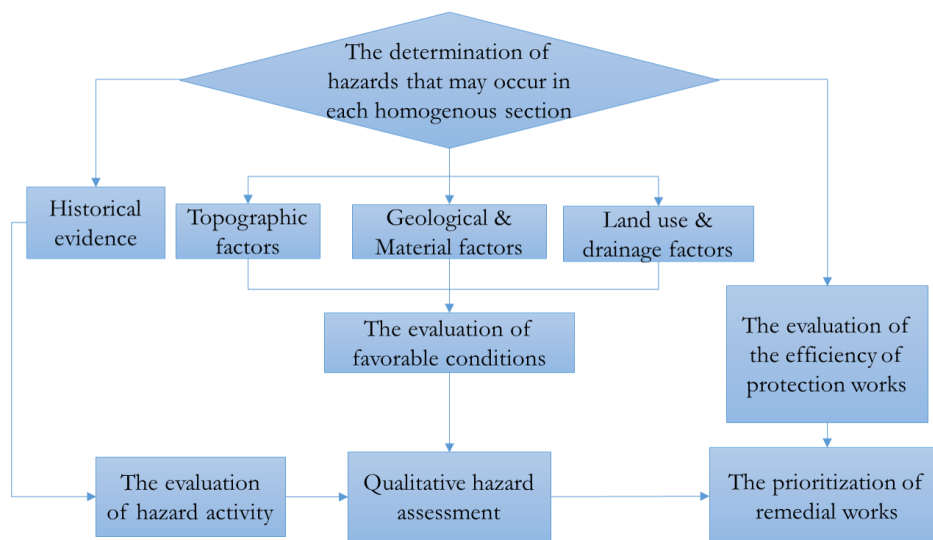
Figure 4.4 The flowchart describing the prioritization process

In this method, a hazard matrix was developed to assess the hazard level based on the evaluation results of the hazard activity and favorable conditions for producing a hazard. The entire procedure for the prioritization of implementing the remedial works is shown in Figure 4.4.

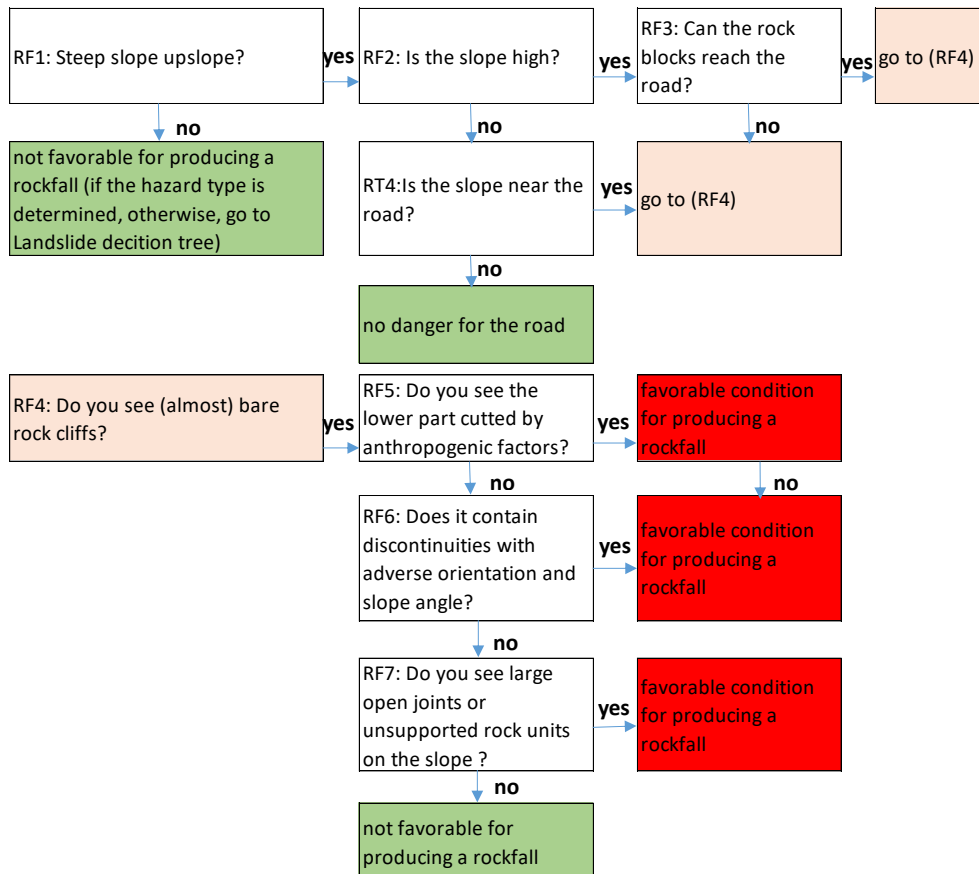
Figure 4.6 “Rockfall favorable conditions” decision tree

To assist with assessing whether the conditions are favourable to lead to mass movement, the decision tree was developed (overall decision tree methods were shown in Appendix 4). The decision tree was developed in an Excel sheet which guides the users by answering some questions. If the answer is yes, the user should move on to the question on the right, vice versa, if the answer is no the user should continue to the question below. By answering these questions, the user will be able to determine if the section is favourable for the occurrence of landslides, rockfalls, debris flows, or embankment failures.

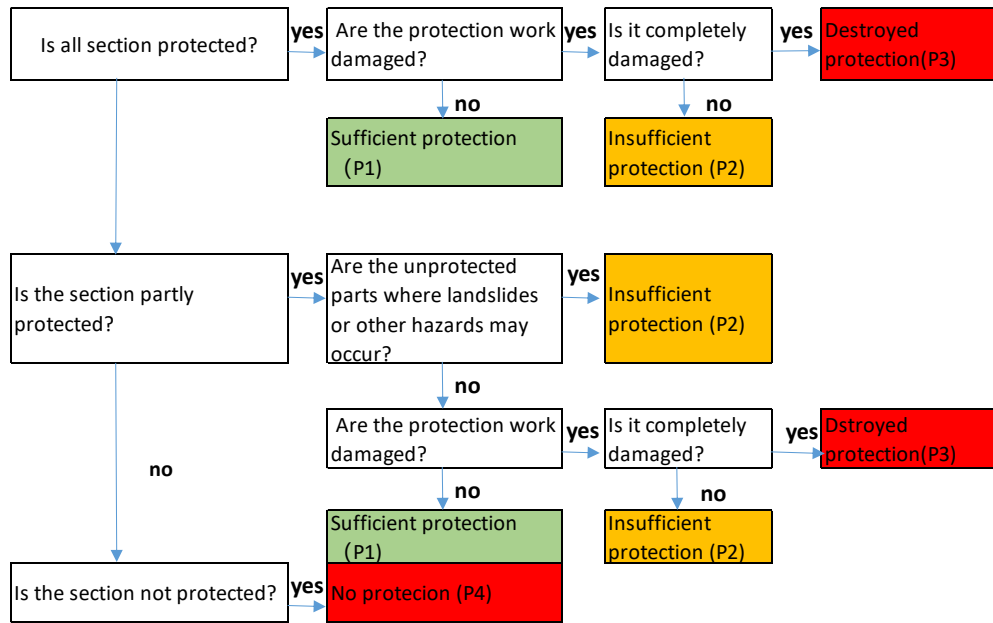
Figure 4.7 The protection efficiency decision tree.

To assist with the evaluation of the efficiency of the protection work, a decision tree was designed (Figure 4.7 and Appendix 5). If the answer is *Yes*, it will go right, if the answer is *No*, it will go downwards, to answer another question. Besides, if the protection works are damaged, some information of the hazard frequency could be obtained, in this case, the activity might be classified in recent activity class. In this study, the efficiency of protection work are classified into four classes: “P1: sufficient protection”, “P2: insufficient protection”, “P3: destroyed protection”, “P4: no protection”.

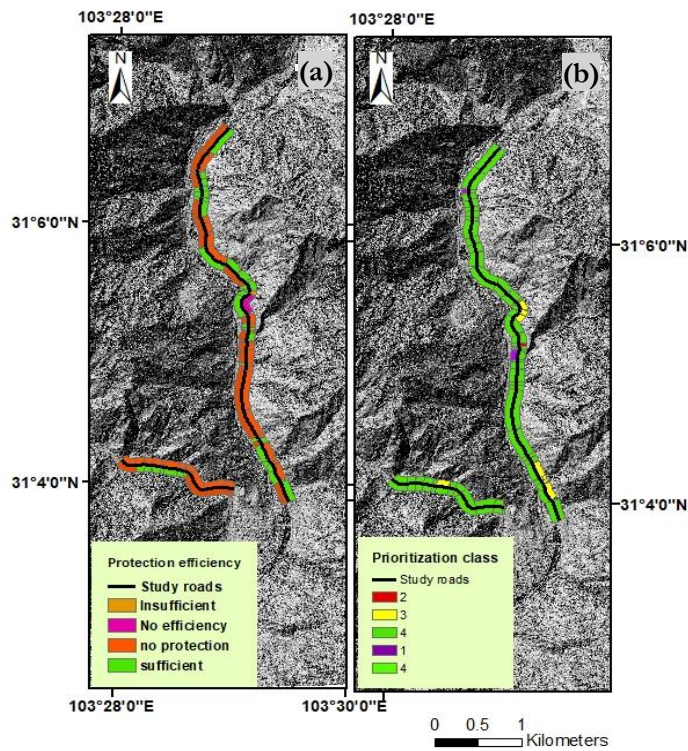
Figure 5.9 The prioritization results (a) The state of protection work in each section (b) The prioritization class of each section

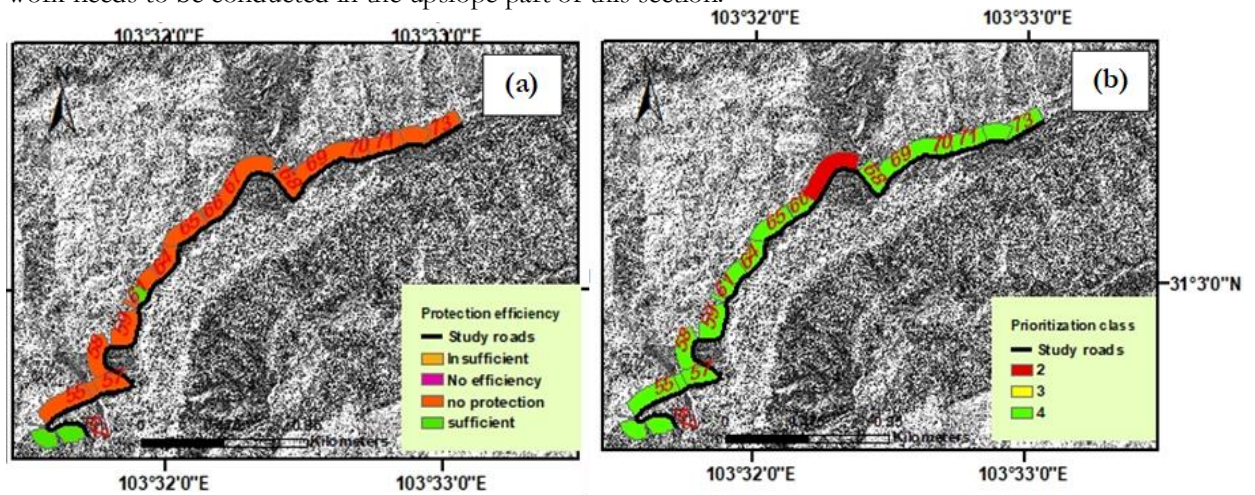
Figure 5.10 The prioritization results (a) The state of protection work of each section (b) The prioritization class of

From Figure 5.10, it can be seen that, there are few places where mitigation works were conducted among the 22 road sections. However, only one section is in prioritization class 2, which means some remedial work needs to be conducted in the upslope part of this section.

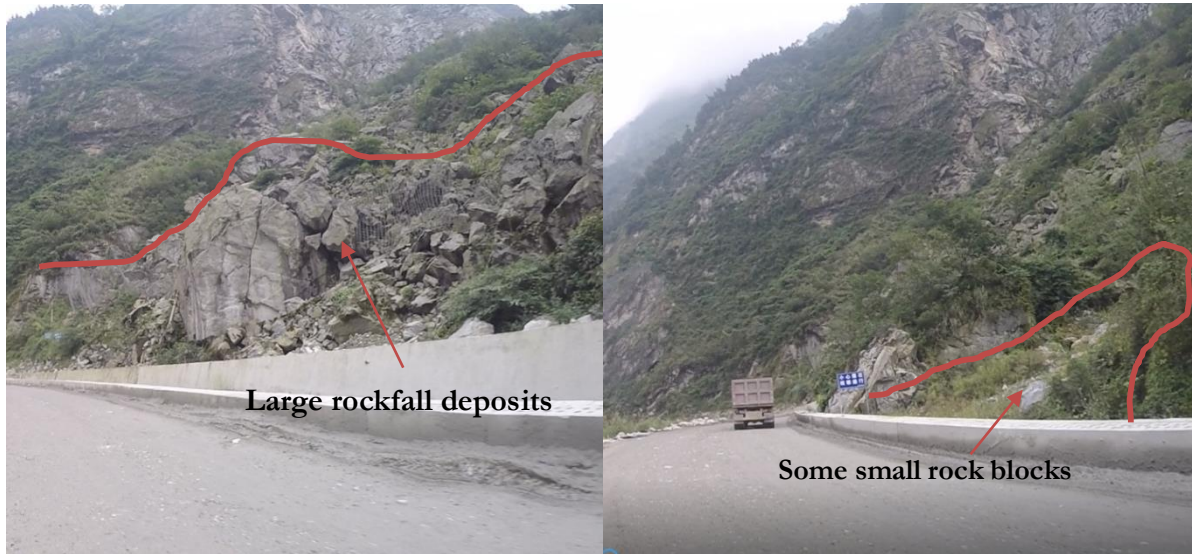
Figure 6.2 Rockfall deposits in section 6.

segmentations in the area of section 6, which is a very large rock fall deposit triggered during the Wenchuan earthquake, and which dammed the main river for some time. Three among the eleven testers divided section 6 into two parts, as lots of rock fall deposits were on the side of the road (Figure 6.2) while the other part only deposits some small rock blocks.

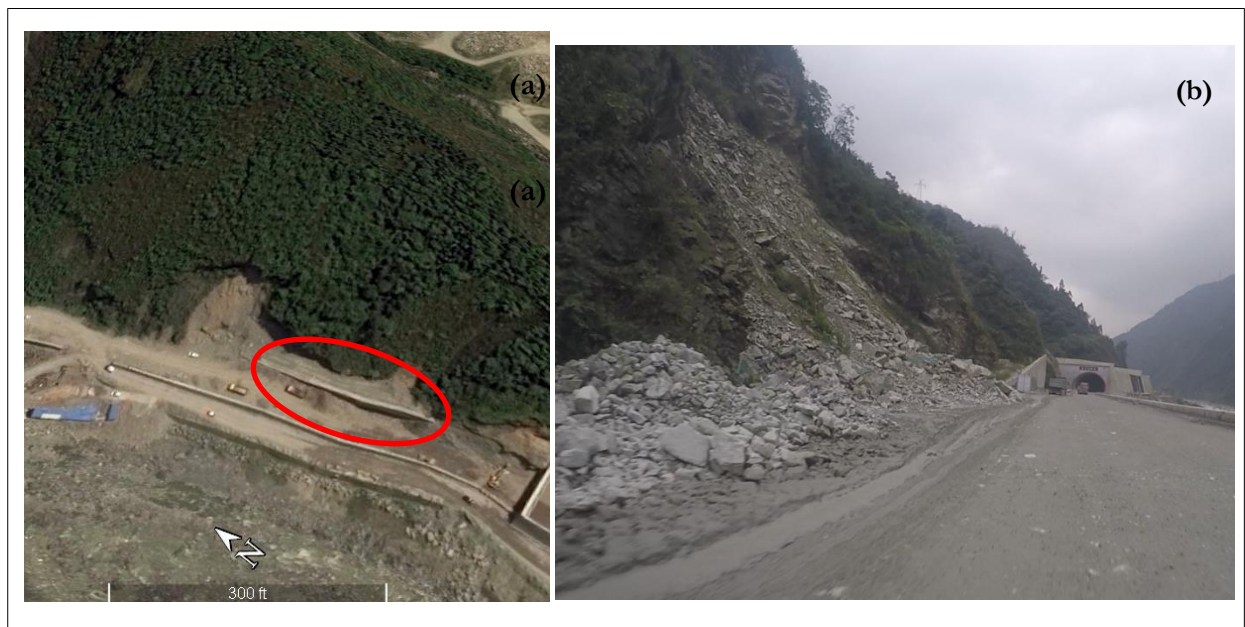
Figure 6.7 (a) Satellite image from Google Earth® on 1/5/2017 (circled in red is the a concrete wall, but it does not make part of the section that is being analysed)(b) Dashboard camera image was collected in October 2017 during the field work.

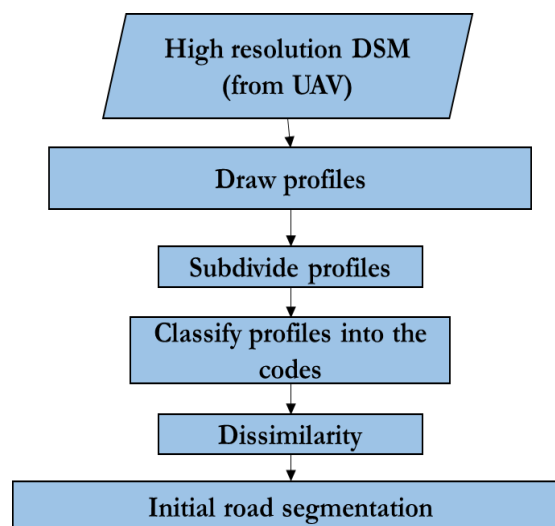
Figure 7.1 The process of semi-automatic road segmentation

Using UAV based high resolution DSM (Digital Surface Model) and images may be helpful achieving semi-automatic work. As the relatively precise road profiles can be generated in the ArcMap, the idea of this semi-automatic procedure is to find the dissimilarity between two adjacent profiles and draw a boundary between two distinct different adjacent profiles. The processes of the possible method are shown in Figure 7.1. First, different distance between two adjacent profiles need to be tested for the sake of determining a rational value of the density of the generation of profiles. Secondly, draw road cross-sectional profile at a regular interval. Then according to the similar shapes of the adjacent profiles, make the first subdivision. After classifying the profile into codes, find the dissimilarity between two adjacent profiles and draw the road section boundary where the two adjacent profiles have different codes.

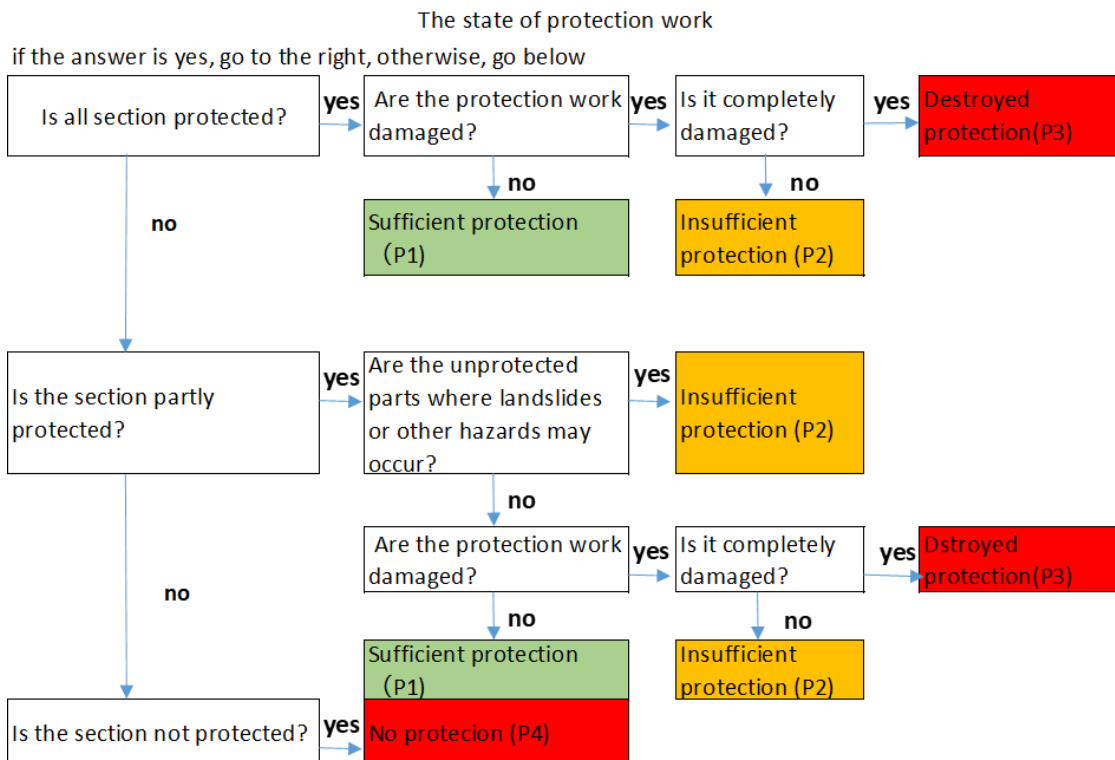
Appendix 5. Protection efficiency decision tree
