NATIONAL SCALE LANDSLIDE HAZARD ASSESSMENT ALONG THE ROAD CORRIDORS OF DOMINICA AND SAINT LUCIA

Thesis submitted to the Faculty of Geo-Information Science and Earth Observation of the University of Twente in partial fulfilment of the requirements for the degree of Master of Science in Geo-information Science and Earth Observation.

Specialization: Applied Earth Sciences (Natural Hazards and Disaster Risk Management)

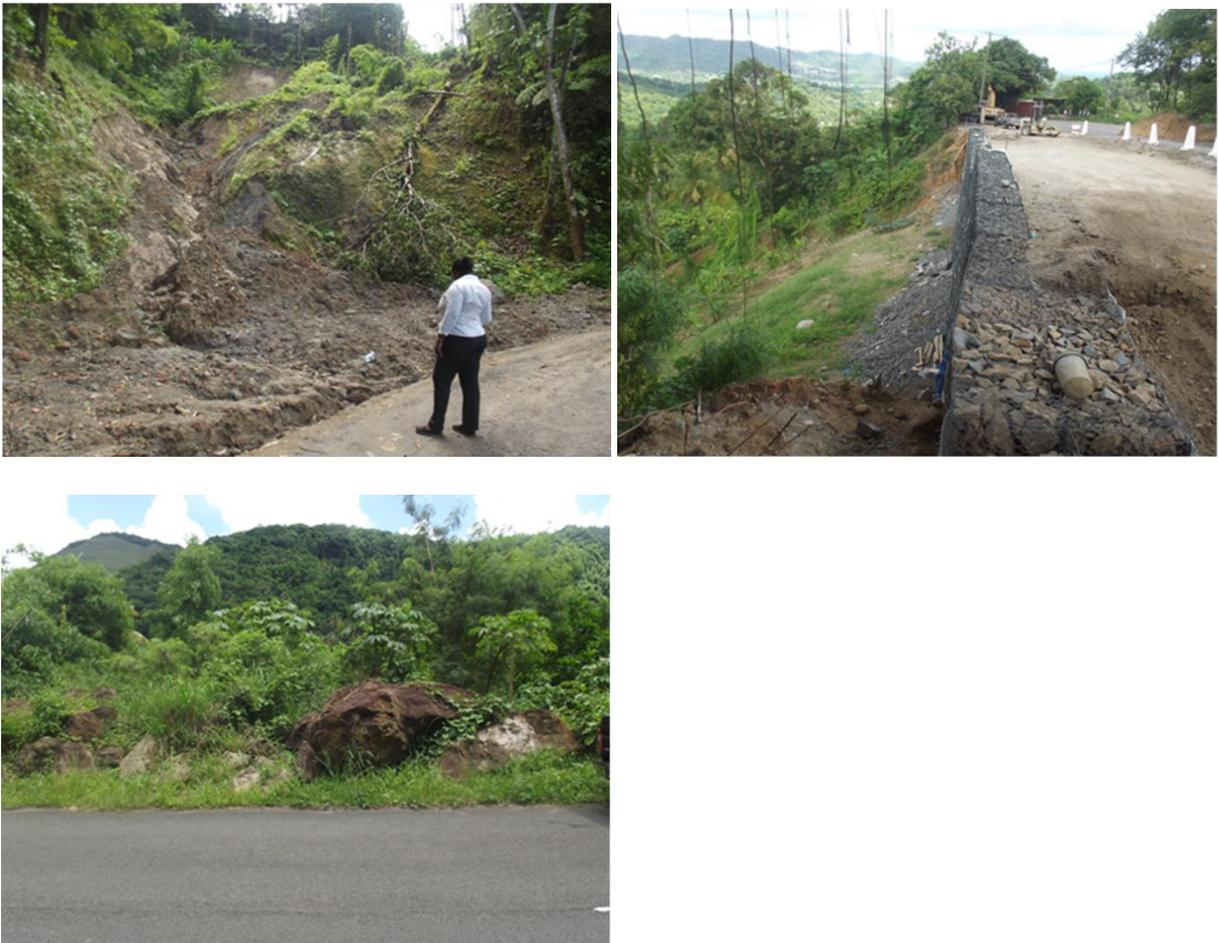
Figure 3.9. Pictures showing landslides along the major roads of Saint Lucia, Hurricane Tomas

During fieldwork, some of the road sections affected by hurricane Tomas was visited. Road sections around Canneries, Soufriere and Dennery regions were mostly affected by this event. The extent of the landslides and their effect was still visible. For instance, four embankment failures were occurred in Dennery region that washed away almost half lane of the road in each failure spots. The failures occurred with 500 meter intervals on average and now the road is being reconstructed (figure 3.8. top right). In addition, the rock falls occurred in Soufriere region during this event were quite considerable. The falling rocks were on average 1 to 1.5 m³ in size. Even though, there was no property damage, the road was closed for some time until it was cleared of the rocks. Figure 3.8 bottom left, shows some of the cleared rocks along this section of the road. The landslides occurred in Canneries were relatively fewer, but they were big in size. This road section was also closed for some time due to this slides. Figure 3.9 top left shows one of the big slides occurred in this region, this slide was also reactivated during the charismas eve event (2013).

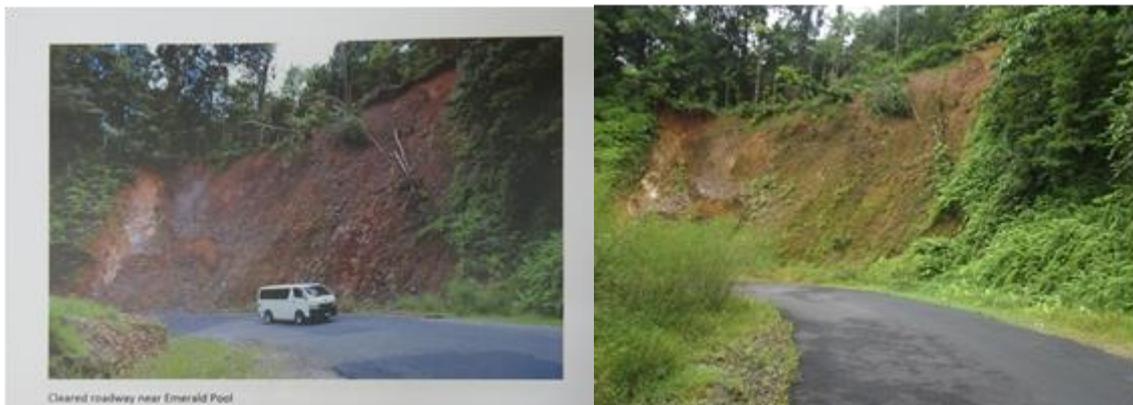
Figure 4.4 Relating the Landslide pictures, left from the report and right taken during field work. Which are very similar and easy to relate.

The reports from April 2013 and September 2011 have accompanying pictures of the landslides at the time of their occurrence. An attempt was made to relate these pictures with the pictures taken during fieldwork and locate them by their GPS point. Some of them were easy to relate because their scars were still visible during the fieldwork (Figure 4.4). But for the others, which were vegetated during the field work period, personal judgment had to be taken in looking for some signatures to relate the pictures as shown in Figure 4.5.

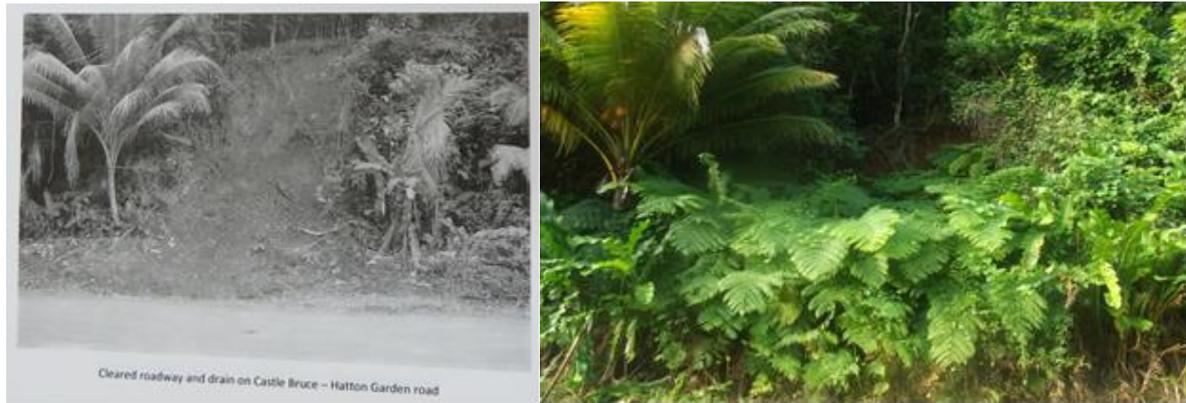
Figure 4.5. Relating the Landslide pictures, left from the report and right taken during field work. Difficult one, I relate them considering the small tree on the left side and tree roots at the top of the scar.

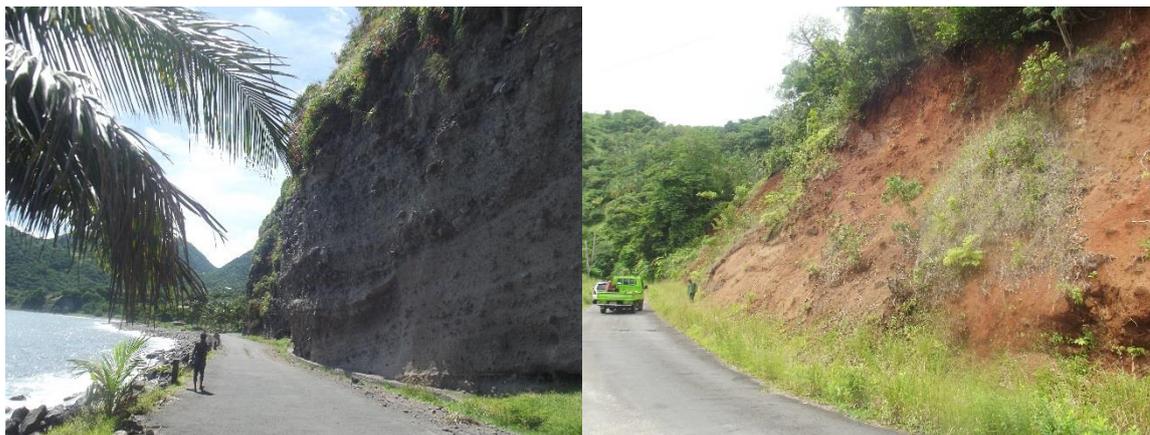
Figure 5.4.2. Road sections from Grand bay to Bagatelle (left) and from Castle Bruce to Petite Soufriere (right).

In terms of Landslide density, the highest density was obtained in Roseau – Elms hall road section for September 2011 and October 2010 events, with 5.66 and 3.77 landslides per kilometer respectively. The next highest was recorded in WoodBridge – Canefield road section with 3.73 landslides per kilometer for September 2009 event. These Road sections, however, encountered landslides only on the specified storm events, no landslides were reported on the other events. The road section from Grand fond to Rosalie has also encountered high landslide density during September 2011 event, 2.95 landslides per kilometer. This road section has also encountered landslides on October 2010 and April 2013 events; although, the landslides densities obtained were not that high. Therefore, based on the results obtained it can be said that road sections, Roseau – Elms hall, Grand fond – Rosalie, Grand bay – Bagatelle, Woodbridge – Canefield, Castle Bruce – Petite Soufriere and Rosalie – Bois Diable, are relatively more susceptible to Landslides than the other road sections. The reason for this could be the steep slope and/or moderate to high weathered material characteristics of the road sections. During the field work some of these road sections were visited. As observed there, Grand bay to Bagatelle and Woodbridge to Canefield possess a steep slope cut slopes (>70) with moderately weathered rock material on most of their parts, and these parts are frequently affected by rock falls (figure below). Whereas, Castle Bruce to Petite Soufriere and Rosalie to Bois Diable have a considerable high cut slope (between 45 and 60 degrees) with highly weathered clay material on most of their parts, which make them Landslide prone areas even with minor storm events (figure Below).
