Quantifying some components of resilience by analysing the changes of elements-at-risk in the Wenchuan epicentral area

Thesis submitted to the Faculty of Geo-Information Science and Earth Observation of the University of Twente in partial fulfilment of the requirements for the degree of Master of Science in Geo-information Science and Earth Observation.

Specialization: Applied Earth Sciences: Natural Hazards and Disaster Risk Management

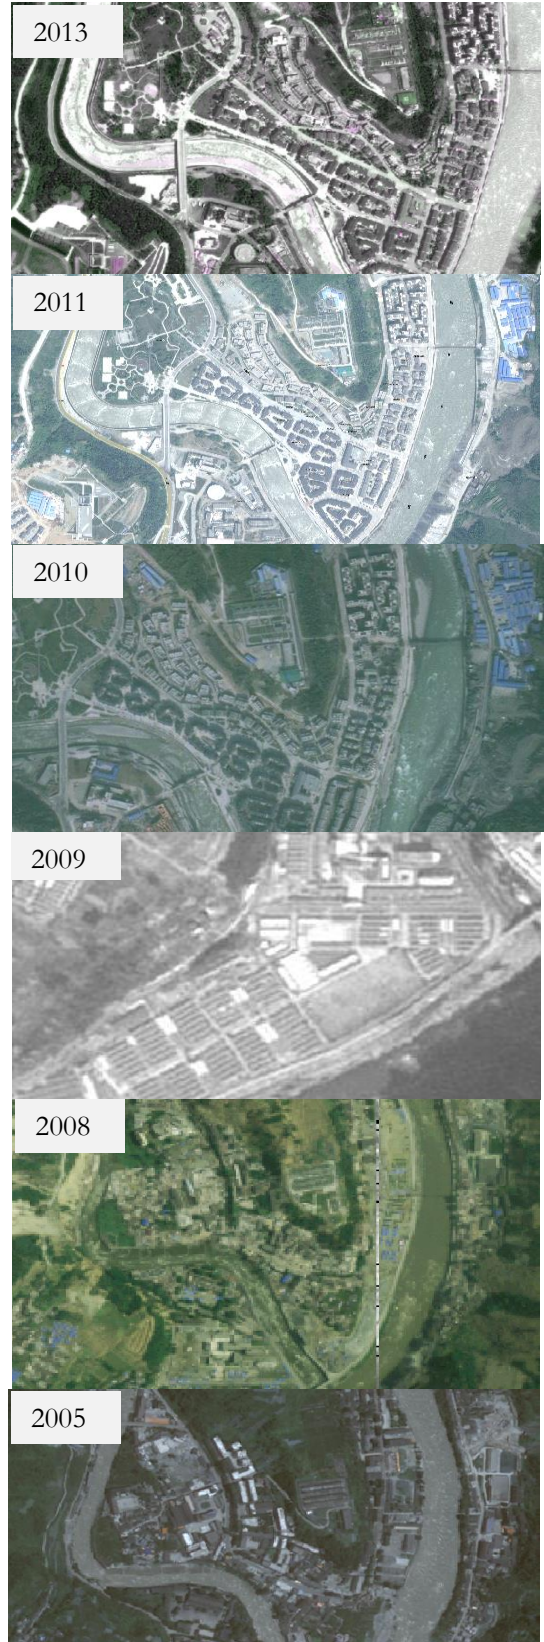
Figure 12. The examples of images about part of Yingxiu town with different resolution and different qualities.

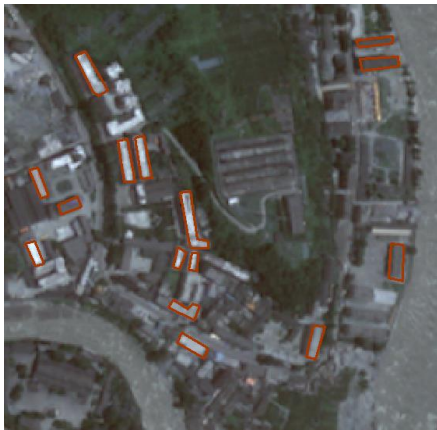
Figure 17. Building samples for town_mixed area in Yingxiu town by using Quickbird image (2.4m).

Sampling is also applied to estimate the number of buildings for year 2005, which cannot be characterized during the fieldwork. Before the earthquake, most of the buildings were individual houses in the study area, and they are concentrated in some residential areas. In this case, random samples are selected from the image whose resolution is 1m (See Figure 15). The average size of buildings is calculated to estimate the total number of buildings (See Figure 16). For the other images whose resolution is 2.4m, only few individual buildings can be interpreted, in this case, the number of buildings is estimated by taking the samples that are easy to digitize (See Figure 17) and the average size is used to estimate the total number of buildings for the occupancy of “town_mixed”.

1) Resolution. Even though the all the images are high resolution images, the required resolution for digitizing the buildings is at least 1m (Brown et al., 2010). In this research, the resolution changes from 0.5m to 5m. For the pre-earthquake image in 2005 whose resolution is 2.4m (See Figure 17), sampling is applied to get the average size of the individual building to estimate the total number of buildings. However, in some area, only few samples can be selected for most of the buildings are connected tightly and difficult to separate. This leads to relative bigger errors in the number of buildings. Moreover, because of the 5m resolution for the Arial photo in 2008, it is difficult to separate the un-collapsed buildings and the collapsed buildings. Here an assumption is made that all the buildings were damaged during the earthquake.

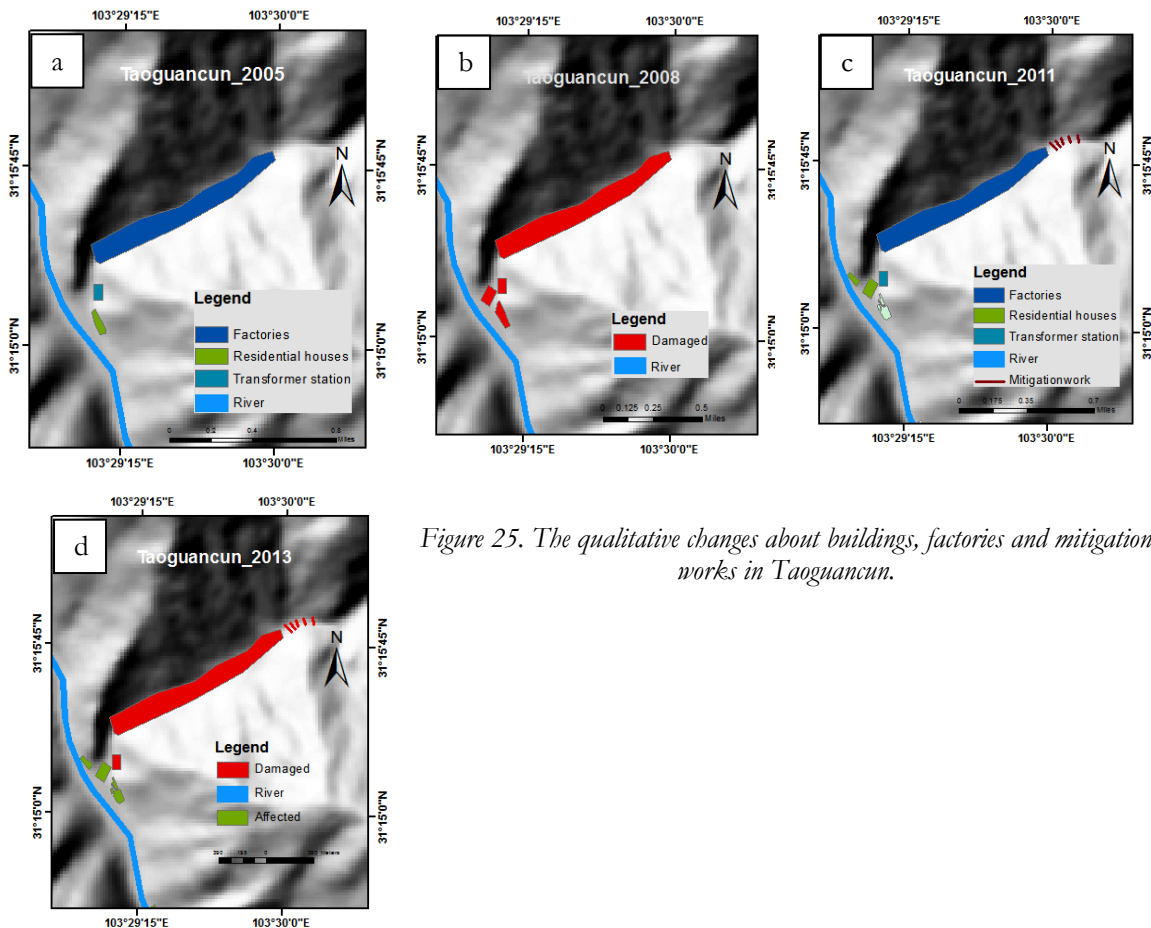
Figure 25. The qualitative changes about buildings, factories and mitigation works in Taoguancun.

Taoguancun was a concentrated industrial area both before and after the earthquake. The factories were constructed in a mountain valley (See Figure 25 (a)). Even though they were damaged during the earthquake and the mountain valley can be a debris flow gully, the reconstruction work was made in the same area with some mitigation works (See Figure 25 (b) and Figure 25 (c)). However, the factories and mitigation works were totally destroyed by the debris flow in 2013 (See Figure 25 (d)). Meanwhile, the residential houses in Taoguancun were affected in different damage degree. After the debris flow, the mitigation works were constructed and completed in 2014, but all the factories were abandoned (See Figure 25 (e)). The quantitative changes about the number of buildings, factories, mitigation works and transformer stations are shown in Figure 26.

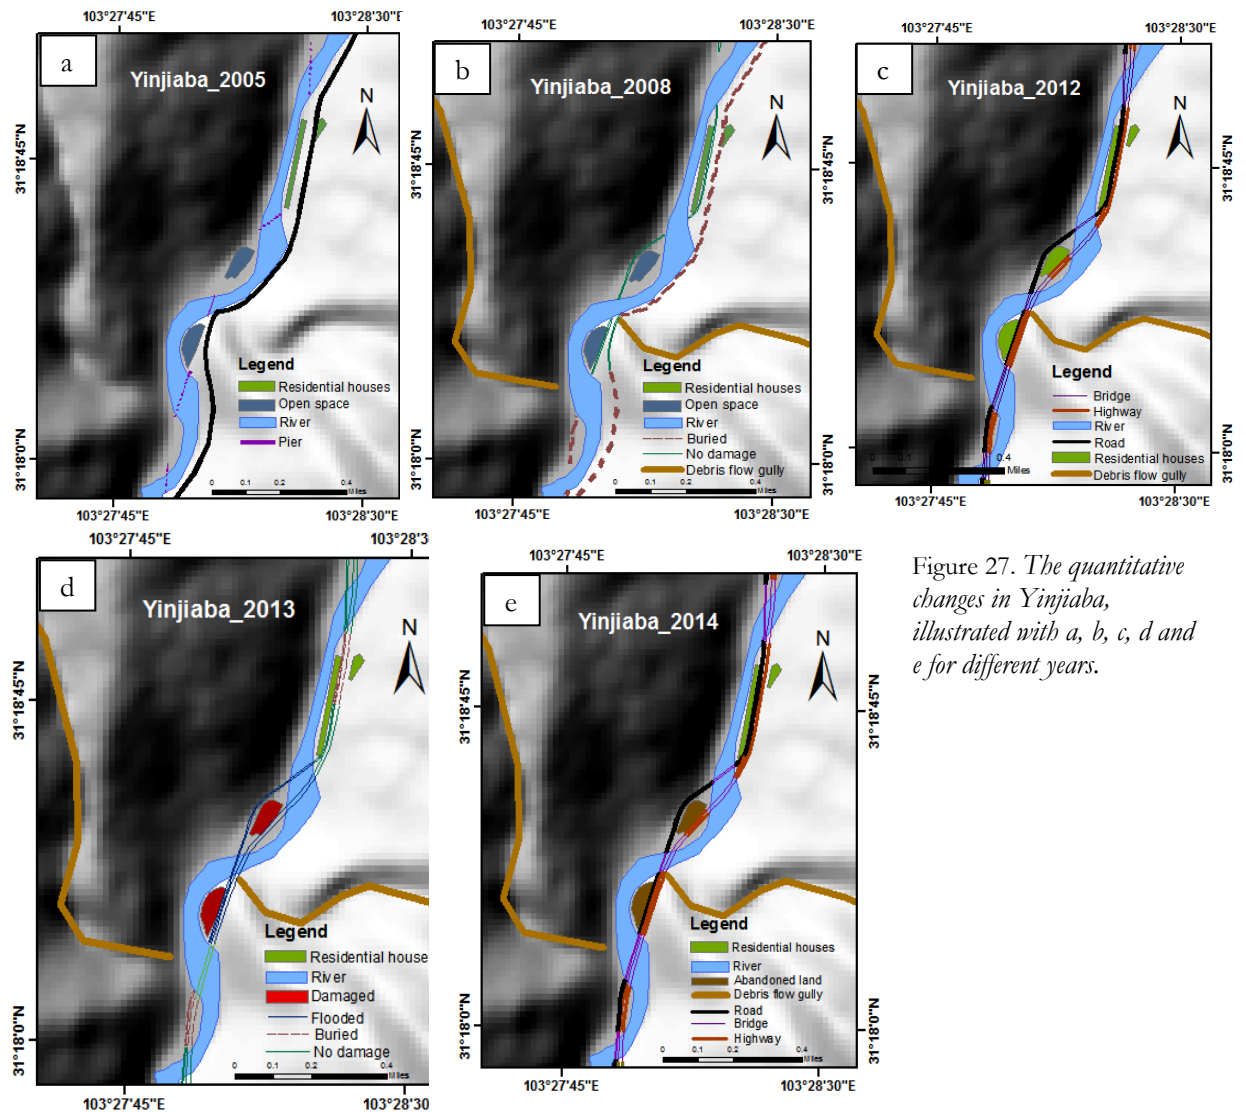
Figure 27. The quantitative changes in Yinjiaba, illustrated with a, b, c, d and e for different years.

Yinjiaba is another typical case to show the changes of damage for buildings through years. This area was open space and no one lived there before the earthquake (See Figure 27 (a)), however, around 200 people moved to this area even though there were two big debris flow gullies without mitigation works nearby after the earthquake (Figure 27 (b) and Figure 27 (c)). All the buildings are damaged or affected by the debris flow in 2013 and after that, people moved to some other places. In 2014, these two debris flow gullies were mitigated and the space were abandoned (See Figure 27 (e)). Figure 28 shows the quantitative changes about the number of buildings in this village.
