Earthquake Building Vulnerability and Damage Assessment with reference to Sikkim Earthquake, 2011

Thesis submitted to the Faculty of Geo-Information Science and Earth Observation of the University of Twente in partial fulfilment of the requirements for the degree of Master of Science in Geo-information Science and Earth Observation.

Specialization: Natural Hazards and Disaster Risk Management

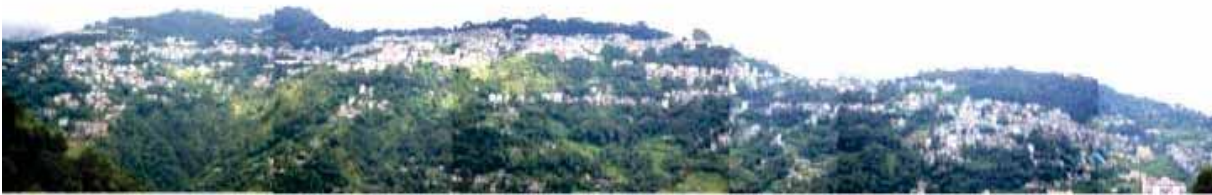
Figure 4-3 Panoramic View of Gangtok and growth along its Ridge Line along N-S direction

Gangtok city is located on flat top of a ridge oriented in NE-SW direction and sloping down in NW-SE direction. City has grown in a linear fashion along the ridge line. It has also started growing towards the NW direction as the slope on west side of the hill has a gentle slope than other side. Because of this kind of skewed development on one side of the hill slope, the city's building and settlement pattern and other infrastructure like water supply and sewerage systems are also located on one side of hill slope thus affecting the slope stability of the region.

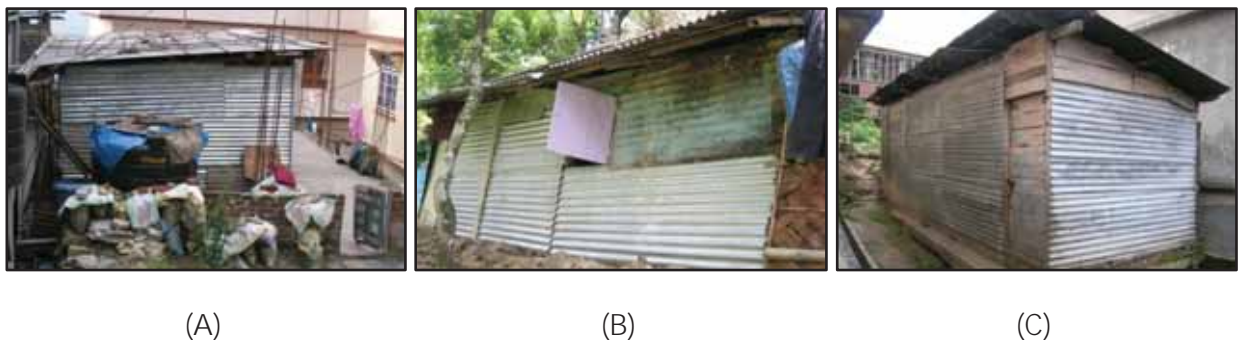
Figure 4-12 Asbestos Building Types in Arithang Ward

These are similar to the Ekra type construction but these are much more temporary and very light in weight. These are just bamboo posts and beams and connected by the asbestos sheets.

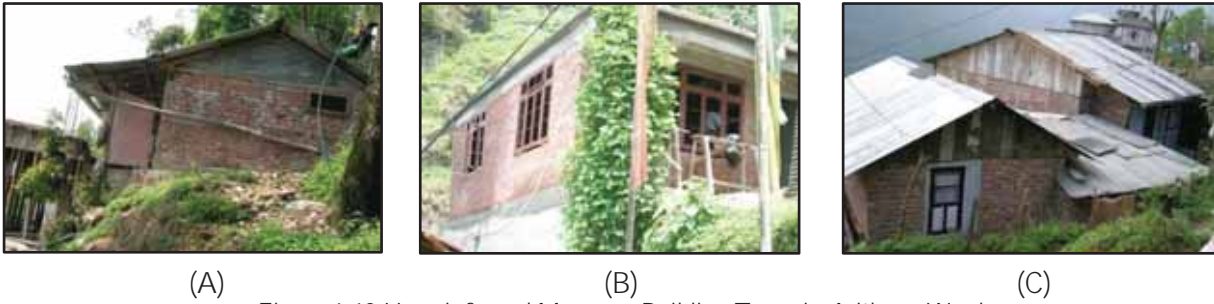
Figure 4-13 Un-reinforced Masonry Building Types in Arithang Ward

Figure 4-13 shows the un-reinforced masonry type structures in the Arithang Ward. Figure 4-13 A and C show the building with un reinforced masonry and asbestos sloping roof supported by these walls, Figure 4-13 B shows the flat slab roof resting on the un-reinforced masonry with wide openings for windows and doors which make these much weaker. These falls under HAZUS class C3L.

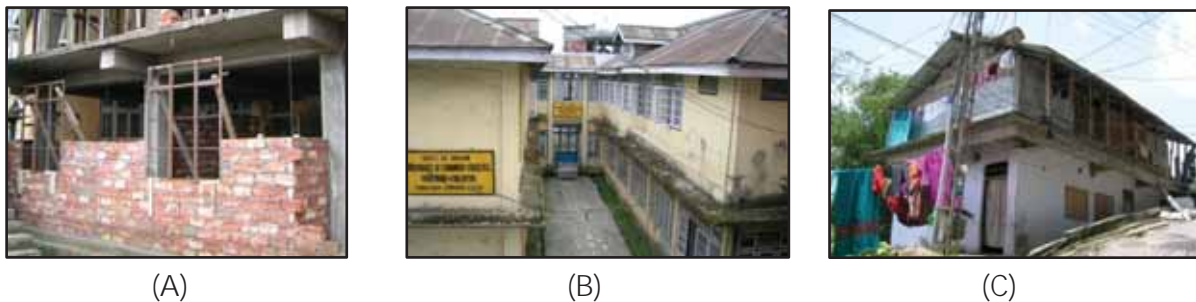
Figure 4-14 Mid-rise Concrete Frame Building Types in Arithang Ward

Figure 4-14 –A shows the un-reinforced masonry walls constructed without any tie beams and not between the columns but at the end of slab/floor. Figure 4-14-B shows the building with concrete slab on first floor and the light asbestos roof on the second. Figure 4-14-C shows the mix type construction with concrete and masonry in ground and Ekra in first floor.

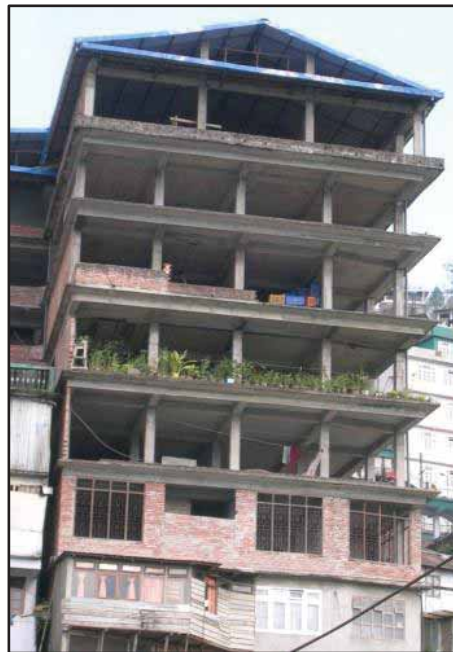
Figure 4-16 High-rise Concrete Frame Building Type in Arithang Ward

Figure 4-16 shows the 8 storey building without any seismic design considerations. Thin columns, walls without any tying, stand independent of columns and there are openings without any support, and is also irregular in shape. Figure 4-16 shows the building material used for construction. Majority of the construction uses concrete followed by wood and bamboo. Few buildings are even built with asbestos. It is clearly seen that all the buildings which are built with wood, bamboo or asbestos are smaller in size and have less number of floors compared to concrete buildings. Figure 4-17 shows the number of buildings in the study ward. Majority of buildings with higher number of floors are closer to the national highway.

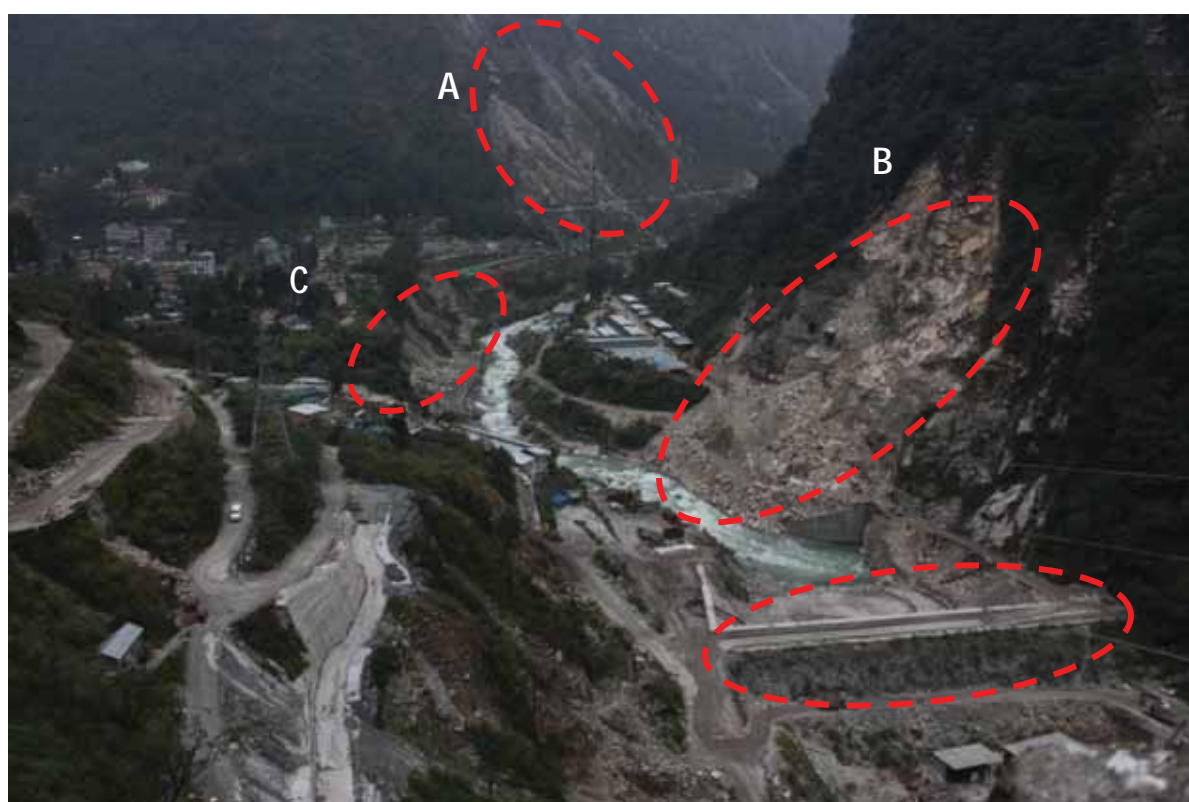
Figure 5-3 Figure Showing the chunthang area and new landslides

From all the areas visited, Chunthang area has experienced highest number of damaged in the earthquake. Located at the point where Lachen and Lachung rivers meet and turn into Teesta River, the major river in the state of Sikkim shown in Figure 5-2 and Figure 5-3. Because of the river, there are lot of colluvial material; the soil in area is very soft and sandy in nature. Many of the buildings experienced extreme to complete damage level.

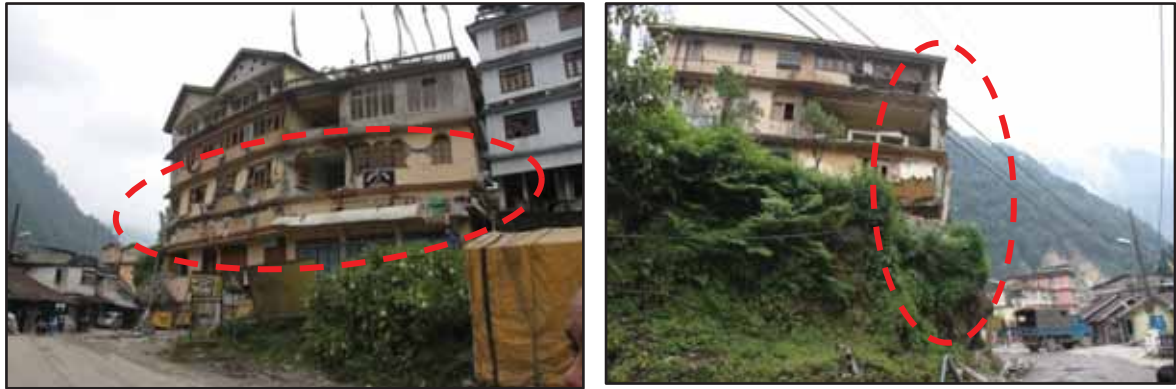
(A)

Figure 5-4 shows school building damaged in Chunthang area. Several buildings are of the same damage states as shown in the figure. Figure 5-4 A and B shows the building in which couple of floors got pancaked as the columns were weak and not supported by shear walls and resulted in complete failure. Also part of the building was resting on a detrital rock (transported large boulder) which might have experienced severe shaking as it is located on soft soil.

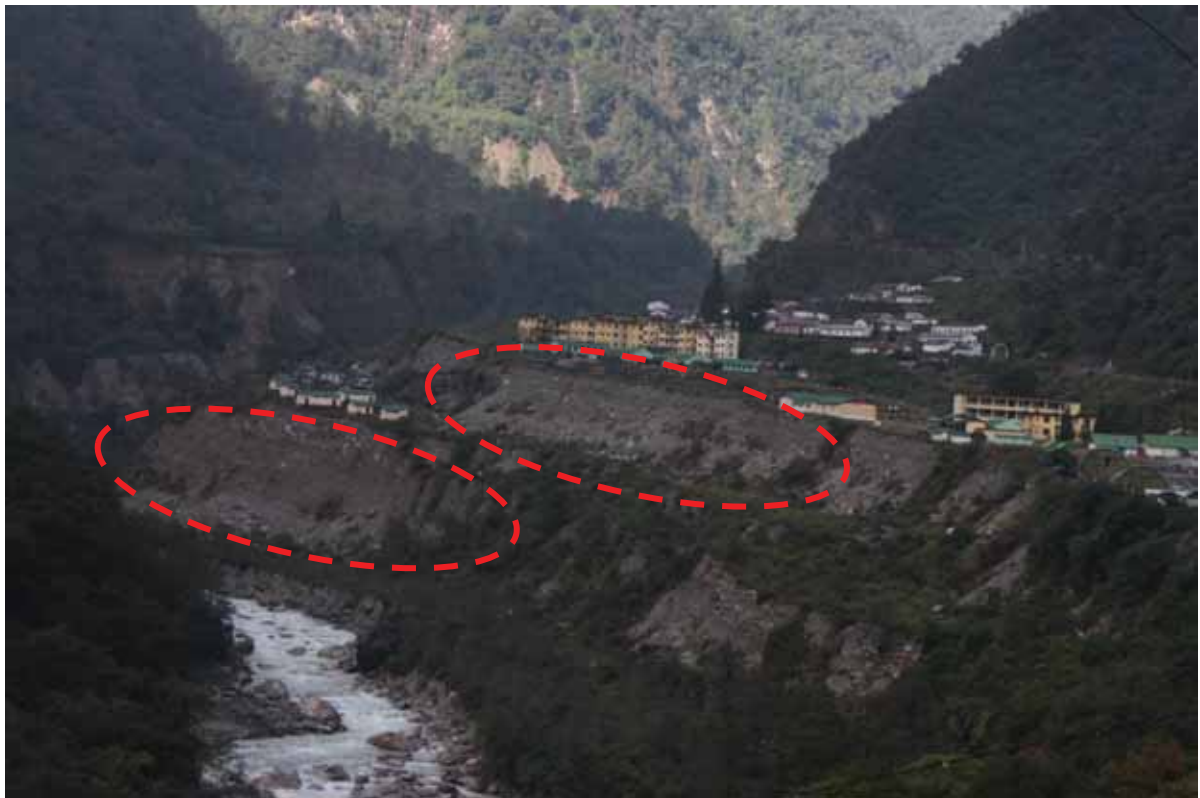
Figure 5-5 River Terraces and Settlements

Figure 5-5 shows the colluvial deposits of the Teesta River. The buildings lying on this type of ground experience more damage than buildings on rock sites. These deposits are constantly cut by the flowing river, and make houses constructed on these deposits vulnerable.

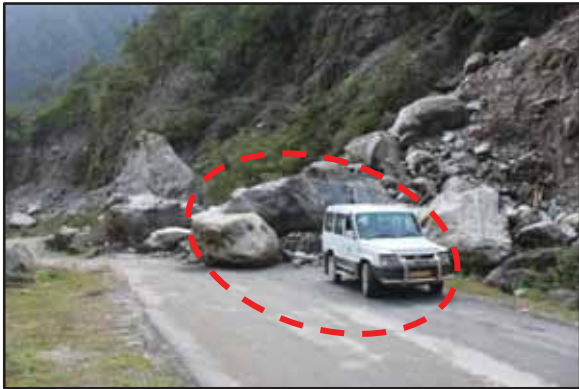
(A)

Figure 5-6 A and B shows the landslides and the scale of rock slides that happened earthquake that block roads.

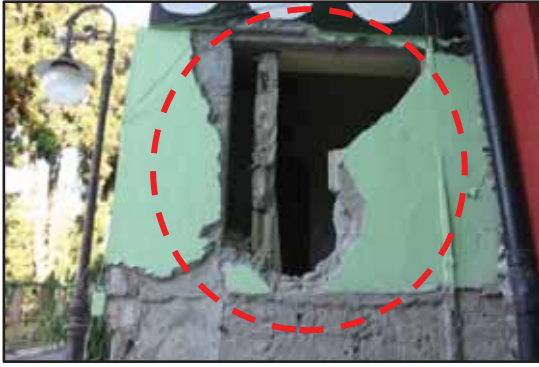
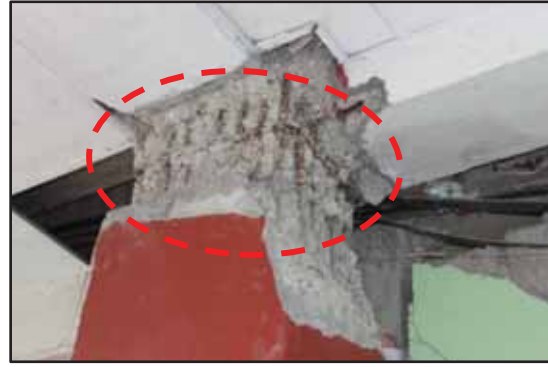
Figure 5-10 Damages in Secretariat Building

Sikkim Government Secretariat, the main centre for states government administration was closed down due to the damage it suffered in the earthquake. Major damage has occurred in the ground floor to the stone masonry walls and columns at the building junction of two buildings. Due to the irregularity in plan shown in the figure 5-10 A, the front long building and back horizontal structure moved in different direction which resulted in the major damage at the junction as shown in shown in the Figure 5-10 B and 5-10 C. Due to improper tying of reinforcement and due to pounding affect, the building failed. No major damage was seen in the upper floor other than few cracks in infill walls, but the ground floor walls have been completely destroyed. Building has sustained several earthquakes in the past and requires complete retrofitting or re-building.

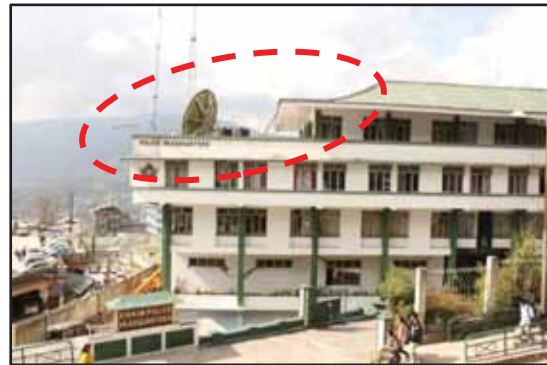
(A)

Name: Sikkim Police Headquarters
Ownership : Government
Building Use: Office
Material : Concrete frame, Cement block Masonry infill's
Number of Floors : 5
HAZUS Class : C3M
Level of Damage : Moderate
Retrofitting Possible : Yes
Number of Deaths: 0
Building Age: 9 years

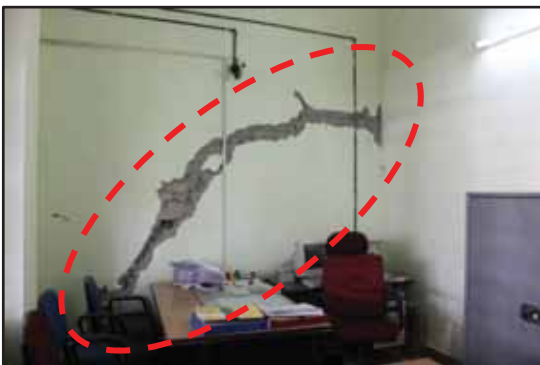
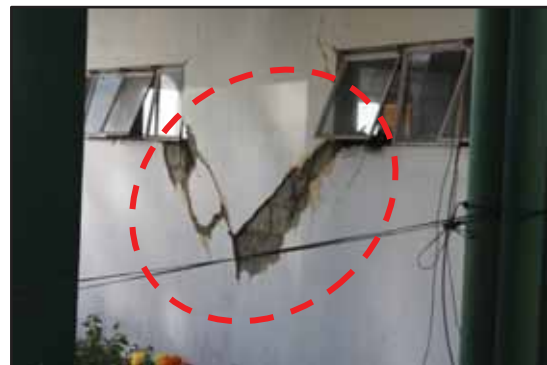
Figure 5-12 Damages in Police Head quarters Building

Sikkim police headquarters building has suffered slight damage in the earthquake. Even though majority infill walls have suffered high damage and ready to fail, the building is still operational and no repairs or retrofitting measures have been taken up even after one month of the event. The building is irregular in plan and have soft storey for parking. As shown in Figure 5-12 A, the building is irregular in elevation, with cantilever in 4th floor and setback in 5th floor. Heavy weights like dishes, batteries and other equipment is placed on the top floor. Due to this, the part of ground floor under this part has suffered severe cracks in the walls. No damage is observed in the columns, due to lack to tying of columns and walls, at some places, the building walls were separated from the columns. All the walls can be repaired and retrofitted

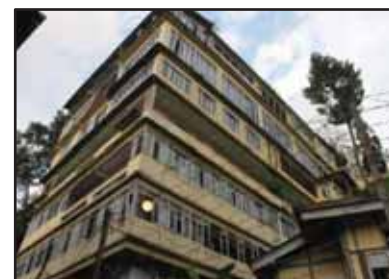
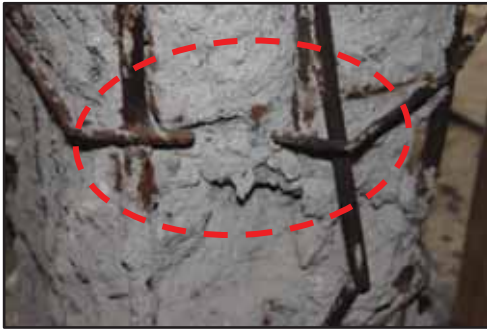
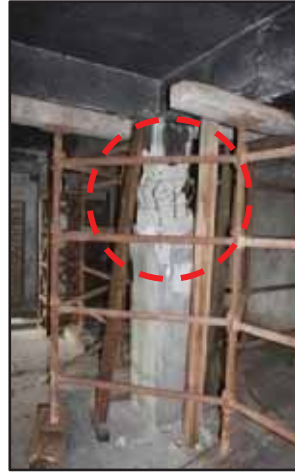
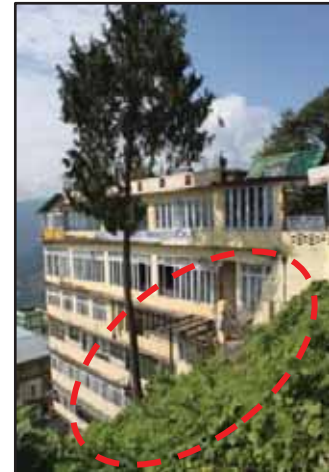
(B)
Figure 5-13 Damages in Hotel Building

Name: Hotel Himanchuli Super View
Ownership : Private
Building Use: Hotel
Material : Concrete frame, Burnt brick Masonry infill's
Number of Floors : 7
HAZUS Class : C3M
Level of Damage : Severe
Retrofitting Possible : No
Number of Deaths: 0
Building Age: 15 + years

All the columns, beams and slabs have to be properly connected with each other. Figure 5-13 shows the poor connections between columns and beams, and columns and slabs etc. Symmetrical arrangement of columns is also important for the structural stability.

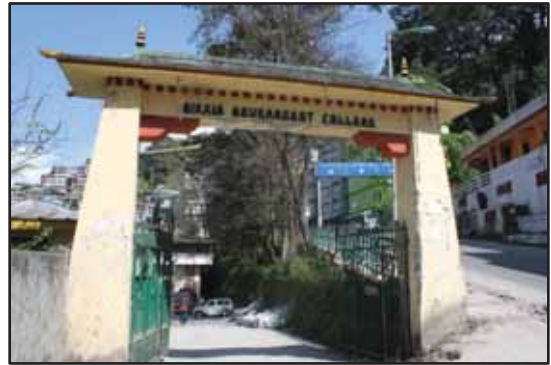
(A)

Name : Government Degree College
 Ownership : Government
 Building Use: Educational
 Material : Concrete frame, Brick Masonry infill's
 Number of Floors : 2
 HAZUS Class : C3L
 Level of Damage : Moderate
 Retrofitting Possible : Yes
 Number of Deaths: 0
 Building Age: 20 + years

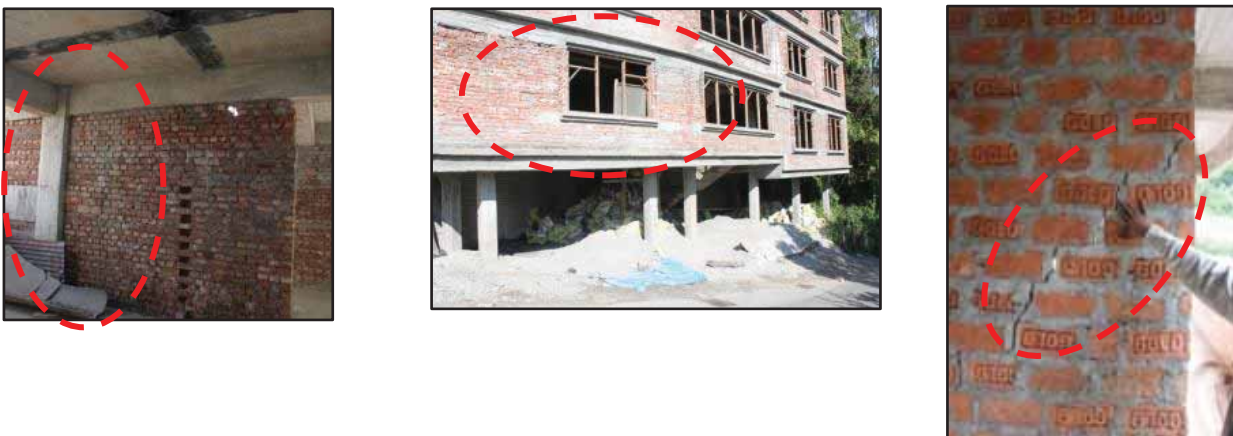
Figure 5-15 Unreinforced Masonry infill's

Most of buildings used burnt bricks as masonry infill in reinforced concrete framed structure. Few buildings like Police head quarters have used hollow concrete blocks as infill materials. All of these walls were observed to be untied with the concrete frame. As these are not connected, the columns and walls tend to shake at differently which results in cracks and failures. Figure 5-15 shows new constructions which do not have any tie beams or rods between walls and columns

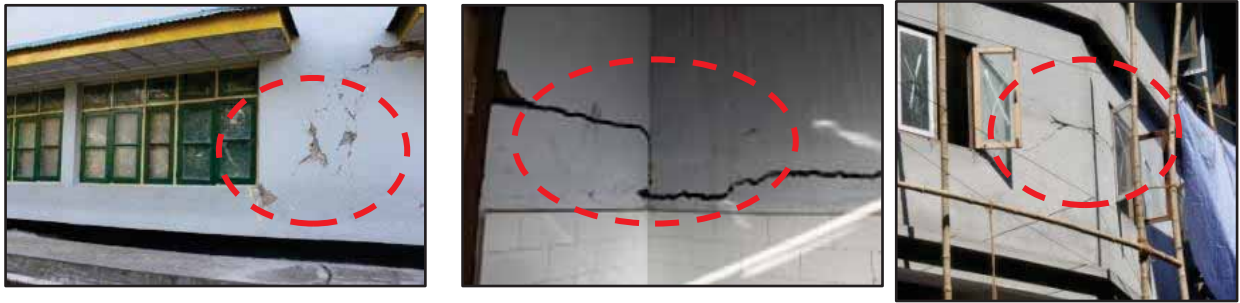
Figure 5-16 Damages in Unreinforced Masonry infill's

Figure 5-16 shows the kind of damages resulted in these kind of masonry walls where there are no tie beams. Figure 5-17 A and B shows the possible reinforcement measures that can be adopted for masonry walls. Figure 5-17 – A indicates that continuous horizontal reinforcement is needed at lintel and sill levels, and all sides of opening and vertical reinforcement at every 4 feet interval. Figure 5-17-B shows the possible retrofitting measures that can be used for repairing the cracks as shown in Figure 5-16 and these reinforcements should be connected properly to the structural members.

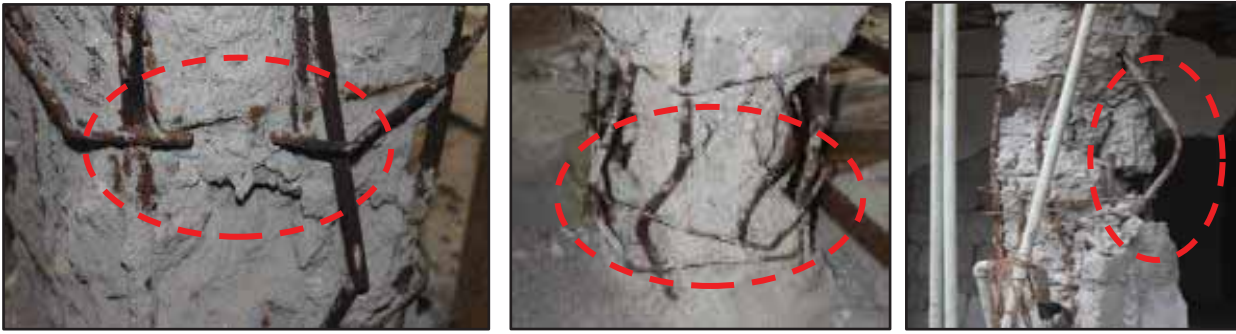
Figure 5-18 Reinforcement failures

Columns and beams are the major contributors to the strength of the building. When these are not properly planned or designed, buildings have higher chance of failure. Different kinds of damages as seen in the columns are given in the Figure 5-18. Usually, the columns fail, when they are no rods of required sizes provided in reinforcements, the vertical reinforcement is not properly tied with the tie rods at equal intervals, there's no proper overlap between the vertical bars, not enough concrete thickness around the reinforcement and poor quality of concrete. These are the main reasons of column failure.

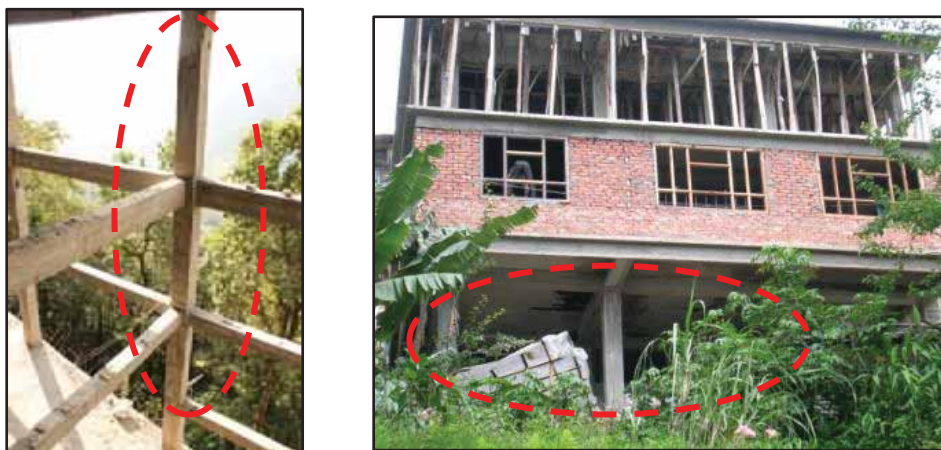
Figure 5-20 Absence of shear walls

The load of the buildings is transferred to the ground by columns. The load of slab is transferred by beams to the columns. In case of shaking in earthquakes, the horizontal shaking of columns between the floors is controlled by shear walls. These carry some weight from the slabs and beams and reduce load on the columns and control horizontal motion. They are higher chances of columns to fail in the absence of shear walls. These walls should be continuous between columns with minimum opening sizes. Figure 5-20 shows the absence of shear walls in buildings.

In cases where shear walls cannot be provided and columns which suffered damage in earthquakes, use of braces is the recommended option. Vertical bracing is done by steel bars which connect columns and transfers load and also control the horizontal movement in columns. Few examples of vertical bracing are shown in Figure 5-21
