**Mechanical Engineering**

**UNIVERSITY OF TWENTE.**

**Description of 3 RET Metro Wheel Set  
Components. Multicriteria Analysis of the failures  
of these components**

**REPORT**

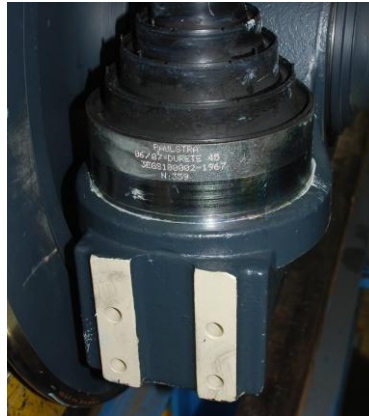
Figure 3: Primary suspension

There are 8 primary suspensions per bogie (figure 5). The primary suspension is a rubber and steel type. It is formed by rubber positioned in a conical way and thin steel cones introduced in between this rubber. The conical form allows to absorb both horizontal and vertical vibrations. In figure 3 we can observe a photograph of the primary suspension.

The primary suspension connects the axle box to the bogie frame. Its function is to mitigate the vibrations and forces. It reacts to the vertical jounce and loads that arise longitudinally and laterally from the influence of the rail track (and wheel) on the vehicle body.

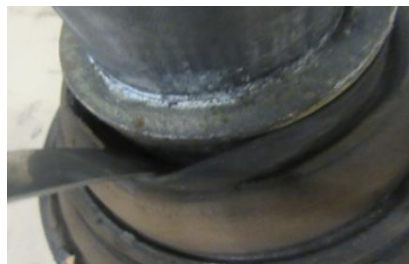
*Figure 13: Rubber loose in Primary suspension*

Another problem observed in the primary suspension is the unknown reason of why the rubber gets loose. This means that its effect is partially or completely lost as it tends to go out of place and is not properly fixed. In figure 13 we observe an example of a loose rubber in the inner ring of the suspension.

For the actual problem of the rubber getting loose and cracked there are no current solutions. This problem which has appeared currently has no actual solution, thus it is important to research on the reasons why the rubber gets loose and to see if it is possible to prevent from occurring.

Differing from the rubber shrinking, which is a more visible and detectable failure, this failure is also not visible until the rubber is completely loose. From the outside no apparent fail is observed and therefore it is difficult to prevent. Now that it is known, it is possible to look for solutions.

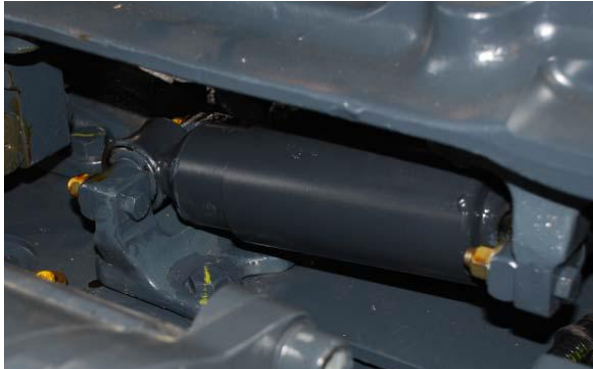
Figure 14: horizontal damper & Vertical damper

The main goal of oil dampers is absorb quick movement vibrations or shocks. There are 2 vertical dampers and one horizontal damper in the bogie. In figure 14 both dampers are observed.

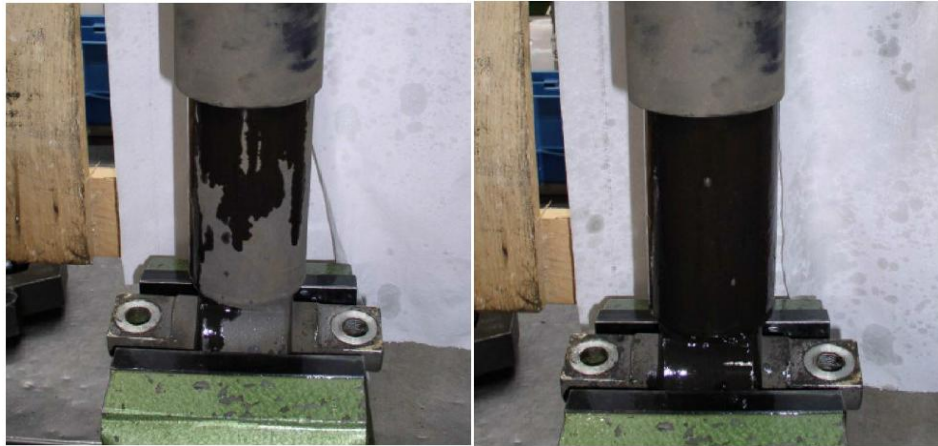
Figure 18: Damper leakage failure

This failure is really problematic due to the fact that it is not controllable currently. When the oil starts leaking out of the damper, independently if its vertical or horizontal, there is no way to determine the amount of liquid remaining inside the damper. In figure 18 we can observe 2 examples of dampers which a leaking oil.

As observed, we can see 2 images where the lower part of the damper is wetted with oil. This does not mean necessarily that the damper is leaking oil as there are also other reasons which can be the cause for it, which makes it even more difficult to detect the leakage.

In this case, the damper is actually losing oil from the inside and thus the damper force is slowly reduced. As mentioned before, there is no way to measure how much oil is gone so it is impossible to control the amount of leakage.

Currently, there are no real solutions to the leakage problem. Actually, it is not even possible to know if the damper is leaking oil permanently as a failure or not. However, there are maintenance procedures which help to control the situation.

It is necessary to clean the damper which we think that is leaking oil. The best way to do so is by dismounting it from the bogie, pull it to its maximum length and clean thoroughly.

After certain time has passed and the damper is checked again, it is possible to know more precisely if the damper is leaking oil. Of course, if the damper is again wetted with oil in its lower part, it may indicate that it is highly probable that the leakage failure is occurring.

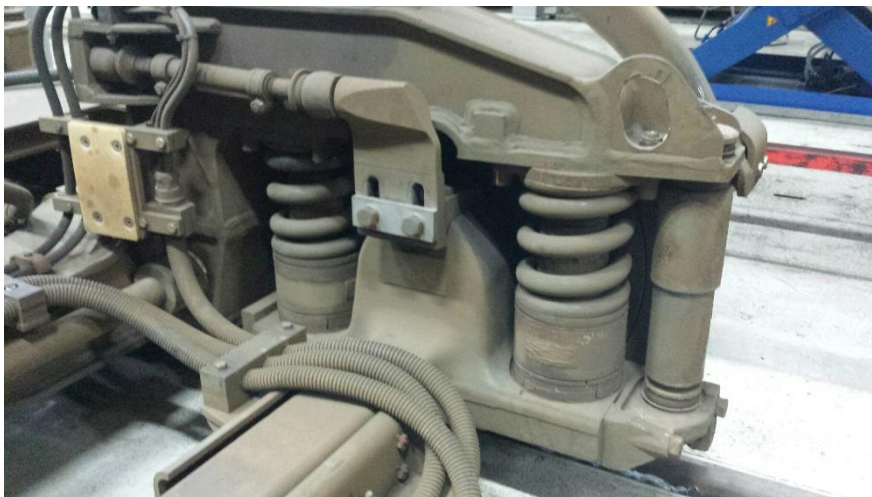
*Figure 28*

With respect to the primary suspensions, the ones used at HTM are mostly conventional metal spring primary suspensions, as seen in picture 1. Therefore, the failures which occur to these kind of components is completely different to the ones used at the RET metros. Of course, the usual steel springs also fail, due to oxidation, rust and corrosion. As well as this, the functionality might decrease, but obviously these failures are not related to the rubber and steel suspensions used at RET metros. Moreover, due to the fact that the way of failing is different, the failure data of metal springs is not useful for the current research.

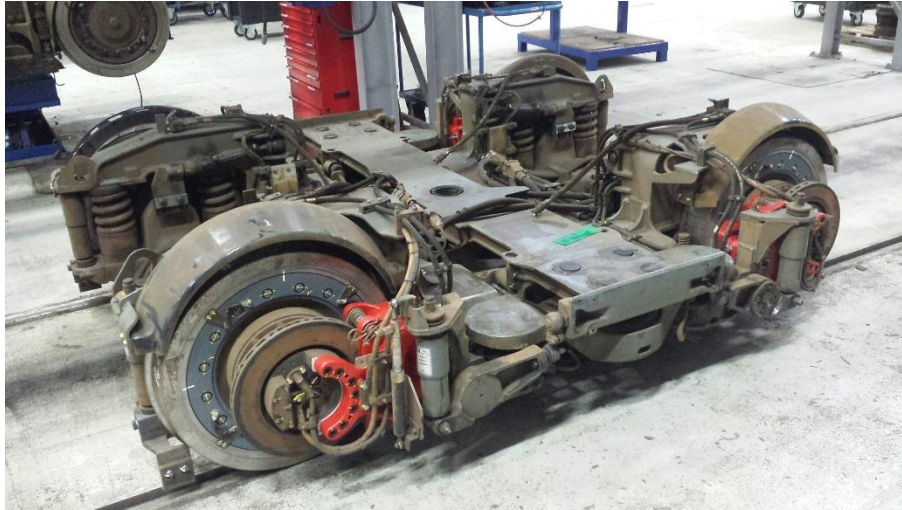
Figure 29

Below a picture of the a bogie at HTM is observed. It is seen how different it is from the ones studied at RET.
