# Quantifying thermal imaging data for piping detection

Analyzing the flow rate and the size of the temperature spots in thermal images of seepage at dykes

**Master Thesis**

University of Twente

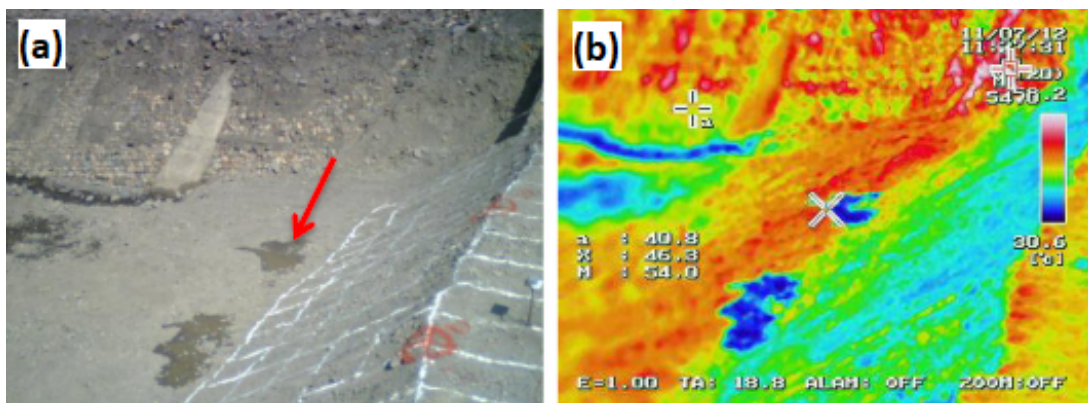
Figure 1.1: Base seepage downstream with (a) being a situation RGB image and (b) being a thermal image ([Chen et al., 2018](#))

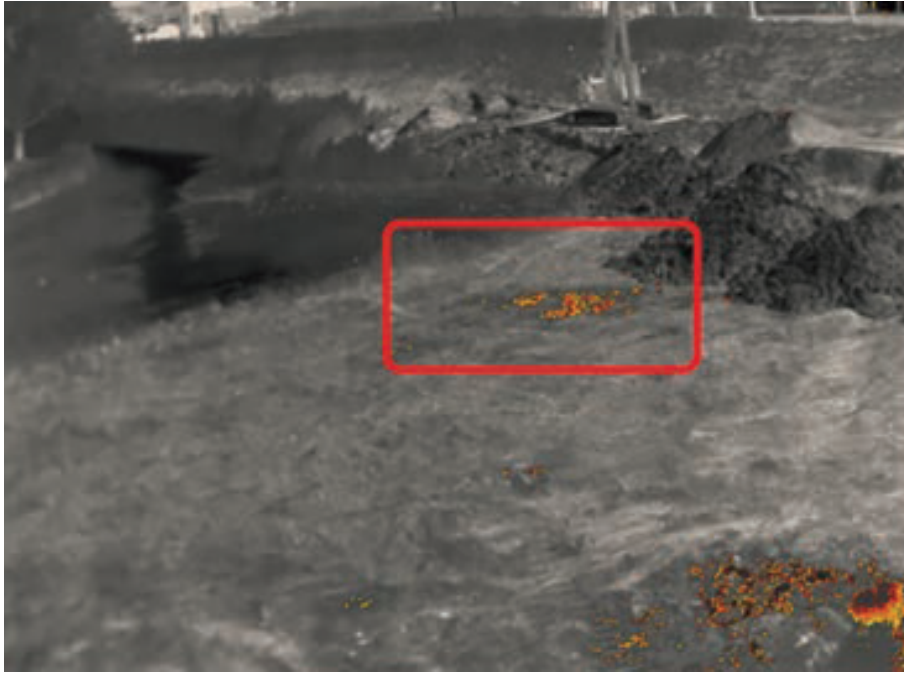
Figure 1.2: Seepage seen in a thermal image, the rectangle with rounded corners indicates one of the seepage spots where the colors indicate seepage spot by lighting up a certain temperature ([Wiggers et al., 2019](#))

and efficiently, while with human inspection they sometimes would be missed due to a coverage of grass or water plants. An example of seepage visualised using thermal imaging can be seen in Figure 1.2. [Wiggers et al. \(2019\)](#) conclude that thermal imaging can be a good additional information source for further investigation of local weak spots (seepage locations) and as a tool for inspections and implementation control. So, the measurement of temperature has shown great potential of monitoring piping in past researches.

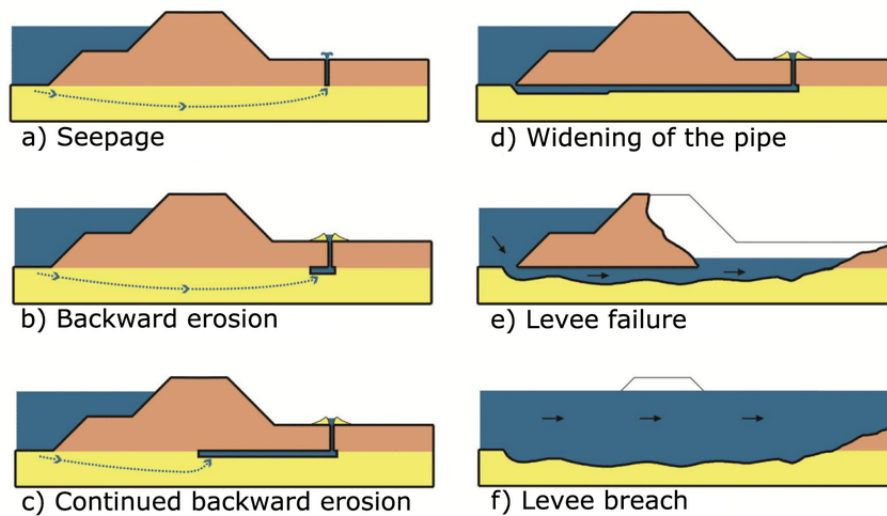
Figure 2.1: The phases of the piping process (Semmens and Zhou, 2019).

Piping is an internal erosion mechanism found in or underneath water-retaining structures such as dykes. In this process, hollow spaces, known as pipes, are formed as a result of water flowing through or underneath the structure. The mechanism consists of the following processes: seepage, backward erosion initiation, backward erosion progression, widening of the pipe, failure of the levee and breach (Semmens and Zhou, 2019) as can be seen in Figure 2.1.

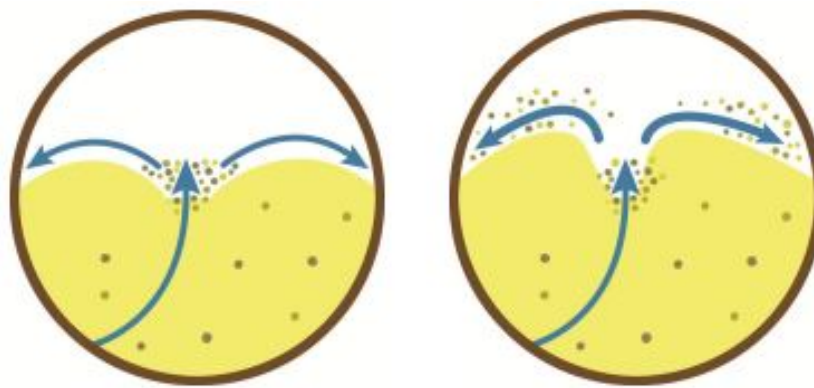
Figure 2.2: Left: a sand boil without sand deposition, the fluid flow is in equilibrium with the weight of the sand mass. Right: a sand boil with sand deposition, the flow velocity is high enough to deposit sand ([van Beek, 2015](#)).

the pore pressures in the sand become higher than the effective stresses in the sand. The seepage velocity increases the pore pressures in the sand. If these pore pressures are sufficient for the fluid state to be reached, it still does not immediately mean that pipe formation will happen ([van Beek et al., 2013](#)). In other words, the initiation of backward erosion does not necessarily lead to the progression of backward erosion. Due to the crack being filled with sand in the fluid state, the resistance in that crack will increase. Now there are two options: (1) the flow speed at the crack in the cover layer decelerates to such a degree that the erosion process stops due to the increased resistance, meaning that no pipe formation will happen, or (2) the flow speed does not decelerate enough, so the sand transport through the crack will continue, meaning that a pipe will start to form. In the first option, only clean water is flowing out of the crack in the surface layer. In case of the second option, a fluid sand mixture will flow out of the crack in the surface layer and will be deposited around it, creating a sand boil ([Technical Advisory Committee, 1999](#)). The two possibilities are schematically displayed in Figure 2.2.

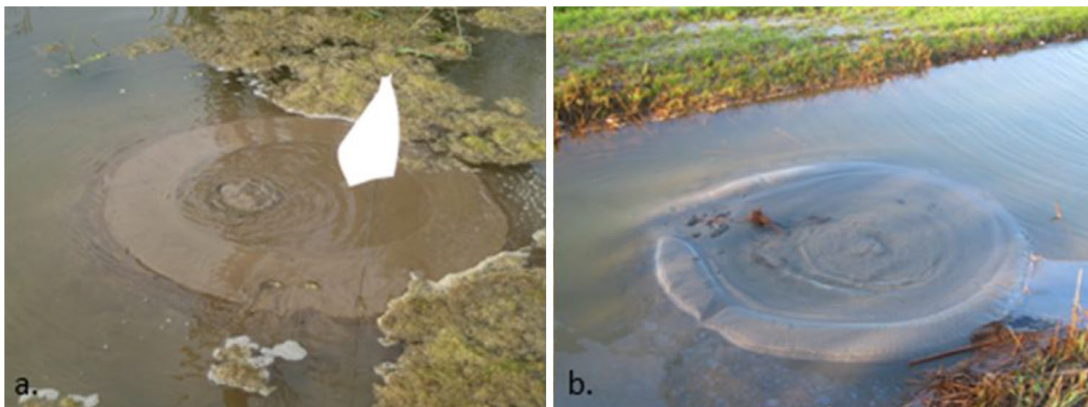
Figure 2.3: Two examples of a typical sand boil in the ditch on the outside of the river dyke. Locations: a. Mississippi River b. Waal River Netherlands. The size can range from millimeters to meters in diameter (Talukdar and Dey, 2019).

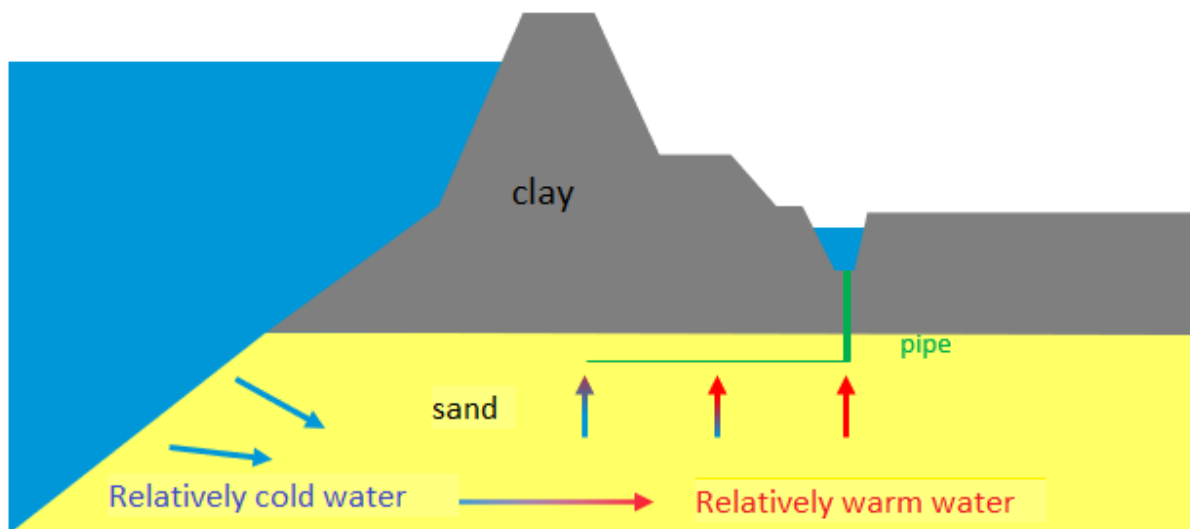
Figure 2.4: Temperature change of seepage water (van de Voort et al., 2021), an example of relatively cold infiltrating water which is changing to a higher temperature by the seepage process.

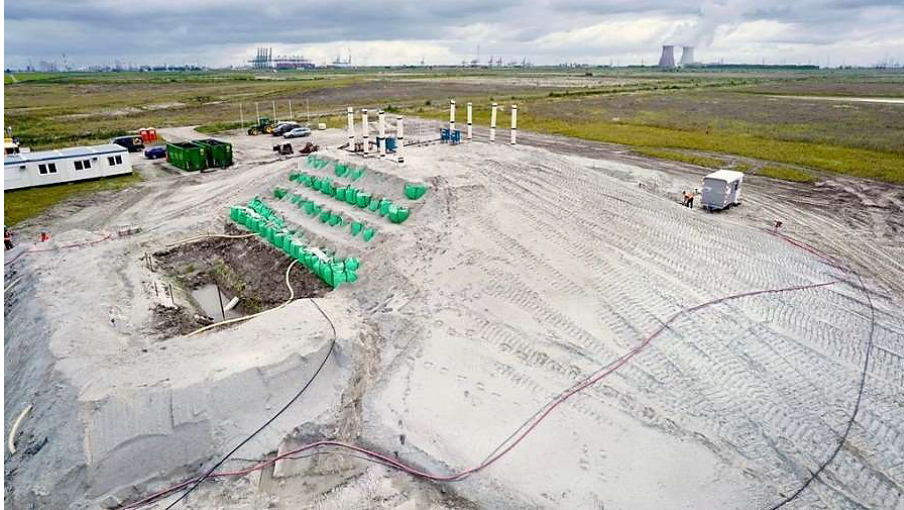
Figure 3.1: Experimental set-up at the LLHPP. The infiltration tubes can be seen on the top of the artificial dyke and the ditch of the North side of the dyke can be seen on the left side.

A picture of the artificial dyke at the experiment can be seen in Figure 3.1. For each side of the dyke, a ditch was created as the exit point for the pipes. These ditches are designed with the dimensions of 10 meter in length, 1 meter in width and 1.6 meter in depth, wherein a very small water level of 0.1 meter is maintained (Steenblik, 2021). This situation is shown in the schematic drawing in Figure 3.2. A sketch of the experimental set-up and additional pictures of the real experimental set-up can be seen in Appendix A in Figure A.1 and Figure A.2.

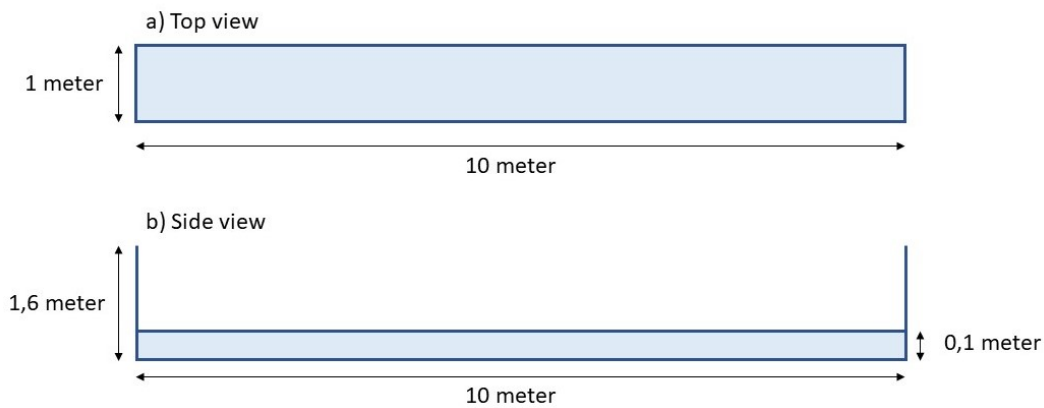
Figure 3.2: Schematic drawing of the dimensions of the ditches at the LLHPP.

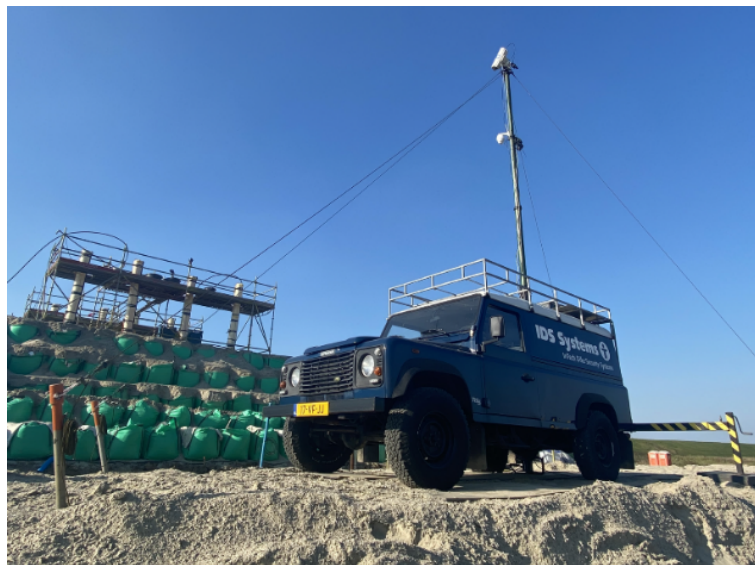
Figure 3.3: Set-up of the thermal imaging measurement device (Steenblik, 2021).

The thermal images were generated with an infra-red sensor containing a thermal resolution of 307.200 points per image. The output is a RAW 16 bit thermal .xpng image, which is a matrix of 480x640 pixels. Each pixel contains a measurement of the temperature. The thermal images are measured every ten seconds. The measurement system is built on an off-road vehicle on an 8 meter high telescopic mast containing a stability system and an Uninterruptible Power Supply (UPS) (Steenblik, 2021). The off-road vehicle is  $\pm 2$  meter high, so the camera is positioned  $\pm 10$  meter high. The set-up of this measurement device can be seen in figure 3.3.

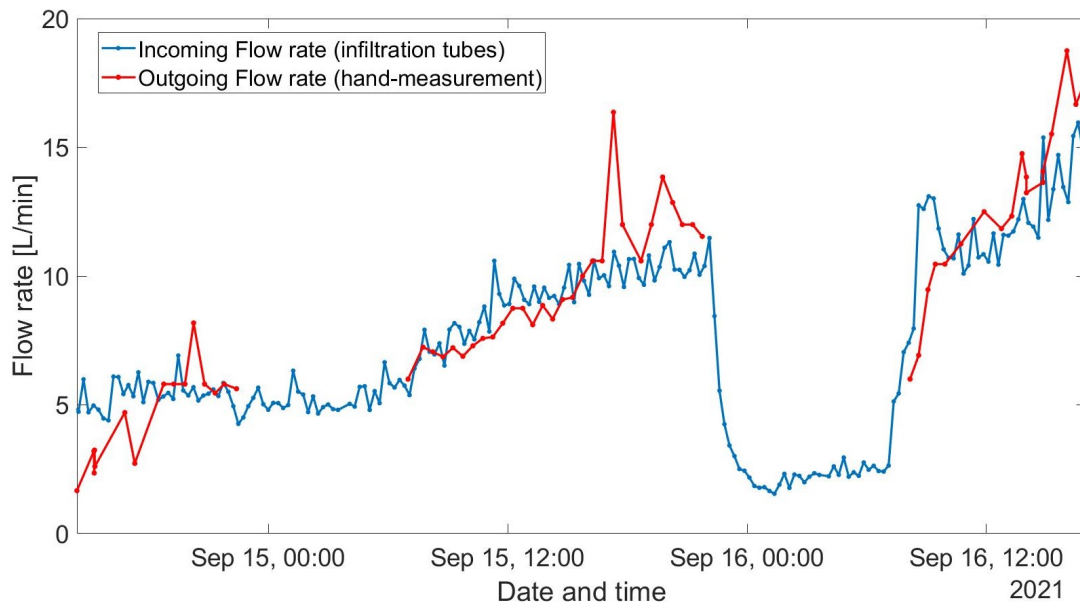
Figure 3.4: Comparison of the flow rate at the infiltration tubes and the hand-measured flow rate out of the ditch.

There are two types of flow rate data: the flow rate coming into the dyke by infiltration tubes per 15 minutes, and the hand-measured flow rate coming out at the ditch. These two data sets are compared in Figure 3.4. In the figure it can be seen that during the night of 15 to 16 September, the flow rate was lowered to be sure that the point of continued pipe growth would occur during the day when observers were present.

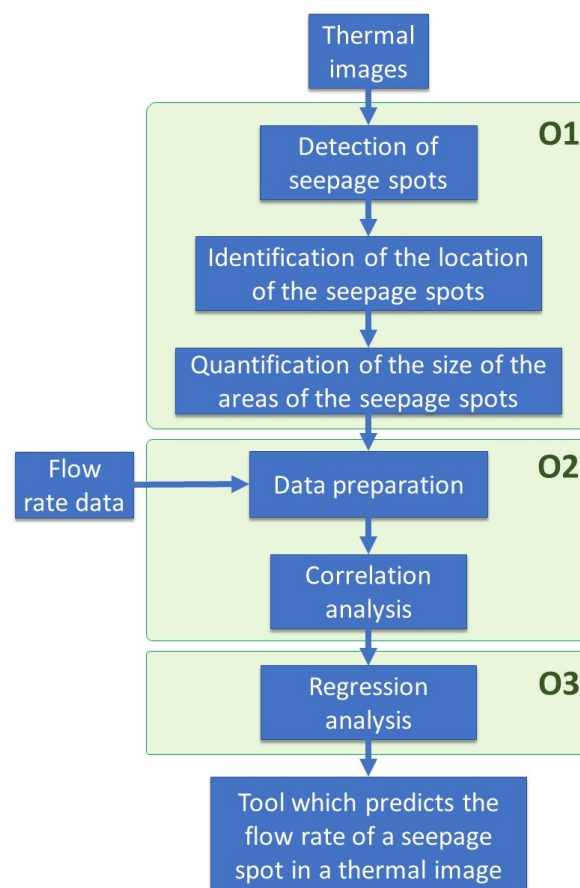
Figure 4.1: Flow chart of the methodology which summarizes the steps taken in the study, where the green squares make a division per objective (O).

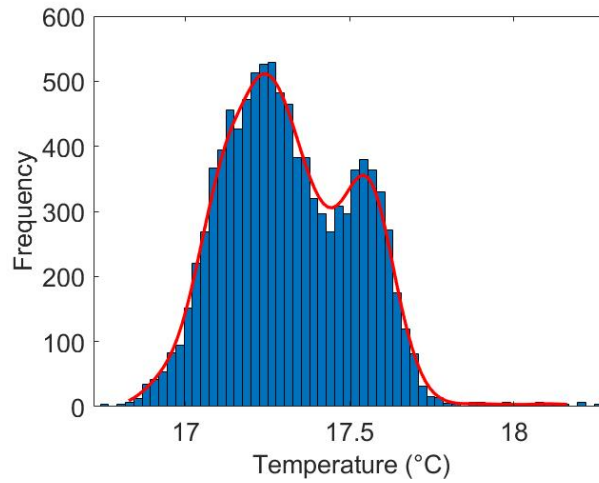
Figure 4.2: An example of an histogram with a fitted Kernel distribution curve.

The third and last reduction of the data set is based on the visibility of temperature differences in the Regions of interest. To be able to extract an area of the seepage spot from the thermal images it is important that the data set for the research consists of images in which a (clear) temperature difference is visible. Tipping points where the seepage water is changing from cold to warm seepage relative to the ditch temperature and weather events are causes of no clear temperature difference being visible ([van de Voort et al., 2021](#)) and are therefore extracted. The temperature differences are detected statistically by histograms together with fitted curves. It is chosen to fit a Kernel type of curve to the histograms of the present temperatures, since the Kernel type follows the shape of the histogram the best. An example can be seen in Figure 4.2, where the frequency of the pixels of a certain temperature is shown with the blue bars and the fitted Kernel distribution is shown with a red line.

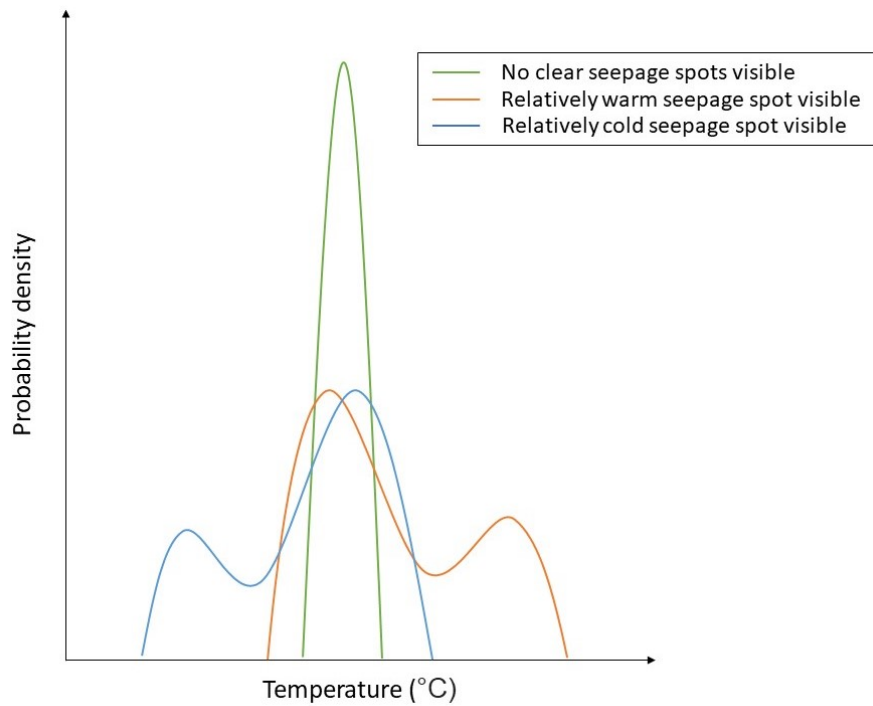
Figure 4.3: Expected temperature distributions in thermal images with and without seepage spots, based on the methods of [Jiang et al. \(2016\)](#) and [Tsanakas and Botsaris \(2012\)](#)

Histograms with fitted curves show the intensity of the temperatures that are found in the ROIs. They are tools that show the different temperatures which are present in the ditch. A high intensity peak and small temperature range will indicate that there is no significant temperature difference between the water in the ditch and the seepage water being visible in the thermal image. A large temperature range and two or more lower intensity peaks indicate that a temperature difference can be seen in the thermal image. This method is based on [Jiang et al. \(2016\)](#) and [Tsanakas and Botsaris \(2012\)](#). Both studies also used histograms with fitted curves to indicate the peaks and to detect hot spots in their thermal images. Figure 4.3 shows the expected shapes of the peaks, where the green line indicates no clear seepage spot visible and red and blue line indicate that seepage is visible.

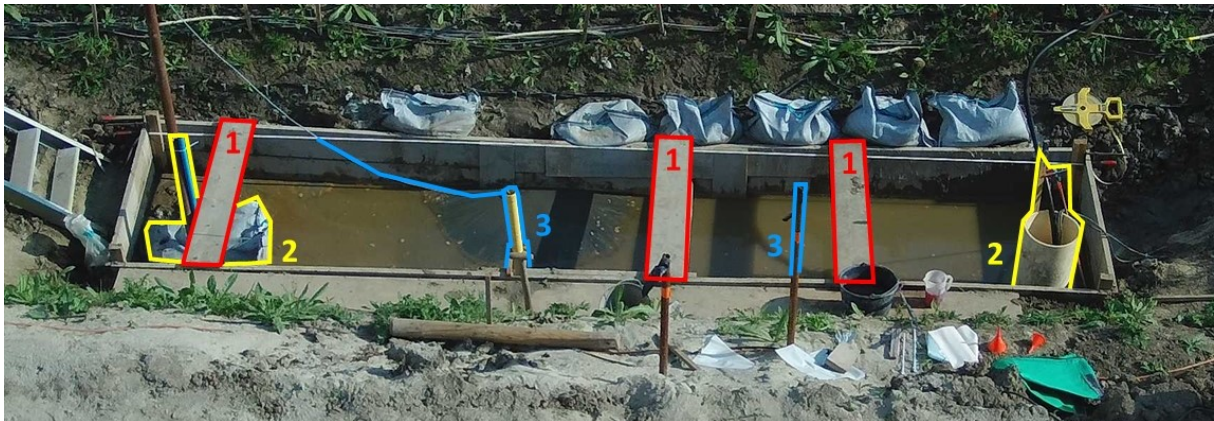
Figure 5.1: Obstacles inside of the ditch at the experimental set-up where the numbering corresponds to 1) wooden gangways 2) larger measurement devices and 3) small measurement devices.

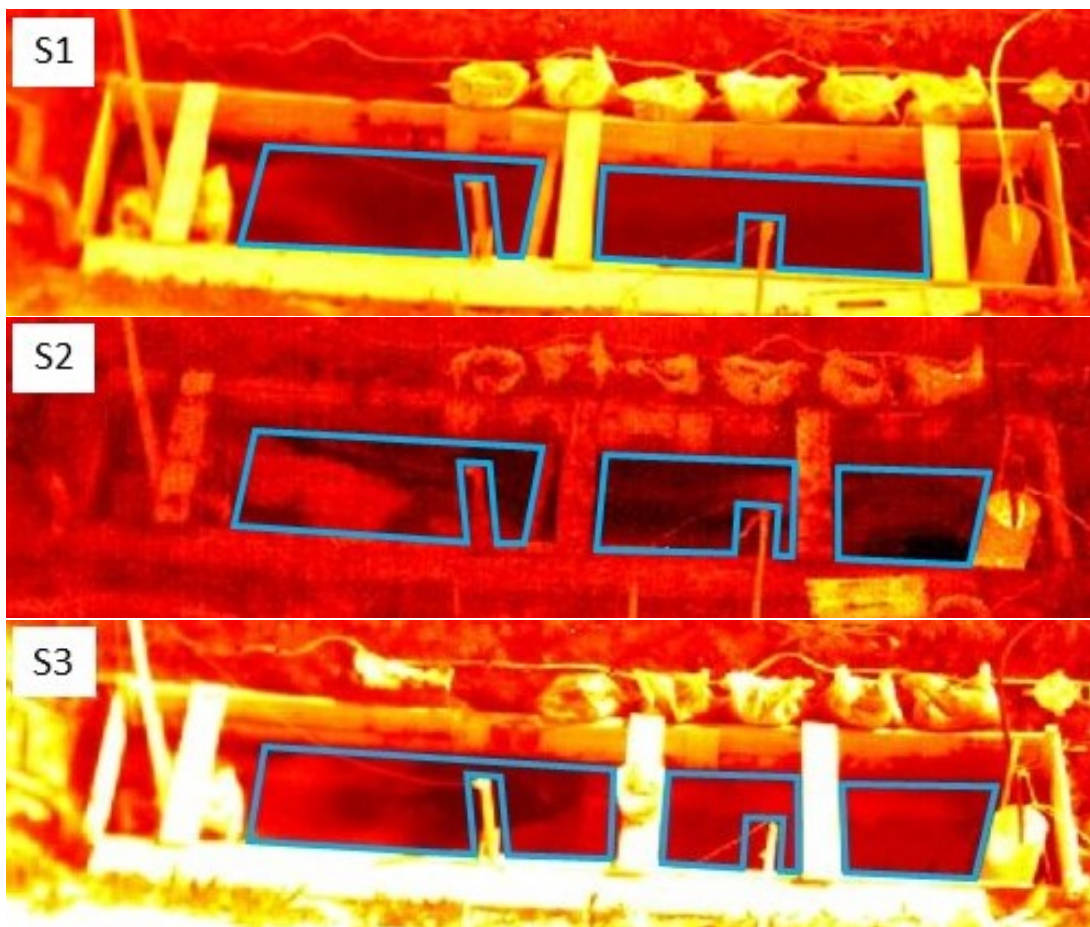
Figure 5.2: The regions of interest for Setting 1 (top), Setting 2 (middle) and Setting 3 (bottom)

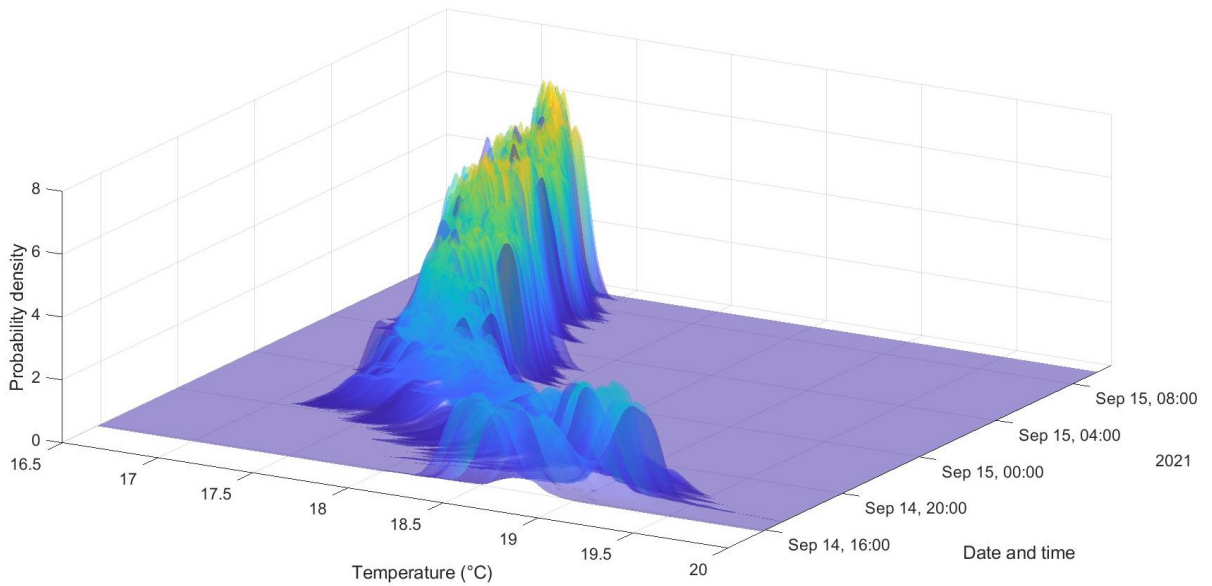
Figure 5.3: Plot of all fitted curves in time for Setting 1 with the purpose to show temperature differences in thermal images

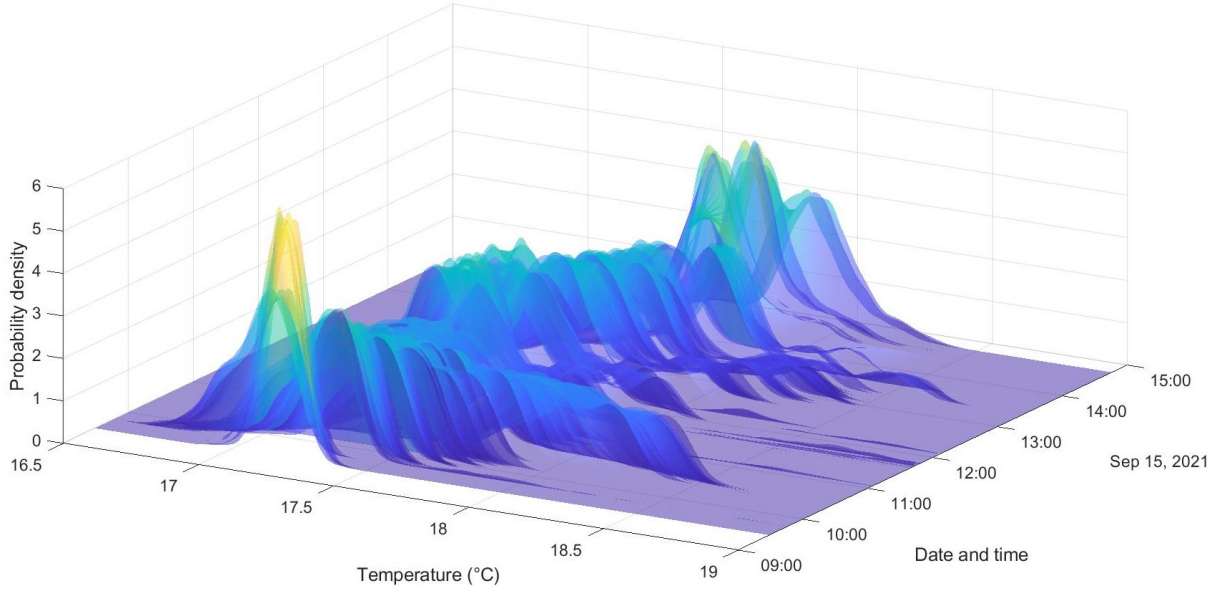
Figure 5.4: Plot of all fitted curves in time for Setting 2 with the purpose to show temperature differences in thermal images

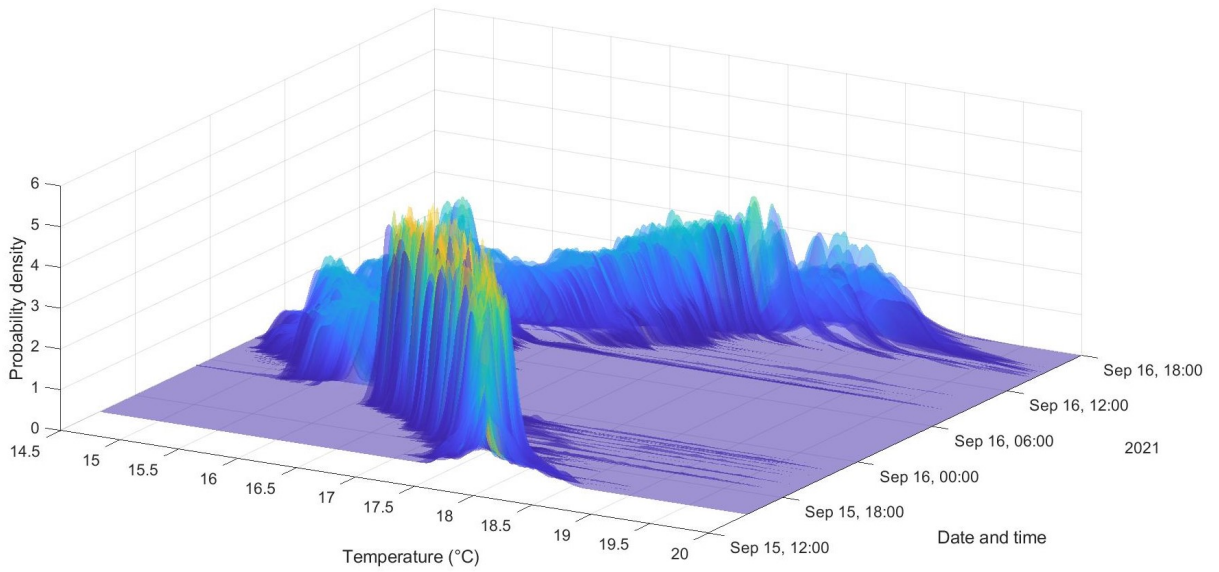
Figure 5.5: Plot of all fitted curves in time for Setting 3 with the purpose to show temperature differences in thermal images

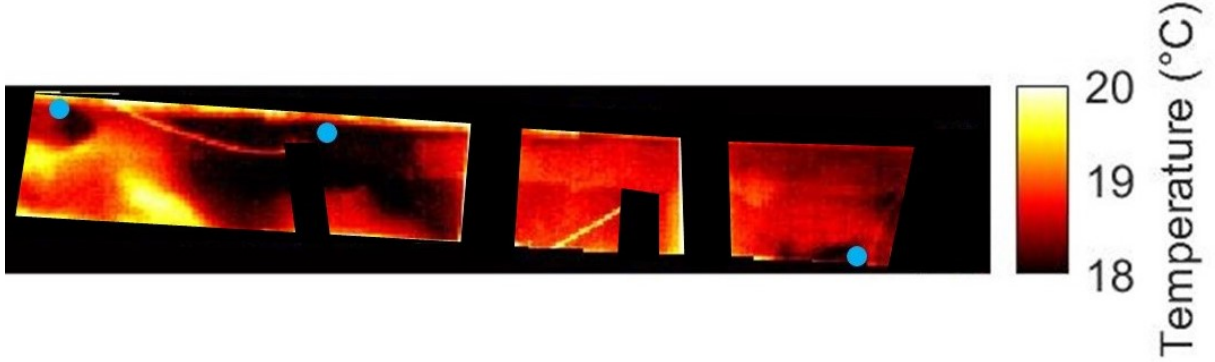
Figure 5.6: The locations of the three seepage spots in the remaining data set, indicated with a blue dot. The seepage spot in the middle is active during the whole data set, the seepage spots on the left and on the right are not active during the complete data set. The obstacles as shown in Figure 5.1 are kept out of the analysis.

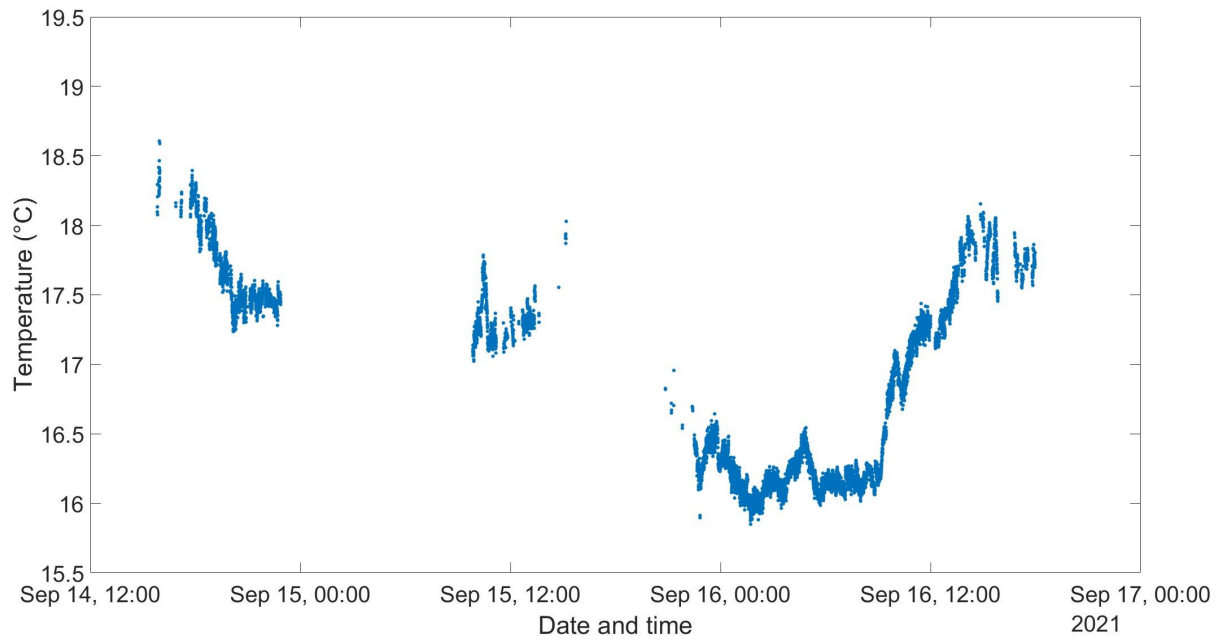
Figure 5.7: A plot of the core temperature of the main seepage spot over time.

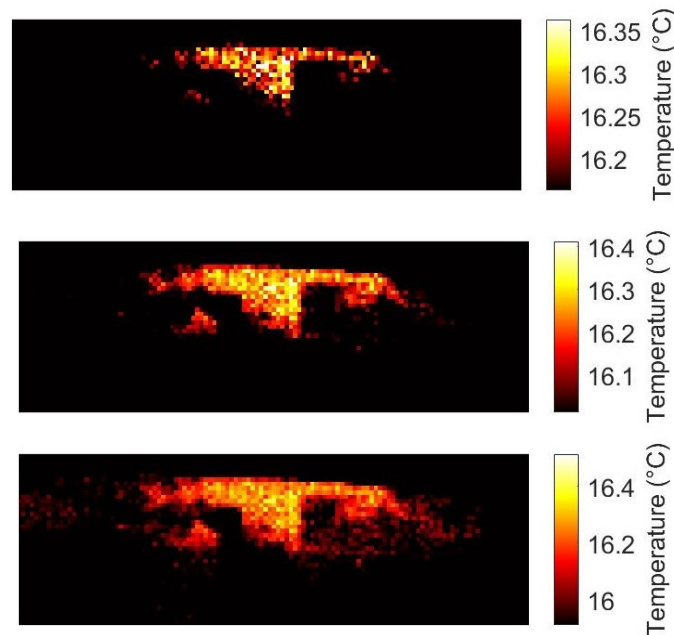
Figure 5.8: The quantified area for three different temperature ranges: 0.2 °C (top), 0.4 °C (middle) and 0.6 °C (bottom) where the yellow/orange/red colors indicate the pixels that are counted as the area. The image is a cropped part of the ditch.

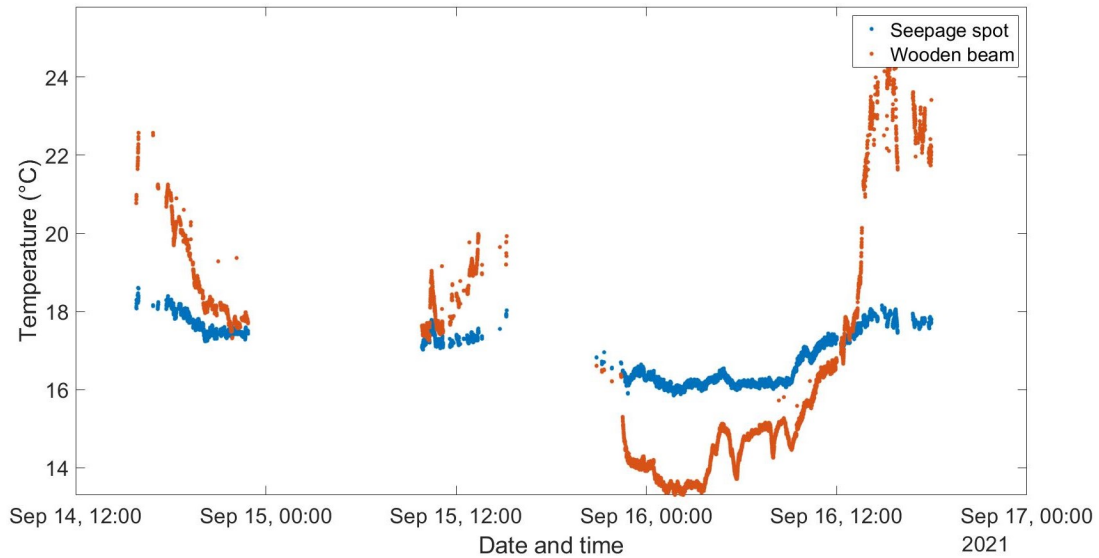
Figure 5.9: A plot of the core temperature of the main seepage spot and the ambient wooden beam temperature over time.

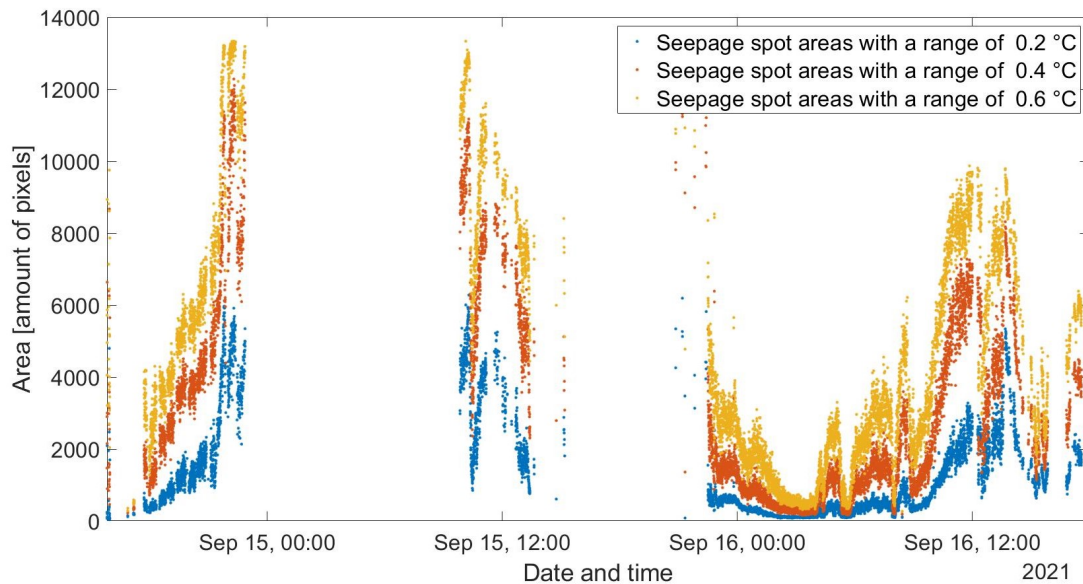
Figure 5.10: The extracted areas from the thermal images in amount of pixels over time for the three different temperature ranges.

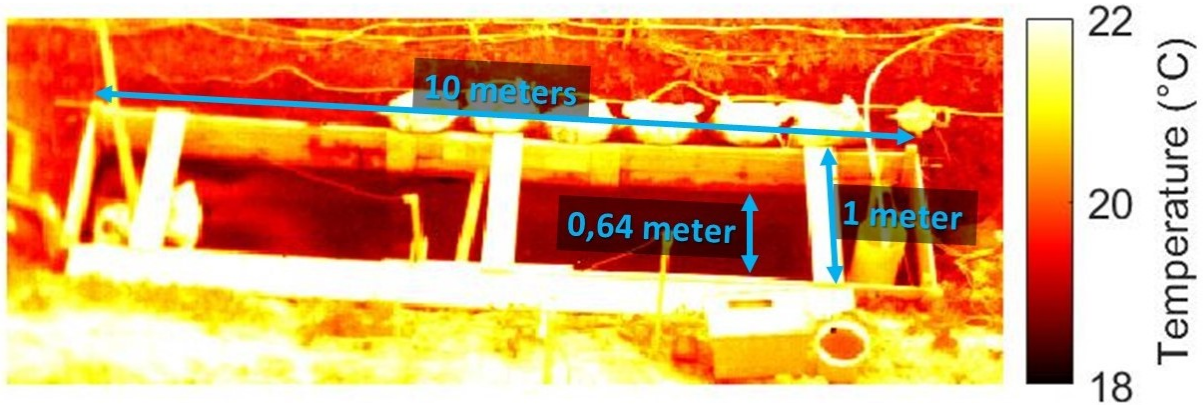
Figure 5.11: Known dimensions in the image which are used for the determination of the pixel size.

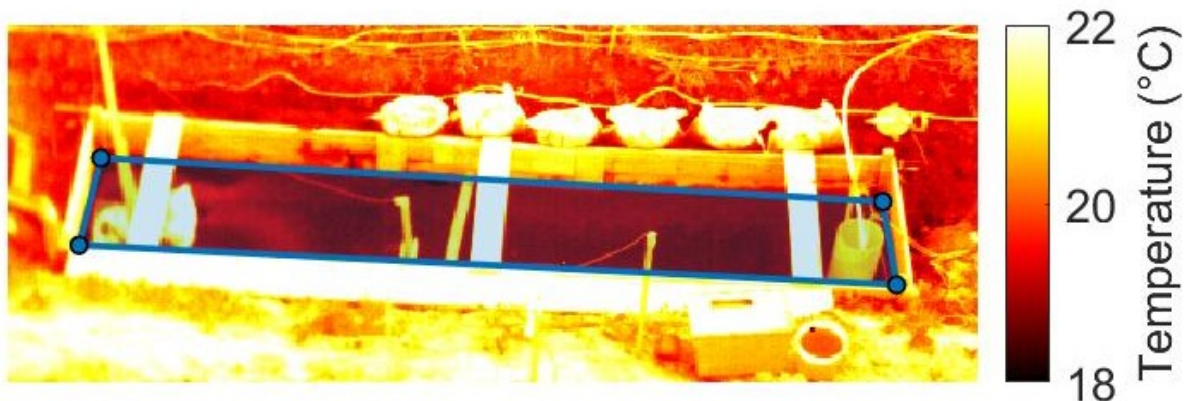
Figure 5.12: The area defined with the blue lines shows the pixels which are counted to calculate the size of the pixels.

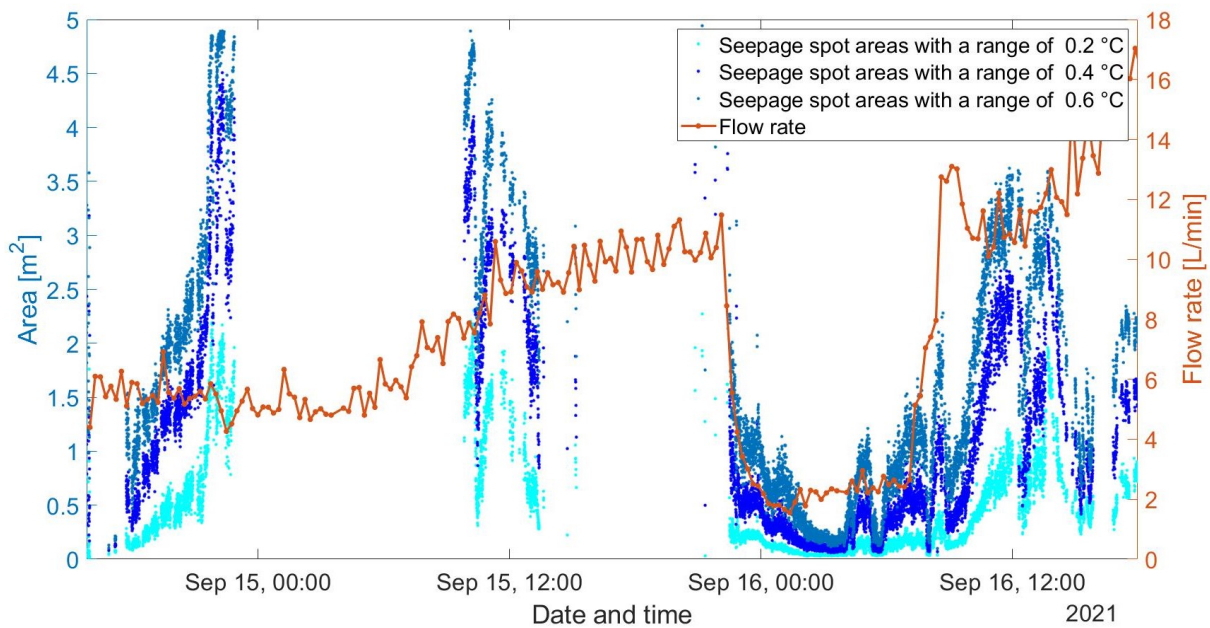
Figure 5.13: Flow rate compared with the areas of the seepage spots for different temperature ranges.

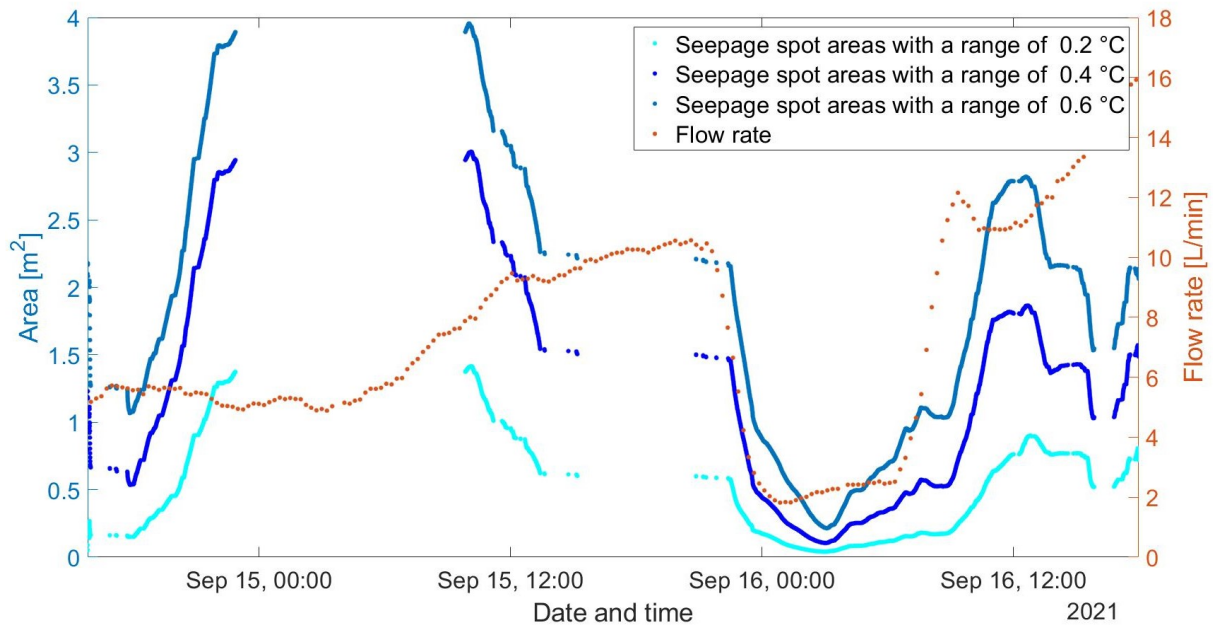
Figure 5.14: Flow rate compared with the smoothed areas of the seepage spots for different temperature ranges.

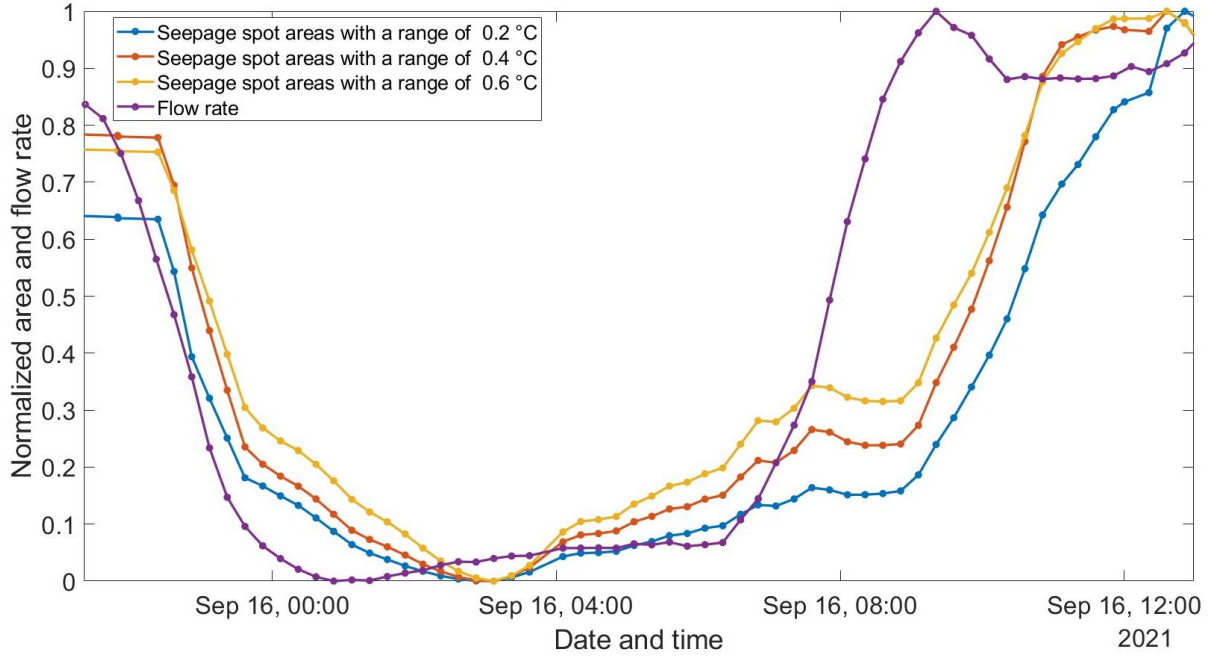
Figure 5.15: Normalized flow rate and areas for the time period of 15 September 21:20h up to 16 September 13:00h.

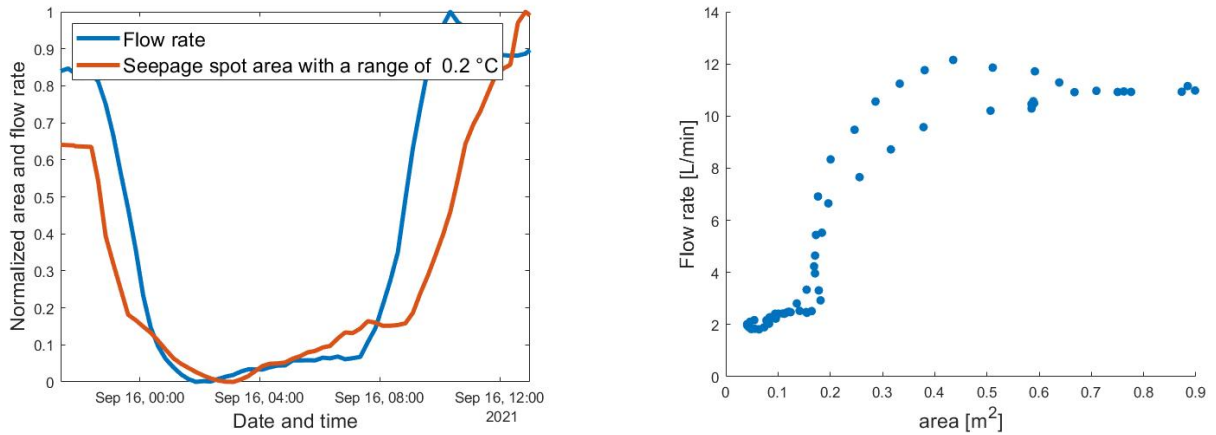
Figure 5.16: Scenario where the area with a range of 0.2 °C is correlated with the shifted flow rate. Left: a normalized plot of the flow rate and area in time. Right: a scatter plot of the flow rate versus the areas.

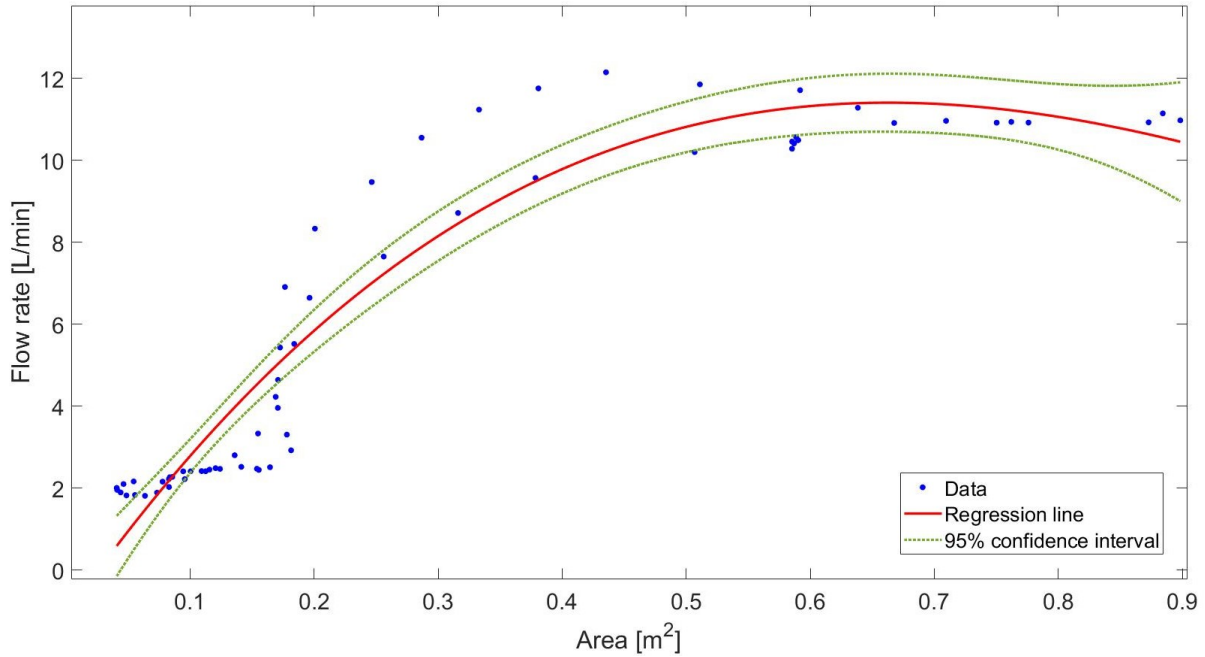
Figure 5.17: A third degree polynomial Regression line that represents the best correlating data set. The 95% confidence interval of the regression line is given as well.

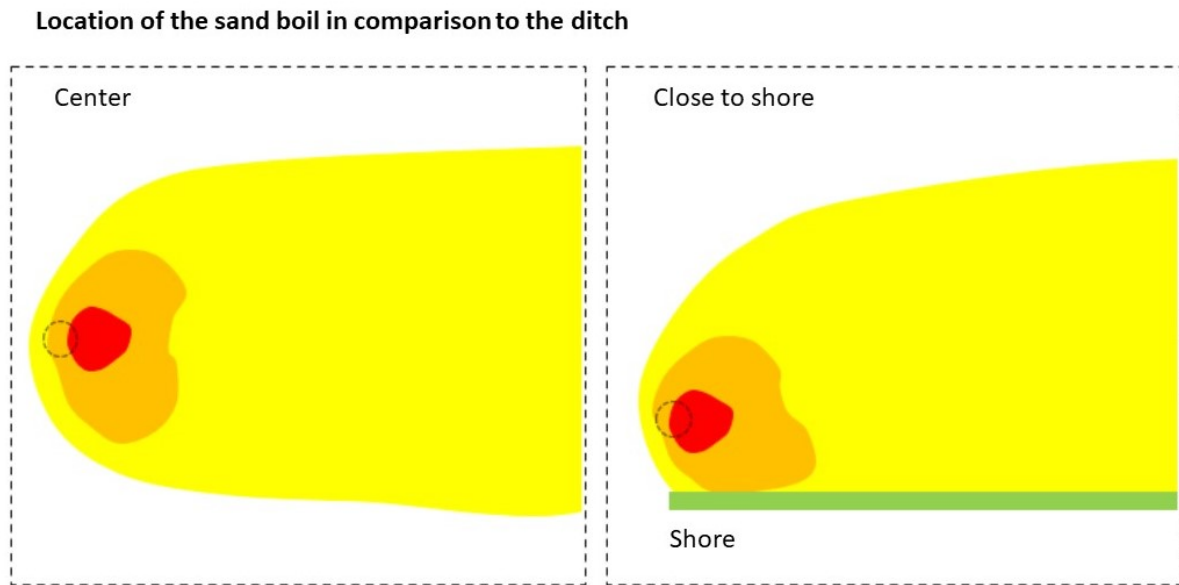
Figure 6.1: Sand boil location in comparison to the ditch shore, resulting in different areas in the thermal image. Adapted from [van de Voort et al. \(2021\)](#).

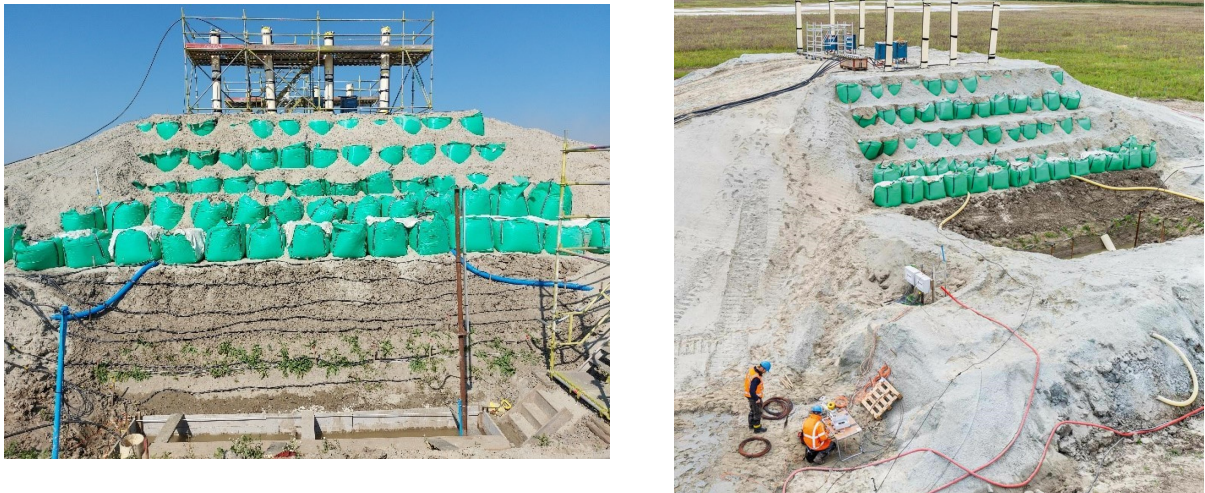
Figure A.1: Real experimental setup at the LLHPP with at the left-hand side the front perspective (Steenblik, 2021) and on the right-hand side the side perspective (Hijma and van Goor, 2021).

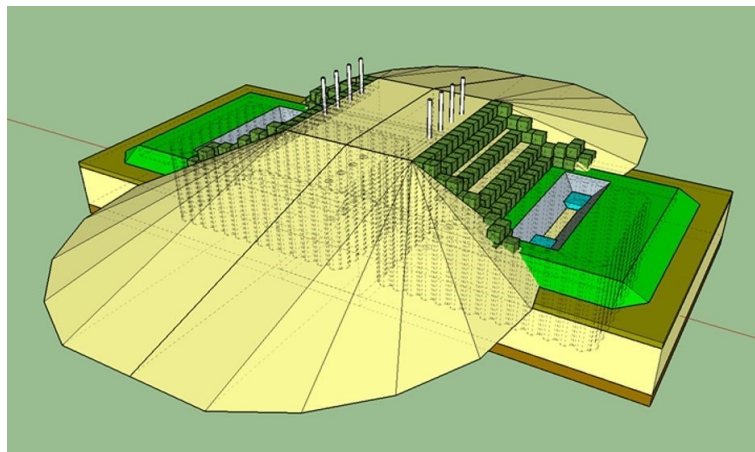
Figure A.2: Sketch of the experimental setup at the LLHPP (Hijma and van Goor, 2021)
