# Quantifying thermal imaging data for piping detection

Analyzing the flow rate and the size of the temperature spots in thermal images of seepage at dykes

**Master Thesis**

University of Twente

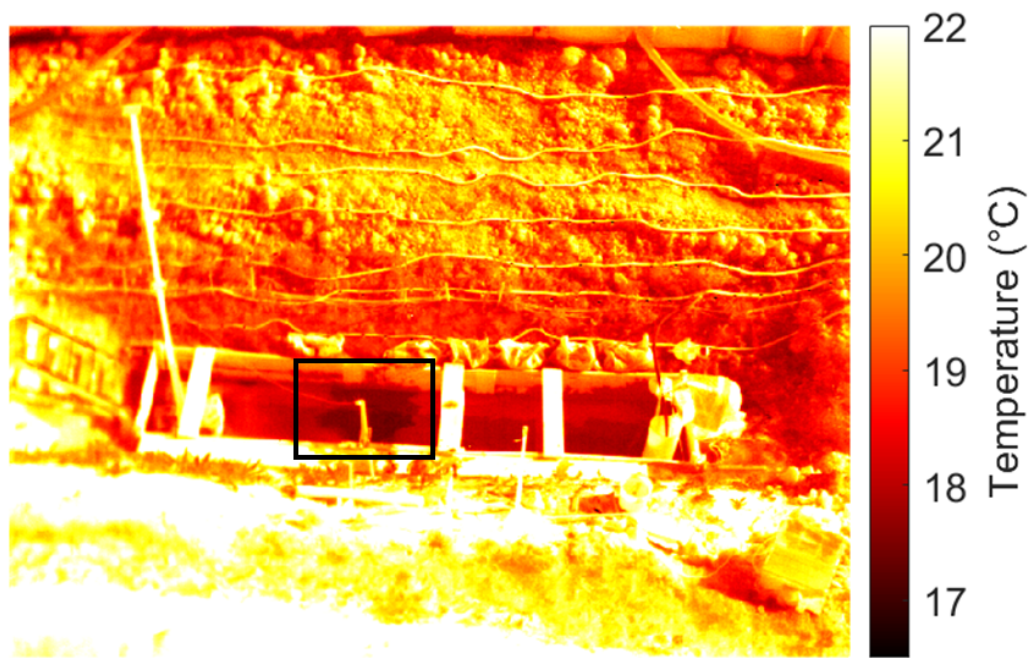
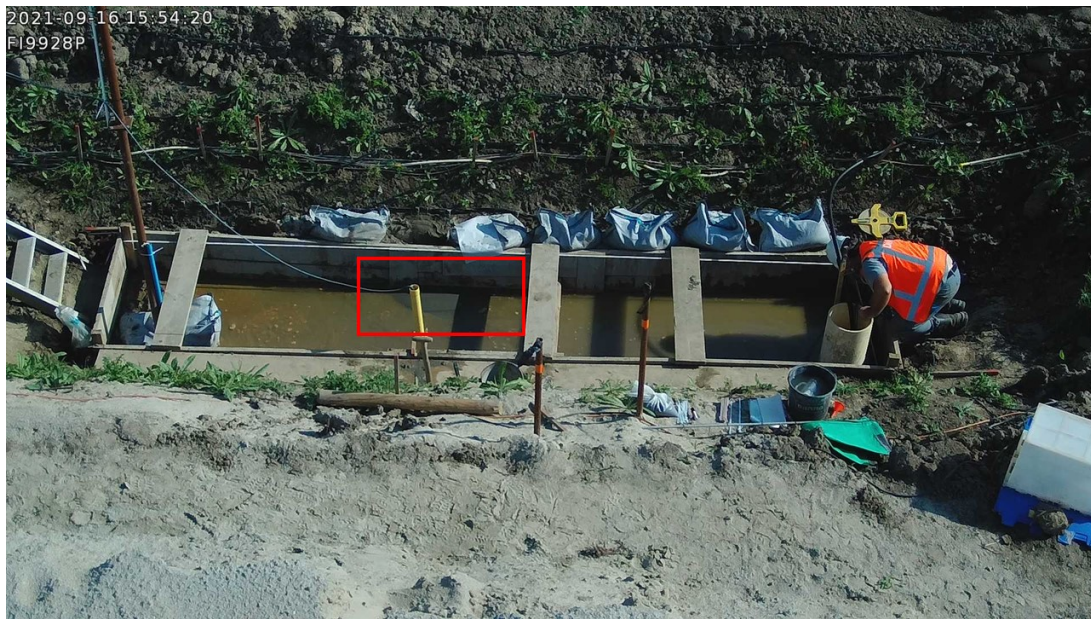
Figure A.3: A thermal (top) and RGB (bottom) image taken on 16 September 2021 at 15:54h. The black (top) and red (bottom) rectangle shows the location of a sand boil.

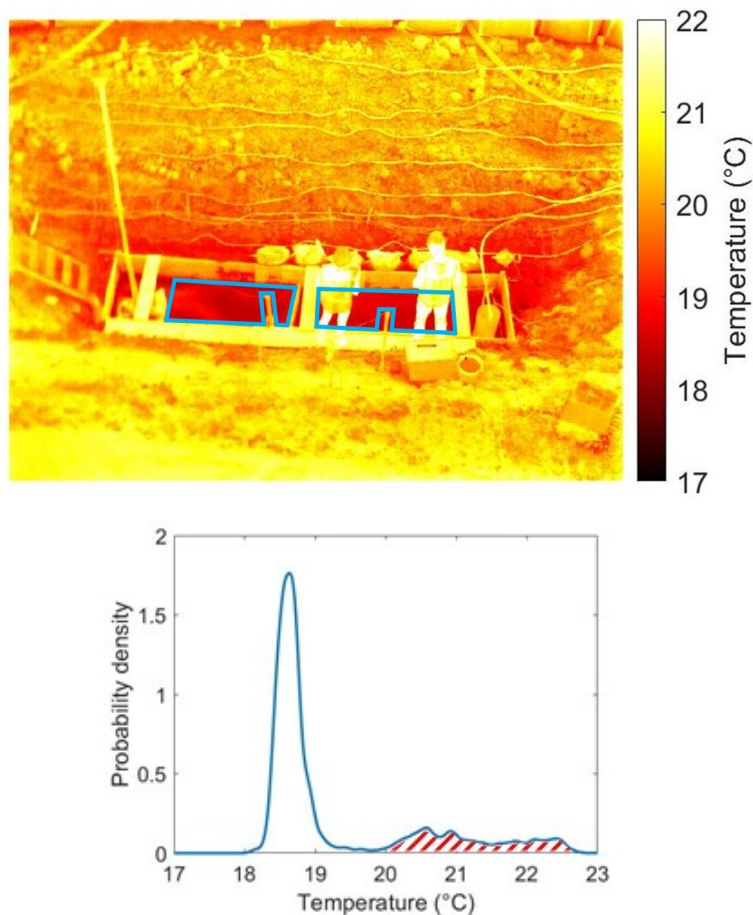
Figure B.1: A thermal image (top) and fitted curve (bottom) with people in front of the ROIs. The ROIs are indicated with blue polygons in the thermal image and the temperature of the people with red lines in the curve

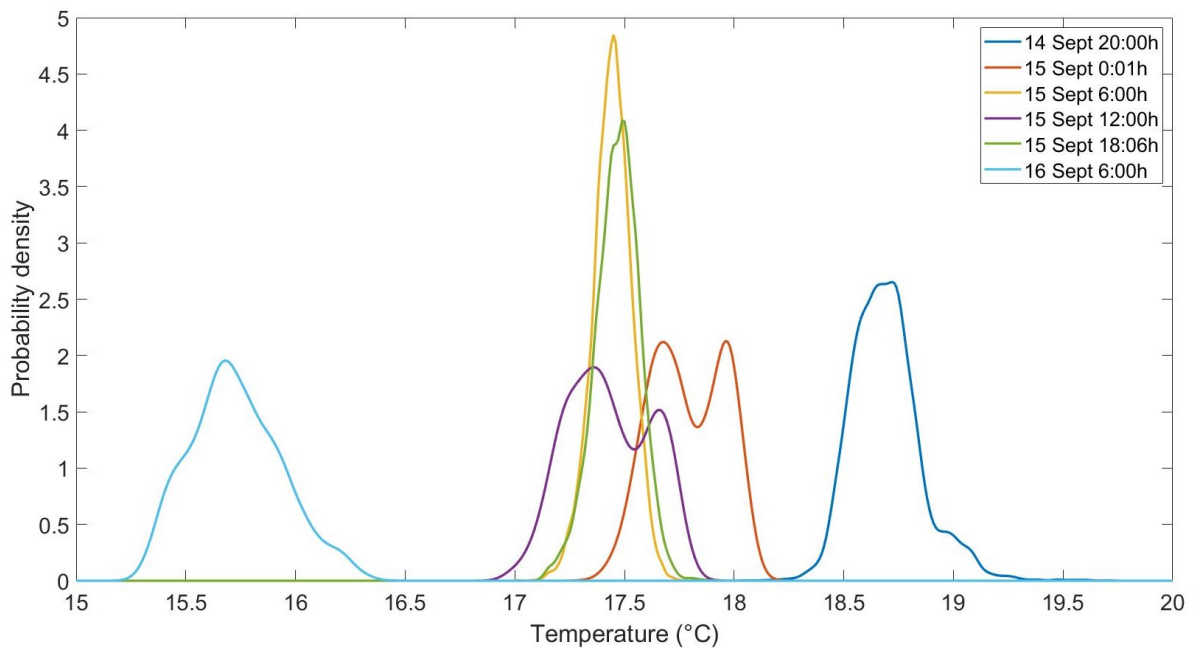
Figure C.1: Examples of fitted curves showing narrow ranges with high peaks and wide ranges with low peaks, the corresponding thermal images can be seen in Figure C.2a to Figure C.2f.

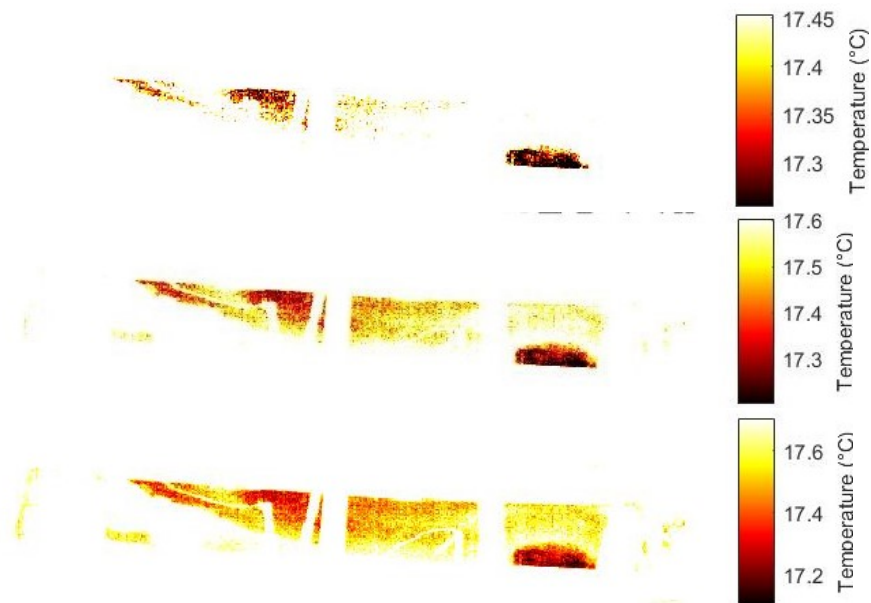
Figure D.1: The quantified area for three different temperature ranges: 0.2 °C (top), 0.4 °C (middle) and 0.6 °C (bottom) where the yellow/orange/red colors indicate the pixels that are counted as the area.

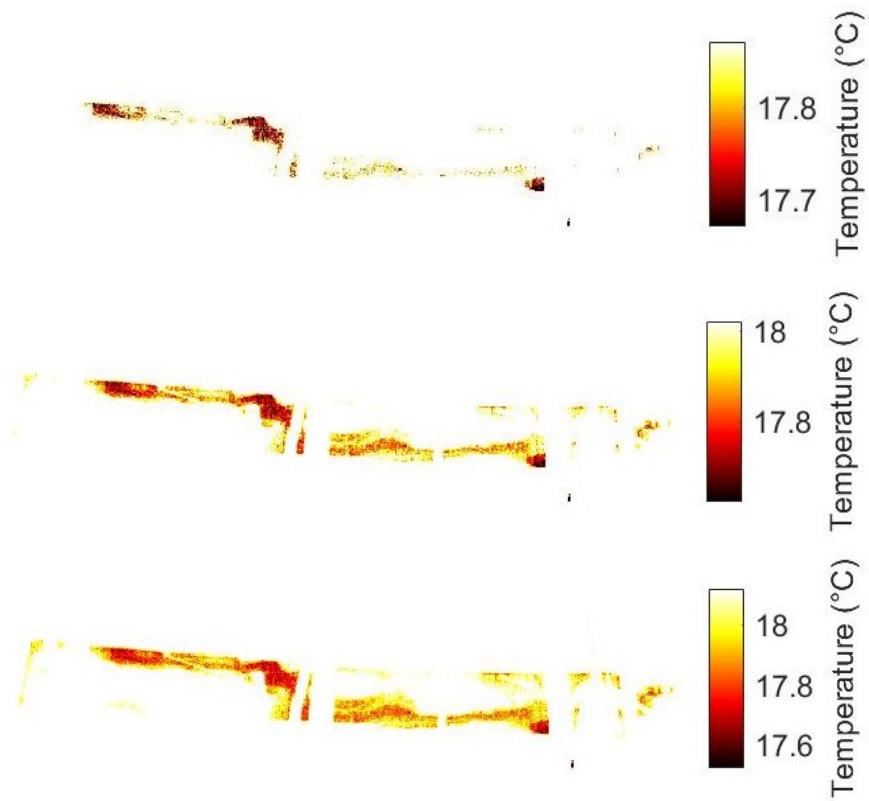
Figure D.2: The quantified area for three different temperature ranges: 0.2 °C (top), 0.4 °C (middle) and 0.6 °C (bottom) where the yellow/orange/red colors indicate the pixels that are counted as the area.

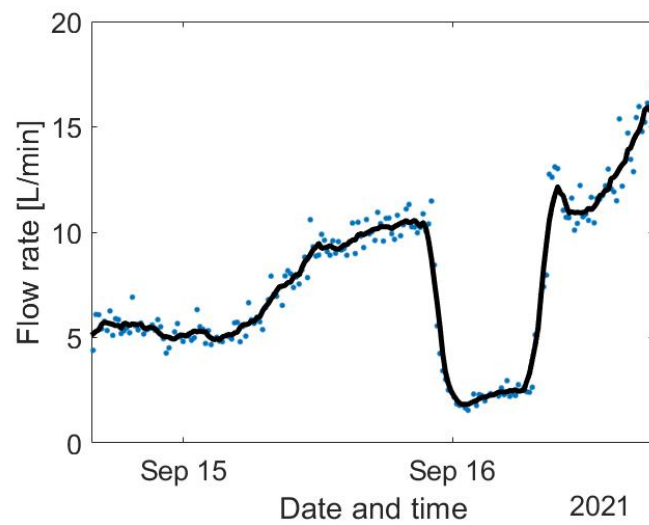
Figure E.1: Smoothed flow rate curve plotted with the original data points.

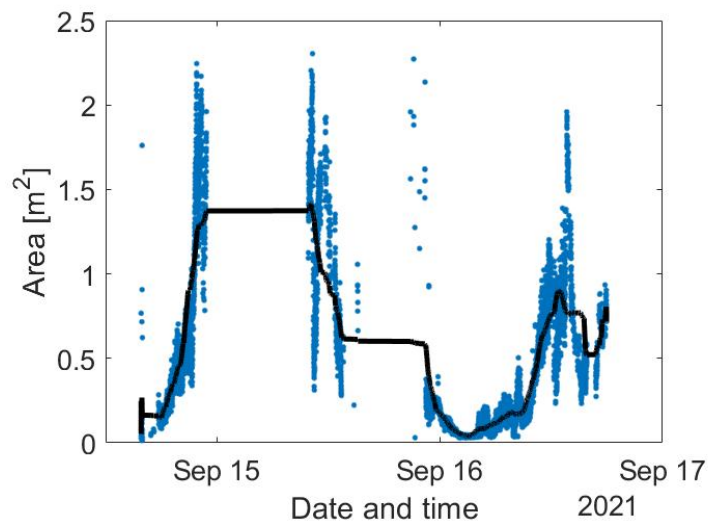
Figure E.2: Smoothed areas curve with a range of 0.2 °C plotted with the original data points.

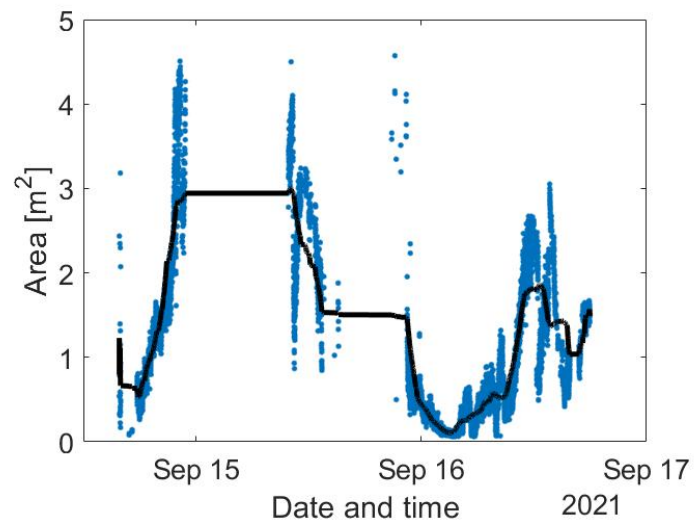
Figure E.3: Smoothed areas curve with a range of 0.4 °C plotted with the original data points.

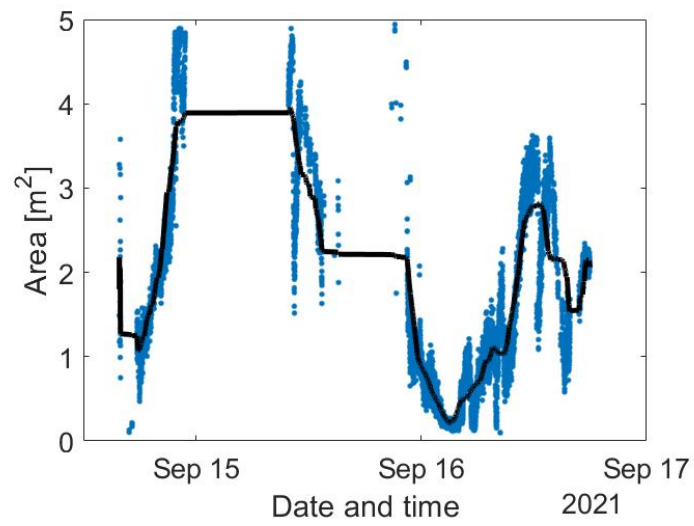
Figure E.4: Smoothed areas curve with a range of 0.6 °C plotted with the original data points.

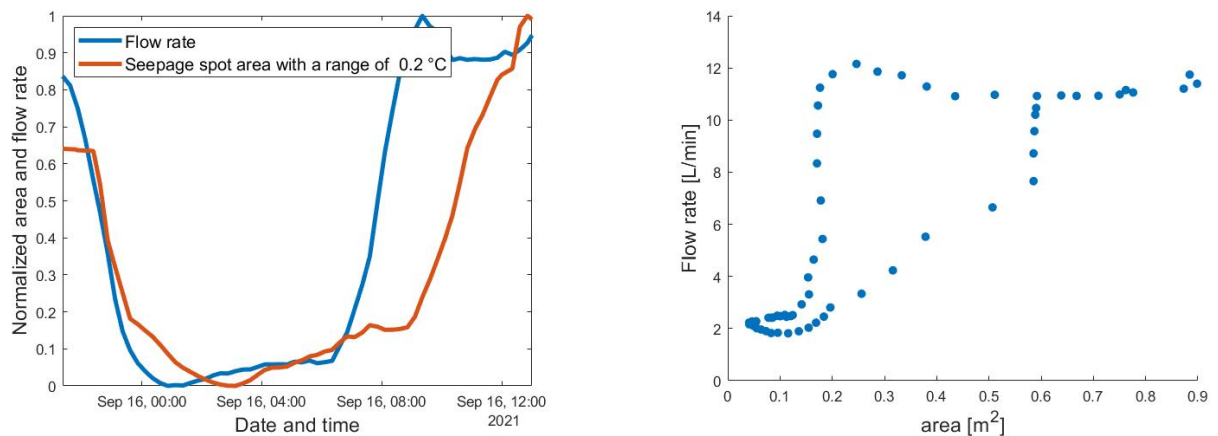
Figure F1: Scenario where the area with a range of 0.2 °C is correlated with the original flow rate. Left: a normalized plot of the flow rate and area in time. Right: a scatter plot of the flow rate versus the areas.

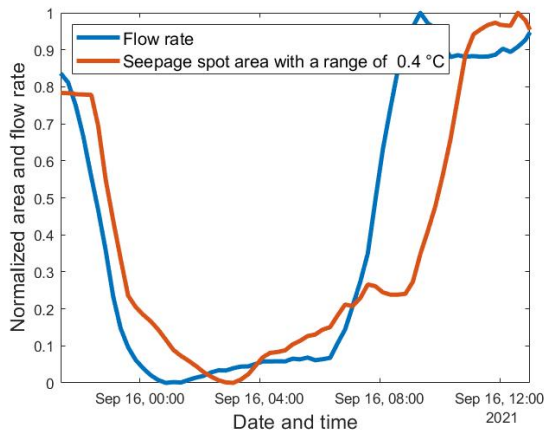
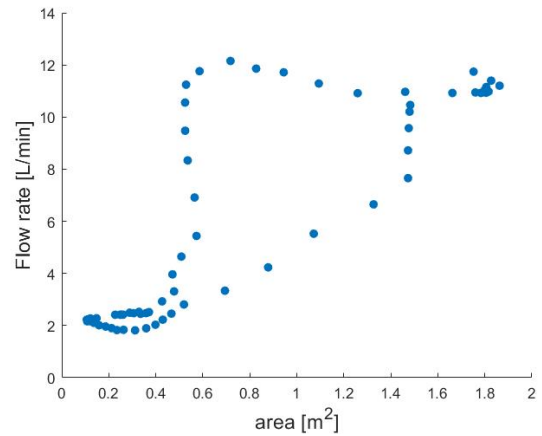
Figure F2: Scenario where the area with a range of 0.4 °C is correlated with the original flow rate. Left: a normalized plot of the flow rate and area in time. Right: a scatter plot of the flow rate versus the areas.

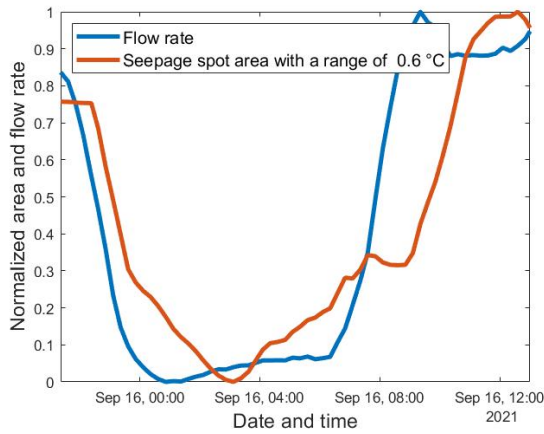
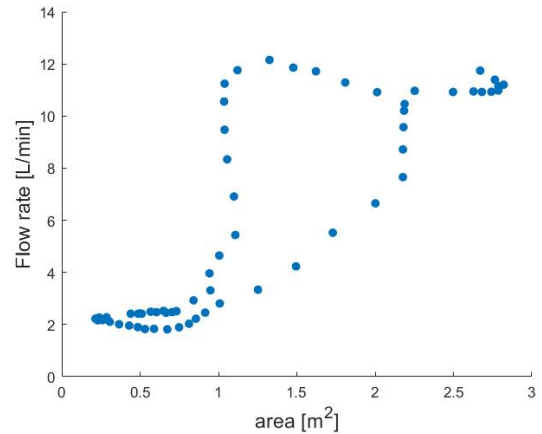
Figure F3: Scenario where the area with a range of 0.6 °C is correlated with the original flow rate. Left: a normalized plot of the flow rate and area in time. Right: a scatter plot of the flow rate versus the areas.

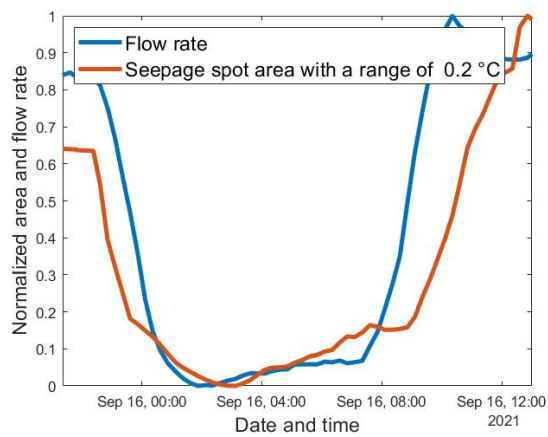
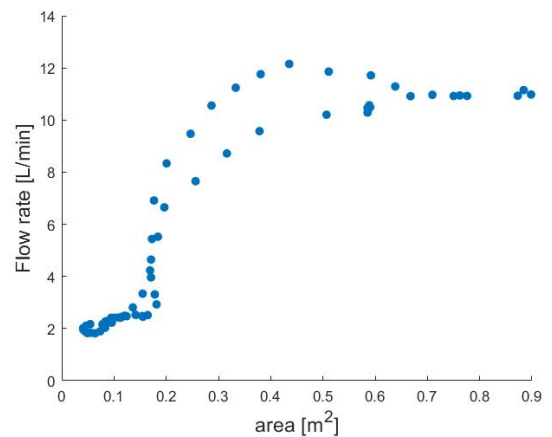
Figure F4: Scenario where the area with a range of 0.2 °C is correlated with the shifted flow rate. Left: a normalized plot of the flow rate and area in time. Right: a scatter plot of the flow rate versus the areas.

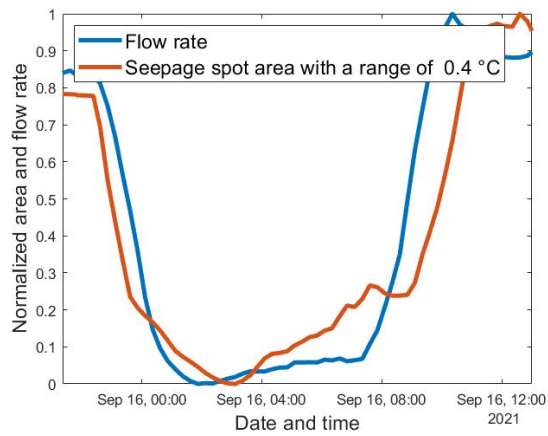
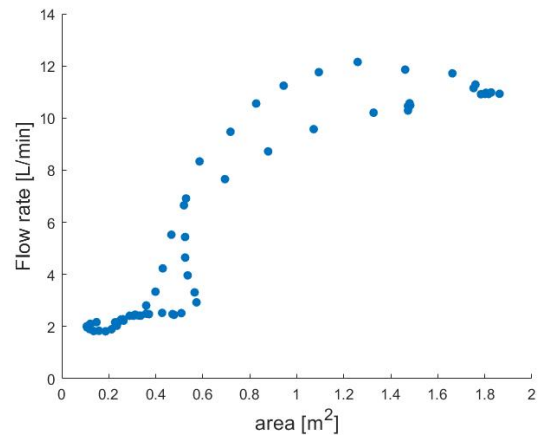
Figure F5: Scenario where the area with a range of 0.4 °C is correlated with the shifted flow rate. Left: a normalized plot of the flow rate and area in time. Right: a scatter plot of the flow rate versus the areas.

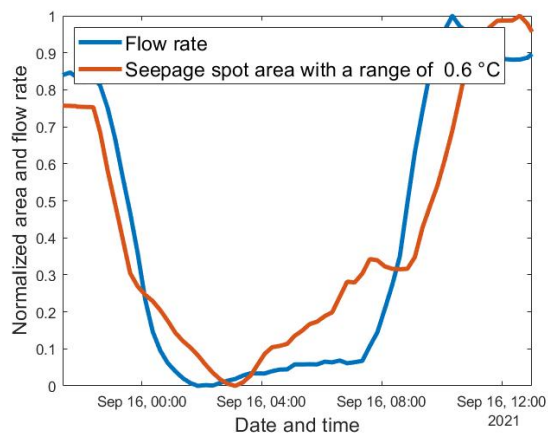
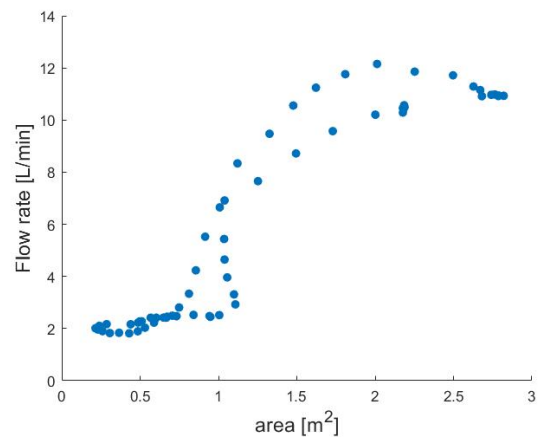
Figure F6: Scenario where the area with a range of 0.6 °C is correlated with the shifted flow rate. Left: a normalized plot of the flow rate and area in time. Right: a scatter plot of the flow rate versus the areas.
