# **WEATHERING RATES OF ROCK AND SOIL MASSES IN YEN BAI CITY, VIETNAM**

Thesis submitted to the Faculty of Geo-Information Science and Earth Observation of the University of Twente in partial fulfilment of the requirements for the degree of Master of Science in Geo-information Science and Earth Observation.

Specialization: Applied Earth Sciences (Geo and Environmental Engineering)

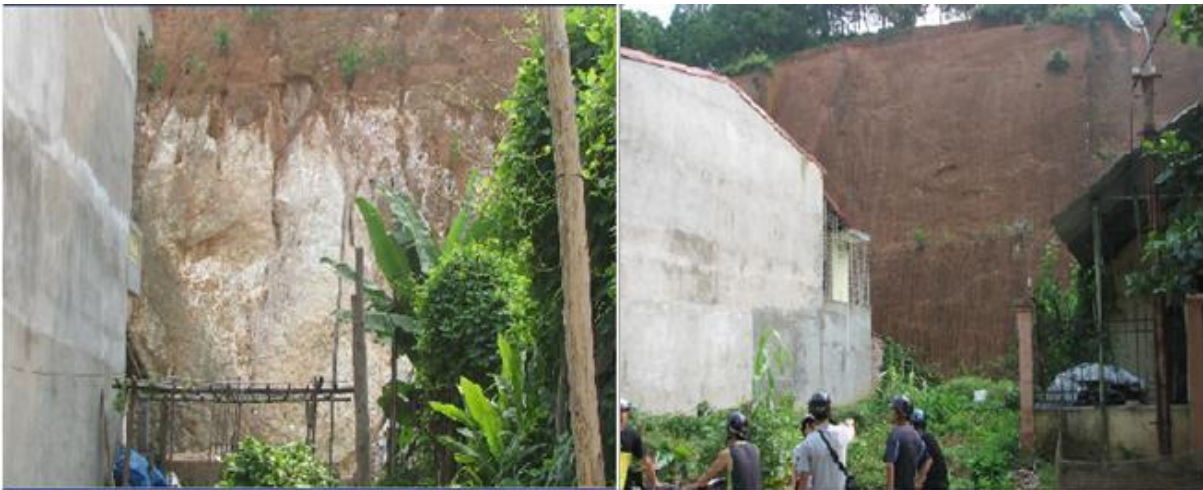
**Figure 1.1: Exposed rock and soil masses through cutting of slopes in the research area**

From observation (fig. 1.1 and appendix 1), since there are many cut and exposed slopes in Yen Bai city and the area is also in the tropical region where the effect of climate is very high which resulted in extreme chemical weathering, there is high possibility of slope failure. This could cause great hazards and loss of lives and properties; hence, there is need to carry out thorough study in order to understand and analyze the slope stability, degree and rate of weathering of the rock or soil masses for estimation of future stability, increase human safety, forecast future degree of weathering and reduction of future hazards.

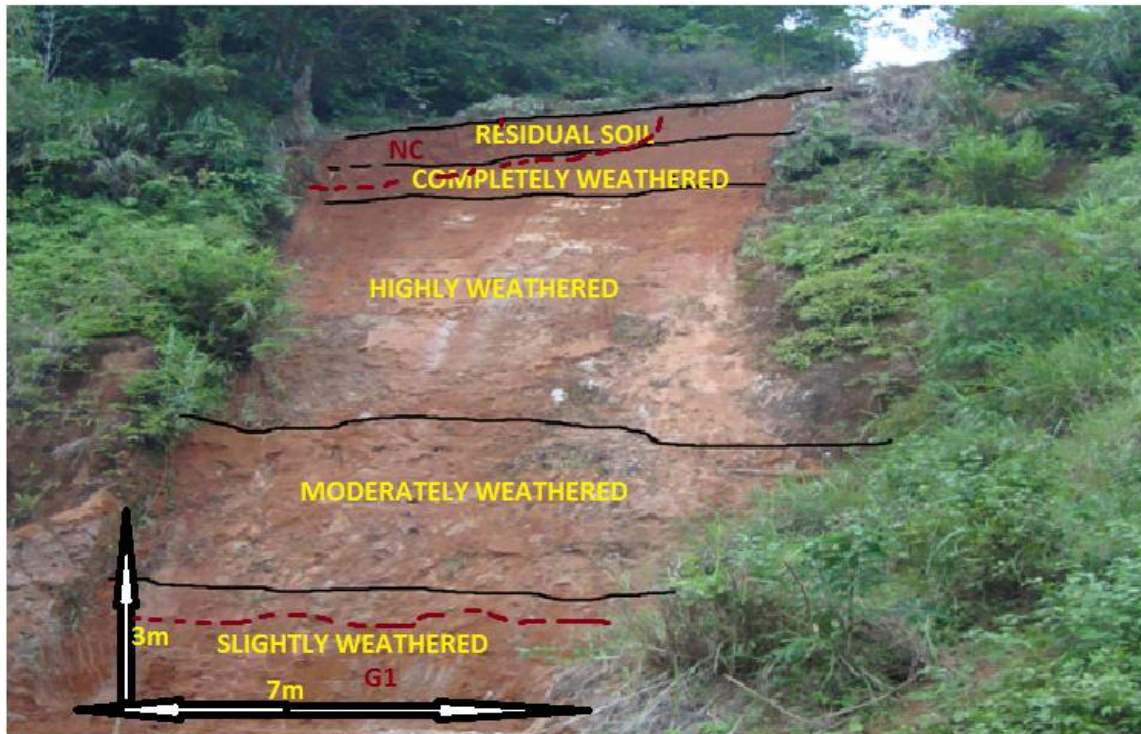
Figure 4.6: The different lithologies and degrees of weathering (see table 3.3) for the recent cut of Slope Y27 (Direction of view - 040°)

The rock mass of slope Y27 has two cut slopes excavated at different times; denoted recent and an old cut. The recent cut slope is five years old while the old cut slope is above twenty years old.

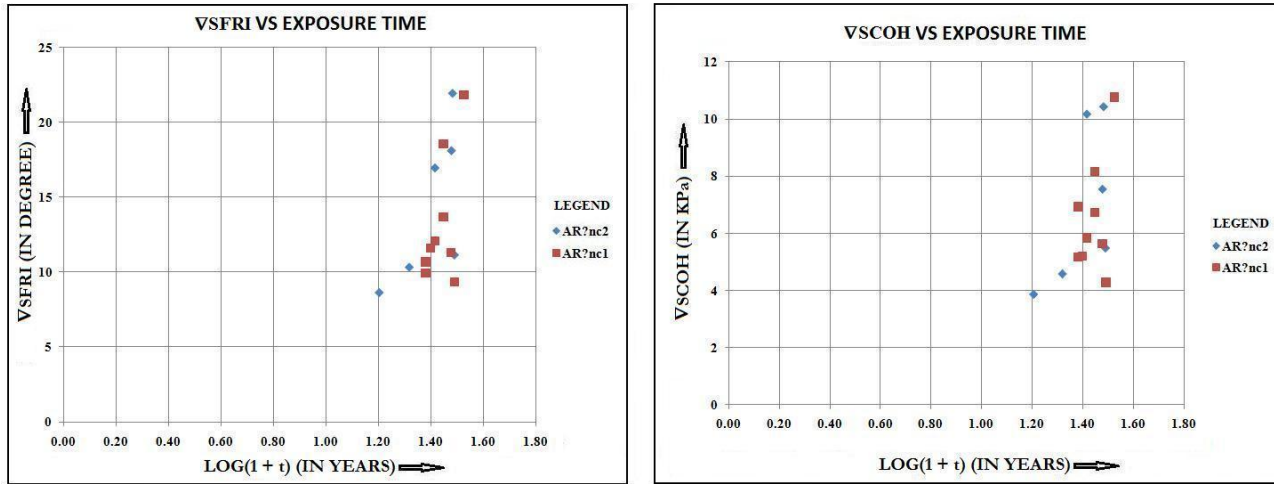
Figure 5.5: Change in cohesion and friction of slope rock mass (VSCOH and VSFRI) against logarithmic scale of exposure time (t) for the geological formations

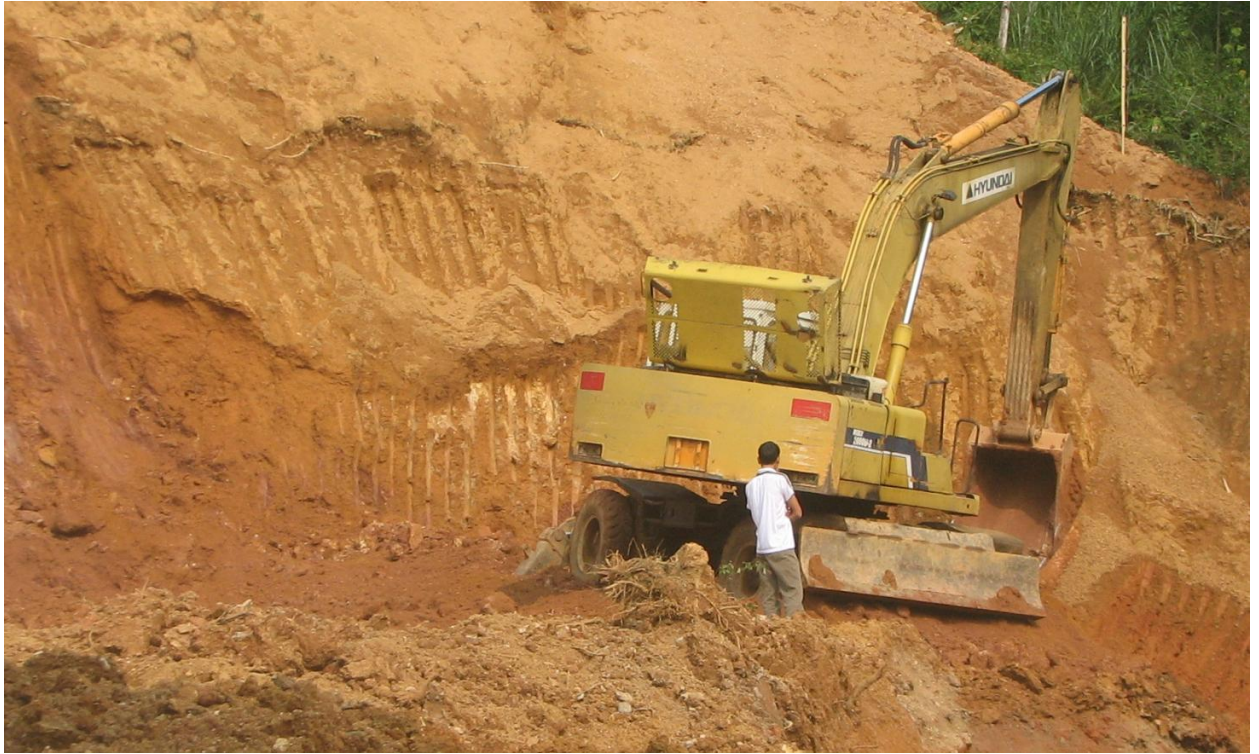
Figure 0.1: A typical excavator machine used for the cutting of slopes in the research area

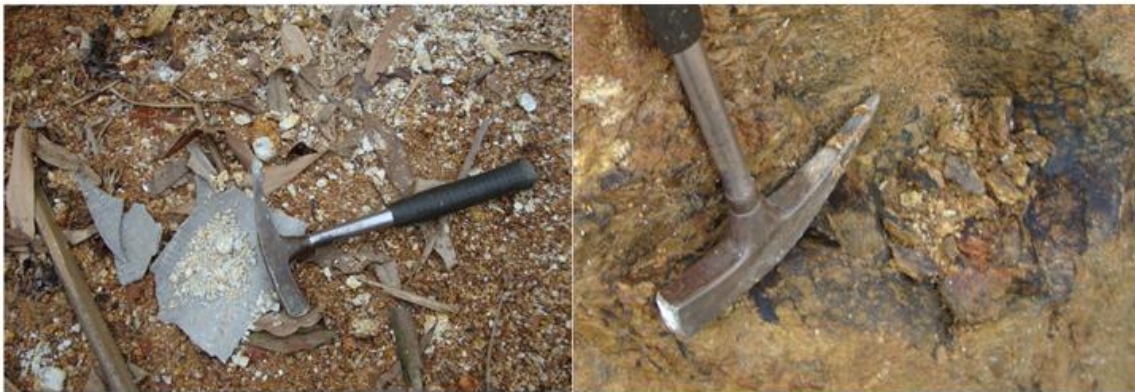
Figure 0.8: Small block size that has large Intact Rock Strength (IRS) from geotechnical unit(s) of Cut slope Y1

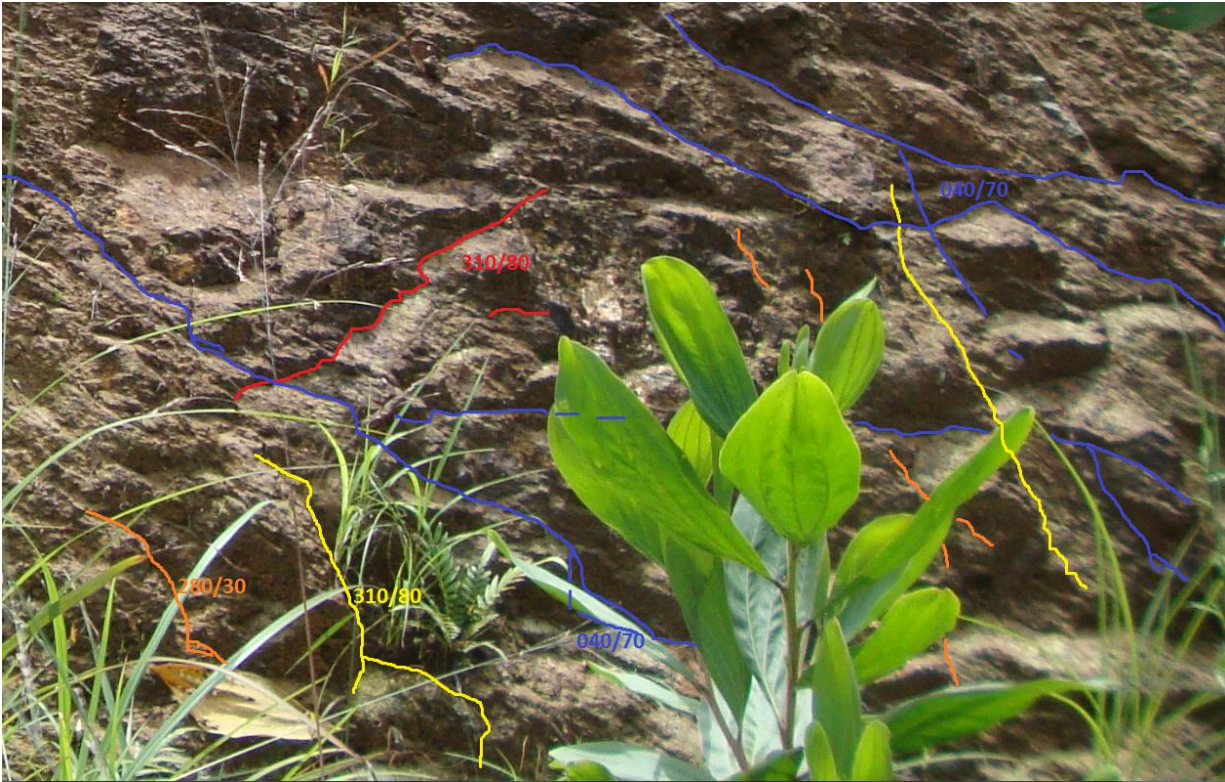
Figure 0.15: Discontinuities' orientation for the geotechnical units of medium part of Slope Y4

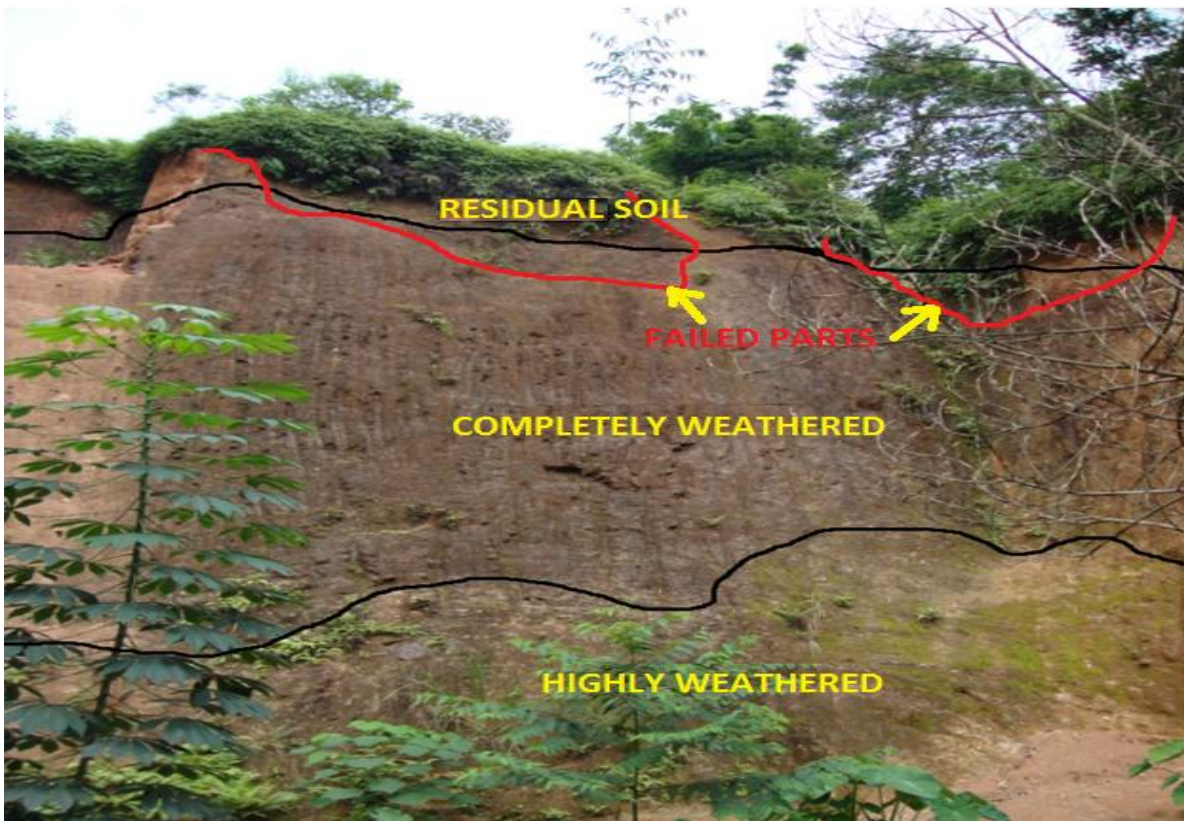
Figure 0.18: The different lithologies and degrees of weathering for the recent cut of Slope Y11 (Direction of view -  $330^{\circ}$ )

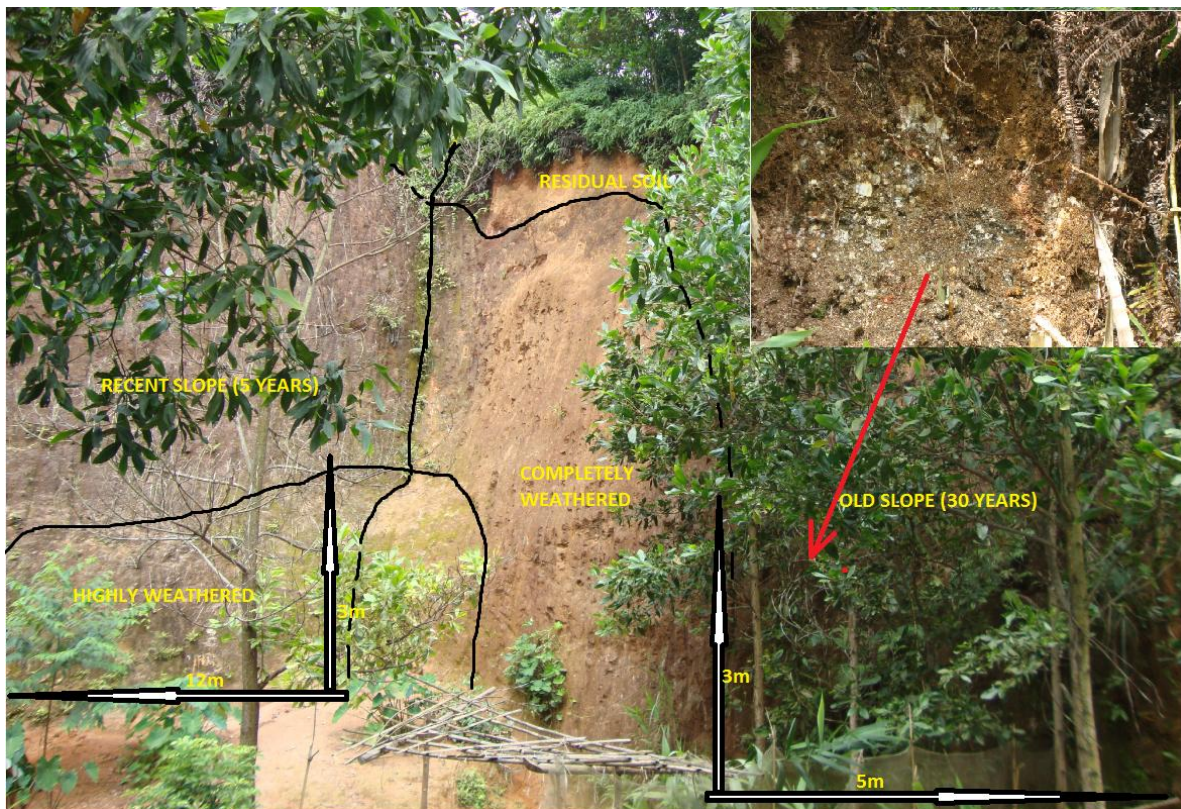
Figure 0.19: The different lithologies and degrees of weathering of Slope Y11 (Direction of view -  $330^{\circ}$ )

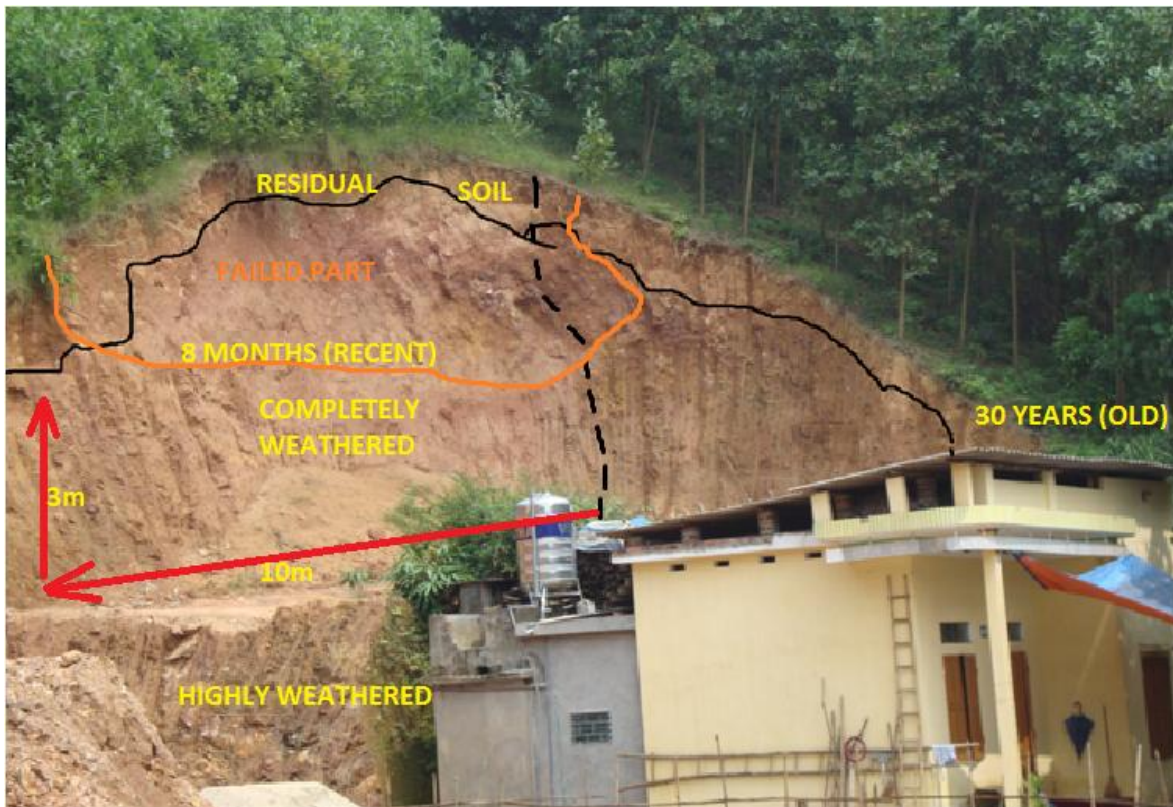
Figure 0.27: The different lithologies and degrees of weathering of Slope Y21 (Direction of view - 020°)

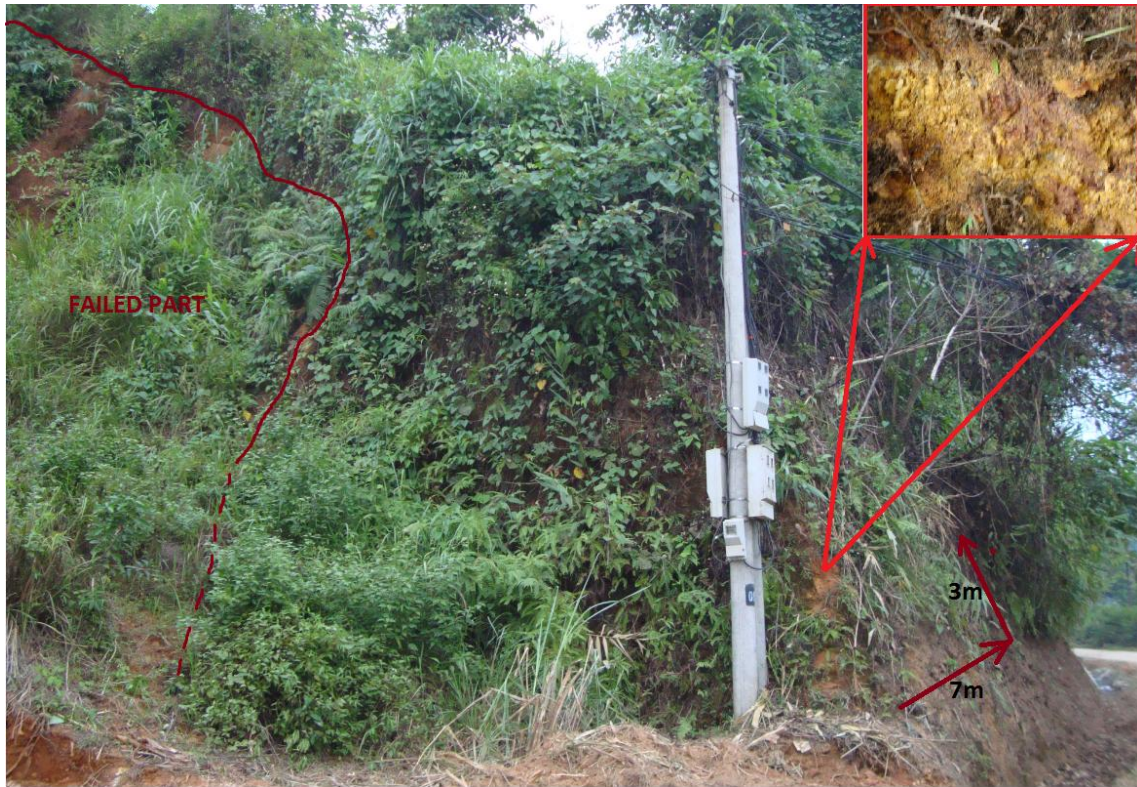
Figure 0.29: The old cut of Slope Y27 (Direction of view - 040°)

The old cut slope (fig. 0.29; appendix 1) is accessible with total mapped length of 7m. The parent formation materials, SDD, and SD angle are the same as the recent slope. The slope has large problem because it is unstable as shown by the slit (indicated at the left hand side in fig 0.29; appendix 1). The accessible (mapped) part of this slope (up to 3m) has one geotechnical unit – G2, which is divided into two sub-geotechnical units G21 and G22. G21 is crystalline mica-schist, which has its colour varying from reddish black to brown, while G22 is porphyritic granite with kaolinite clay, which has white colour. The slope face is covered with algae and ferns, which makes the characterization of the discontinuities impossible. Its SPA is 0.005m. It is assumed that the  $SDD_{disc}$ ,  $SD_{disc}$  and CD (except infill materials (lm), which is fine clay) of the unit are the same as the G1 geotechnical unit of the recent slope. The WE is highly weathered for both sub-geotechnical units.

The results show that part of cut slope Y27 is subjected to failure through sliding while the other cut slopes (i.e. Y6 and Y24) are not. This seems true as the photograph of the slope shows the slit (as indicated in fig. 0.29; appendix 1). Generally, it is expected that slope instability will occur in both cut slopes Y6 and Y24 through combination of IRS, SPA and CD since they are stable in sliding and toppling stability probability. While Y27 will be unstable due to sliding and combination of IRS, SPA and CD.

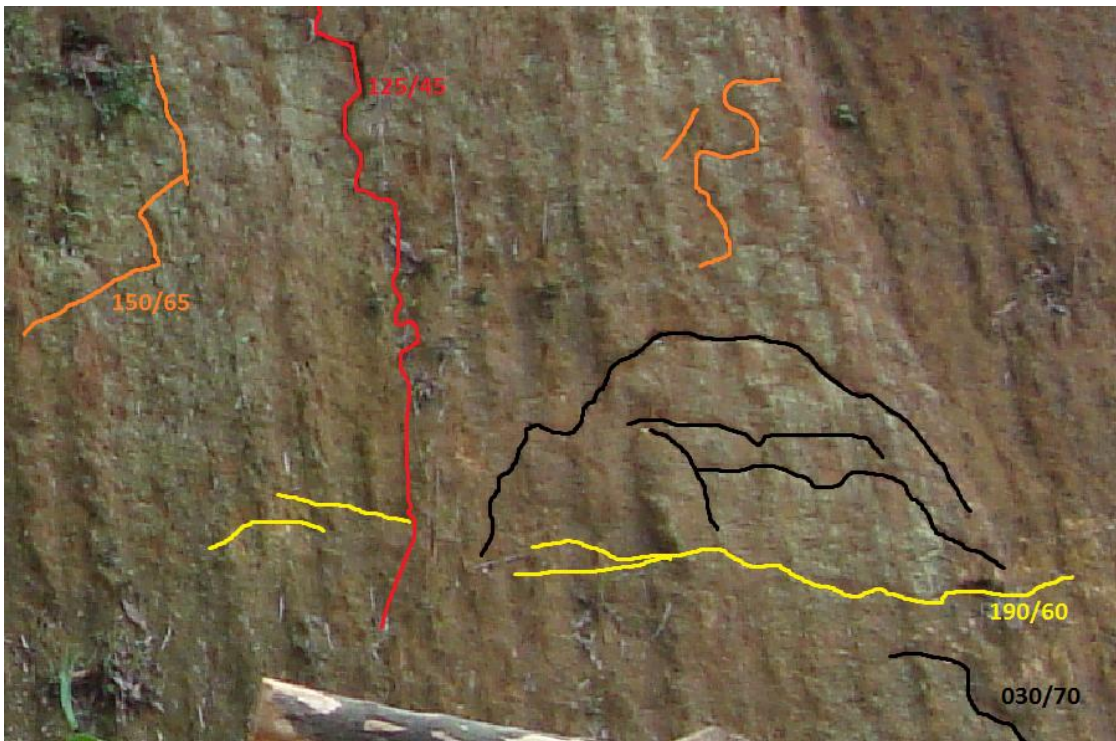
Figure 0.31: Discontinuities' orientation for the geotechnical units of Slope Y28

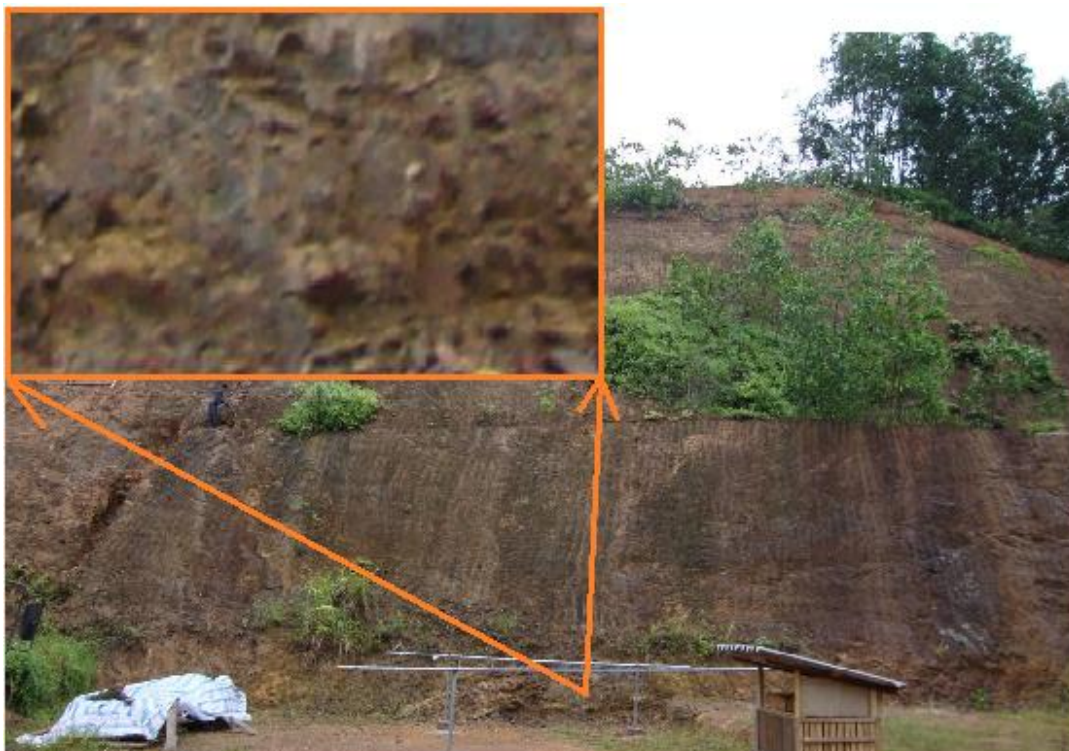
Figure 0.54: Typical slightly weathered rock materials from the research area - (cut slope Y2 – 22/09/2010 – 11.38hrs; scale – 1:8000) (Inset - scale – 1:3500)

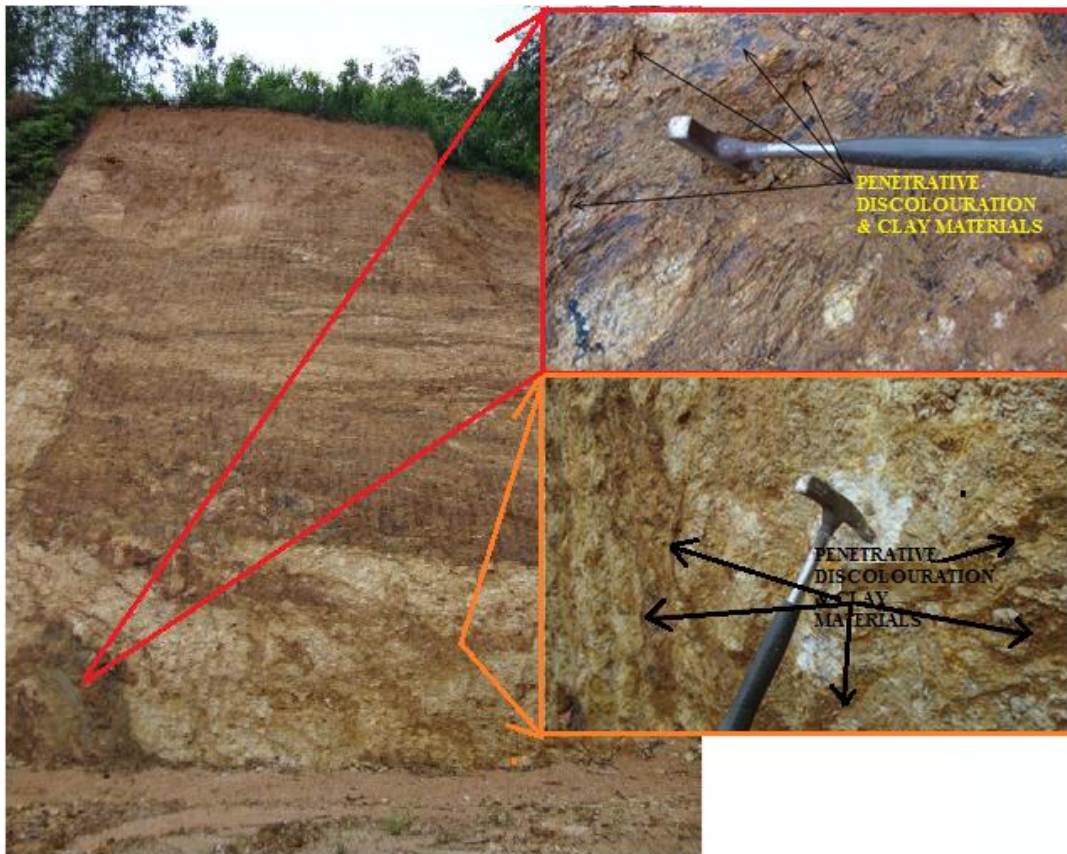
Figure 0.55: Typical moderately weathered rock materials from the research area - cut slope Y1 - 27/09/2010 - 10.00hrs; Scale - 1:6000)

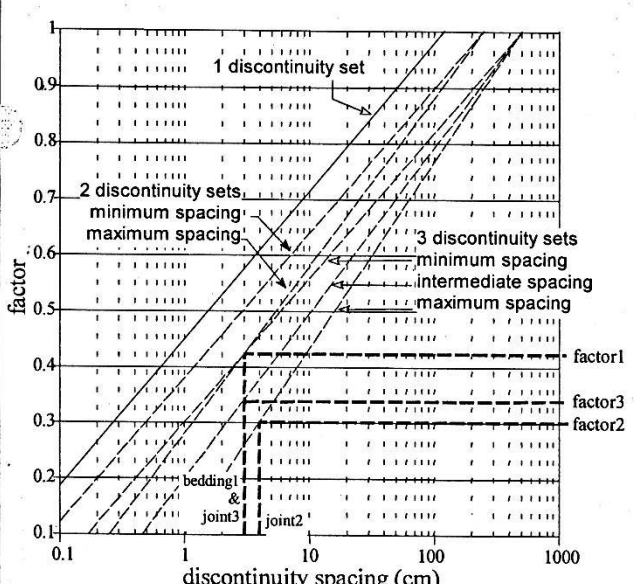
SPA (see figure below) = factor1 * factor2 * factor3 = 0.2 * 0.11 * 0.10 = 0.002 corrected for weathering and method of excavation: RSPA = SPA / (WE * ME) (with a maximum of 1.00) RSPA = 0.002 / (0.925 * 1.00) = 0.002
CONDITION OF DISCONTINUITIES (RTC & RCD)						
DISCONTINUITIES		1	2	3	4	5
Roughness large scale (Rl)		0.95	0.95	0.95		
Roughness small scale (Rs)		0.95	0.95	0.95
