CLASSIFICATION OF DAMAGED BUILDINGS IN AERIAL OBLIQUE IMAGES AND LASER SCANNING DATA

Enschede, The Netherlands, February, 2013

Thesis submitted to the Faculty of Geo-Information Science and Earth Observation of the University of Twente in partial fulfilment of the requirements for the degree of Master of Science in Geo-information Science and Earth Observation.

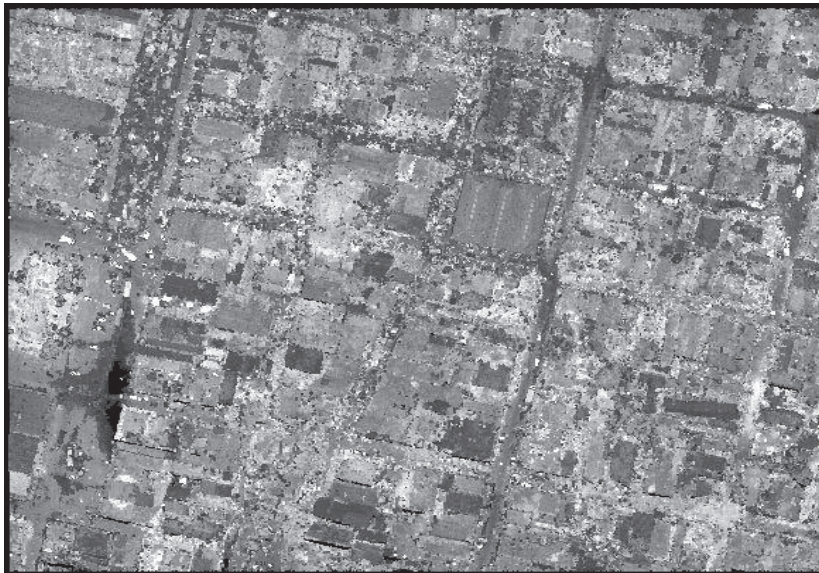
Figure 3-1. LiDAR point cloud visualized using reflectance.

This was acquired by Kucera International between January 21-27, 2010 using a Leica ALS50 LiDAR system. This was done as part of the damage assessment efforts during the evaluation of effects of the earthquake that hit Haiti on the 12th of January 2010. It has an average point density of about 3 points per square metre (3.4 pts/m²) (SDSC, 2012). This dataset contains intensity, specifically reflectance information which was acquired as a result of the LiDAR system in use that possessed the ability to record the return amplitude of the received echo. Specifically the dataset in use covers the north western part of the Port-au-Prince area. Figure below shows the dataset visualized using PCM software and portrayed by reflectance values.

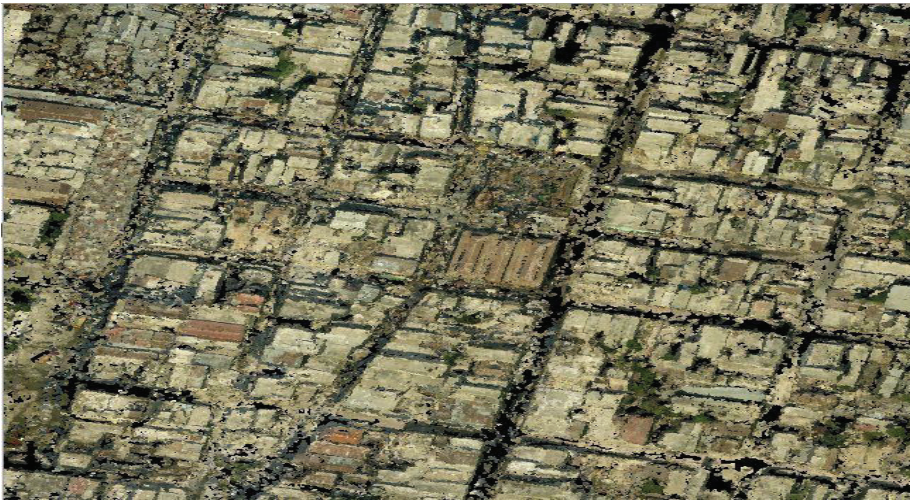
Figure 3-2. Aerial Oblique Photograph generated point cloud visualized using own colour.

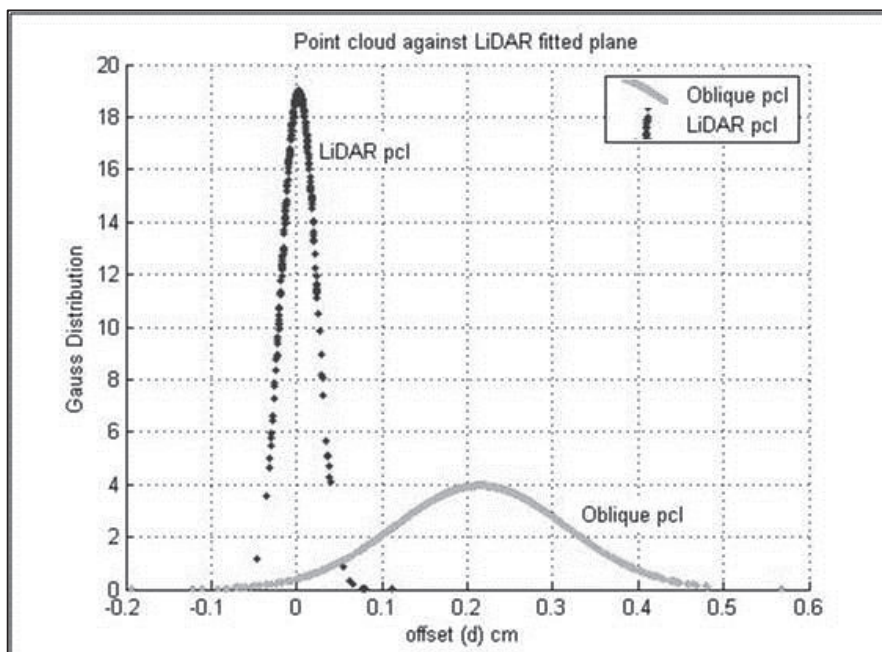
Figure 4-4. Gaussian distribution of offsets from LiDAR fit planes

Plots of the Gaussian distribution of the offsets were visualised as illustrated in figure 4-4 below. A key observation here was the sharp rise and narrow shape of the LiDAR point's offsets compared to the low and spread nature of the AOP point's offsets. This indicated closeness of the LiDAR points offsets to their mean as compared to the AOP point cloud, a pointer to lower noise levels in the LiDAR data compared to the AOP data.

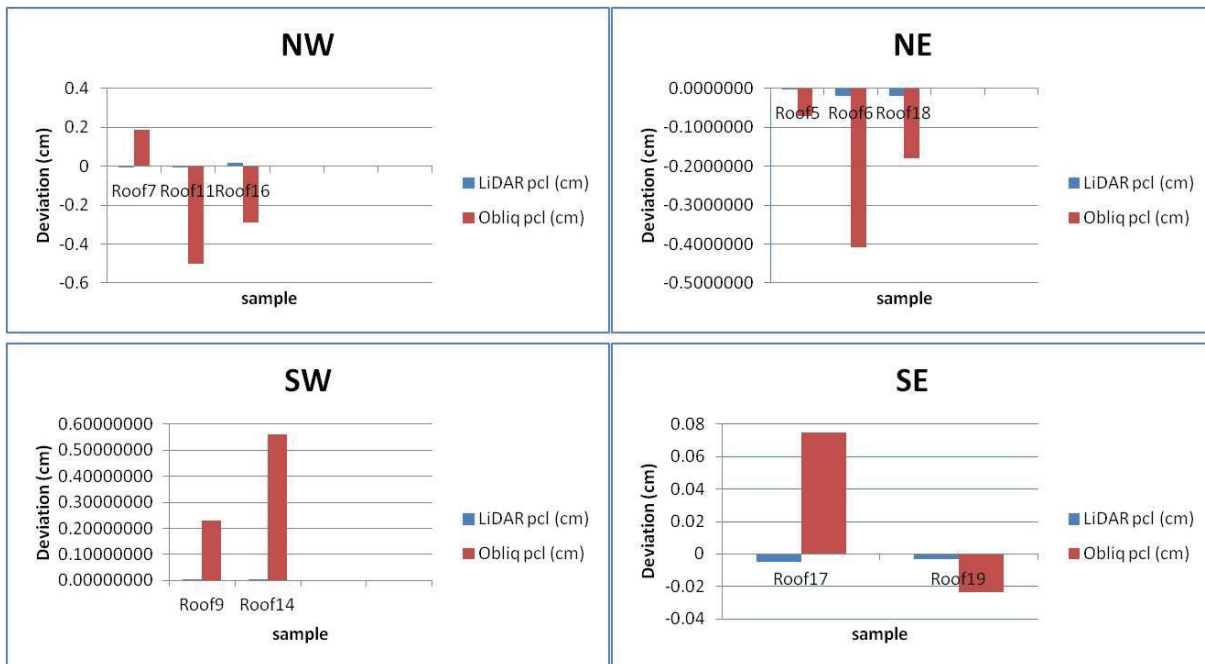
Figure 4-5. General Datasets offsets across the representative area.

A general dataset analysis was carried out by comparing the mean offsets across the samples from various locations. This was due to the urge to detect the presence of any specific systematic tilt or site wide shift between the two datasets. The site of interest was divided into four regions; North West, North East, South West and South East from which the departures values from each region were plotted together and compared. As illustrated in figure 4-5 below, the offsets were found to have random variations with no tendency of being skewed in any direction.

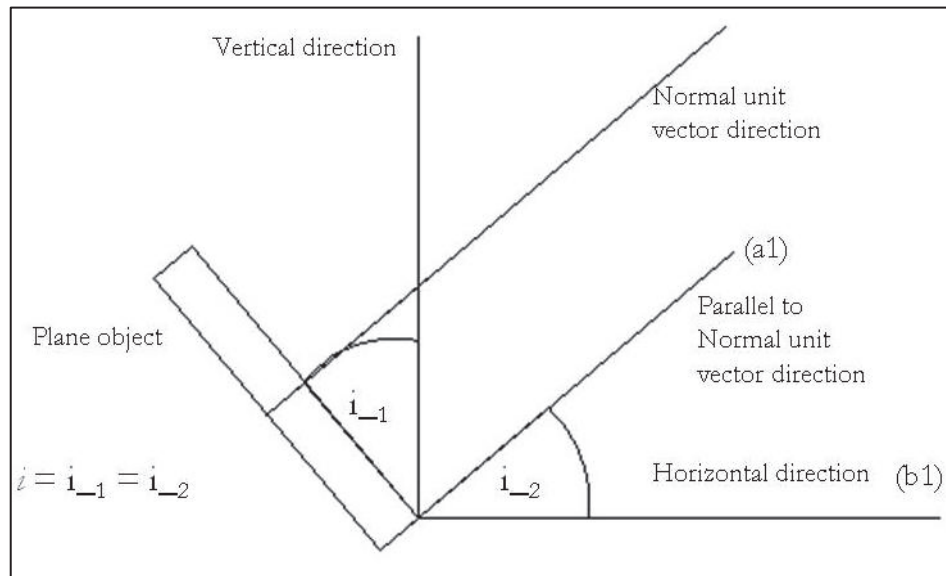
Figure 4-6. inclination angle based on normal unit vector

$\widehat{b1} = aX + bY + cZ$ is the normal unit vector of the plane.

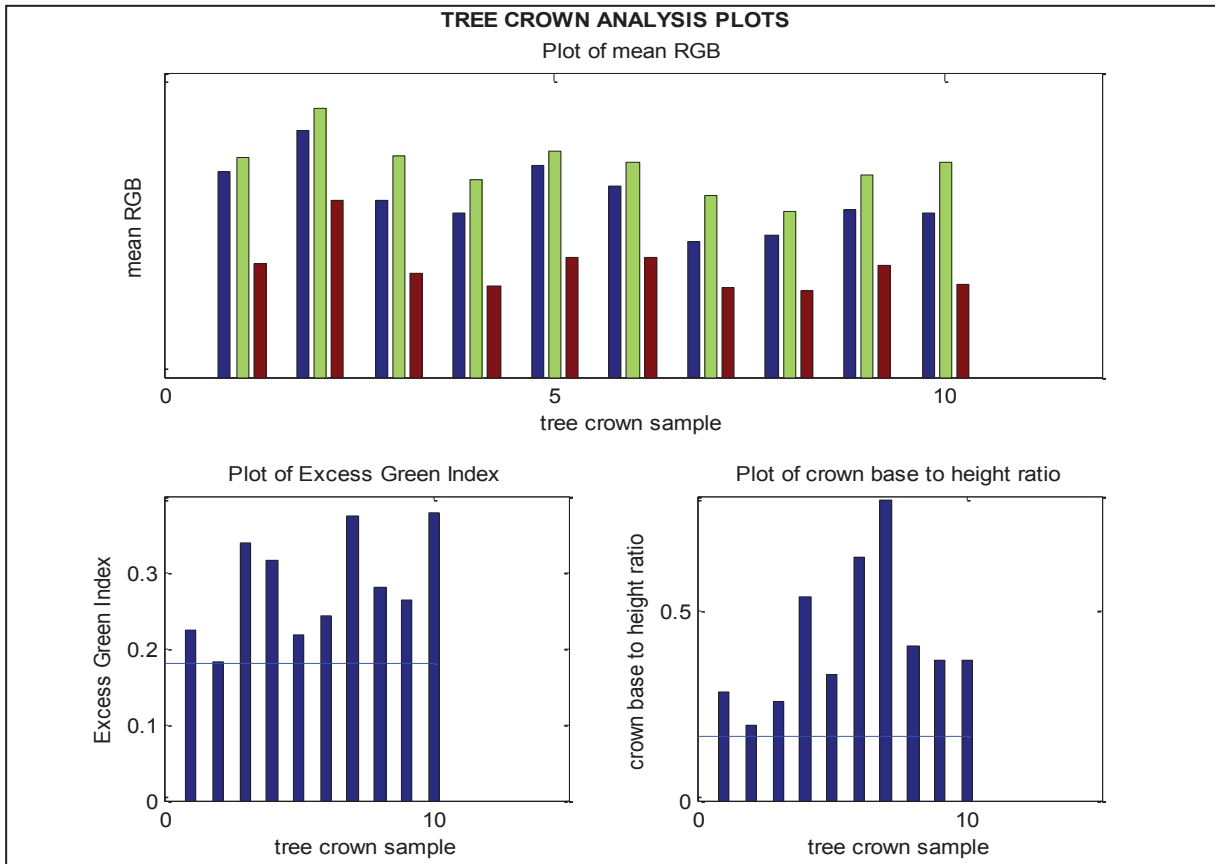
Figure 4-12. Sample tree crown features

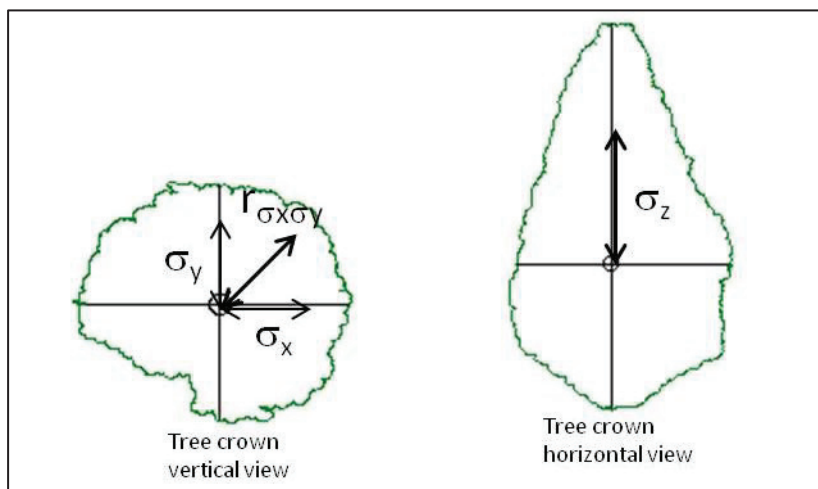
Figure 4-13. Tree crown form

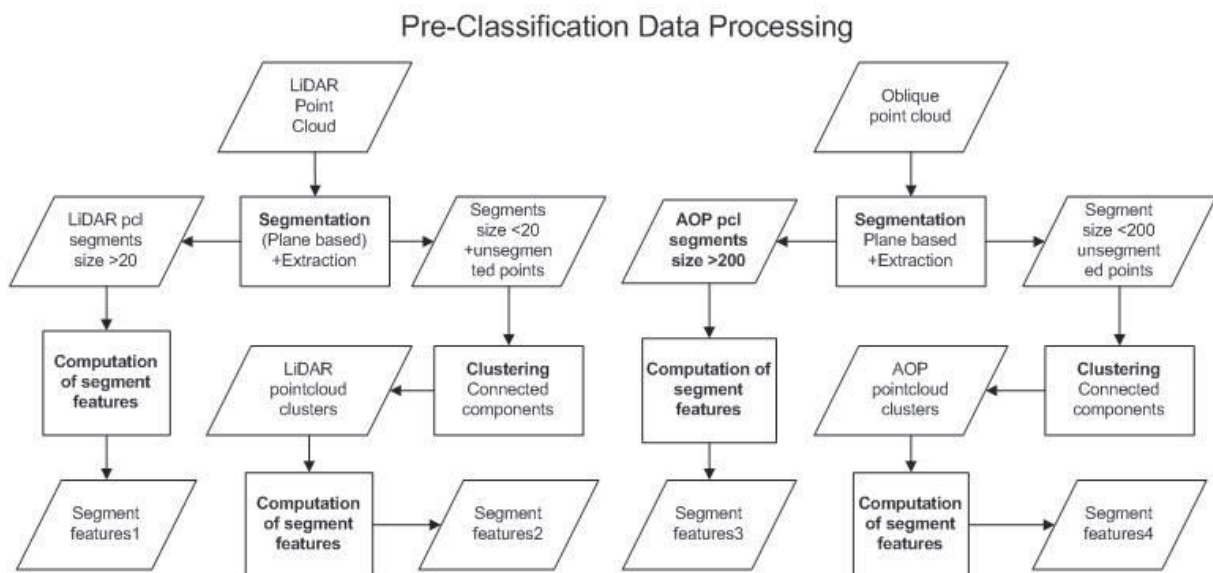
Figure 5-2. Pre-classification data processing

Point cloud in its raw form contains both useful and non useful information depending on the project at hand. This research focussed on buildings and related objects within their environment. Input point cloud data had to be structured into desired forms, from which target objects would be extracted. The process involved segmentation and clustering of the point cloud datasets, extracting plane and cluster segment features, and computation of extracted segment features as illustrated in figure 5-2. Despite the process being the same for both datasets, different settings were applied for each dataset due to the varying densities and noise levels for the two input point cloud datasets.

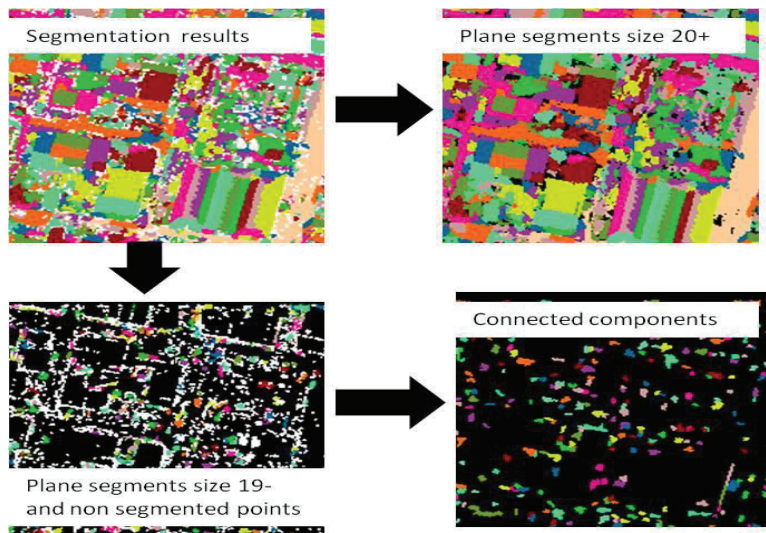
Figure 5-3. LiDAR point cloud segmentation and clustering

The products of the processes segmentation and clustering are illustrated in figure 5-3 below.

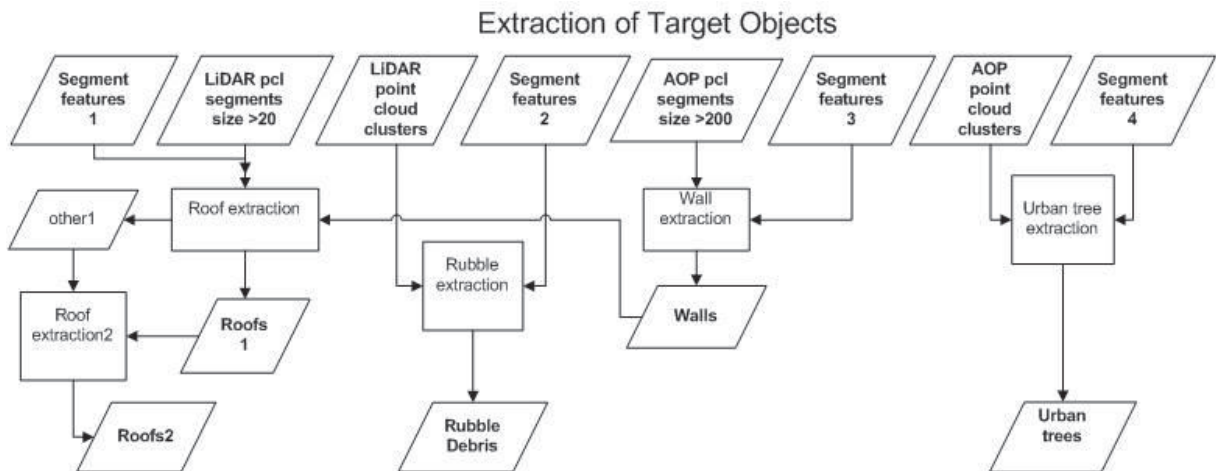
Figure 5-4. Extraction of target objects.

The main target objects of interest were the walls, roofs, rubble and urban trees (vegetation). Based on their natural status, the characteristics of the objects of interest were defined and used for extraction of the objects of interest. For the walls being planar in nature, their defining characteristics came from the results of plane fitting residual analysis and related components. Extraction followed a similar bottom up approach first walls, then roofs as in the normal building structural construction process. Further, following the content and form of the respective segments; Walls and roofs were extracted from Oblique and LiDAR plane segments respectively, while vegetation was extracted from Oblique connected component cluster segments while rubble was extracted from both LiDAR connected component cluster segments. The process is illustrated in figure 5-4 below.

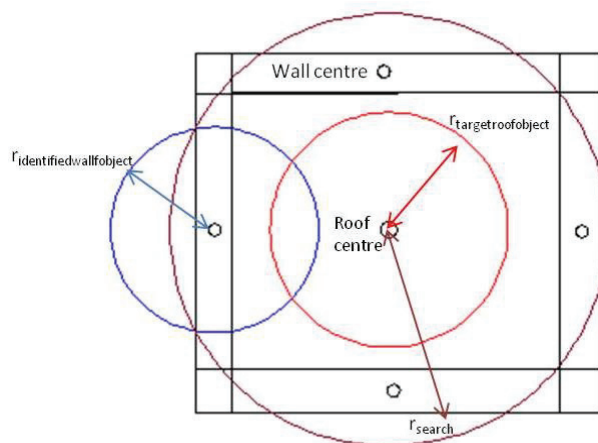
Figure 5-5. Roof identification based on existing walls

The First set of roofs was extracted based on their minimum height above minimum height surrounding walls. They had to be at least 2m above minimum height of surrounding walls. Given the point cloud segments had a normal distribution then their standard deviation showed their spread typically covering about 70% of the points as shown in the Gaussian plot (section 4.3). This was used to define the search radius between walls and adjacent roofs. Combining the standard distance defined by the horizontal (planar) standard deviation of any particular roof and surrounding walls, a search radius was defined. This was a modification of the standard distance defined for spatial analysis as the total length obtained by the square root of the sum of squared standard deviation in X and Y directions for features or points around their statistical mean. Given the segments were composed of points, this helped in linking roofs to adjacent walls using their centres (point defined by mean X and mean Y of each segment) as illustrated in figure 5-5 below.

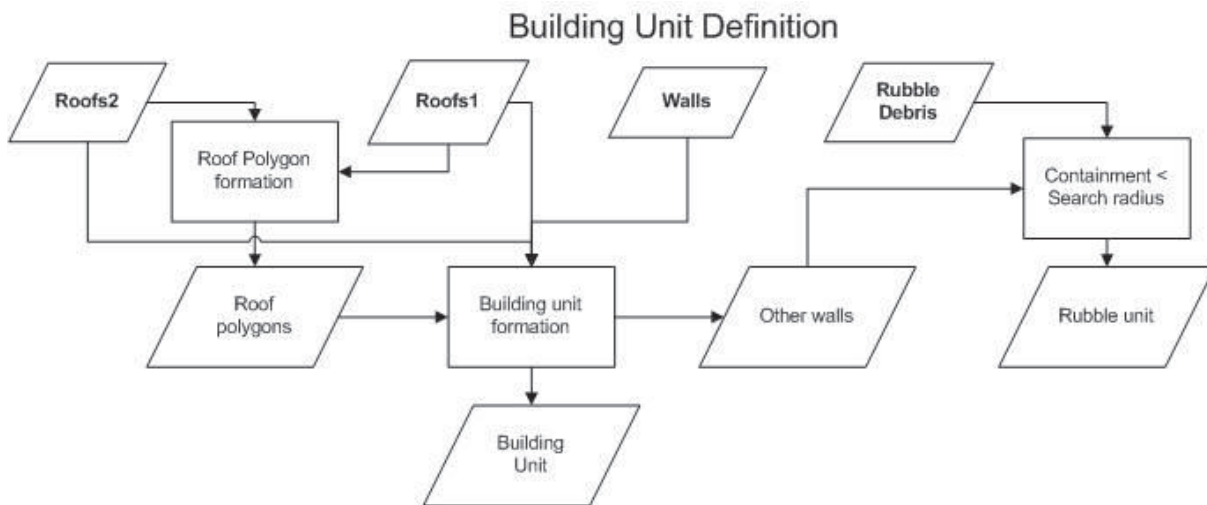
Figure 5-7. Defining building units

The second consideration of building units were rubble clusters. This was especially so in cases of collapsed roofs thus rubble clusters form on top of storey buildings with two or more floors. The main link was the search radius defined as the combined standard distance of the rubble cluster and surrounding walls. The process of defining building units is illustrated in figure 5-7 below.

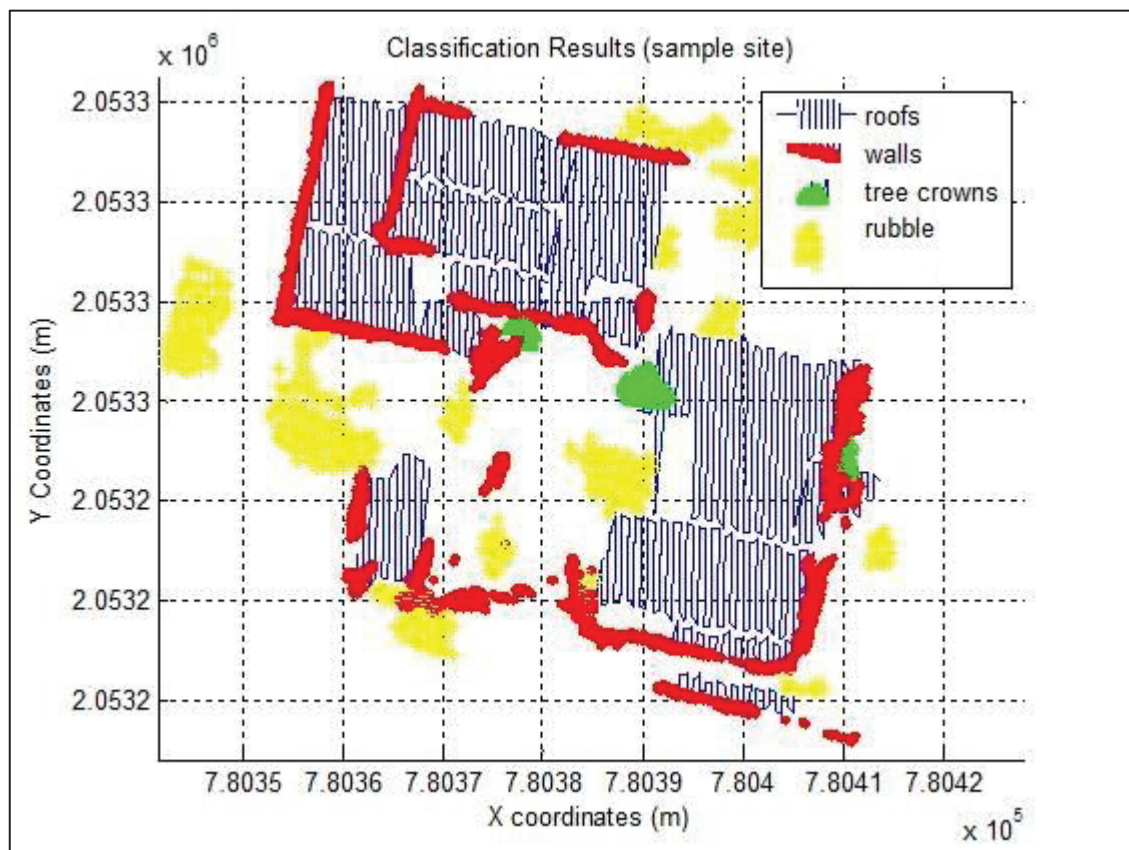
Figure 6-1. Sample site classification results

Illustrated below in Figure 6-1 is part of the results of the extracted objects of interest. The objects are differentiated by colour and pattern for ease of identification. Roofs are blue lines, Walls are Red, Urban tree crowns are green and Rubble is in yellow. The scenario depicts what is repeated throughout the study site, where walls are generally located around the edges of roofs. Tree crowns are located in areas of limited space next to buildings. Rubble (bright broken concrete pieces) are located in areas around partly or fully collapsed building structures.

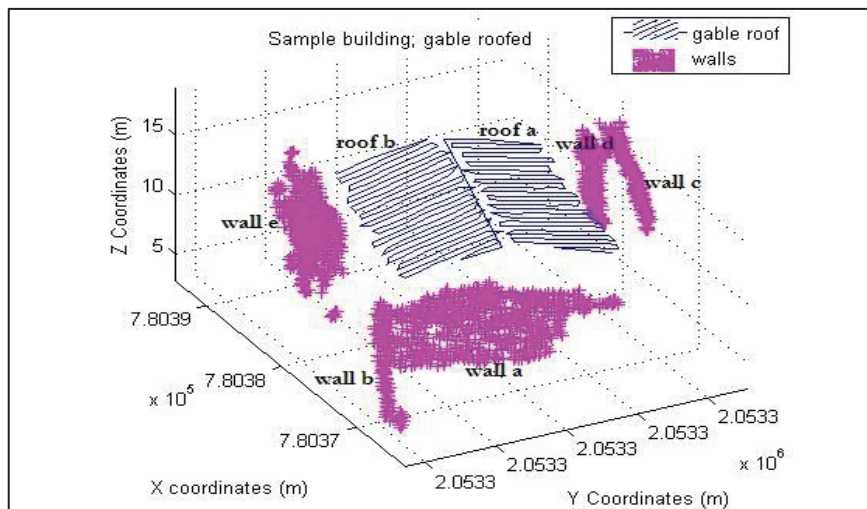
Figure 6-3. sample gable roofed building

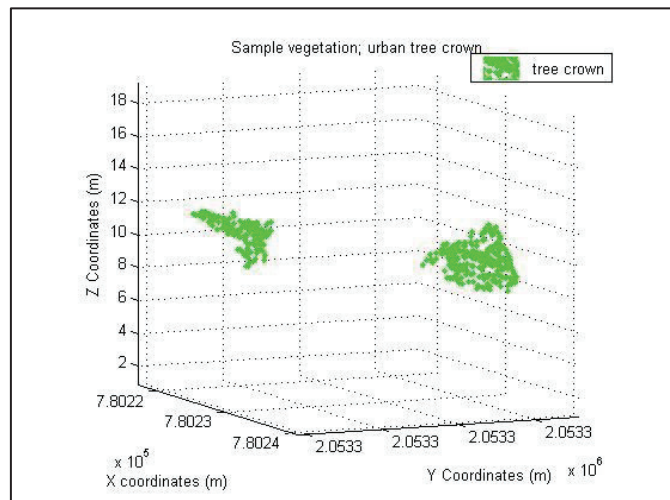
Figure 6-4. Sample Urban tree crowns

Urban tree crown consist of non planar cluster of points dominated by the green colouration as illustrated in figure 6-4. The main features used in their detection are colour information (mean RGB), standard deviation in x, y and z, and segment size. Derived features based on these and found useful were the excess green index and the tree crown base to height ratio as presented in table 6-3.

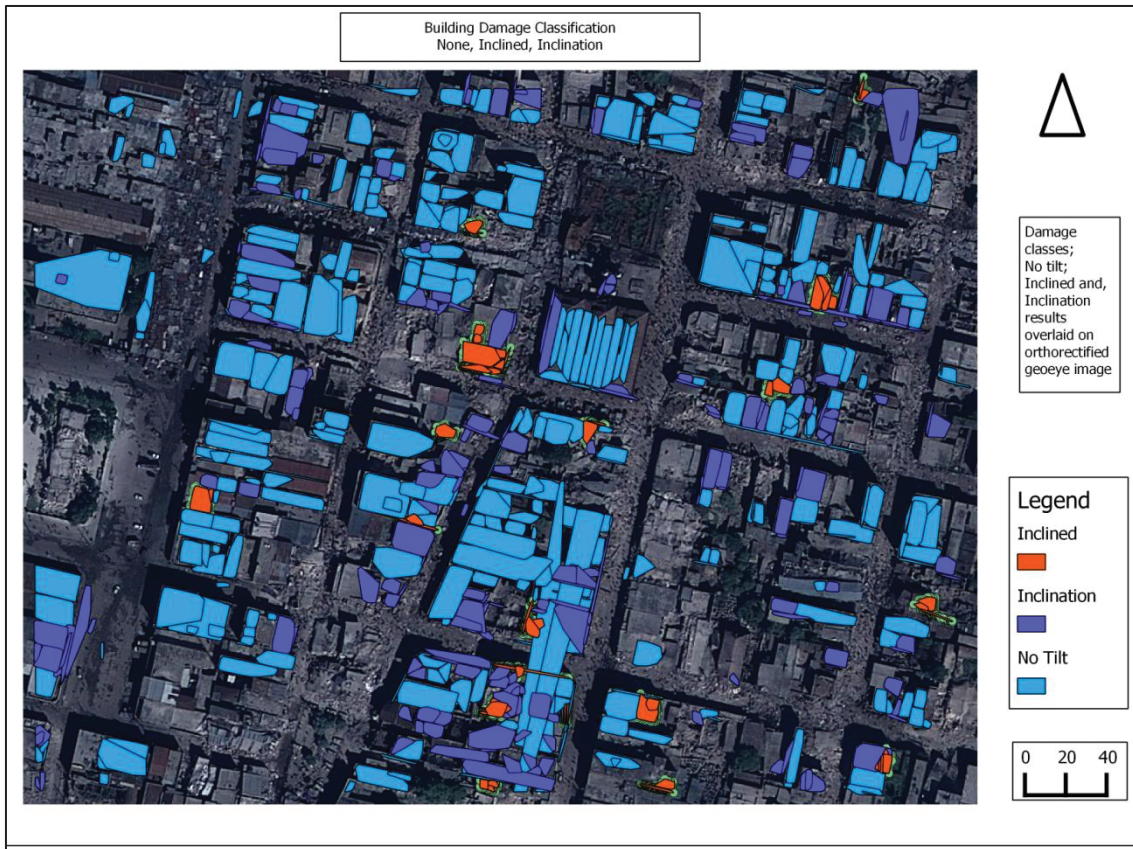
Figure 6-7. No Tilt, Inclined and Inclination damage classes

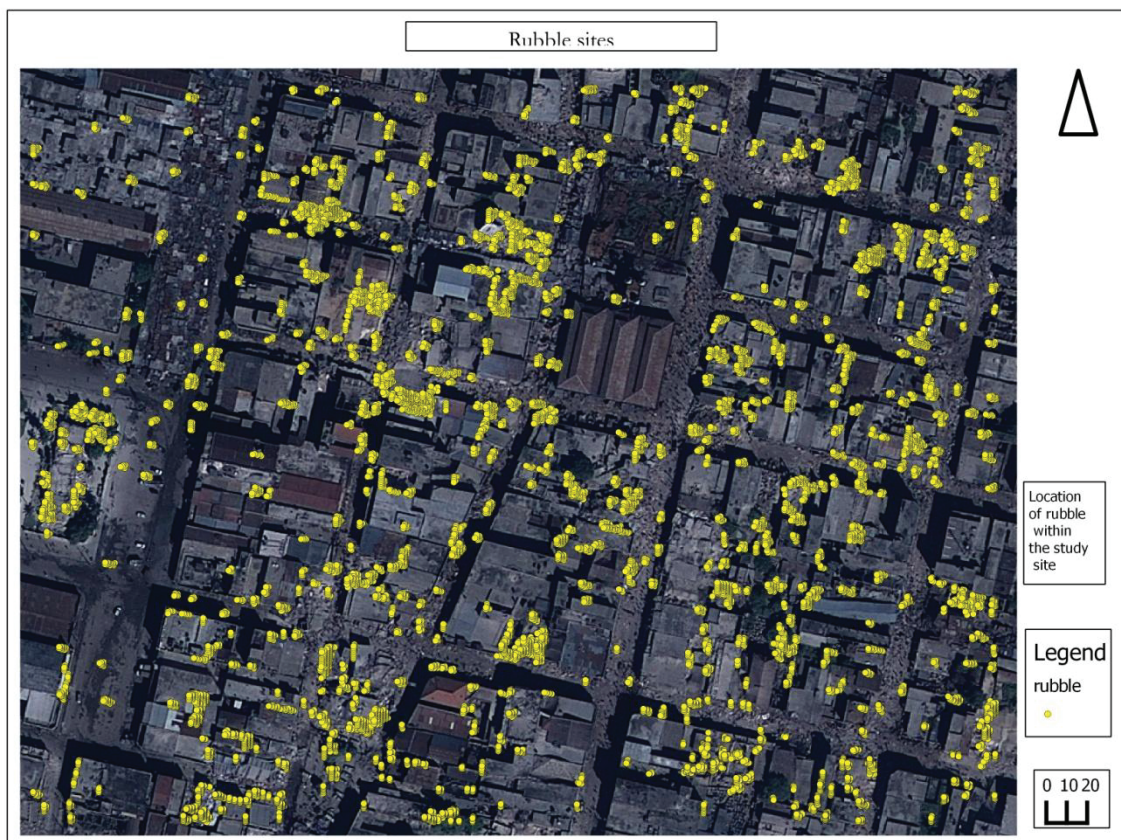
Figure 6-8. Rubble /Debris sites

Heap of Debris taken as rubble was identified as illustrated in figure 6-8. The key consideration was segment size and reflectance value, given the high presence of sand component on collapsed building material. From the figure it is quite clear that not all heap of debris was identified given the definition of rubble applied in this research (sections 4.3.3 and 5.3.3).

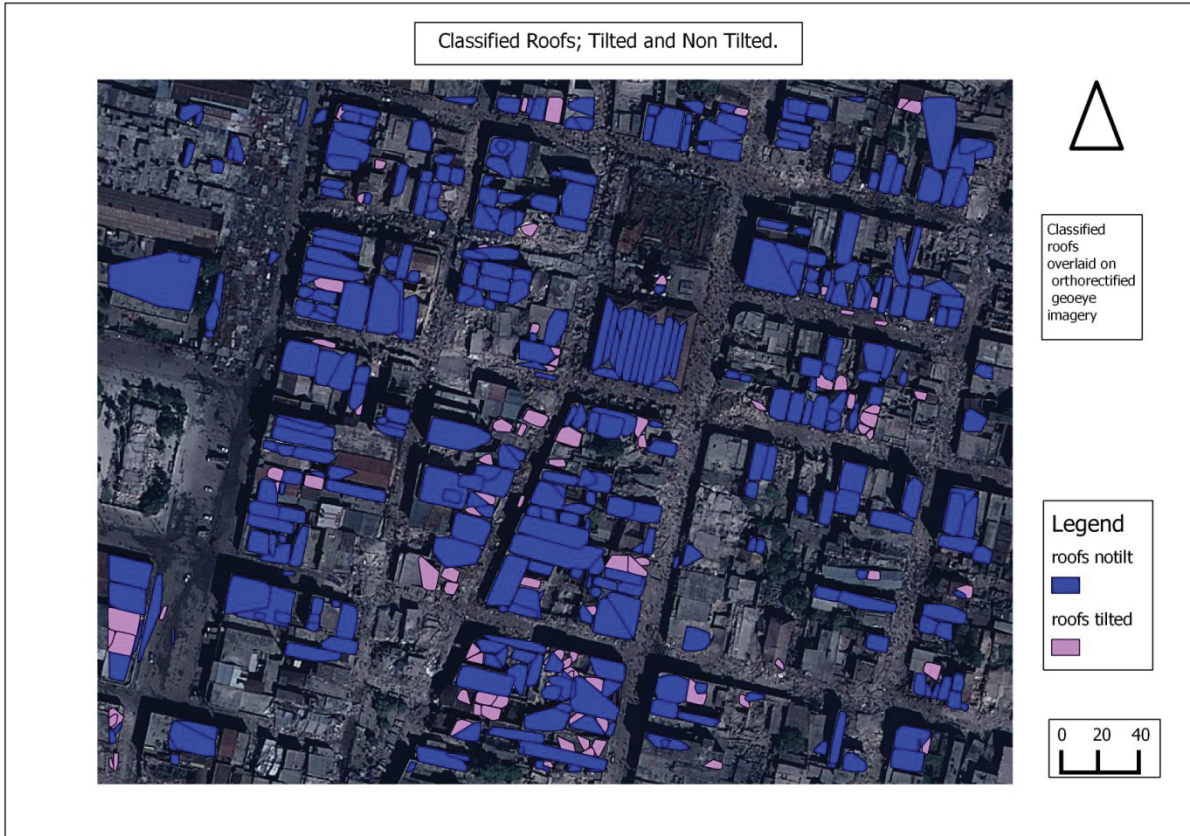
Figure 6-9. Roofs, Tilted and Non Tilted

Roofs were further classified into tilted and non tilted roofs as illustrated in figure 6-9. Consideration was given to presence or absence of horizontal slope along the main edges of flat roofs, and the upper and lower edges of gable roofs. From the figure it is quite evident that a few roofs are actually tilted, however the situation may vary on the ground.
