# **INFLUENCE OF WEATHERING AND STRESS RELIEF ON GEOTECHNICAL PROPERTIES OF ROADCUT MASS AND EMBANKMENT FILL ON ST. VINCENT AND ST. LUCIA**

Enschede, The Netherlands, March, 2015.

Thesis submitted to the Faculty of Geo-Information Science and  
Earth Observation of the University of Twente in partial fulfilment of the  
requirements for the degree of Master of Science in Geo-information  
Science and Earth Observation.

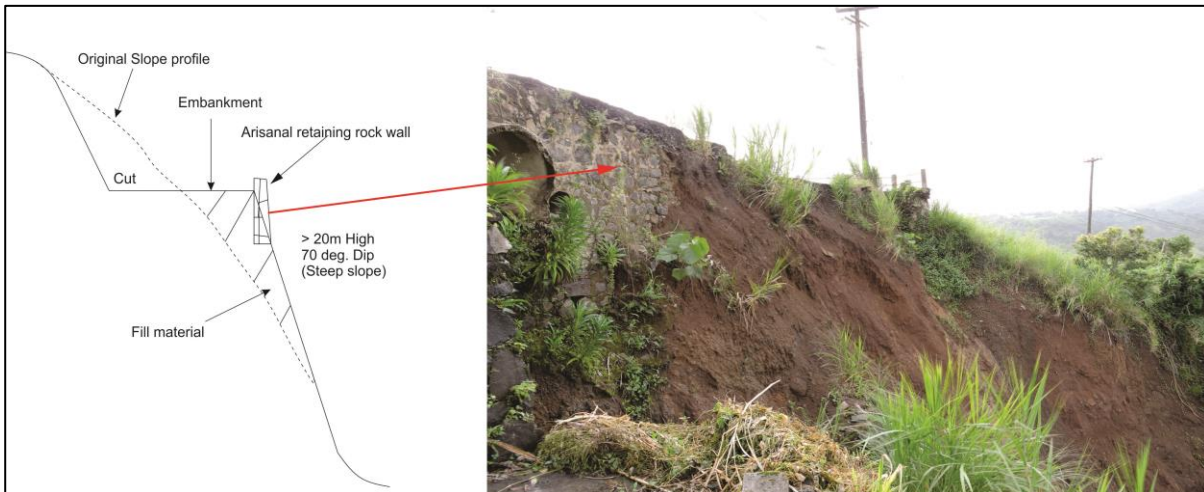
Figure 28: Belmont embankment showing the retaining rock wall (St Vincent).

From table 9, chapter 6.2.2.2, it can be seen that increasing the factor of safety from 0.9 to 1.5 and then 2.0 leads to a decline in cohesion and friction angle developed along the shear plane, and the allowable height. The critical height, which is the maximum height at which the critical equilibrium occurs in the embankment slope, is 29.8 meters, and it is calculated based on the effective cohesion and internal friction angle. A factor of safety 0.9 for the embankment is assumed to have failed, since the calculated allowable height is above the critical height. At this height, the calculated cohesion is less than the estimate value, while the angle of internal friction is slightly higher than the estimate value. This scenario results into a definite failure since the allowable value of height is also higher than the critical value. The acceptable design factor of safety 1.5 gives the maximum allowable height of 18.8 meters. At this height, the slope is expected to be stable. The factor of safety 2 at which the embankment slope would be very stable gives the lowest allowable height of 9.3 meters. The embankment was constructed at a height of about 25 meters well above the calculated maximum critical and allowable height of failure. The material was probably held in place by the artisanal retaining wall built on the fill material repose slope surface (Figure 28). This assertion is evident from the wall's remains still hanging on the embankment slope face, and the nearby intact embankment roads.
