Rural Risk Assessment due to Flooding and Riverbank Erosion in Majuli, Assam, India

Thesis submitted to the Faculty of Geo-Information Science and Earth Observation of the University of Twente in partial fulfilment of the requirements for the degree of Master of Science in Geo-information Science and Earth Observation.

Specialization: Natural Hazards and Disaster Risk Management

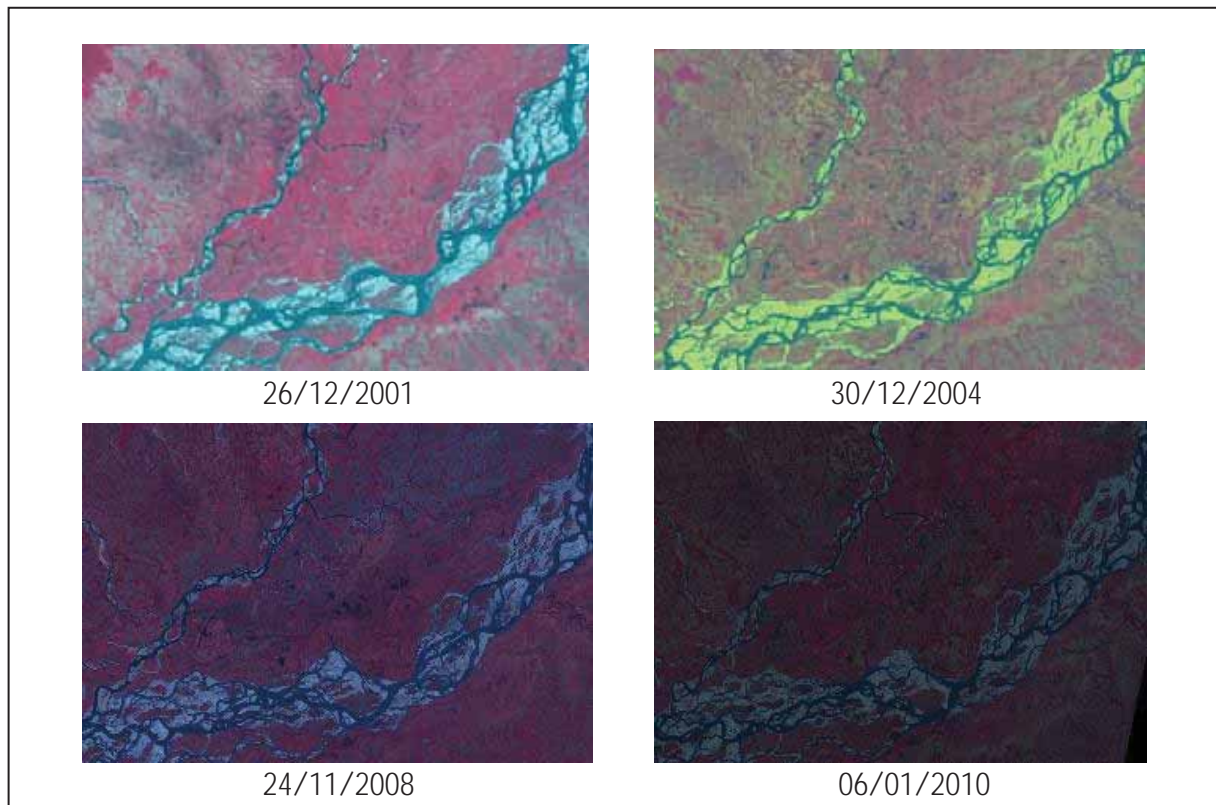
The Linear Imaging Self Scanning Sensor (LISS) is an optical multi-spectral sensor that operates in four spectral bands; three are in the visible and near infra-red region and one in the short wave infra-red (SWIR) region. For the present study, IRS 1D and IRS P6 LISS-III imageries of 26/12/2001, 30/12/2004, 24/11/2008 and 06/01/2010 (Figure 4.1) having a spatial resolution of 23.5 m were used to extract the area of Majuli at different time periods and also to delineate the river bank lines over 2001 to 2010 thereby identifying the channel planform change during that period.

Figure 4.1: LISS-III imageries of the Study Area

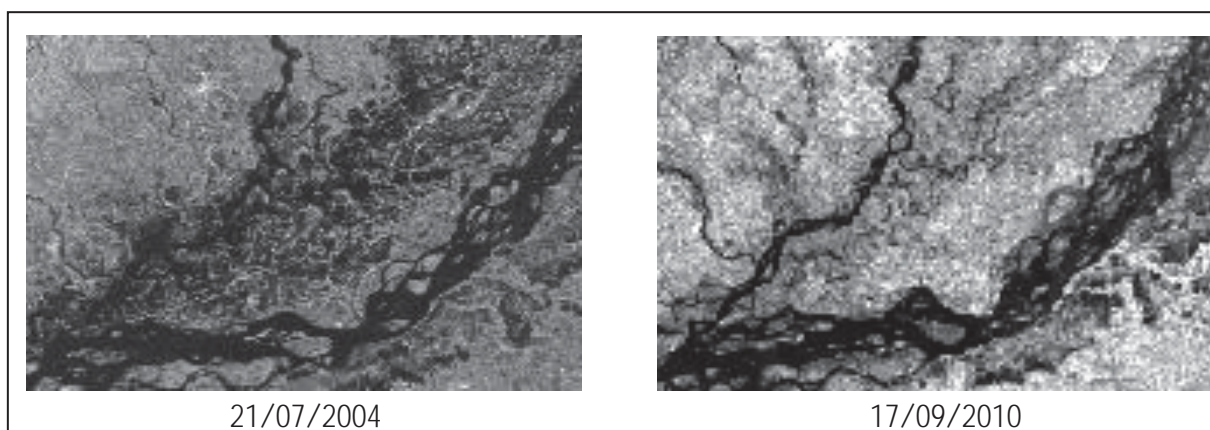
Radarsat-1 is a microwave satellite launched by the Canadian Space Agency in November, 1995 that uses SAR (Synthetic Aperture Radar) sensor. Being active in nature, SAR sensors are very effective in flood studies due to their all weather capabilities as during monsoon season optical images in most of the flood-prone areas are not useful due to high cloud cover. Therefore, to extract the flood inundation areas in the present study, Radarsat-1 imageries, operated in the C-band (ScanSAR Wide mode), with a spatial resolution of 50 m were used for the dates 21st July, 2004 and 17th September, 2010 (Figure 4.2).

Figure 4.2: Radarsat-1 imageries of the Study Area

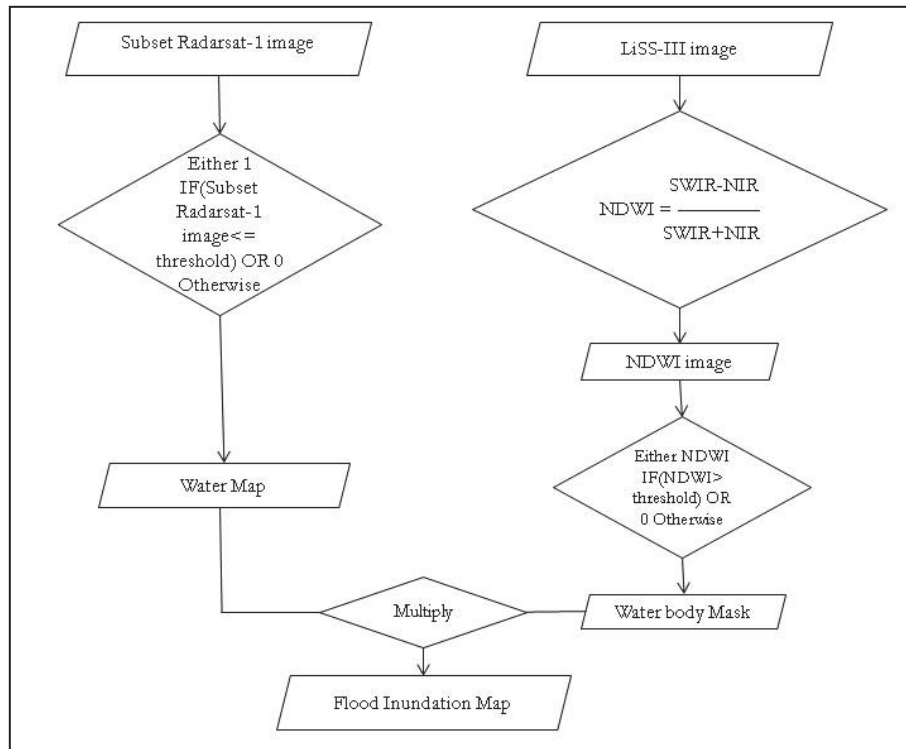
The following algorithm (Figure 4.5) was used in Erdas Modeler to extract the flood inundation areas of Majuli in the two flood events i.e. 2004 and 2010 (IIRS, 2012).

Figure 4.5: Algorithm used in Erdas Image to extract the flood inundated areas

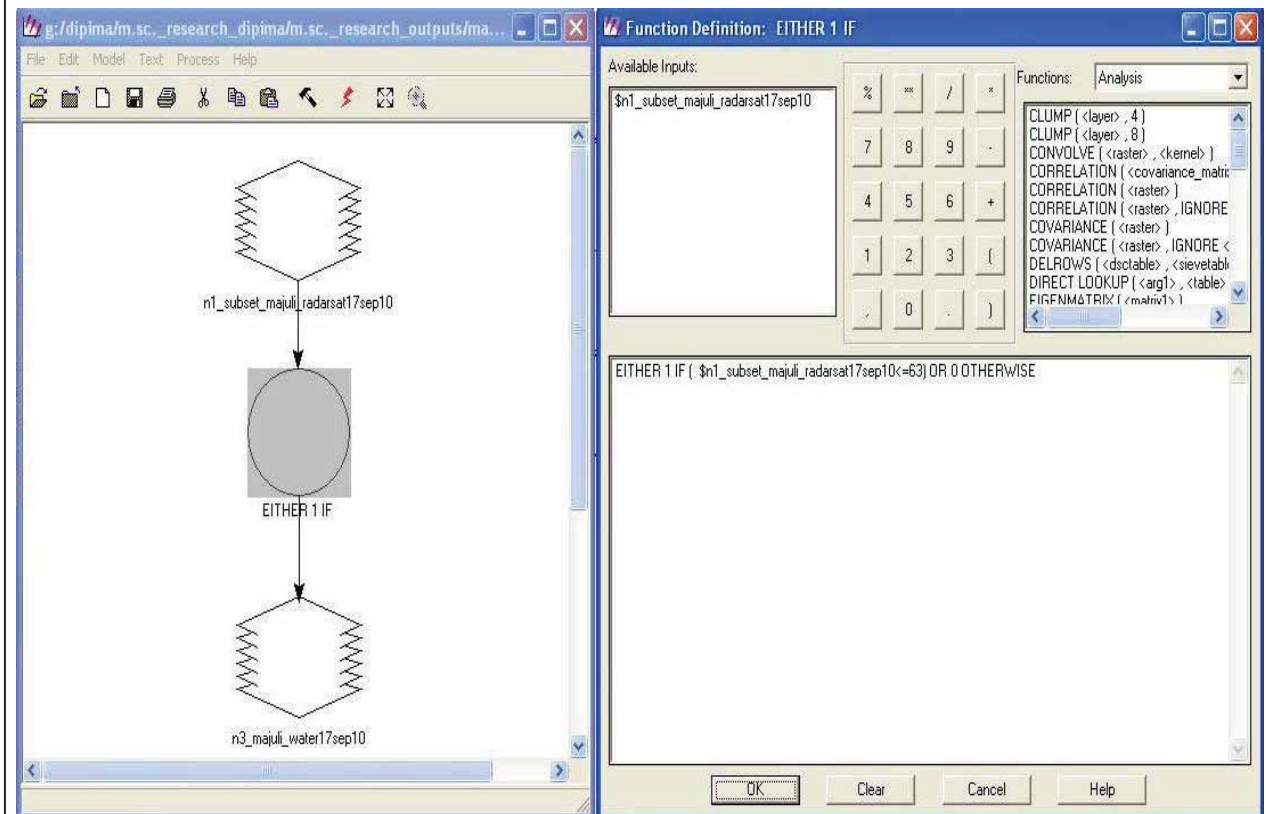
The Radarsat-1 imageries were reprojected to the co-ordinate system same as of the LISS-III imageries and subset to the extent of the study area. Then the DB values for land and water were observed for both the imageries and a threshold value of 49 was set for 2004 imagery and that of

63 was set for 2010 to extract the water pixels. The models used to extract the water pixels for the two years are shown in the following figures (Figure 4.8 a. and b.). The output data type was set as 'unsigned 1 bit'.

Figure 4.8: Model used in Erdas Modeler to extract the water pixels from the Radarsat-1 imagery

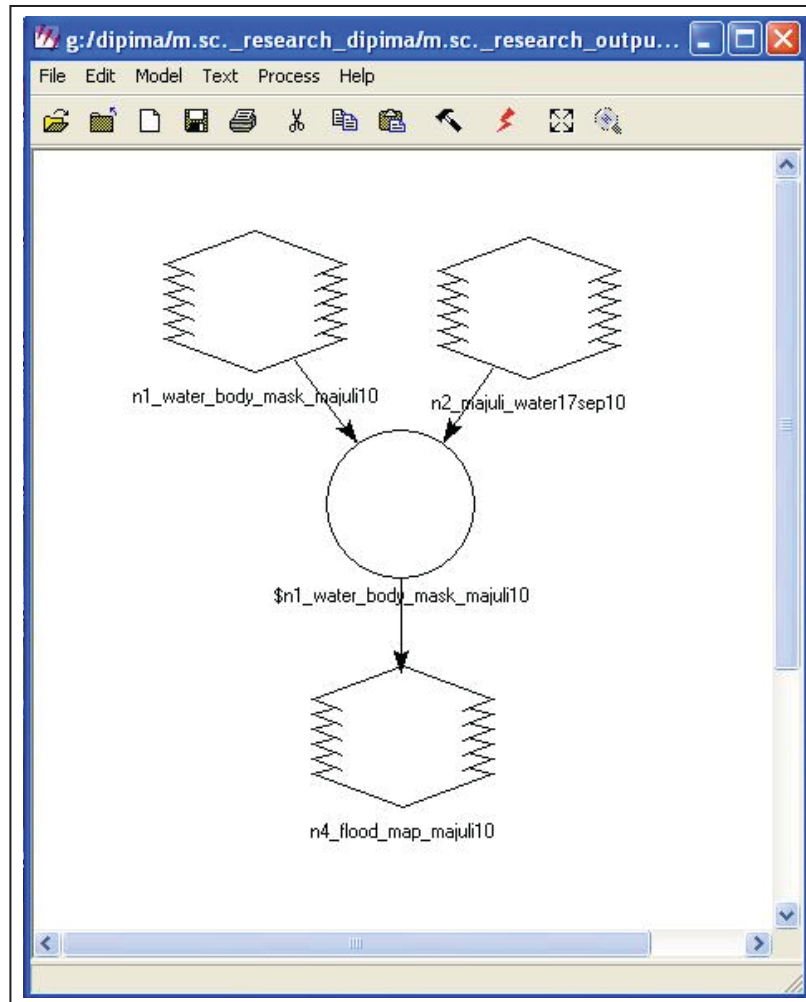
To extract the actual flooded area, the water body maps generated from the LISS-III imagery of each year was multiplied with their respective water maps generated from the Radarsat-1 imagery. Figure 4.9 shows the model used for actual flood area extraction in Erdas (Figure 4.9).

Figure 4.9: Model used in Erdas Modeler for Flood Inundation Area Extraction

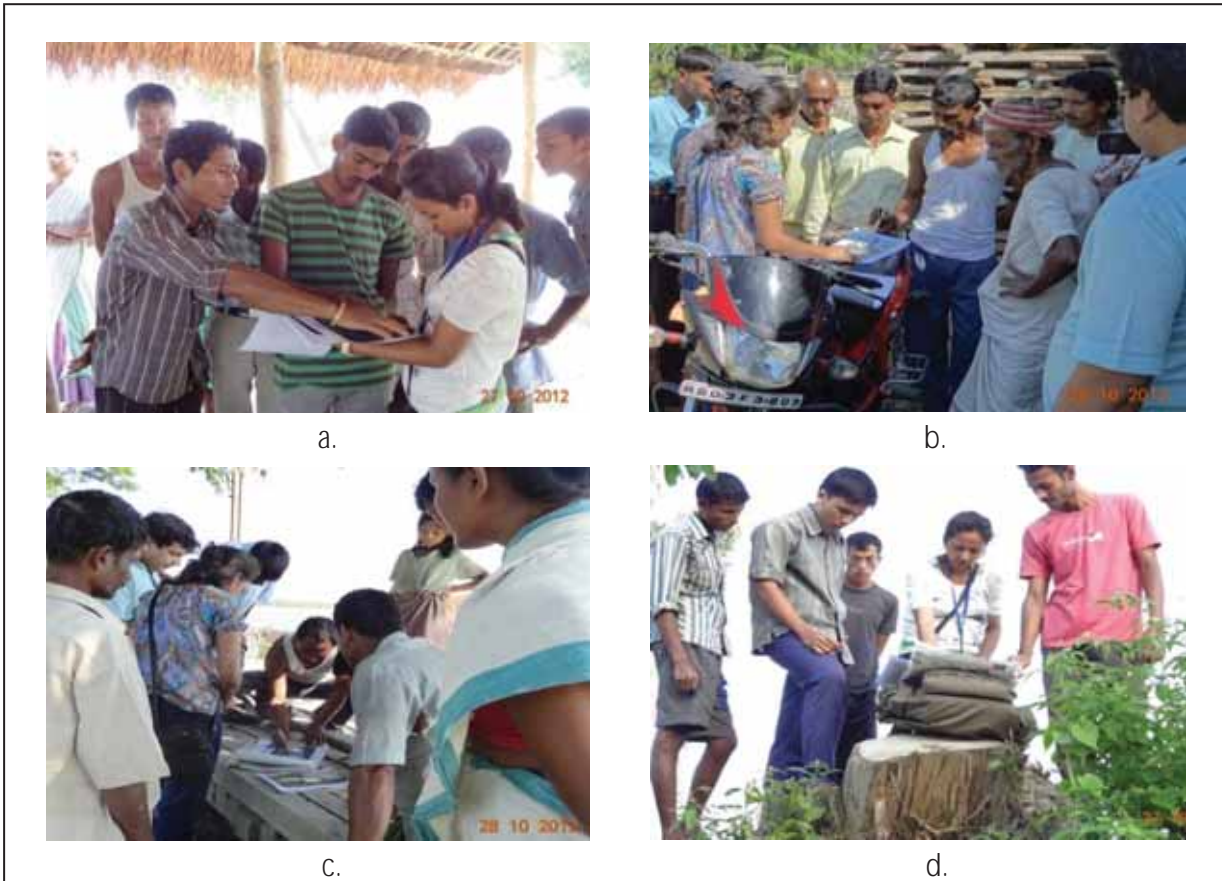
Figure 4.11: Participatory GIS mapping in the villages of Majuli

A field survey was carried out in the area during the month of October just after the big flood event of 2012. To assess the damage due to flood and riverbank erosion, a questionnaire was prepared (Annexure - II) and thirty three households were surveyed on random basis covering the entire study area. After the survey, the areas facing large-scale damage due to both flood and erosion were identified and subsequently Participatory GIS (PGIS) mapping was carried out in those areas viz. Haladhibari and Sonowal – Kachari village, Salmora village, Upper – Sonowal and Sukhunamukh village and Korotipar, Malowal Kalita and Ukhalchuk village (Figure 4.11 a., b., c. and d.) to see the channel migration over the period and to have an idea about the villages already engulfed by the rivers. Field GPS points were also collected for the active erosion areas, road breach and embankment breach points (Figure 4.12).

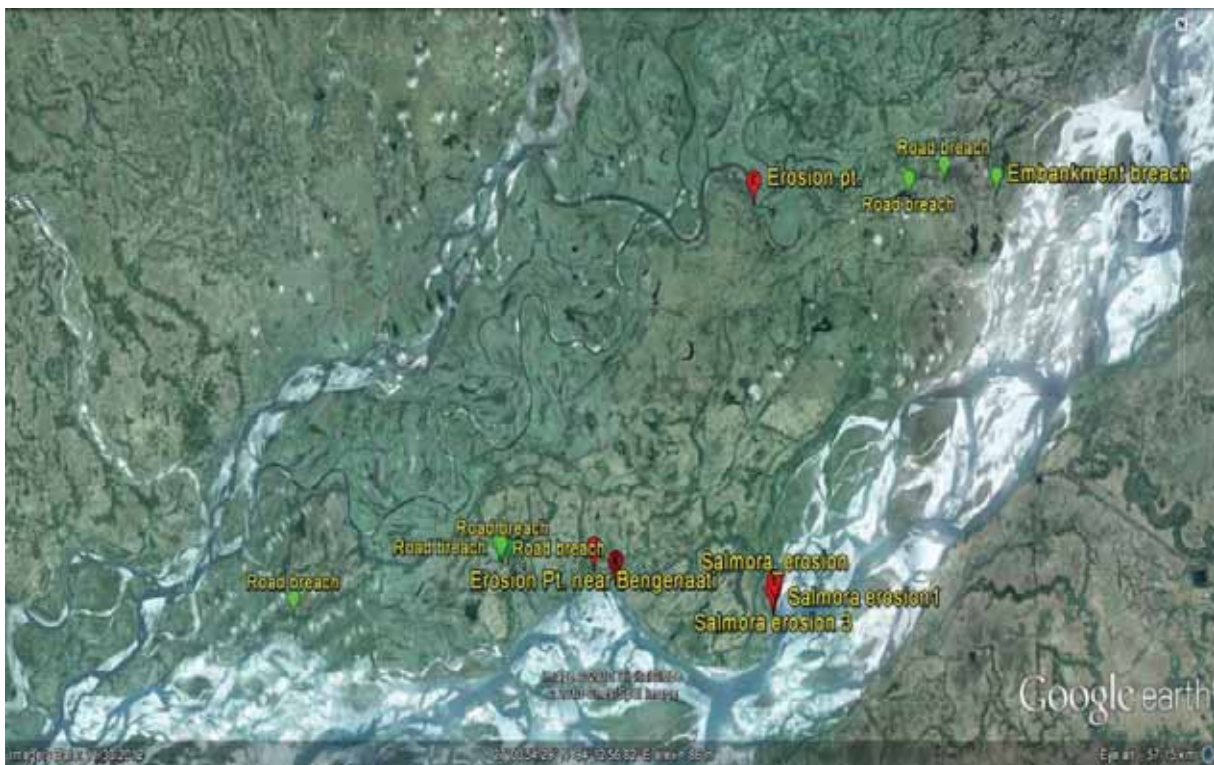
Figure 4.12: Field GPS points showing Erosion points, Embankment and Road breach points

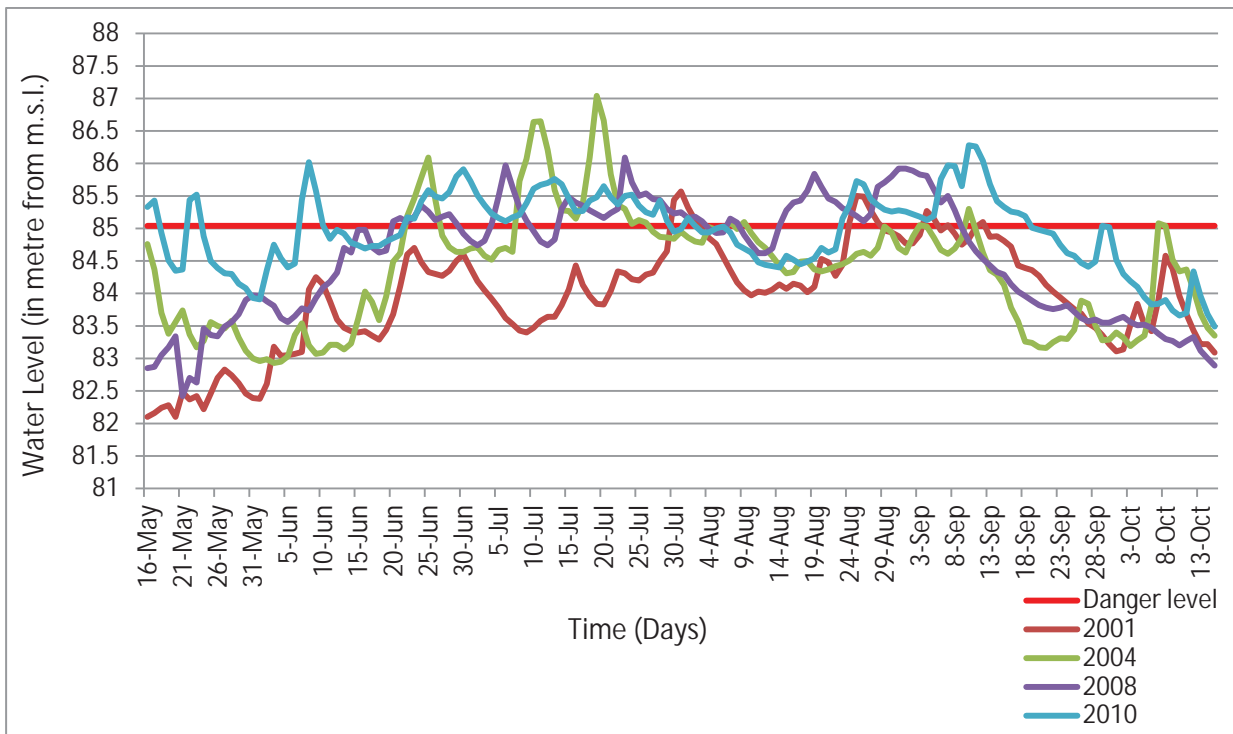
Figure 5.3: Flood Hydrographs for the Brahmaputra River

Flood hydrographs are very effectively used in flood studies as it gives a visualization of the river response over a time period. Therefore to understand the flood characteristics of Majuli, flood hydrographs were prepared from the available data for the years 2001, 2004, 2008 and 2010 in case of the Brahmaputra river and for the years 2004 and 2008 in case of the Subansiri river (Figure 5.3 and 5.4). From Figure 5.3, it has been observed that over the period of 2001 - 2010, the year 2004 experienced some large flood events, the highest level of water in the Brahmaputra being more than 87 m above m.s.l. It is also evident from Figure 5.3 that in the year 2010, though the level of flood water is not very high, the duration of the flood events was much longer than

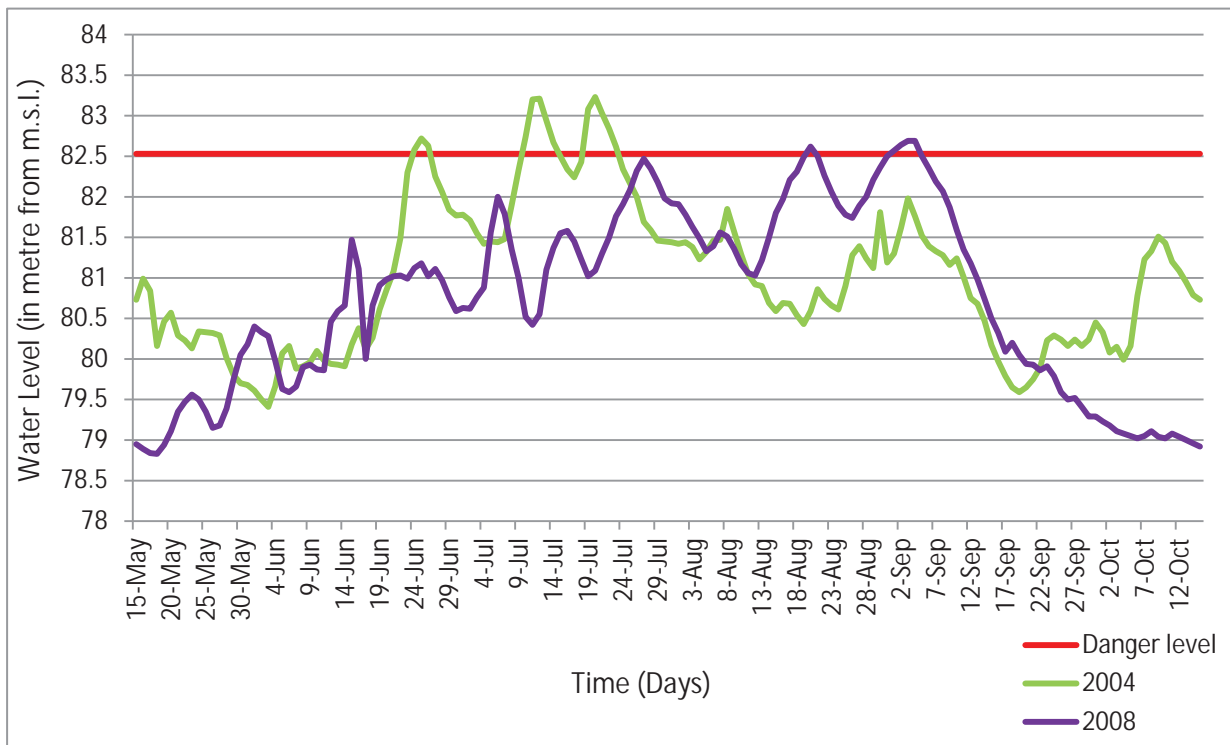
Figure 5.4: Flood Hydrographs for the Subansiri River

that of 2001, 2004 and 2008. Figure 5.4 depicts that the flood water level of 2004 was much higher than that of 2008 in the Subansiri river.

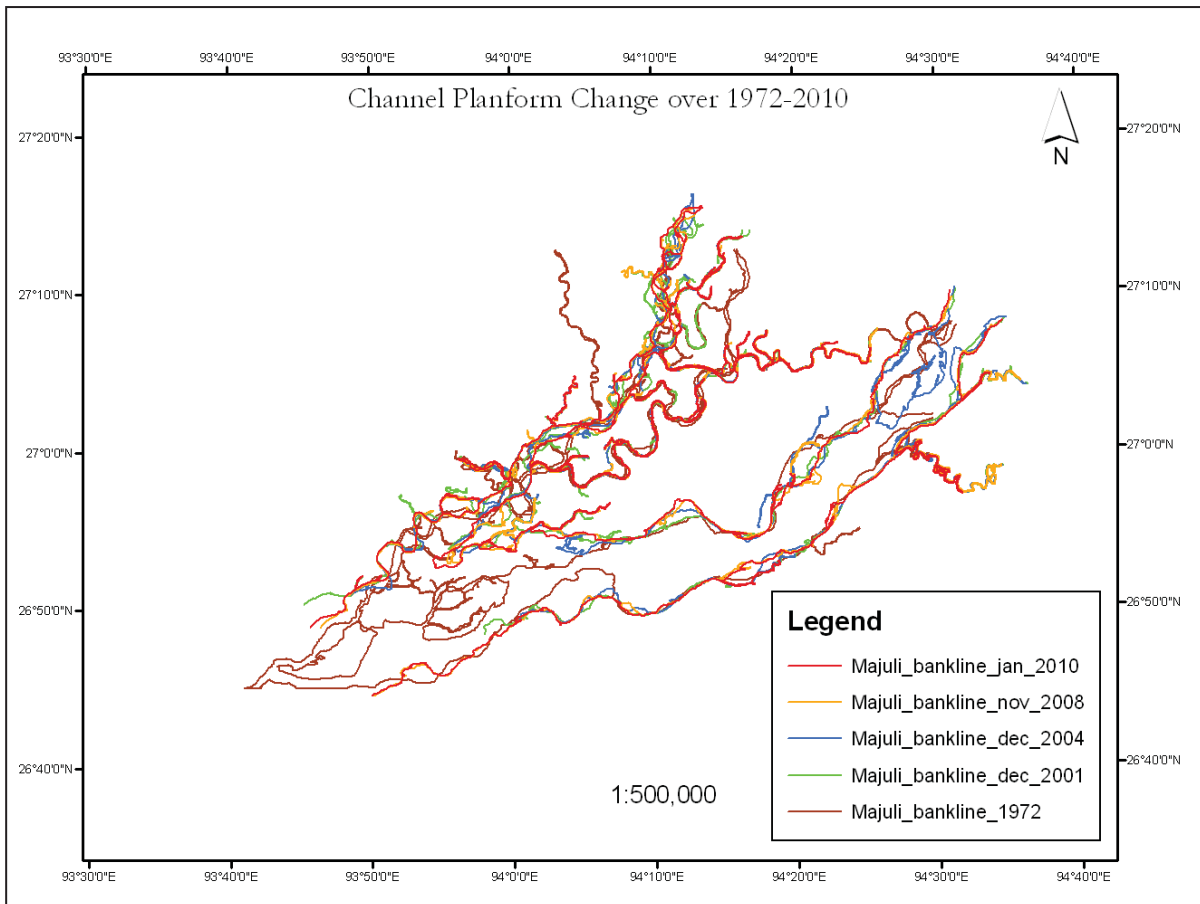
Figure 5.8: Channel Planform change over 1972 - 2010

To study the channel planform change over 1972 to 2010, the river bank lines at different years were overlaid on top of each other (Figure 5.8). From Figure 5.8 it is observed that most of the changes in the river bank lines took place at the confluence zone of the river Brahmaputra and Subansiri. A huge amount of land has been eroded away by both the rivers at the confluence zone over 1972 -2010. Besides the erosion at the confluence zone, active processes are also significant at the southern and south-western part of Majuli.

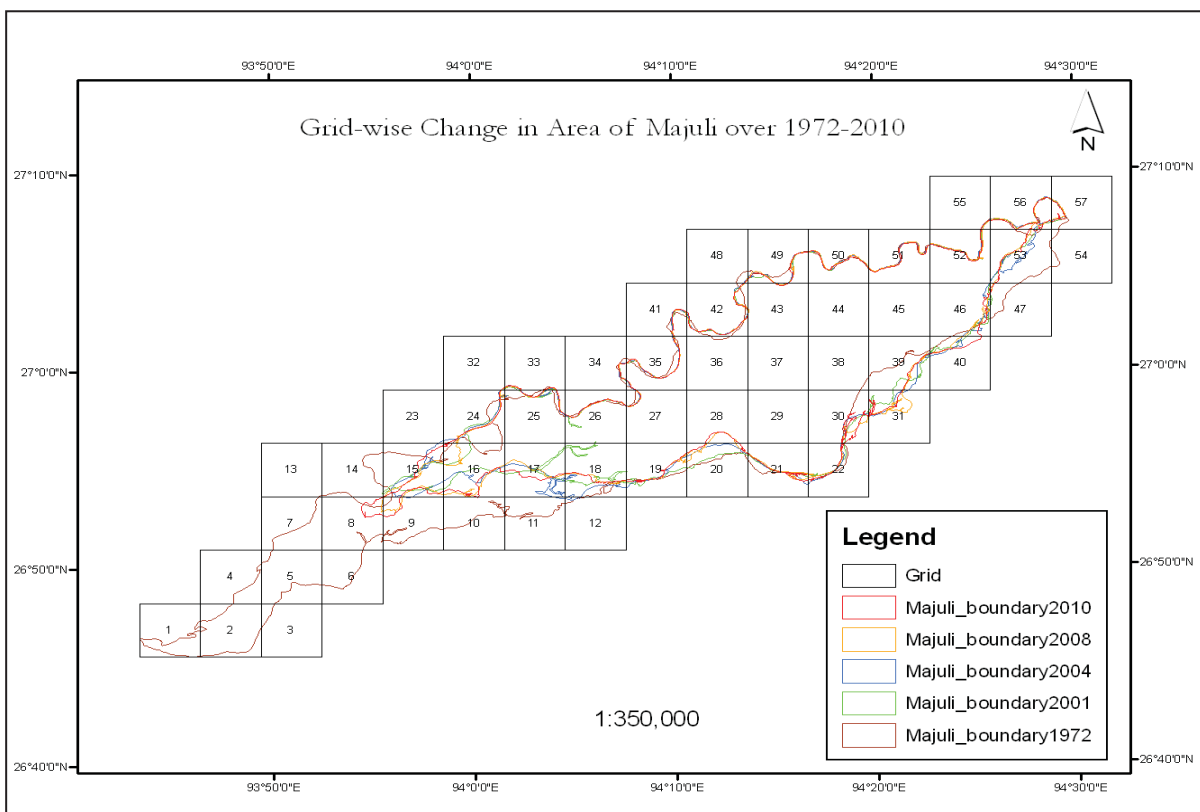
Figure 5.9: Grid-wise Change in Area of Majuli over 1972 - 2010

To point out the areas facing acute erosion problem, (5 km x 5 km) grid was constructed and the change in area at each grid was calculated by intersecting this grid file with the boundaries of the area in different years (Figure 5.9, Figure 5.10).

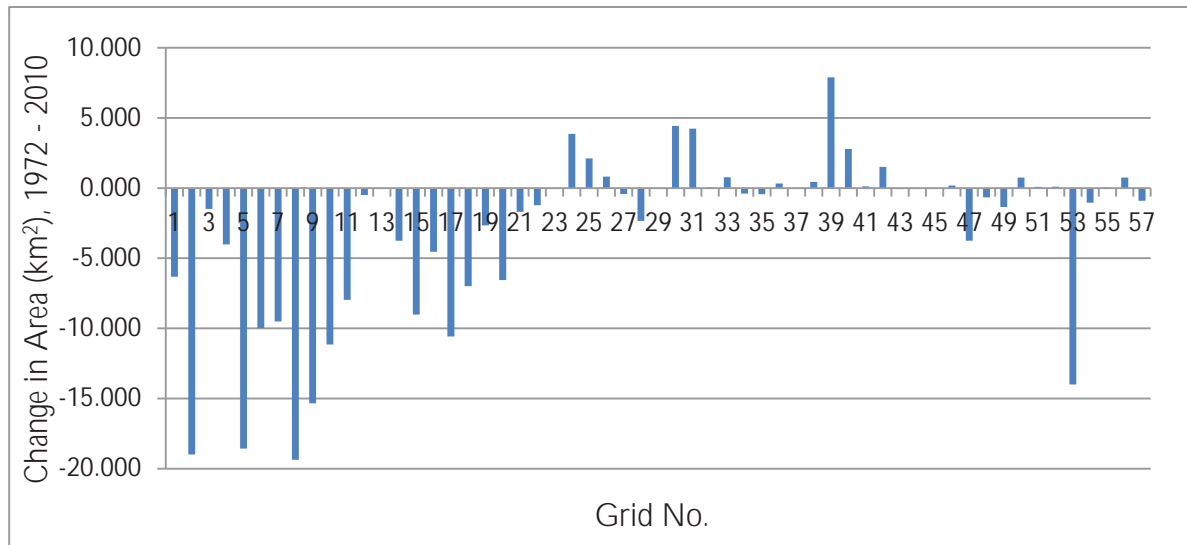
Figure 5.10: Grid-wise Change in Land Area (in km²) over 1972 -2010

From Figure 5.10, it is evident that the grids numbering 1 to 22, 27, 28, 34, 35, 47, 48, 49, 53, 54 and 57 were facing the problem of erosion over 1972 – 2010. The negative values of the change in area describe the erosion in the grids while the positive values describe the deposition. It is also observed from the analysis of the data regarding the change in land area in each grid over different time periods (Table 5.2), that the land area contained in the grids 1 to 7, 10, 13 and 54 had been completely engulfed by the two rivers over 1972-2001. However, some amount of deposition is also associated with few grids.

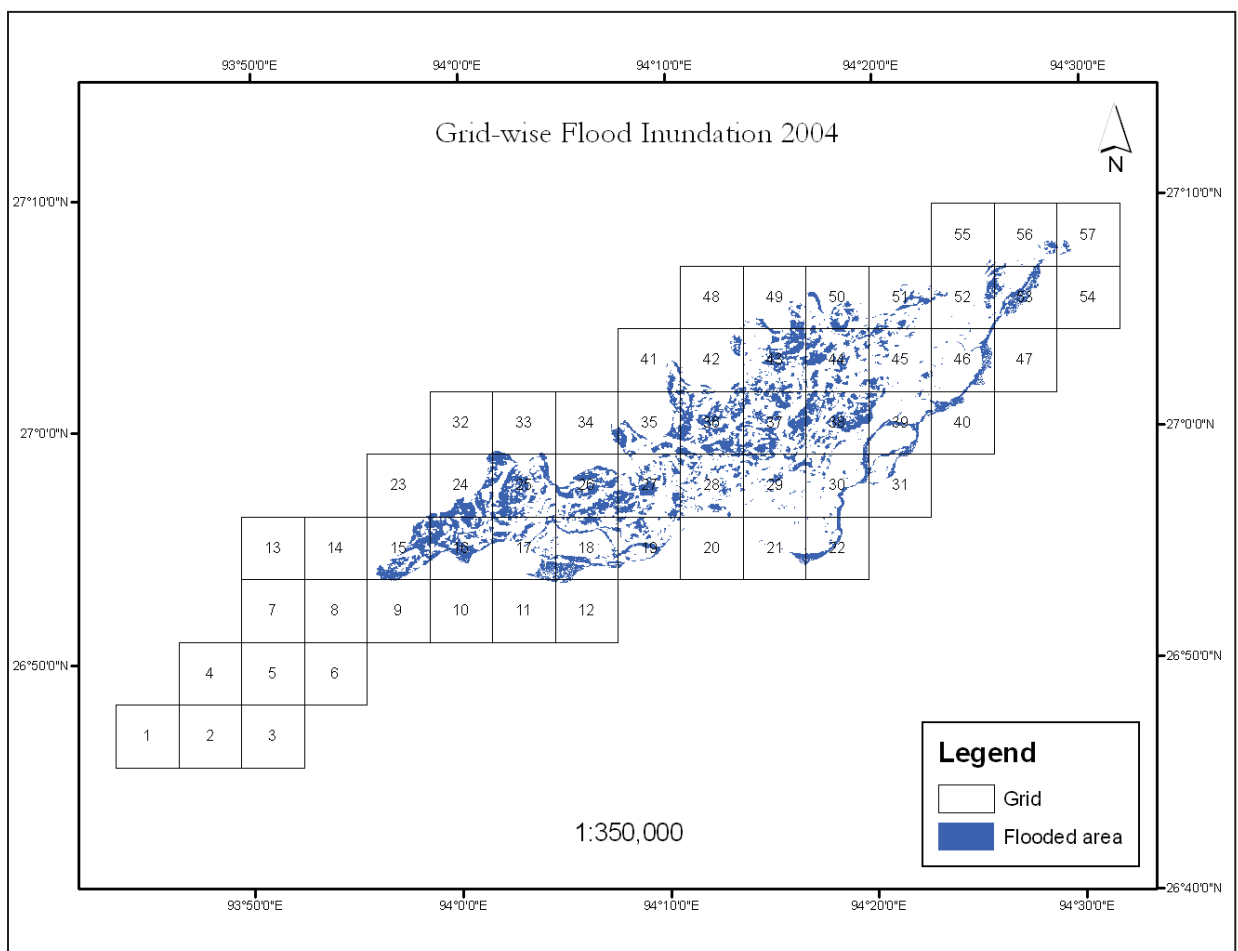
Figure 5.11: Grid-wise Flood Inundation Map of 2004

To identify the areas facing both the problems of flooding and riverbank erosion, the same grid of (5 km x 5 km) was intersected with the flood inundation maps of 2004 and 2010 (Figure 5.11 and 5.12) and a plot was drawn to visualize the area of inundation in each grid during both the flood events of 2004 and 2010 (Figure 5.13). Another plot was drawn between the flood inundation of 2004 and the amount of erosion/ deposition over 2004 – 2008 (Figure 5.14). From the Figures 5.11, 5.12 and 5.13, it is observed that the grids 15, 16, 17, 18, 19, 21, 22, 24, 25, 26, 28, 30, 31, 39, 40, 46, 49, 50 and 53 got flooded during both the flood events of 2004 and 2010, the level of flood inundation being much higher in 2004. It is also observed from Figure 5.13 that in the grid 36, the area inundated due to the flood event of 2004 is more than 10 km².

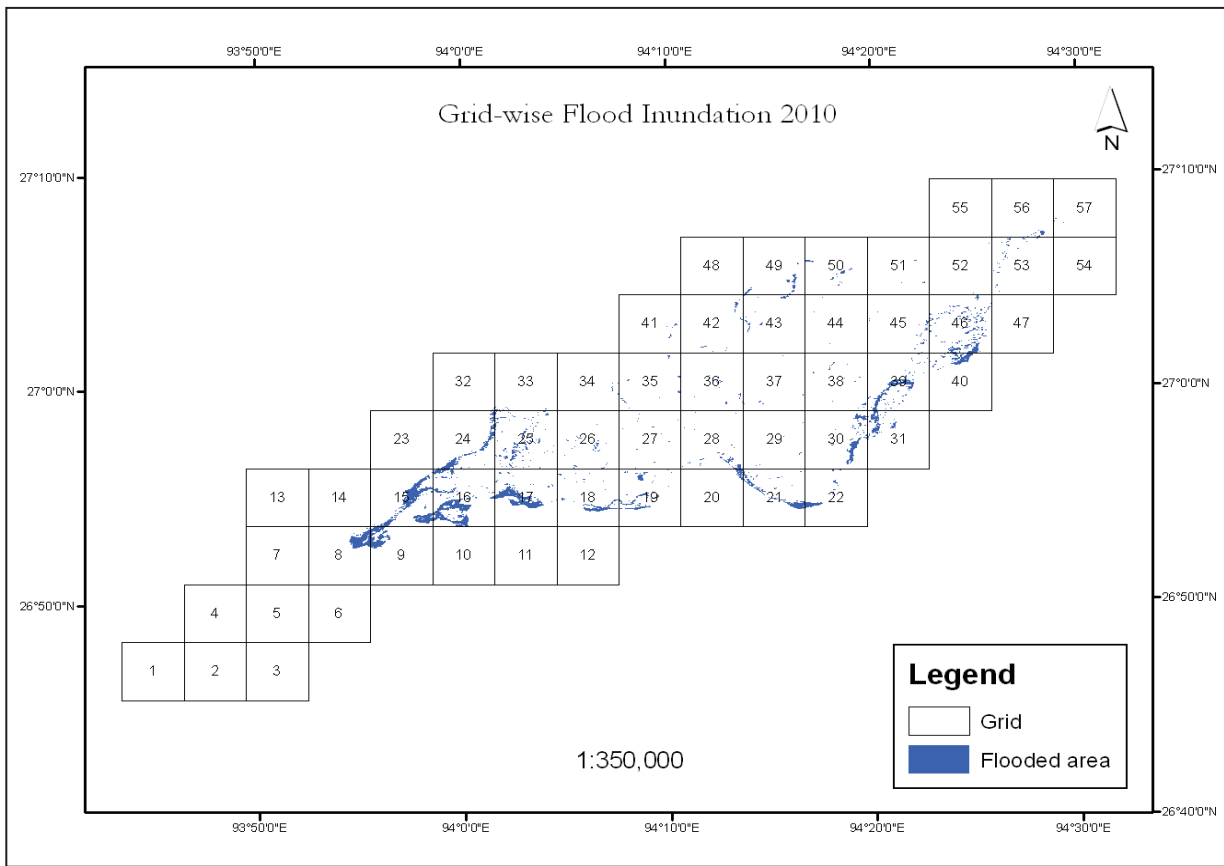
Figure 5.12: Grid-wise Flood Inundation Map of 2010

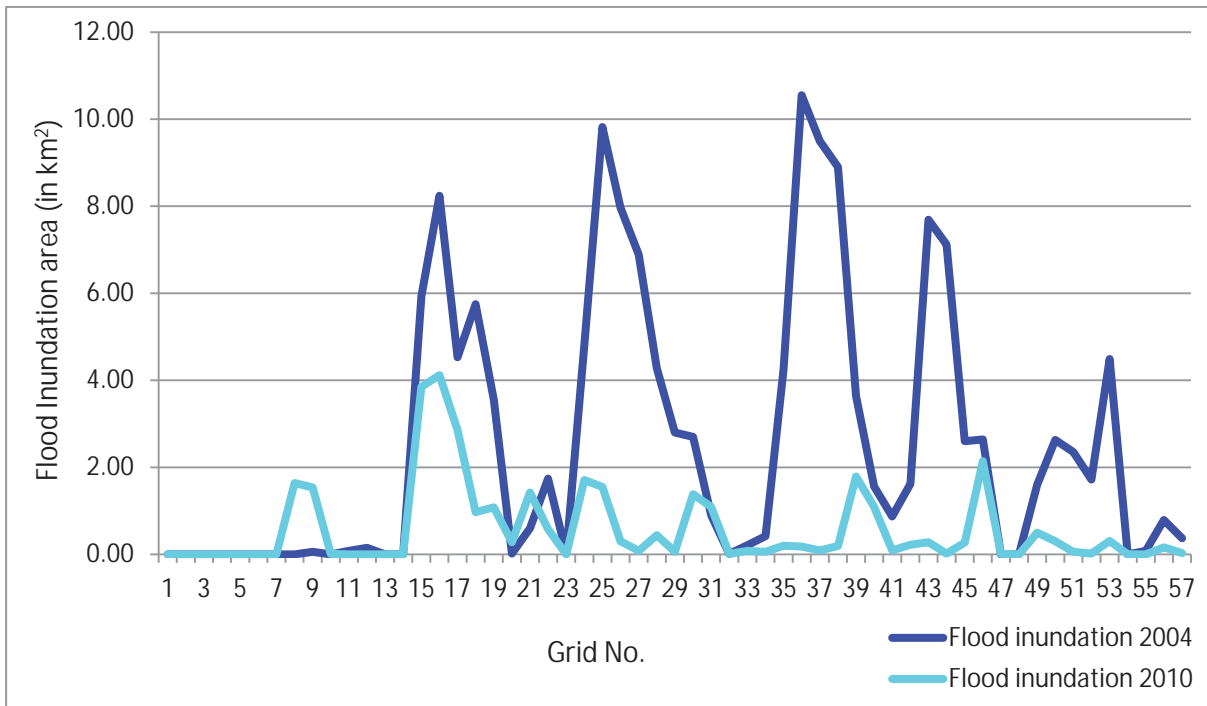
Figure 5.13: Grid-wise Flood Inundation Area (in km²) in 2004 and 2010

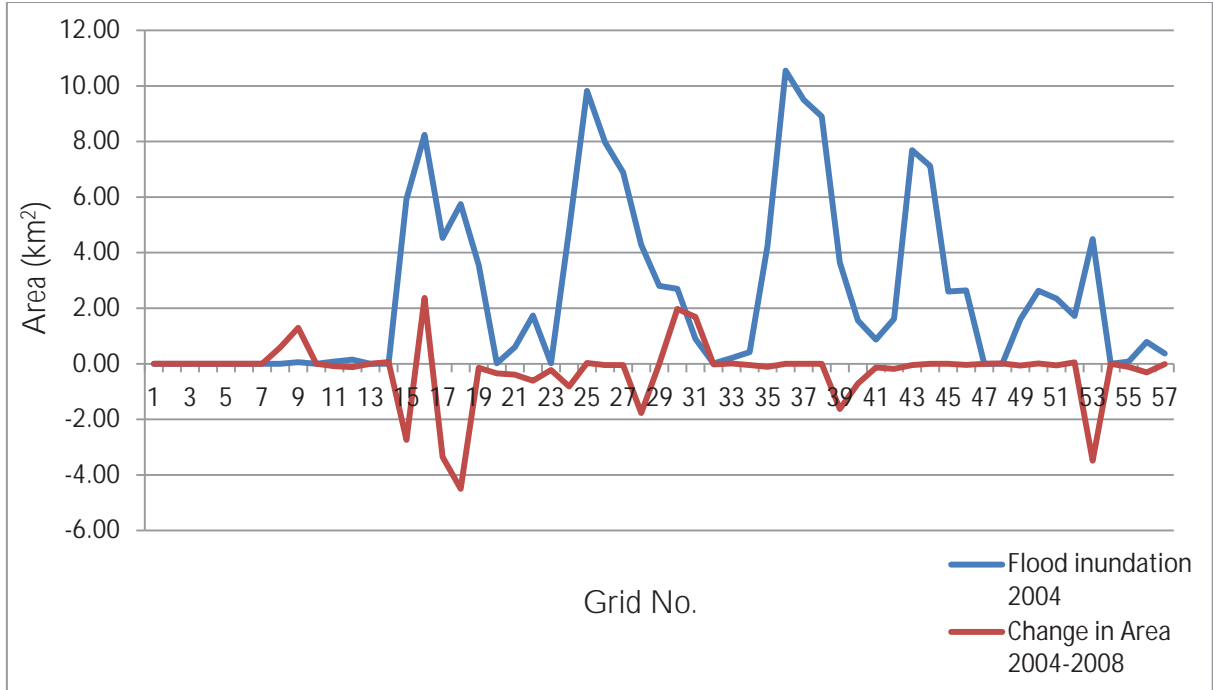
Figure 5.14: Grid-wise comparison between Flood 2004 and Change in Area over 2004-2008

From Figure 5.14 it is apparent that the grids 15, 18, 22, 24, 28, 39, 40 and 53 faced acute problems of both flooding and erosion during 2004 to 2008.

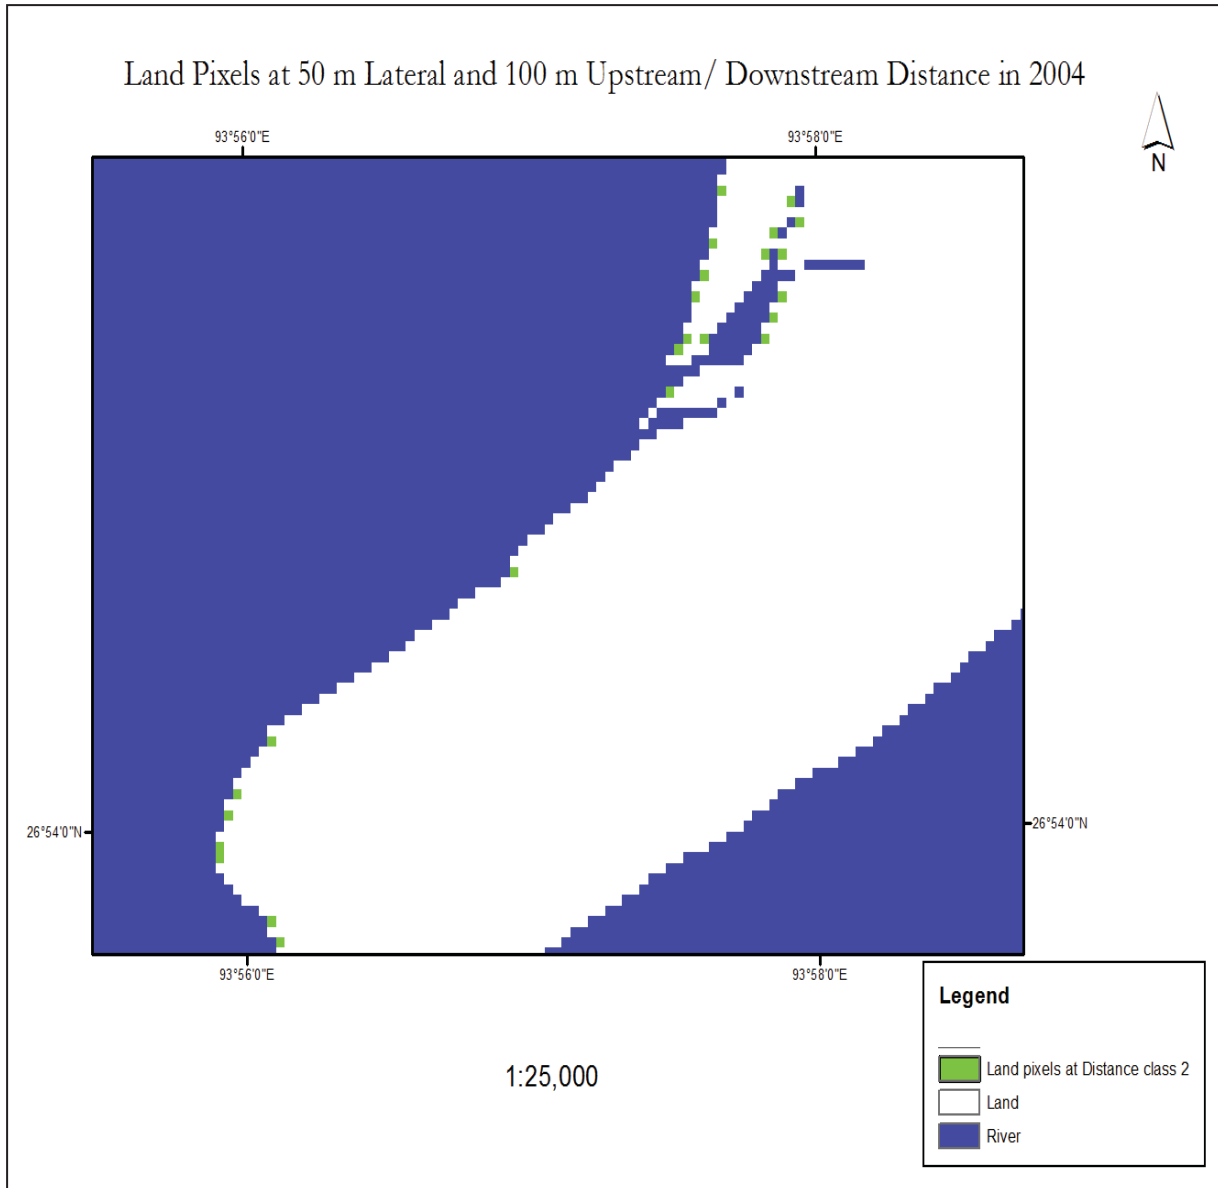
Figure 5.15: Land Pixels present in the Distance Class 2 (50 m Lateral and 100 m Upstream/Downstream 2004) in a part of Majuli

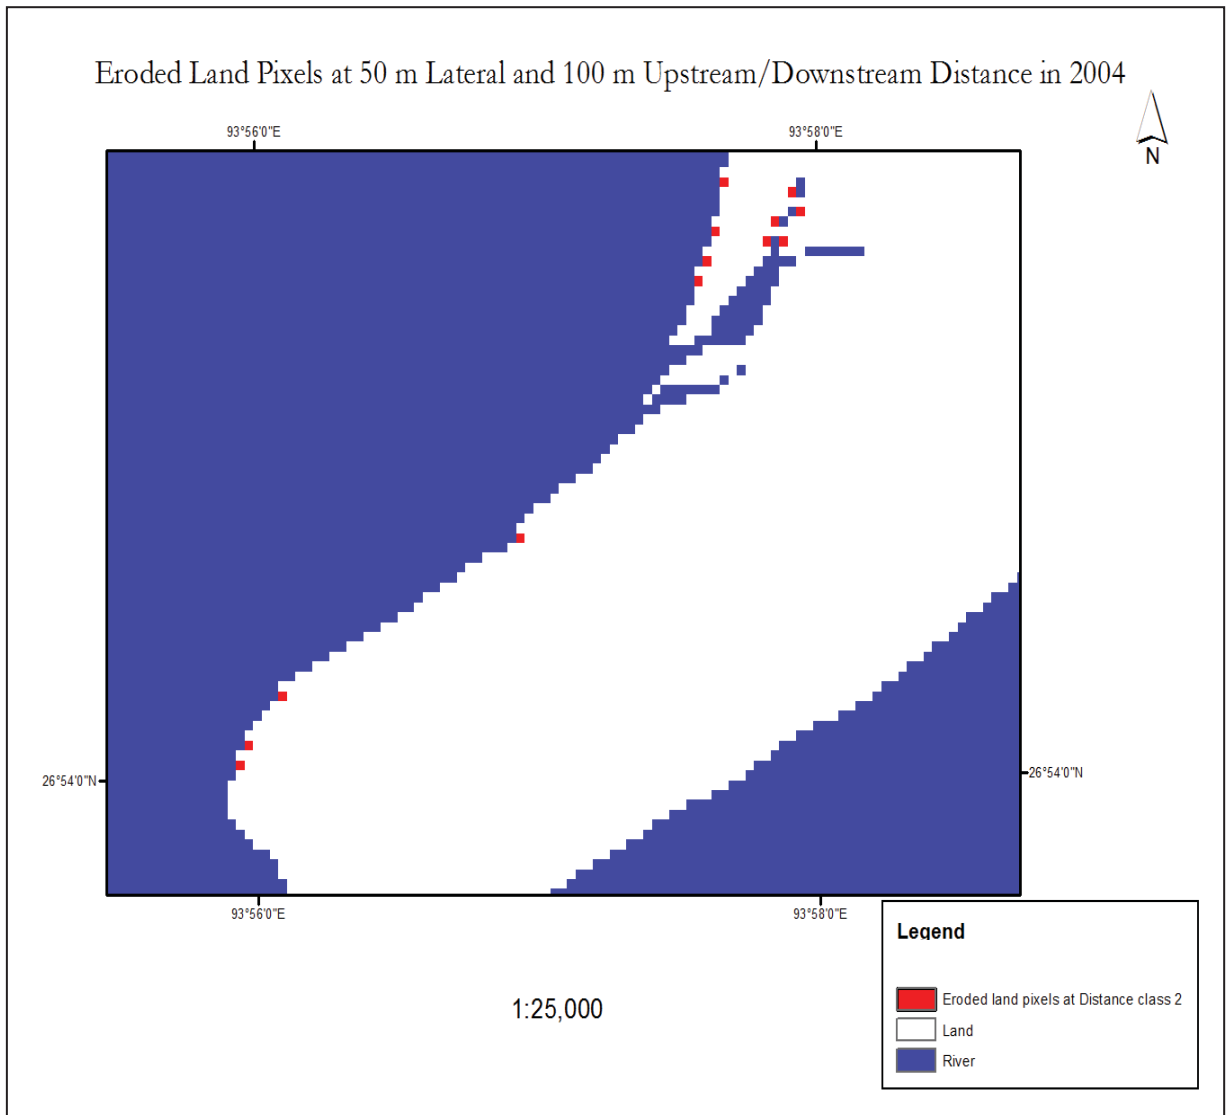
Figure 5.16: Eroded Land Pixels at Distance Class 2 during 2004 - 2008

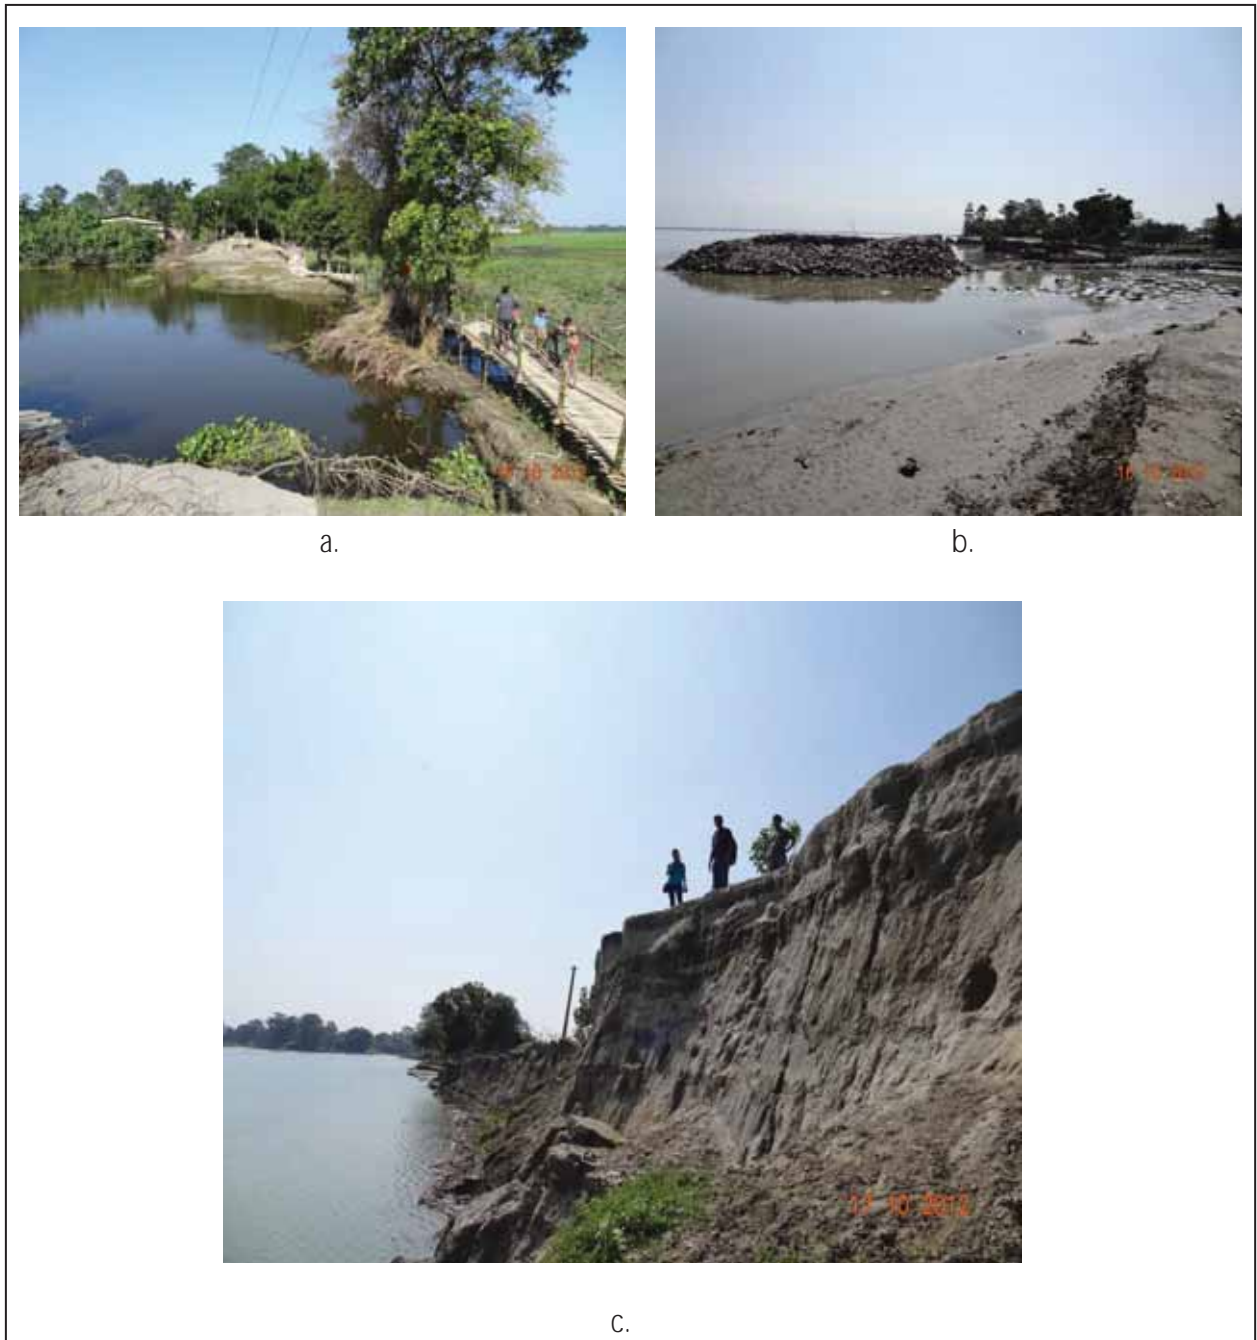
Figure 6.1: Breaches due to flood in a. Road, b. Spur, c. Embankment

the embankments, spurs and roads were noticed (Figure 6.1). A Participatory GIS Mapping (Figure 6.2) was also carried out during the field survey and it was found that the main reason for large extent of flood inundation in 2012 (Figure 6.3) was the breach in the Tekeliphuta embankment near Haladhibari. This embankment had breached two times during the two large flood events of June and September, 2012. Due to this breaching in the embankment, deposition of a huge amount of sand (sand casting) was also observed during the survey in the Haladhibari and Sonowal Kachari villages that caused damage to a large amount of agricultural land and also to the houses and properties of the villagers (Figure 6.4).

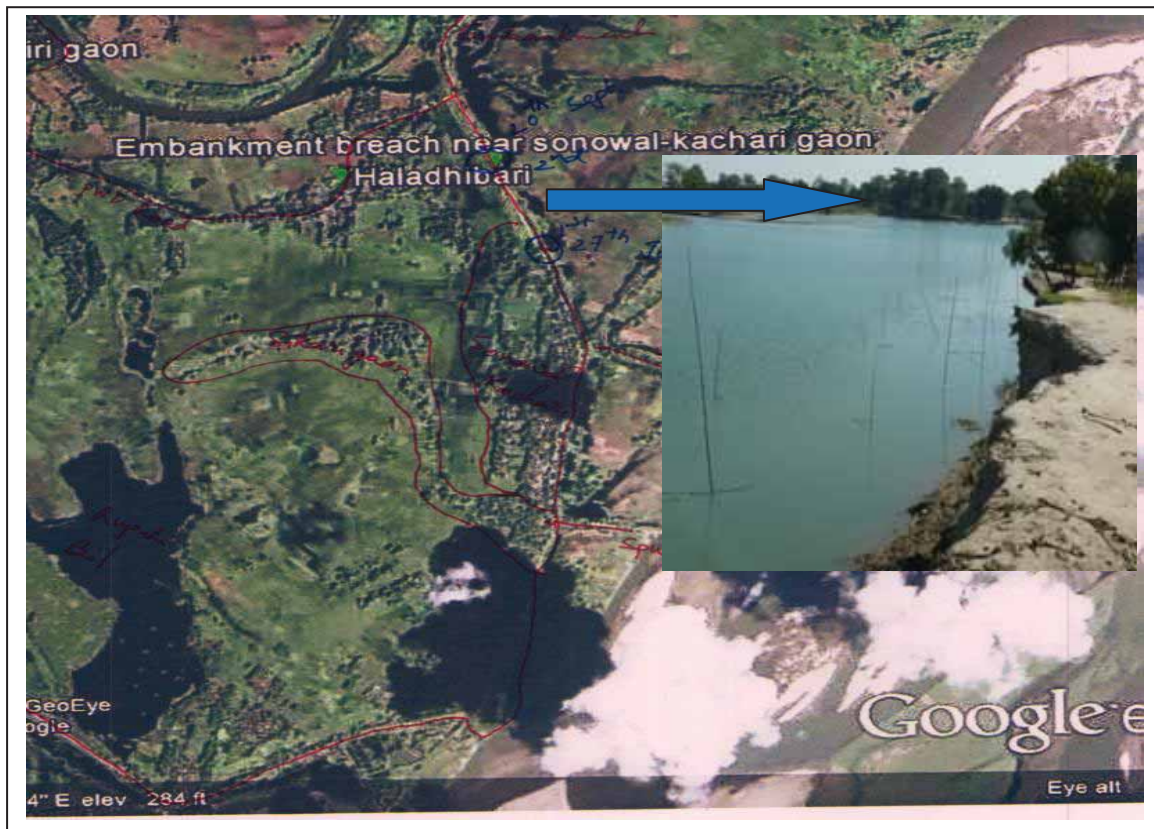
Figure 6.2: Embankment breach near Haladhibari during Flood 2012
