Rural Risk Assessment due to Flooding and Riverbank Erosion in Majuli, Assam, India

Thesis submitted to the Faculty of Geo-Information Science and Earth Observation of the University of Twente in partial fulfilment of the requirements for the degree of Master of Science in Geo-information Science and Earth Observation.

Specialization: Natural Hazards and Disaster Risk Management

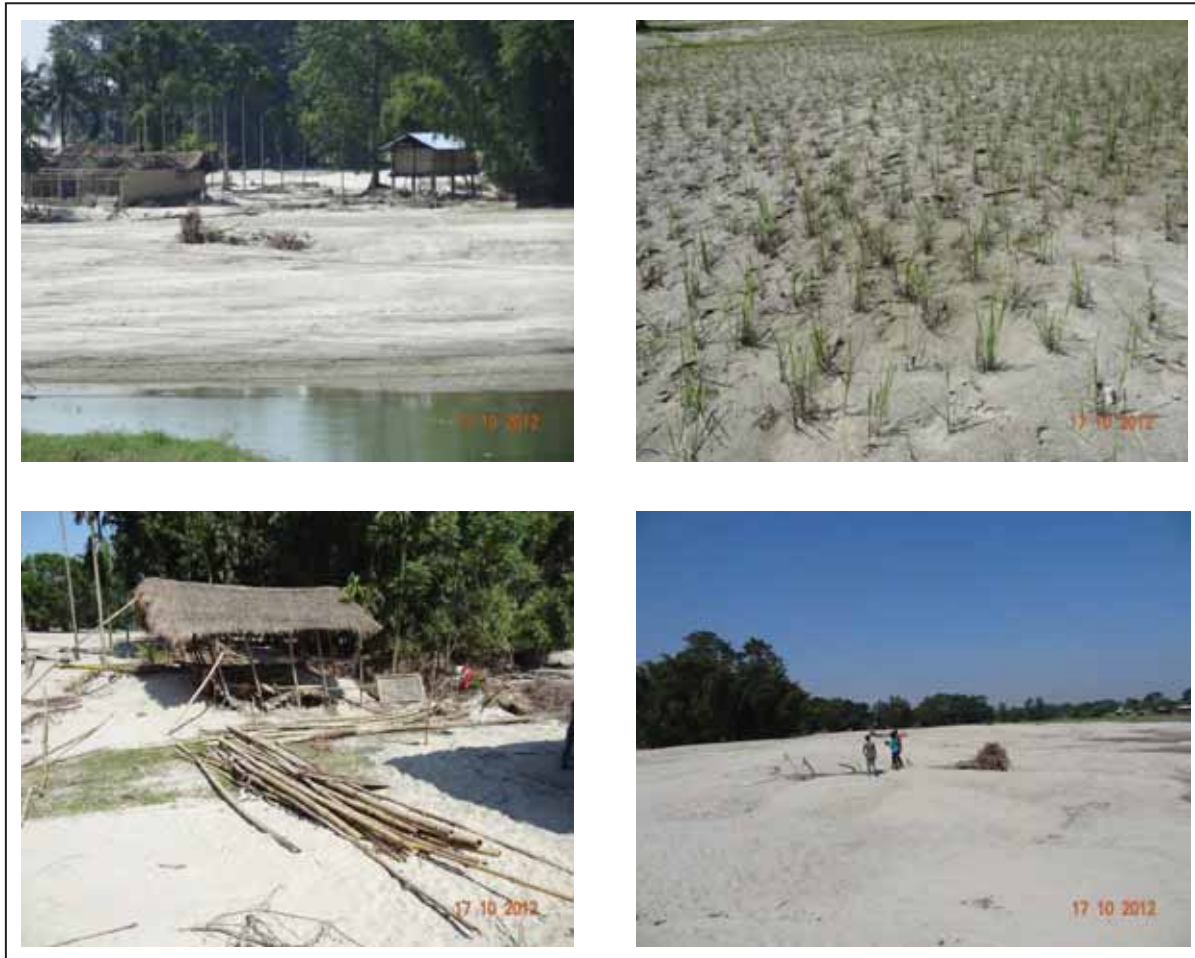
Figure 6.4: Sand Casting in the Sonowal - Kachari Village

the embankments, spurs and roads were noticed (Figure 6.1). A Participatory GIS Mapping (Figure 6.2) was also carried out during the field survey and it was found that the main reason for large extent of flood inundation in 2012 (Figure 6.3) was the breach in the Tekeliphuta embankment near Haladhibari. This embankment had breached two times during the two large flood events of June and September, 2012. Due to this breaching in the embankment, deposition of a huge amount of sand (sand casting) was also observed during the survey in the Haladhibari and Sonowal Kachari villages that caused damage to a large amount of agricultural land and also to the houses and properties of the villagers (Figure 6.4).

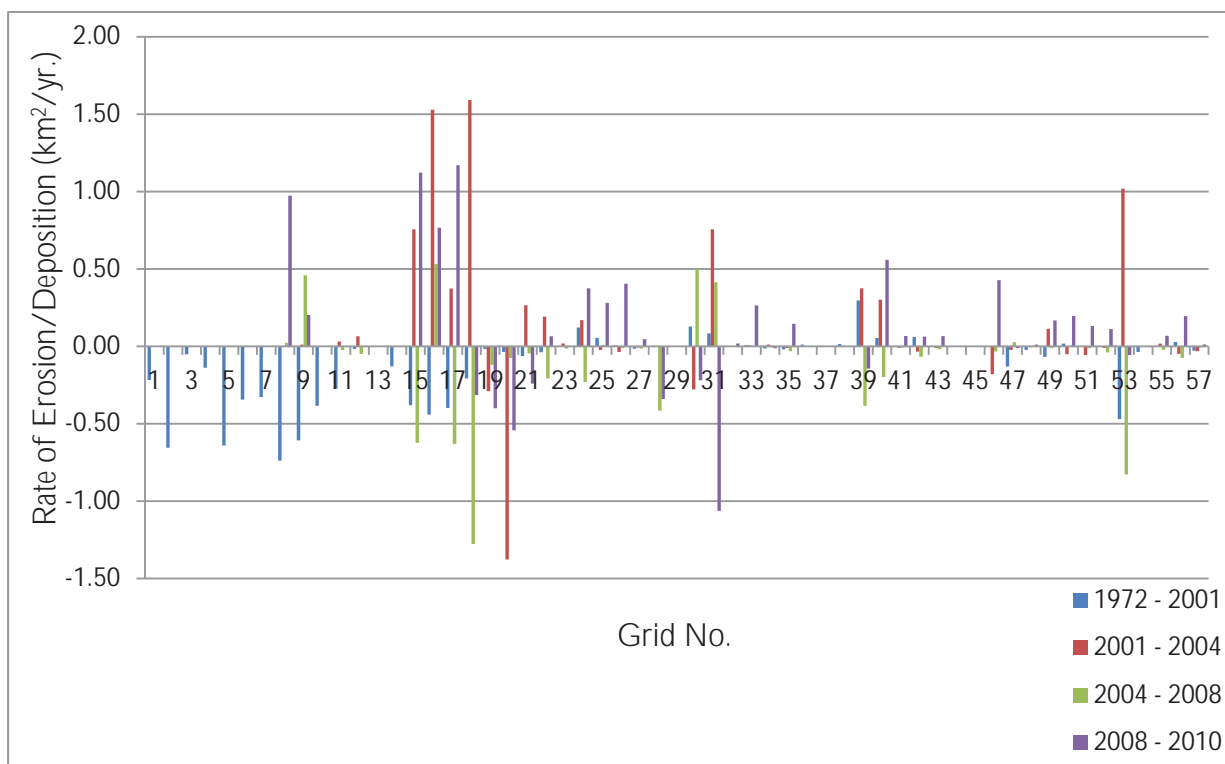
Figure 6.7: Grid-wise rate of Erosion/ Deposition (km²/yr.) in different time intervals

➤ From the grid-based analysis of riverbank erosion, the amount of area eroded in different time periods and the annual average rate of erosion was calculated. The annual average rate of erosion in different time intervals are found as – 6.92 km²/ yr. over 1972-2001, 2.47 km²/yr. over 2001-2004, 5.48 km²/yr. over 2004-2008 and 3.34 km²/yr. over 2008-2010.

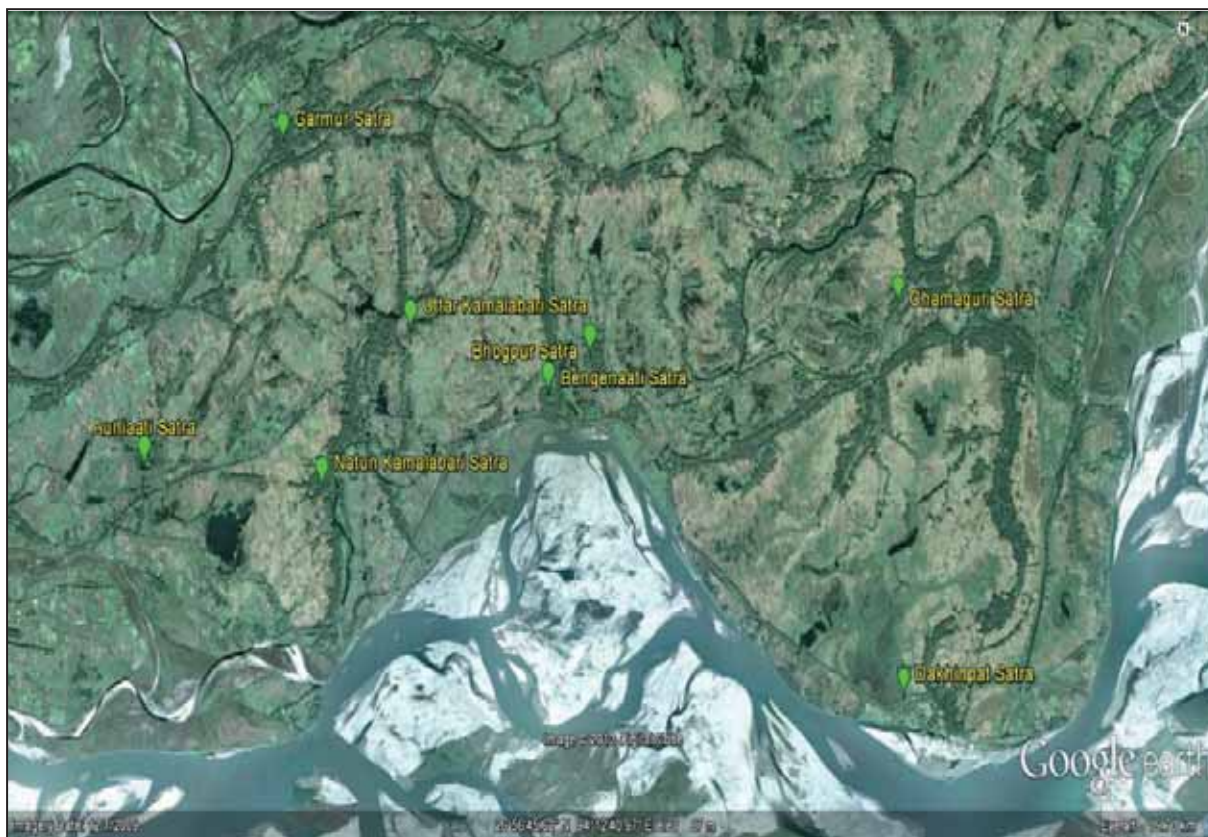
Figure 6.9: Location map of the historically important *Satras*

➤ The elements at risk i.e. the *Satras* and the agricultural lands of the area are mapped (Figure 6.8 and 6.9) and a field survey was carried out to assess the vulnerability of these elements. From Figure 6.9 it can be remarked that due to unrelenting bank erosion in the southern part of Majuli, most of the historically important *Satras* are becoming vulnerable to flood hazard as their proximity to river is increasing. In this regard, the vulnerability of the *Dakhinpat Satra* and the *Bengenati Satra* is very high. However, both these *Satras* are protected by an embankment. But at any case of embankment breach near this area, both the *Satras* will be at high risk of flood hazard. From the field survey it is observed that most of the agricultural lands are vulnerable to flood hazard, as high flood water remains stagnant in the fields for about 15-30 days. However, in places where flood is associated embankment breach the flood water remains stagnant in the fields for about 3 – 4 months.

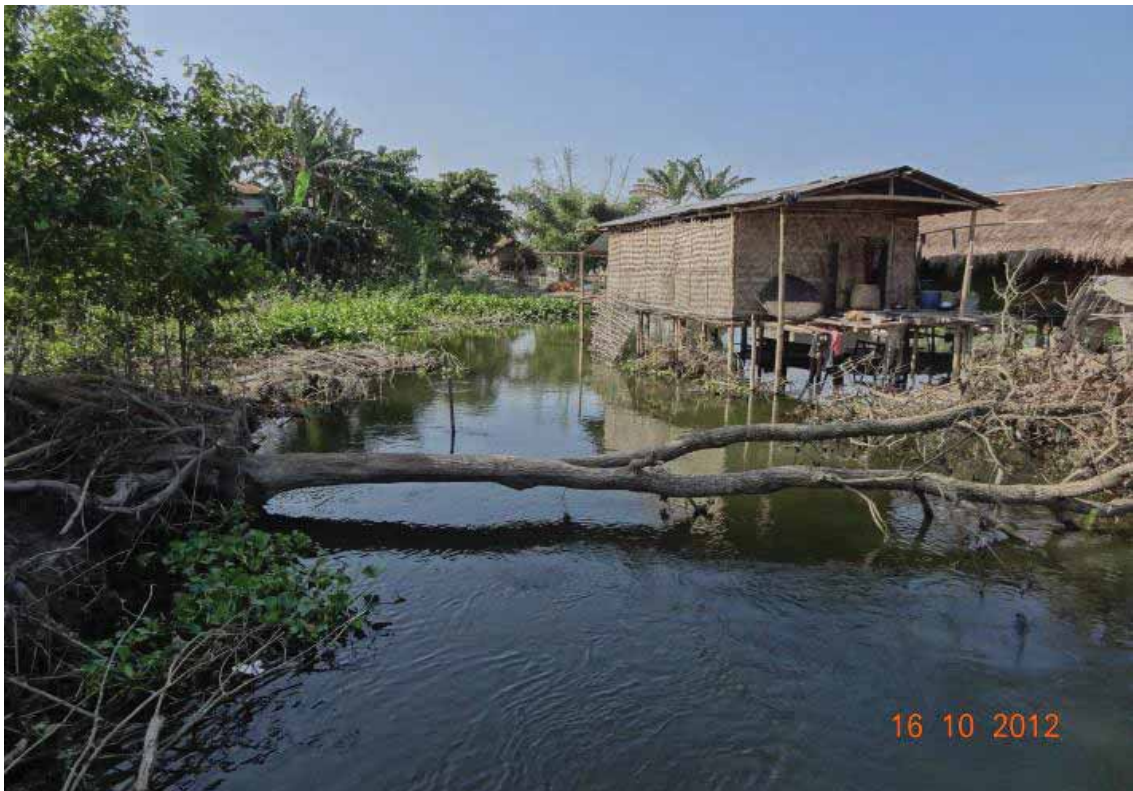
Figure 7.1: House under flood water due to road breach

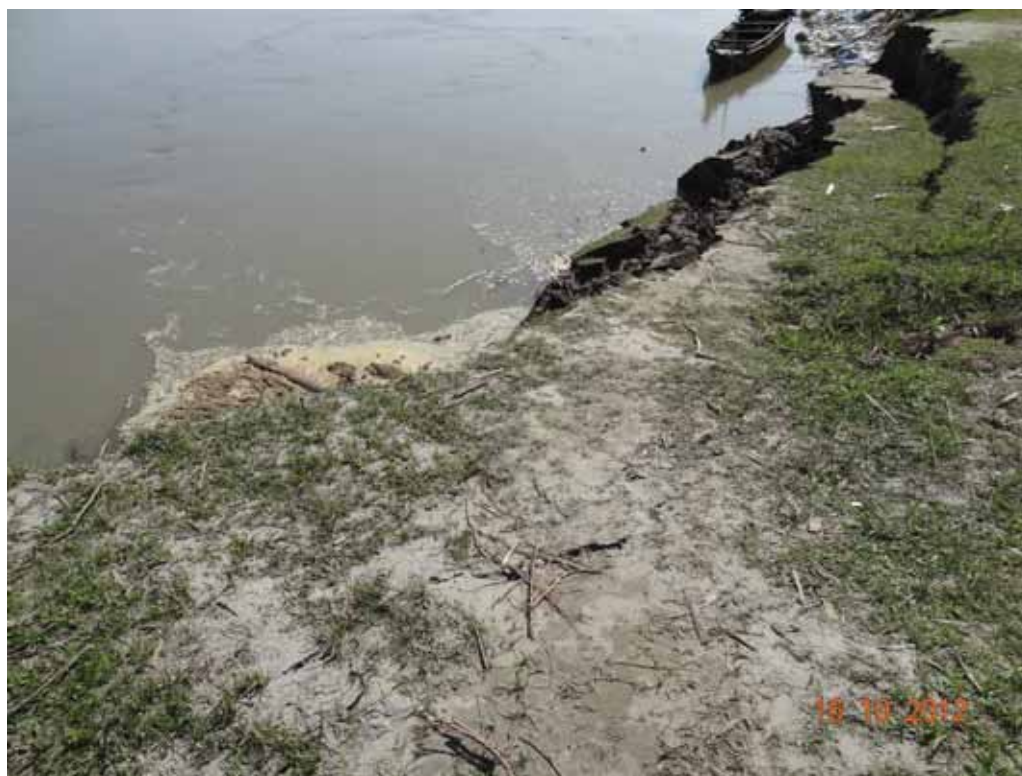
Figure 7.2: Active riverbank erosion process at Salmora

From the study, it is observed that there is a continuous change in the area of Majuli due to active processes of erosion and deposition (Figure 7.2). The total area of Majuli in 1972 was 685.29 km², in 2001 510.51 km², in 2004 525.92 km², in 2008 511.88 km² and in 2010 521.52 km². However, the deposition is not a permanent process and gets eroded during high flood events. The erosion problem is more acute after the flood events in most of the places, the main cause being over-steepening of the bank materials due to the deposition of high amounts of sediments during the flood (Sankhua *et al.*, 2005).
