# **FLOOD VULNERABILITY ASSESSMENT OF THE 2010 EVENT, USING PARTICIPATORY MAPPING TOOLS AND MODELING IN YINGXIU TOWN, CHINA**

Thesis submitted to the Faculty of Geo-Information Science and Earth  
Observation of the University of Twente in partial fulfilment of the  
requirements for the degree of Master of Science in Geo-information Science  
and Earth Observation.

Specialization: Applied Earth Sciences

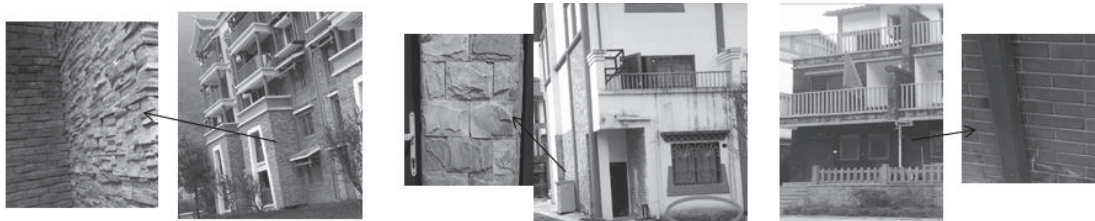
In these building walls are built of concrete and in several cases coated with another material. Bricks and fragments of rocks such as granite are used. Types of coating used depend of building design (Figure 24).

Figure 24. Types of material coating recovering walls on different buildings designs

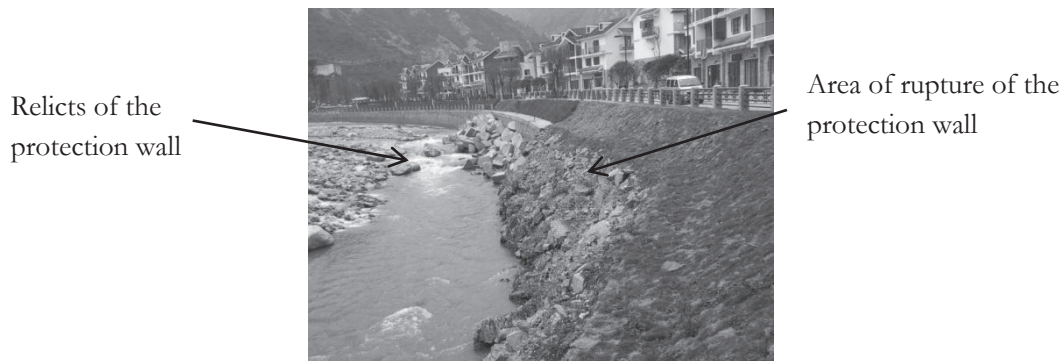
Figure 45. The wall protection broken by the Roa River

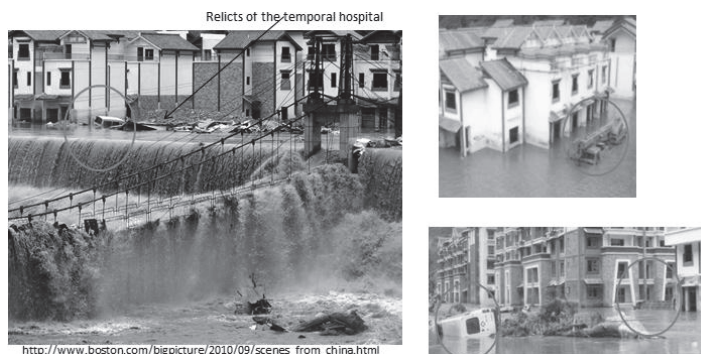
**Figure 50. Damage by 2010 flood event**
