Effect of Compaction and Asphalt Temperature During Paving on Asphalt Lifespan

02/07/2019

Samuel Rutten
S1790099

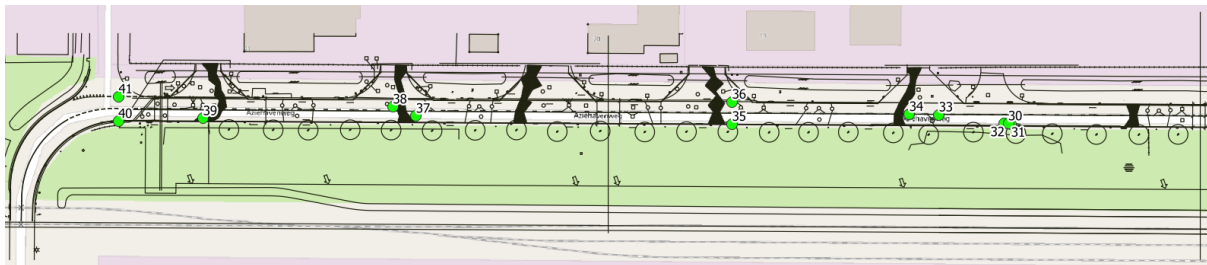
Figure 15: Damage Locations 3

This last image (Figure 15) shows the last third of the road. Points 40 and 41 show the end of the road and the joint that is located there. Points 30, 31, and 32 show the midpoint and the beginning and end points respectively of a rather large longitudinal crack. Points 33 and 34 also show the beginning and end points of a longitudinal crack whereas points 35 and 36 show the endpoints of a large transverse crack and 39 also shows a transverse crack. Finally, points 37 and 38 show the beginning of two large raveling sections of medium to high raveling in both of the lanes which seem to have resulted directly from paving mistakes.

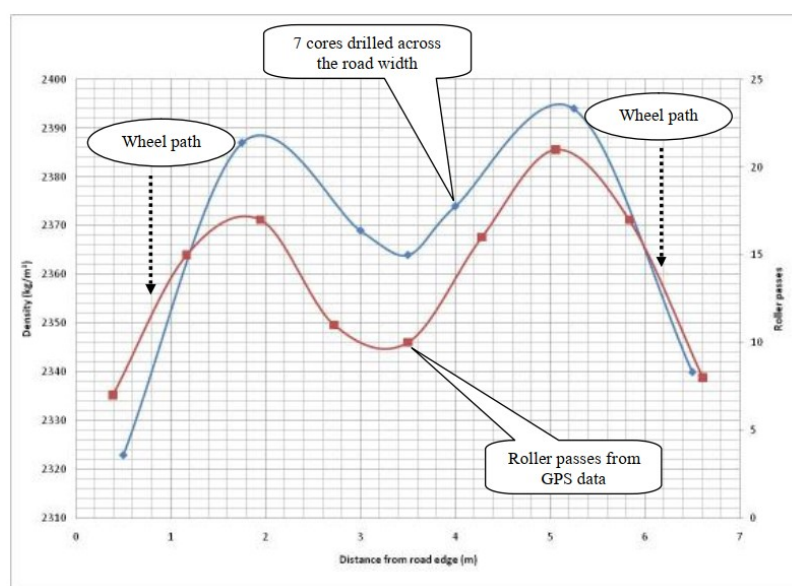
Figure 19: Comparing road density and roller passes for STAB layer position 240m (Miller & Dorée, Temperature profiling and monitoring of equipment movements during construction (Aziëhavenweg), 2008)

As can be clearly seen, there is a similarity between the roller passes and the density achieved. In locations where the roller compacted significantly less, like the sides and the middle, the density is also less. It is noticeable that the rollers compact mainly in the center of each lane and neglect to compact the sides of each lane as much as the middle. Based on this evidence, it can be concluded that less compaction does result in less dense asphalt.

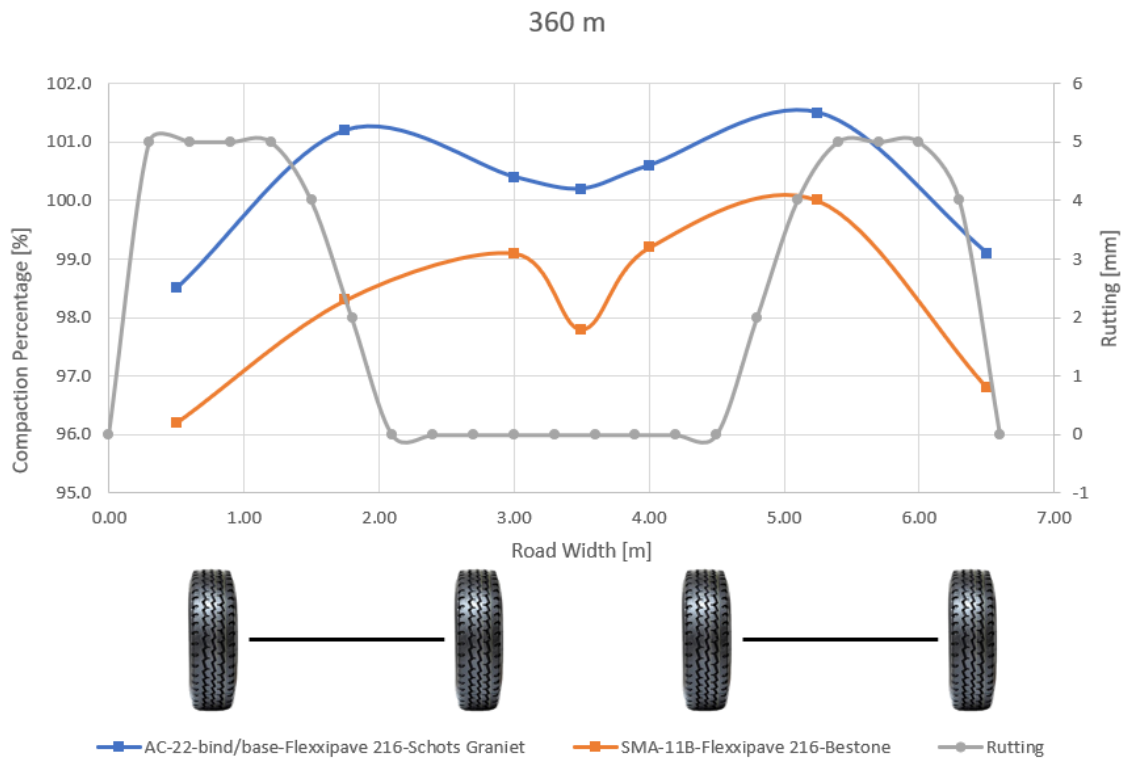
Figure 21: Compaction and Rutting vs. Road Width 360m

It is to be expected that rutting will predominantly arise in the wheel paths since that is where the forces are focused. In all these three graphs it is clear that the left wheel path for both directions has significantly less rutting than the right wheel path. Every graph shows that the left wheel path going both directions has

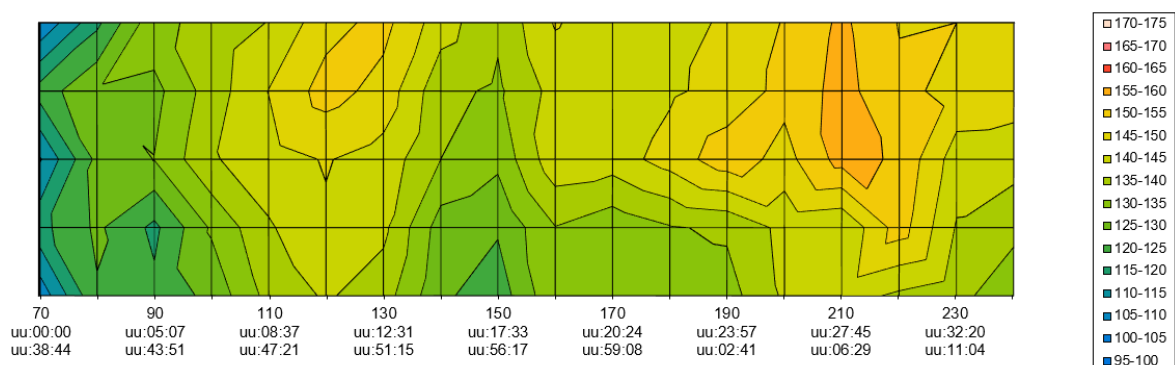
Figure 26: Temperature Contour Map Wednesday Lane 3

The temperature contour map for the third and final lane paved on Wednesday night can be seen in Figure 26. Similar to the second lane paved, the first 10 meters is significantly cooler than the rest of the contour map. However, the temperature difference is less severe than observed in lane 2. Also, similar to the second lane, this temperature contour map starts at the 70-meter mark. In this case that is because the lane does not start until 70 meters after the begin point of the other lanes. The average temperature at the 70-meter mark is 112.4 °C. After that the temperature rises to between 130 and 140 °C. At 210 meters is the only point that the temperature rises to above 150 °C. Except for the beginning, the rest of the mat has a good temperature homogeneity since there are no large and rapid temperature differences.

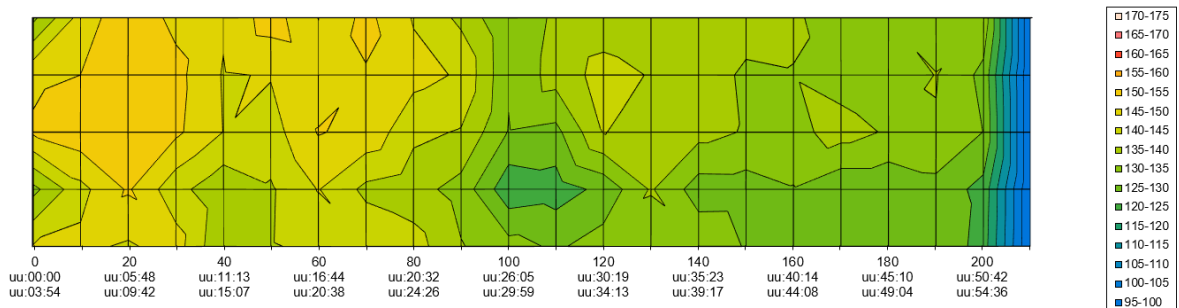
Figure 28: Temperature Contour Map Thursday Lane 2

The final temperature contour map is Figure 28 and shows the paving operations in the second lane paved on Thursday night. The first, roughly, 90 meters of the asphalt mat shows temperatures between 140 and 150 °C. After that the average temperature drops to the mid to low 130's. At the 200 meter point the average temperature is 127.6 °C. Then, the temperature drops to an average of 75.6 °C in 10 meters. At this point the paving operations are done. The temperature homogeneity of the most of this asphalt mat is quite good with only slight temperature differences between the first (0-90 meters) and second (90-200 meters) sections. However, the end has bad homogeneity since the temperature drops very quickly to very low temperatures.

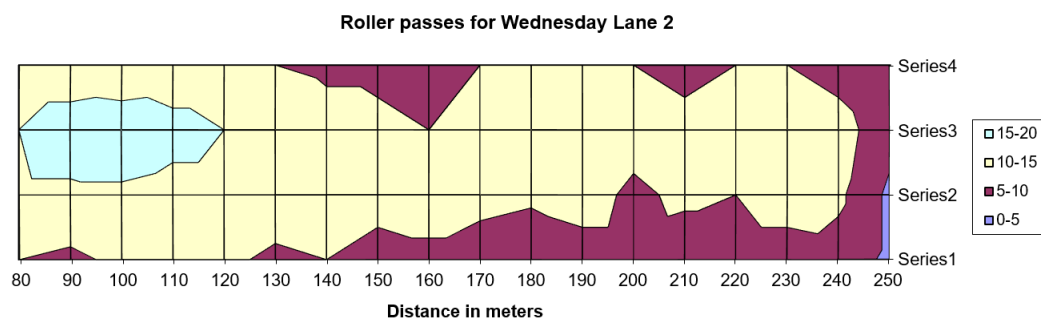
Figure 30: Roller Passes Map Wednesday Lane 2

Figure 30 Shows the roller passes for the section of lane 2 which was paved on the first night. Similarly, to lane 1, the majority of the section was rolled between 10 and 15 times. Large parts of the edges of the lane were rolled slightly less (5 to 10 times). Additionally, a large section at the beginning of the lane was rolled

more (15 to 20 times). There is one small section at the very end of the asphalt mat which was neglected and received only between 0 and 5 roller passes.

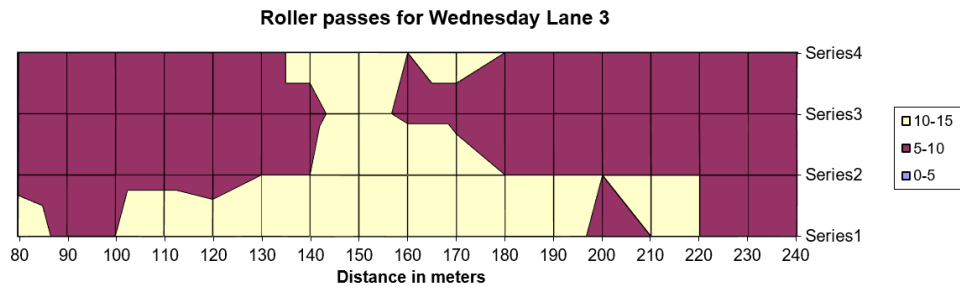
Figure 31: Roller Passes Map Wednesday Lane 3

The final section paved on Wednesday night was lane 3. The roller passes for that section can be seen in Figure 31. The majority of this section was rolled between 5 to 10 times. In the middle there is a large section where it was rolled slightly more at 10 to 15 times.

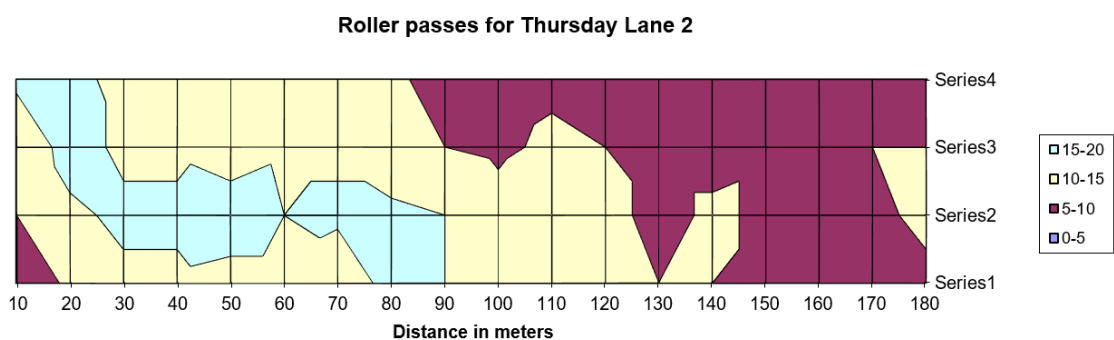
Figure 33: Roller Passes Map Thursday Lane 2

The roller passes for the second half of lane 2, completed on the second night, can be seen in Figure 33. As can be seen, the first half of the section, roughly speaking, was paved much more than the second half. The large majority of the first half has been rolled 10 to 15 times and 15 to 20 times. The same can't be said for the second half. For that section the majority of the asphalt mat was rolled between 5-10 times and sometimes 10-15 times. This suggests, as discussed in the section on compaction, that the roller drivers are often tempted to end the compaction process before it was truly finished.

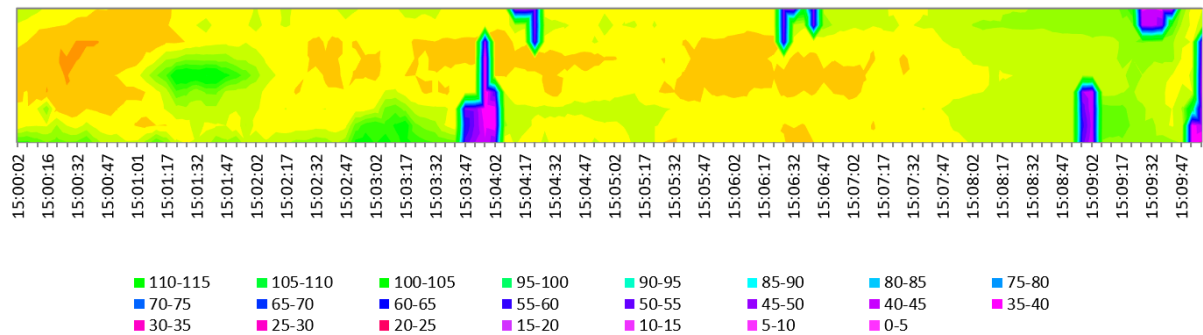
Figure 43: Temperature Contour Map Aziëhavenweg Method 2 Hour 4

The final roughly 9 minutes of paving (Figure 43) gives little insight into the entire process. The temperature homogeneity during this section is good, staying between 130 and 150 °C.

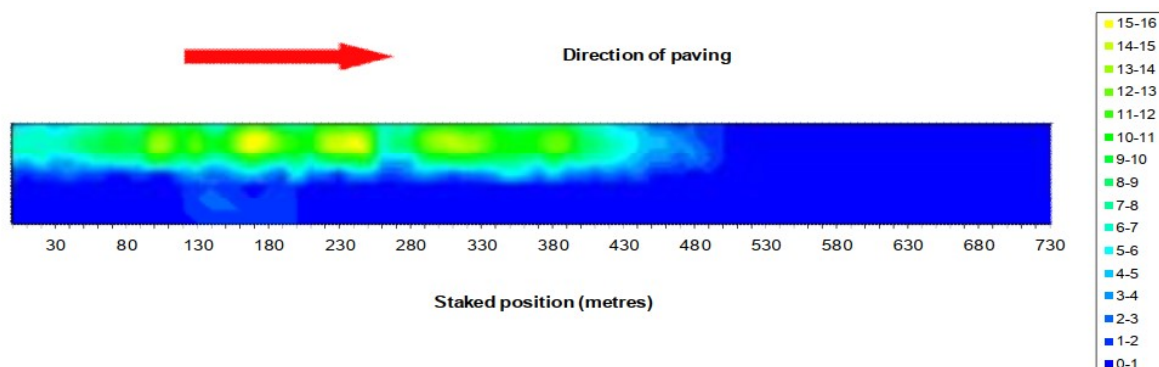
Figure 44: Roller passes Deadweight Roller 1

The roller passes displayed in Figure 44 show the first deadweight roller. There were two deadweight rollers working together, but the other one was not recorded. As can be seen this roller focused on predominantly the top half of the first 450 meters of the asphalt mat. The sections not focused on by this roller seem to not have been rolled over at all based on the legend. The area this roller did roll was covered in between 5 (the teal on the edges) and 16 times (the yellow in the middle). This shows that the coverage of this area still lacks consistency.

There is reason to believe that the roller not recorded covered the other half (bottom half) of the asphalt mat. First of all, in the report it is stated that the deadweight roller was observed to have behaved as it did for the bottom layer (STAB). From the roller passes recorded for the bottom layer it is clear to see that the two deadweight rollers worked together to achieve a more even compaction (Miller & Dorée, Temperature profiling and monitoring of equipment movements during construction (Aziehavenweg), 2008). This is also logical since it is known that roller operators often work together in this way (Jagt, 2019). Because of these reasons, it is expected that the deadweight roller which was not recorded did act in this way. However, this does not explain why the end of the asphalt mat was compacted significantly less.

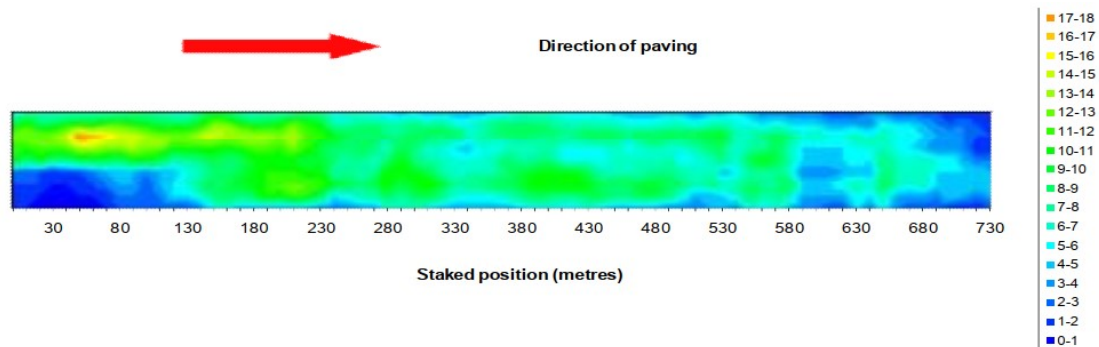
Figure 45: Roller Passes Tandem Roller 1

The first tandem roller's roller passes (Figure 45) are significantly more spread out over the entire asphalt mat than the passes recorded for the deadweight rollers. There are visible locations in which the roller did little to no compaction. These areas are the bottom left corner and some sections at the end of the asphalt mat. The largest part of the asphalt mat was evenly covered. The majority of the areas were rolled between 5 to 6 times on the edges and 13 to 14 times in the center. There is only one area where the asphalt has been rolled visibly more (around 17 to 18 times); located in the top left corner.

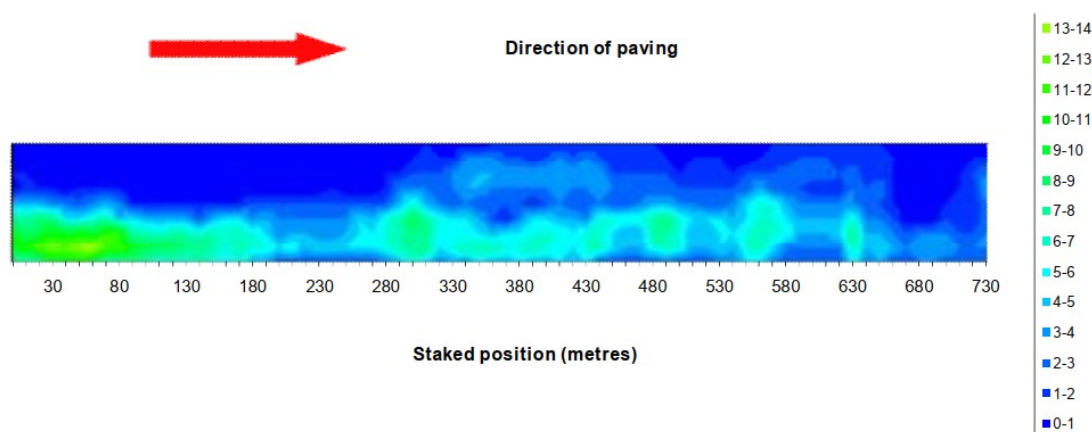
Figure 46: Roller Passes Tandem Roller 2

The second tandem roller shows much less compaction than the first one (as can be seen in Figure 46). The majority of the asphalt mat was not rolled by this roller. It is clear that there was some coordination between the roller operators because the major area neglected by the first tandem roller was hit the most by this tandem roller with between 5 to 6 passes on the edges and 12 to 14 passes in the middle. The other

large area not rolled by the first roller, the end of the asphalt mat, was also largely neglected by the second roller. Because of this, the first roughly 600 meters was covered much better than the last 130 meters.

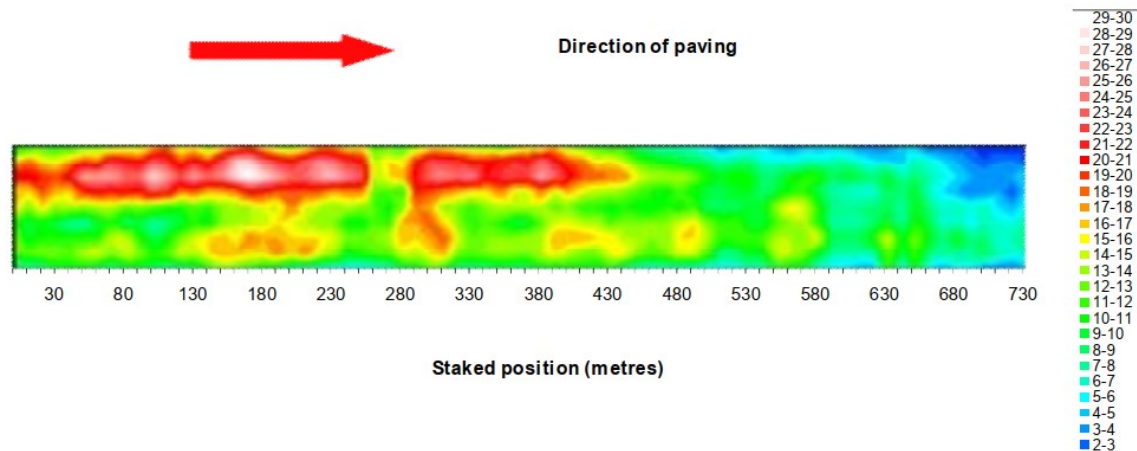
Figure 47: Overall Roller Passes (excluding one deadweight roller)

In appendix section 8.2.2 an extensive analysis on the compaction coverage of the Aziëhavenweg along with the paving patterns of each individual roller can be found. The compaction contour plot showing the total number of roller passes for the entire road is Figure 47 in 8.2.2. As stated, the coverage of one of the

Combining the previous three figures generates Figure 47. This figure shows the entire compaction of the top layer on the Aziëhavenweg. As is expected, the end of the asphalt mat was significantly less compacted than the beginning. From about 480 meters onward sections that were rolled significantly less, to none begin appearing. The end (from about 660 to 730) was compacted even less. This section is almost entirely neglected. A very probable reason for this is human error and the roller operators' tendency to quit compaction relatively soon after the paver is done (Jagt, 2019). On the other hand, the first part of the asphalt mat was compacted significantly more. It is clear that the top half shows more roller passes than the bottom half. Again, this is because the roller passes for one of the deadweight rollers was not recorded. S explained earlier, there is reason to believe that the second deadweight roller did compact the bottom half which would, roughly, even out the compaction in that sense. There is no reason to believe that the second deadweight roller did more rolling at the end of the asphalt mat, so that is not expected.

Some small parts of the asphalt mat were roller up to 30 times (in white). These parts are at the center of areas which were rolled between 20 and 25 times (red). Furthermore, the majority of the asphalt mat was covered in 8 to 14 roller passes (green) with small sections having been rolled up to 17 or 18 times (yellow/orange). As stated, the end of the road was only rolled between 2 to 8 times (blue and teal).

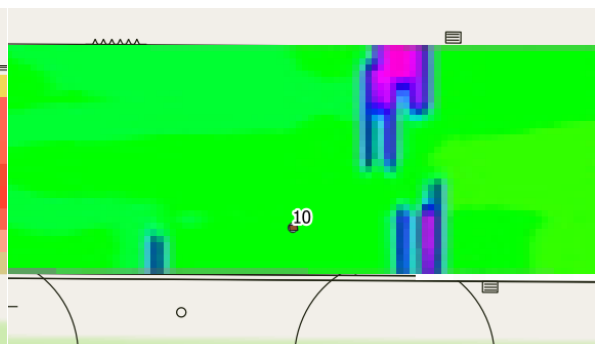
Figure 57: Point 10 TCM Method 2

- Point 10: light raveling

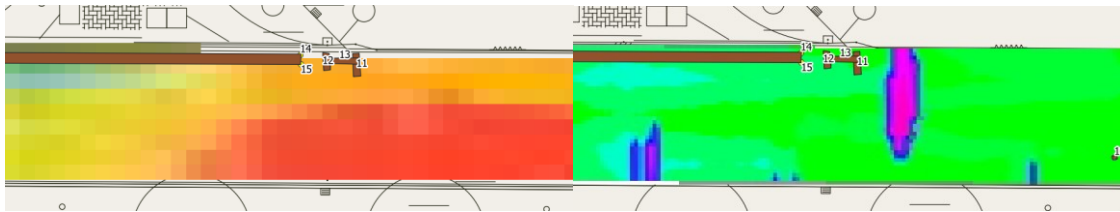
Figure 59: Points 11, 12 and 13 TCM Method 2

- Points 11, 12 and 13: Connected Heavy Longitudinal and Transverse Cracking

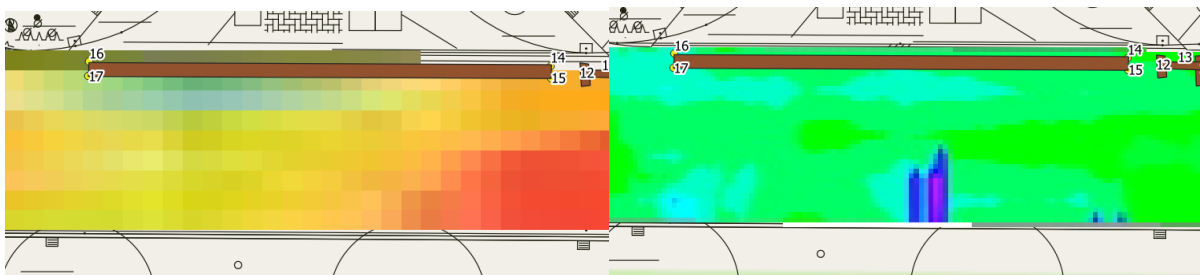
Figure 62: Points 14-17 TCM Method 1

- Points 14-17: patching

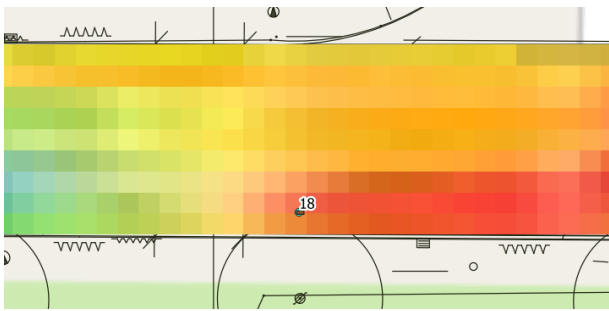
Figure 65: Point 18 TCM Method 1

- Point 18: light raveling

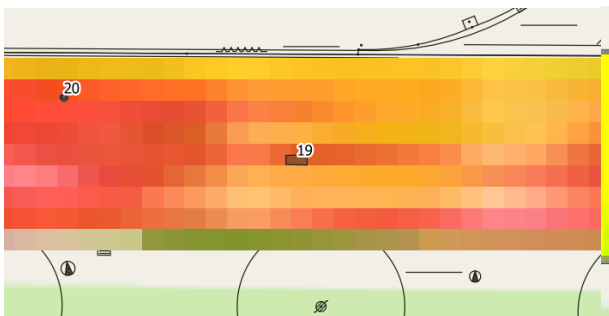
Figure 68: Point 19 TCM Method 1

- in an area where the temperature changes rapidly from 150-160 °C to 110-120 °C		
<i>Point 19: Light Raveling</i>	No connection with the data	No connection with the data	Possible connection with the data - in an area with roughly 15 roller passes
<i>Point 26: Light Raveling</i>	Possible connection with the data - Slightly off of the TCM, but next to a location with a severe stop/cold spot (<100 °C)	No connection with the data	No connection with the data
<i>Point 27 and 28: Light Longitudinal Cracking</i>	Connection with the data - Exactly in a cold stop area where the temperature changes from 150-160°C to under 100°C	No connection with the data	Connection with the data - On the side of the road where this is located very few roller passes were used (5-6)
<i>Point 29: Light Transverse Cracking</i>	Connection with data - In an area where temperature changes from 150°C to 120°C	Possible Connection with data - In a colder are, but not near a transition	Connection with the data - On the side of the road where this is located very few roller passes were used (5-6)

- Point 19: light raveling

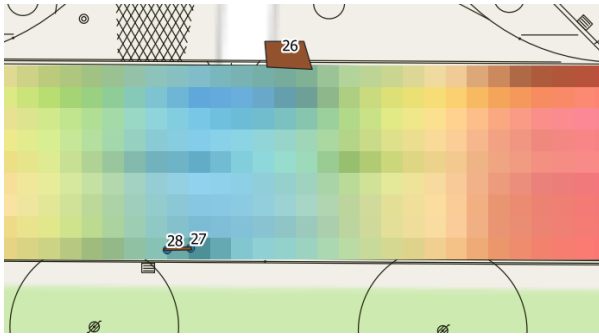
Figure 71: Point 26 TCM Method 1

- Point 26: light raveling

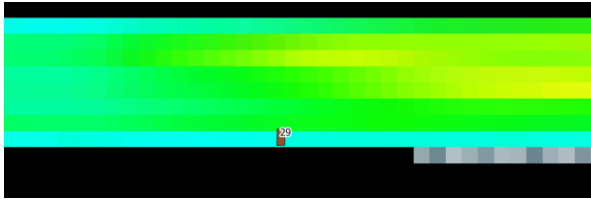
Figure 79: Point 29 Roller Passes Map

- Point 29: Light Transverse Cracking

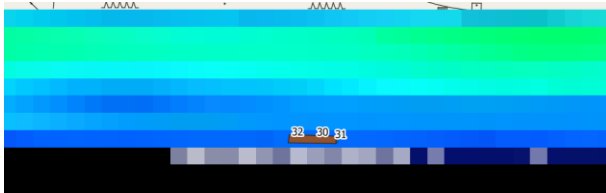
Figure 82: Points 30, 31 and 32 Roller Passes Map

<i>Points 30, 31 and 32: Light Longitudinal Cracking</i>	No connection with the data	Possible Connection with data - In a colder are, but not near a transition	Connection with the data - On the side of the road where this is located very few roller passes were used (<5)
<i>Points 33 and 34: Medium Longitudinal Cracking</i>	No connection with the data	Possible Connection with data - In a colder are, but not near a transition	No data available

- Points 30, 31 and 32: Light Longitudinal Cracking

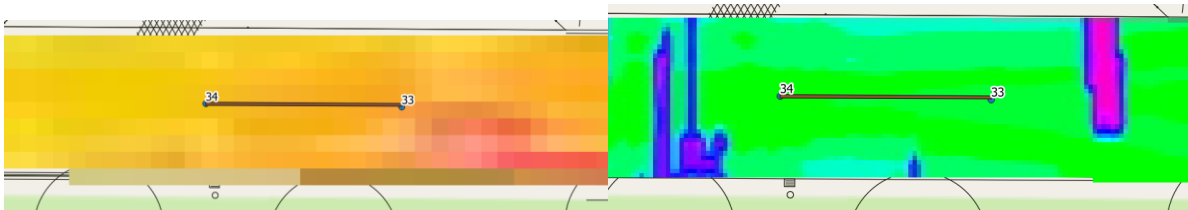
Figure 83: Points 33 and 34 TCM Method 2

- Points 33 and 34: Medium Longitudinal Cracking
