THESIS

UTILIZATION OF GEOTAGGED PHOTOGRAPH, REMOTE SENSING AND GIS FOR POST-DISASTER DAMAGE ASSESSMENT IN CANGKRINGAN SUB-DISTRICT, SLEMAN, YOGYAKARTA AS VOLCANIC DISASTER-PRONE AREA

Thesis submitted to the Double Degree M.Sc. Programme, Gadjah Mada University and Faculty of Geo-Information Science and Earth Observation, University of Twente in partial fulfillment of the requirement for the degree of Master of Science in Geo-Information for Spatial Planning and Risk Management

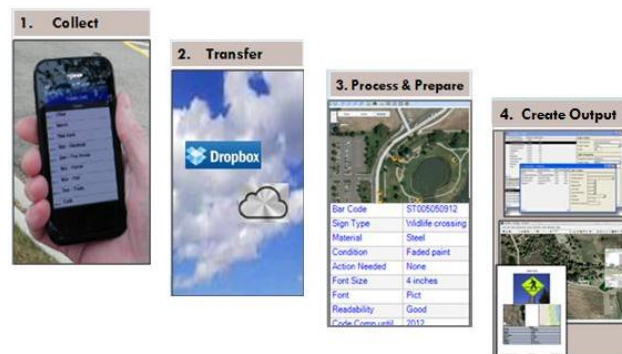
Figure 1. GeoJot for geotagging that can be used for disaster damage assessment (Geospatial Experts, 2012b)

The development of geotagged photograph and Geographic Information System can make more possibilities for utilization in disaster management. According to Welsh et al (2012), “*geotagging is easy to undertake and is potentially cost effective*”. Geotagged photos can be generated directly through the GPS equipment and digital cameras (Yaegashi et al, 2009). With the current technological developments, the smartphone is also equipped with geotagging facility. The use of smartphone allows the use of certain applications for geotagging. One of the applications on the Android-based smartphone for geotagging is GeoJot. Geojot application produces geotag photos with GPS coordinates and can be used also to add the attribute data associated with geotag photos such as *name, condition, value, etc* (Geospatial Experts, 2012a). The attributes data of geotag photos can be used as input for analysis in GIS as shown in figure 1 below:

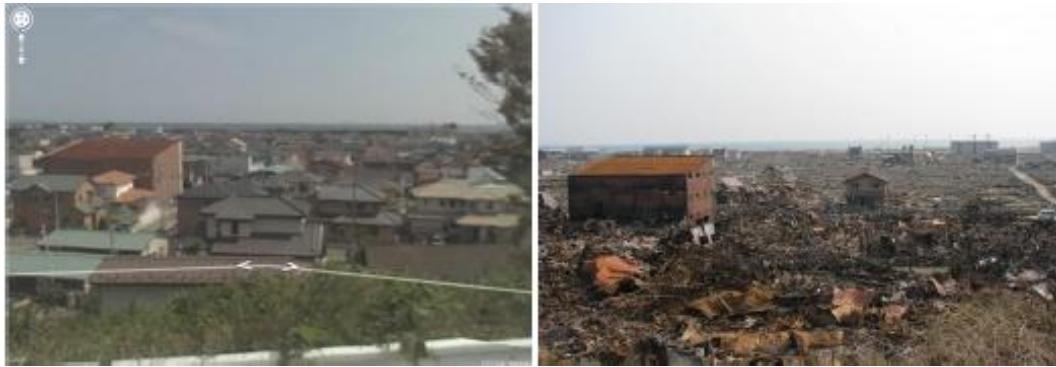
Figure 6. Disaster damage seen from geotagged photograph (Fontugne et al, 2011)

According to Welsh et al (2012), “*Geotagging photographs could be considered as an innovative field technique which brings together several existing fieldwork techniques*”. Maiyo et al (2010) explains that by using geotagged photograph database system users can search for various specific information at specific locations and search location based on infrastructure damage due to disasters. Accurate information of damage caused by disasters is needed urgently by the government and insurance companies. Accurate data collection, geotagged photos and video documentation required for accurate reporting (RunMobile, 2012). Availability of geotagged photos is very important to help speed up the formal assessment of damages by the government after the disaster subsided. This has been done in Brown County, South Dacota where geotagged photos with location information and time of capture helps FEMA to assess damage of infrastructure due to flooding (Geospatial Experts, 2010a). Figure 6 shows geotagged photograph sample of the condition of the area before and after the disaster.

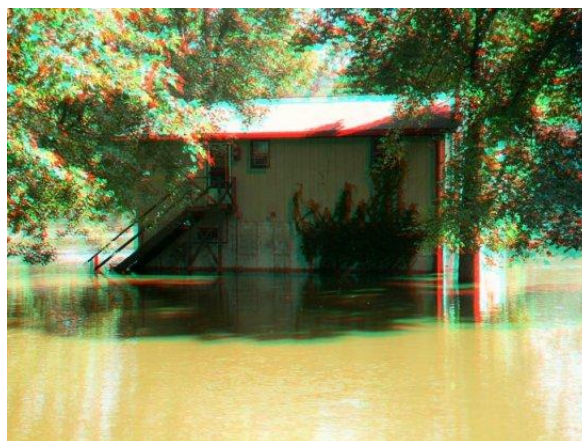
Figure 8. Anaglyph 3D Photograph of flooded house (Fototing, 2007)

“Anaglyphs are one of the simple and economical methods for 3D visualization” (Ideses et al, 2005). Dietz, H. G. (2012) explains that anaglyph is an image that creates the impression of three-dimensional depth when viewed using glasses with a particular filter. According to Doneus M, Hanke K. (1999), *“The detectability of depth differences decreases with the squared distance from the observer to the object. Its capacity is very high with the object close to the observer”*. Geotagged photographs can be processed into Anaglyph image using certain software. Example Anaglyph photo which depicted the condition of the building affected by disaster is as shown in figure 8 below.

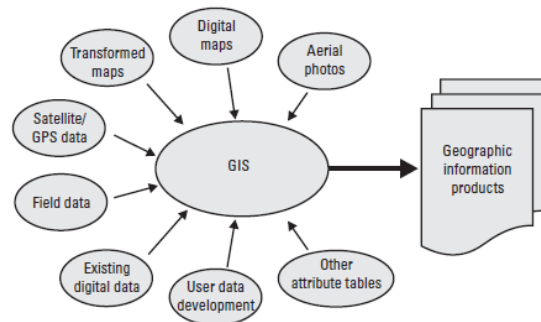
Figure 9. Geographic Information System path (Galati, 2006).

Geographic Information System is “a collection of computer, hardware, software, and geographic data for capturing, storing, updating, manipulating, analyzing, and displaying all forms of geographically referenced information” (Kennedy, 2001). Geographic Information System (GIS) consists of several parts as shown in the figure 9 below.

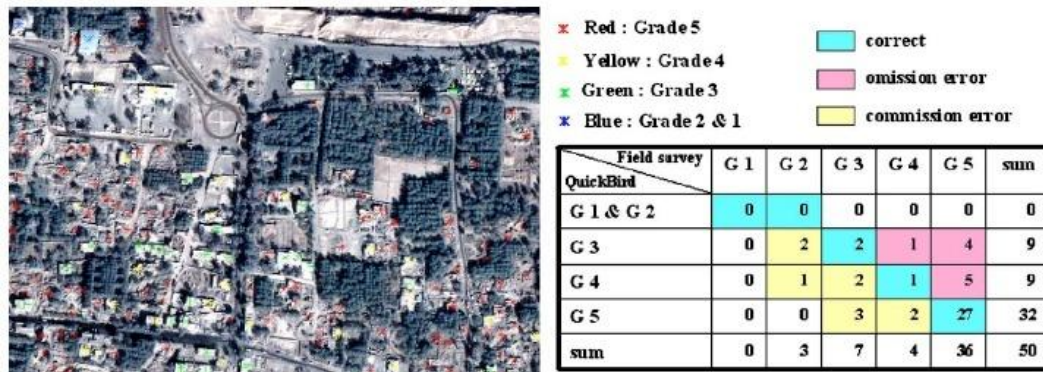
Figure 13. Accuracy assessment of the damage interpretation (Hisada et al (2005) in Yamazaki et al, 2005)

The results of visual interpretation must be compared with field surveys to determine the level of accuracy assessment of the damage as figure 13.

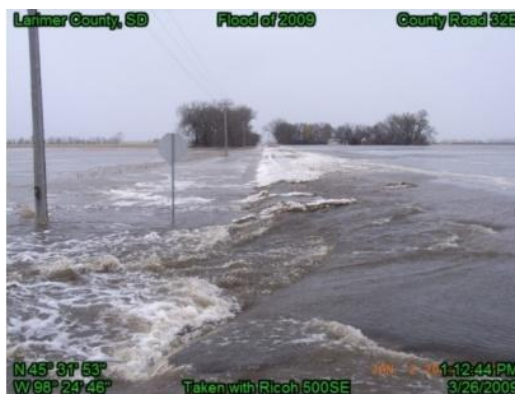
Figure 14. Geotagged photograph integrated with field data entry (Geospatial Experts, 2010c).

The location information is “*the most important attribute of information*” that can be managed with GIS and elements required “*in disaster management and response*” (Kevany, 2005). Further, Kevany (2005) explains that an application to enter data in the field that is integrated with a digital camera that records the disaster conditions is useful for the assessment of damages. Figure 14 & 15 below shows geotagged photograph integrated with field data entry to describe the disaster event and damage assessment from photograph for flood disaster.

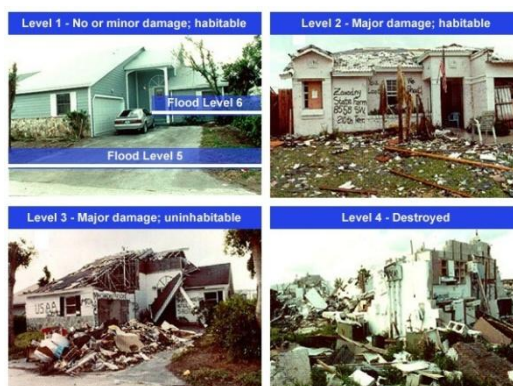
Figure 15. Damage assessment from photograph (Broward, n.d.)

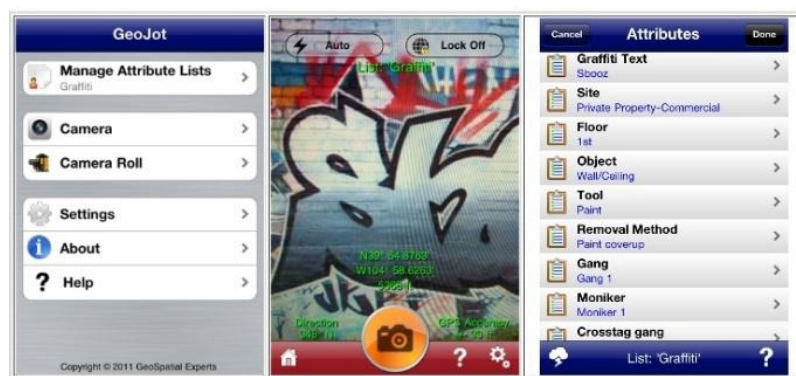
Figure 19. Attribute design of geotagged photograph in Geojot (Geospatial Experts, 2012d)

Further, the attributes design of the geotagged photograph is drawn on the Geojot application. This design is adapted to the post-disaster damage assessment criteria of disaster management agency of Indonesia and other source. Figure 19 below show the example of attribute design of geotagged photograph in Geojot.

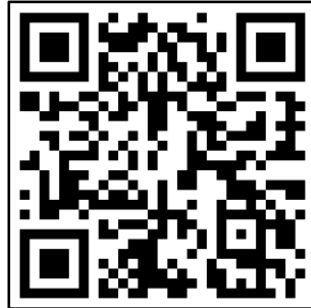
Figure 20. QR code sample for building identification

QR code (Quick Response Code) for identification of the building using Geojot combine with QR code scanner software for Android is designed as a scenario for combination of spatial data from satellite image interpretation and attribute of geotagged photos. QR code designed and printed using Zint Barcode Studio and attached directly to the building that were sampled in the scenario. QR code is designed with a format like this format:

Example: **Cangkringan\Argomulyo\Bakalan\Sosro Supriyono\19**

Figure 20 below shows the QR code sample for building identification as text above.

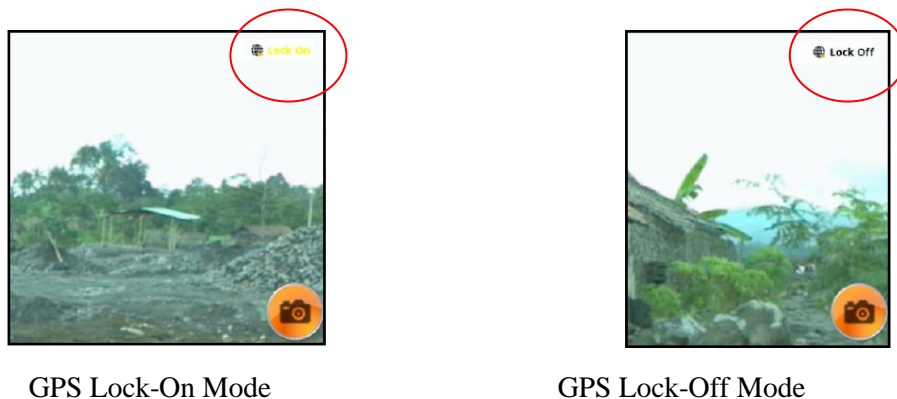
Figure 21. GPS Lock-Off/On Mode for geotagged photograph in Geojot

In addition, the GPS scenario Lock-Off mode and GPS Lock-On mode when shooting object will also be conducted to determine their role in the combination of attributes photo and satellite image interpretation results as shown in the figure 21 below.

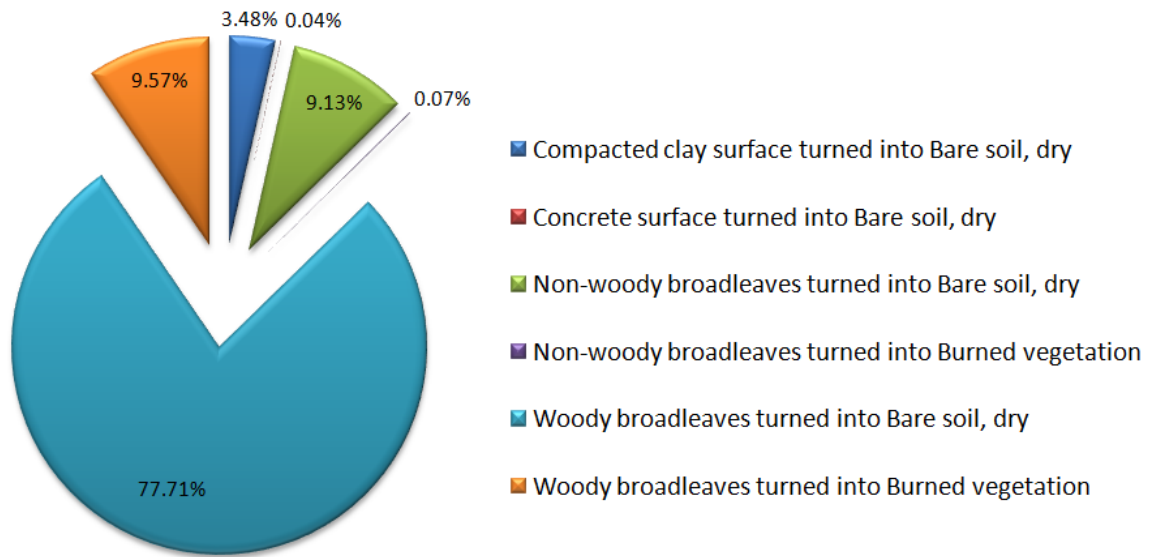
Figure 33. Pie chart of landcover changes after Merapi volcanic disaster 2010

According to the figure 33 and table 26 above, most of the area changed after the eruption of Merapi is the area with the type of land cover woody broadleaves (77.71 % into bare soil and 9.57 % into burned vegetation). Another major change is the landcover type of non woody broadleaves that turns into a bare soil (9.13 %). Compacted clay surface also experienced considerable changes in land cover that turns into bare soil (3.48 %).

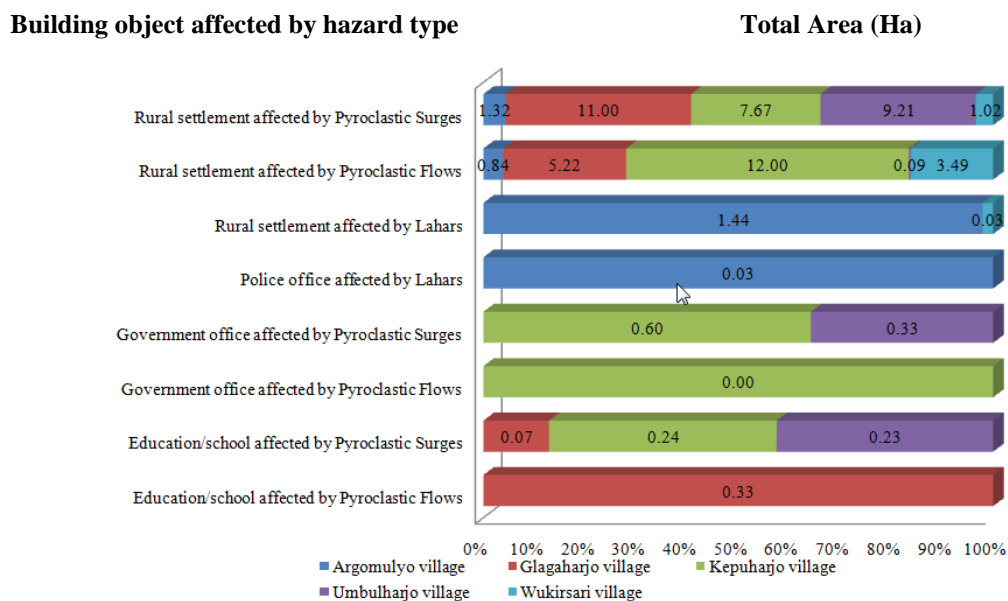
Figure 35. Building object affected by hazard type of Merapi volcanic eruption 2010

The figure 35 below presents a comparison of specific land use for building objects in each of the villages in Cangkringan sub-district affected by pyroclastic flows, pyroclastic surges and lahars. Settlement widely affected by pyroclastic surges are situated in the Glagaharjo, Umbulharjo and Kepuharjo village respectively 11 Ha, 9.21 Ha, and 7.67 Ha, while the largest area of settlement affected by pyroclastic flows is located in the Glagaharjo and Kepuharjo village respectively 12 Ha and 5.22 Ha. Settlement for the widest area affected by lahars is located in the Argomulyo village with total area of 1.44 Ha.

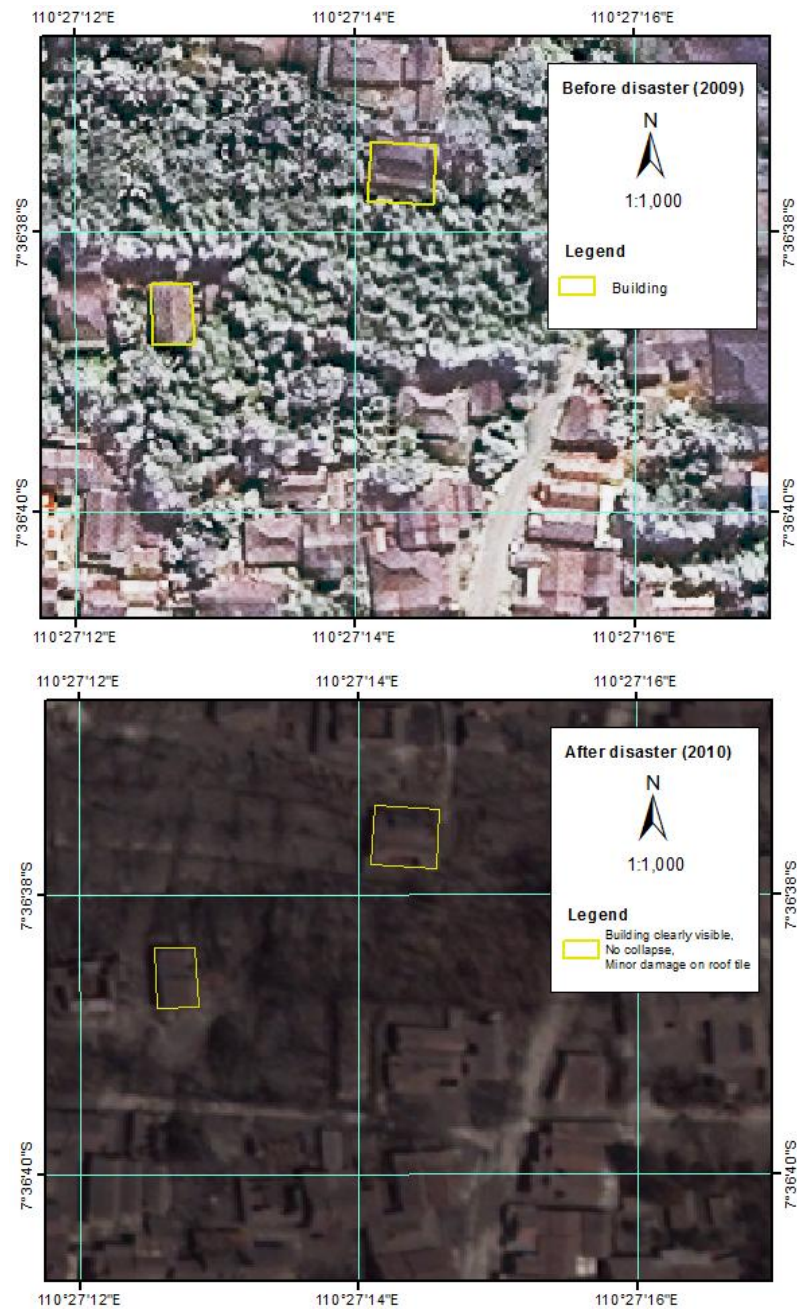
Figure 43. Building with criteria clearly visible/building still stands, no collapse, and minor damage on roof tile

g. Building clearly visible/building still stands, no collapse, and minor damage on roof tile

In figure 43 below that compare imagery before and after disaster, visibility of building is very good, no collapse (no shape change) and only minor damage happen in roof tile that can be identified by different color pattern (brownish gray color interspersed with black) in roof tile in a small area. The actual color of the tiles on the roof was brown. Gray color on the roof is the color of volcanic ash material that covered the roof. The black color is caused by the small portion of tiles that has been damaged.

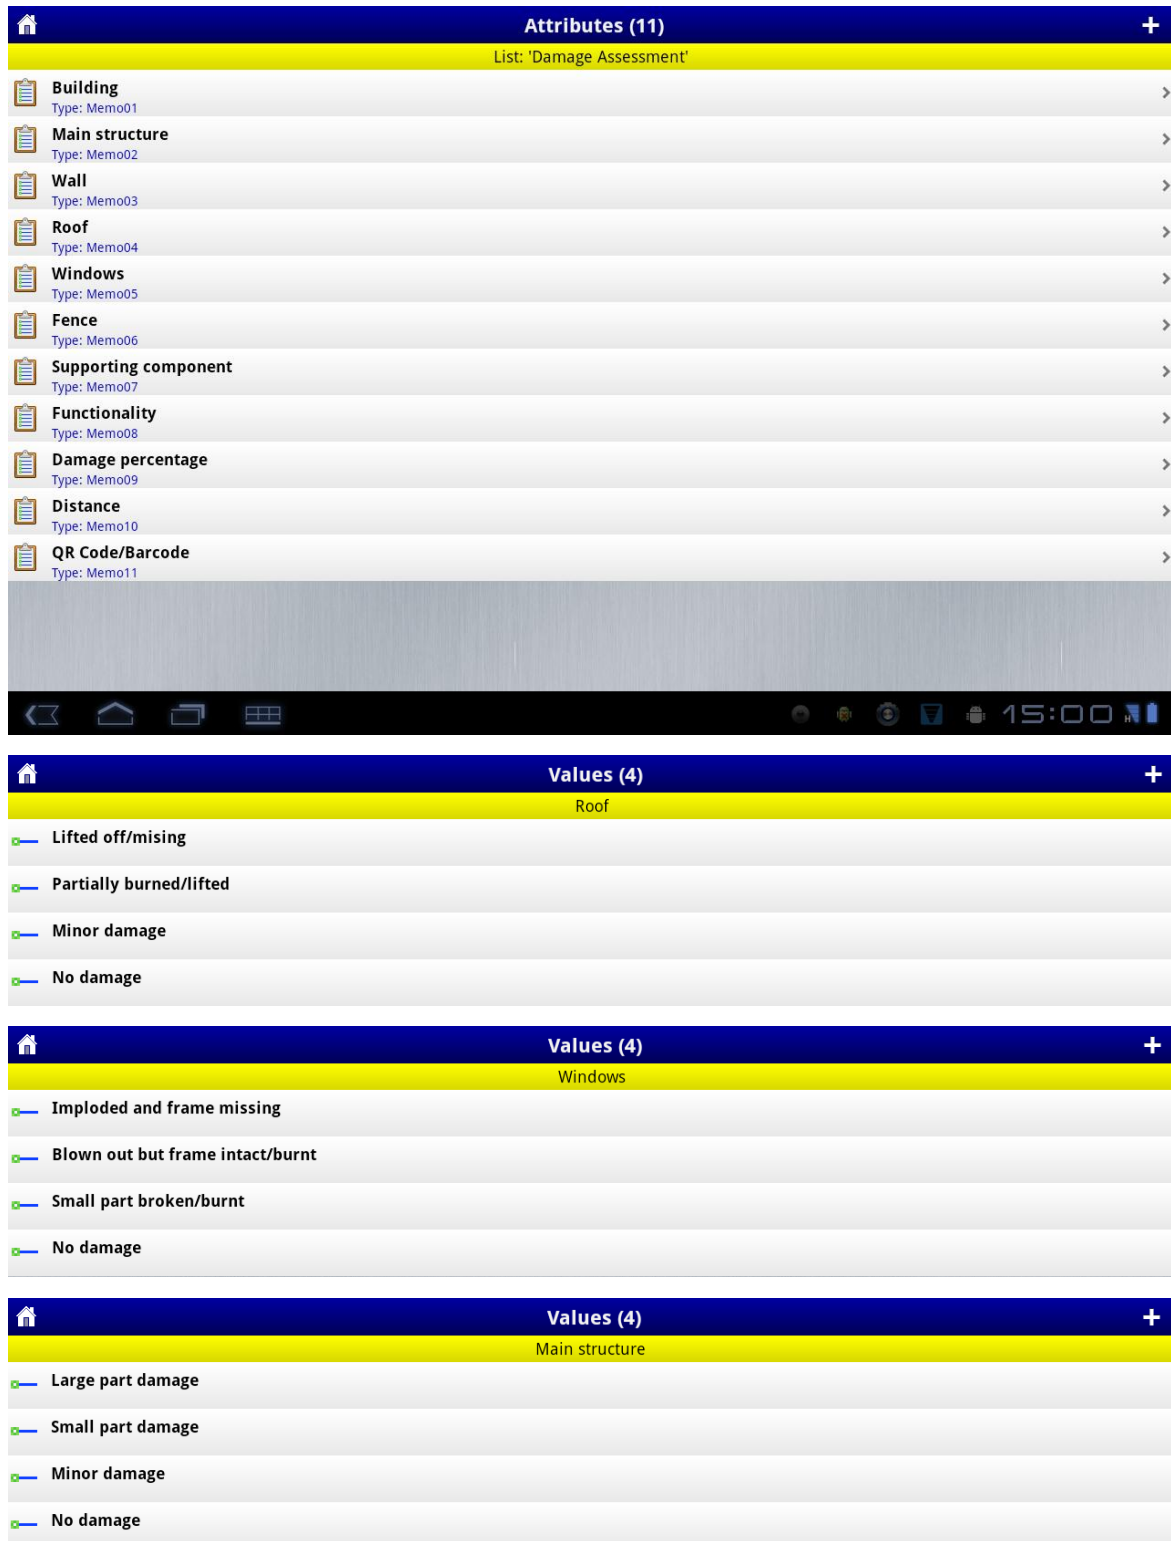
Figure 48. Geojot photos attribute list for pyroclastic flow/surge hazard on building damage

Based on the attributes of damage to buildings, damage assessment list in Geojot is created as shown in Figure 48.

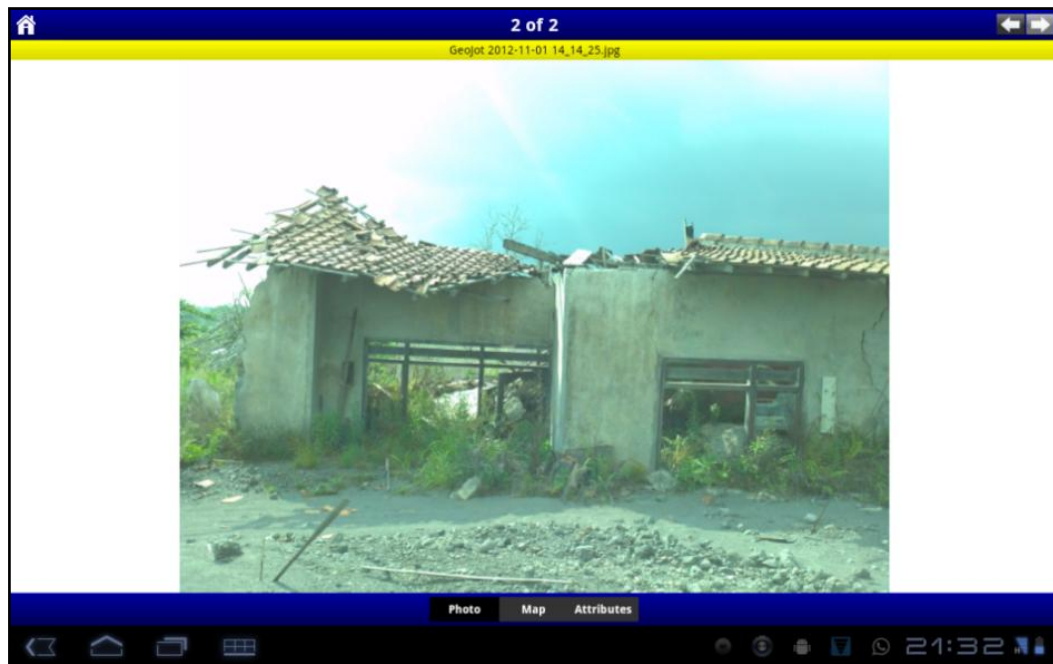
Figure 49. Building example after volcanic disaster

Figure 49 is an example of the interpretation of damage to buildings in the Bakalan sub-village, Argomulyo village, Cangkringan by using Geojot and GPS Photo Link application. Geojot is used to generate geotagged photograph and to fill the attributes of geotagged photograph, while the GPS Photo Link is used to create reports and spatial data based on photographs from Geojot with attributes that have been filled.

In the building above in figure 49, it can be seen that the large building collapse happen, large part damage on main structure, most broken/cracked/removed, partialy lifted on roof, blown out on windows but frame intact, totally damage on supporting component, and harm to be functionalized. The figure 50 below shows the data entry of building damage interpretation from geotagged photograph loaded on the Geojot attributes form:

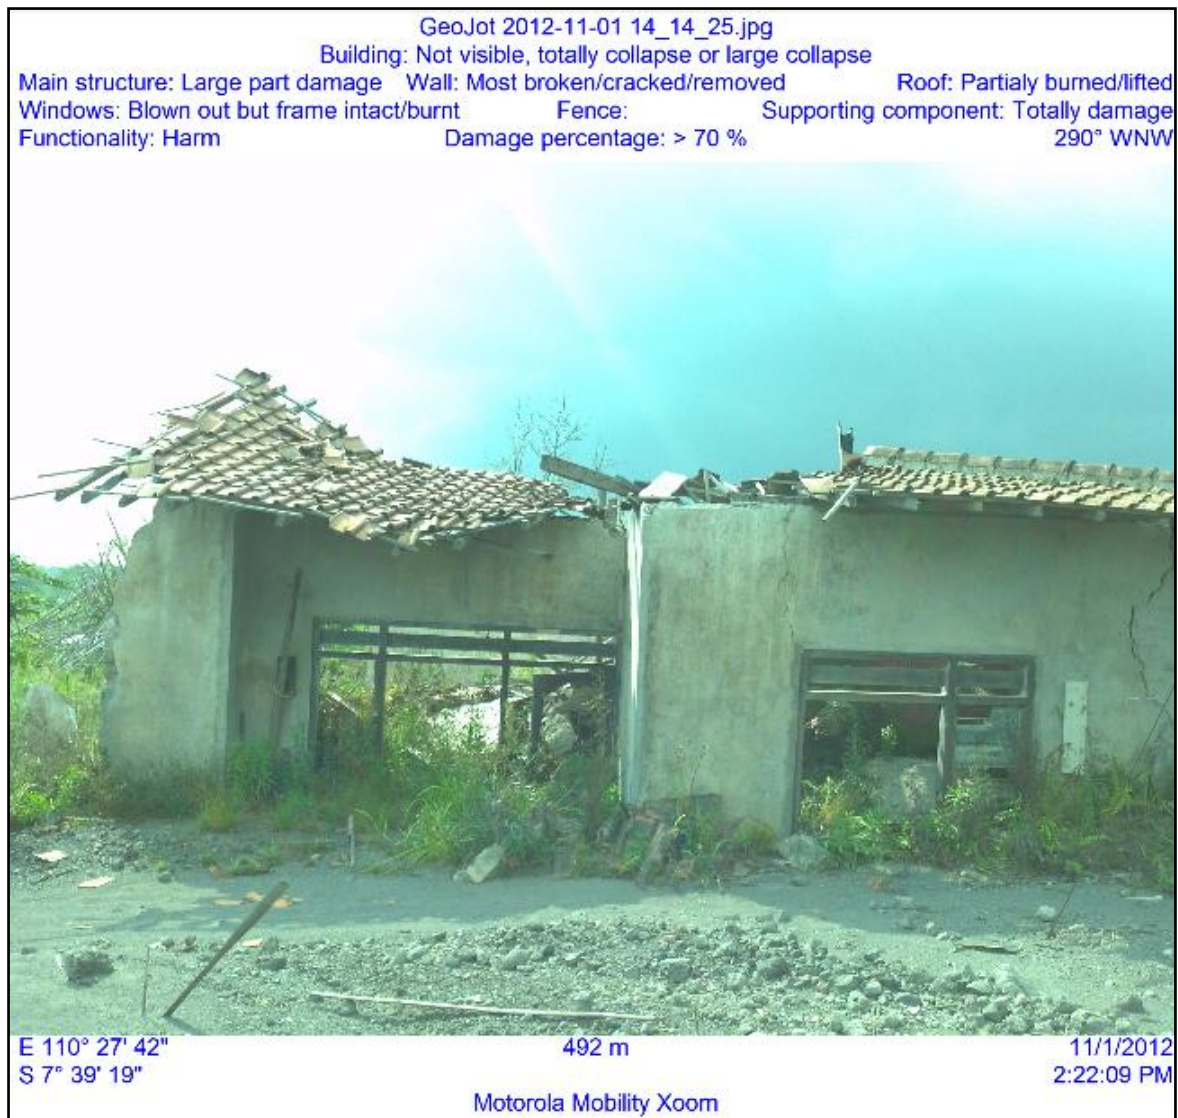
Figure 51. Building damage interpretation report from Geojot to GPS Photo Link (direction of 290 ° WNW)

The geotagged photograph as shown in figure 51 above was taken with GPS Lock-Off mode so that the coordinates listed are the coordinates of camera positions. Figures 290° WNW is the direction of the shooting (the camera towards the object to be photographed). If one side of the building are still not able to describe the entire building, it would require another geotagged photos taken from the other side can clearly describe the damage. The geotagged photograph in figure 52 was taken from the other side (direction of 187° S) showing the building (yellow line) had collapsed so that the only remaining building on the front side, while figure 53 shows Field of View (FOV) in Geojot online map by direction of 187 ° S from camera position to the building object. Blue circle with black arrows show the coordinates / location where the camera captures the object building and shooting direction, the purple triangle shows Field of View (FOV) of shooting towards the direction of the object and yellow arrows indicate the object photographed buildings. Accuracy of the GPS when photographing that building object is 5 meters. GPS accuracy that can be obtained when shooting with geotagging Android devices are \pm 5-10 meters. Desired minimum accuracy limit for the GPS when photographing can be determined on Geojot settings.

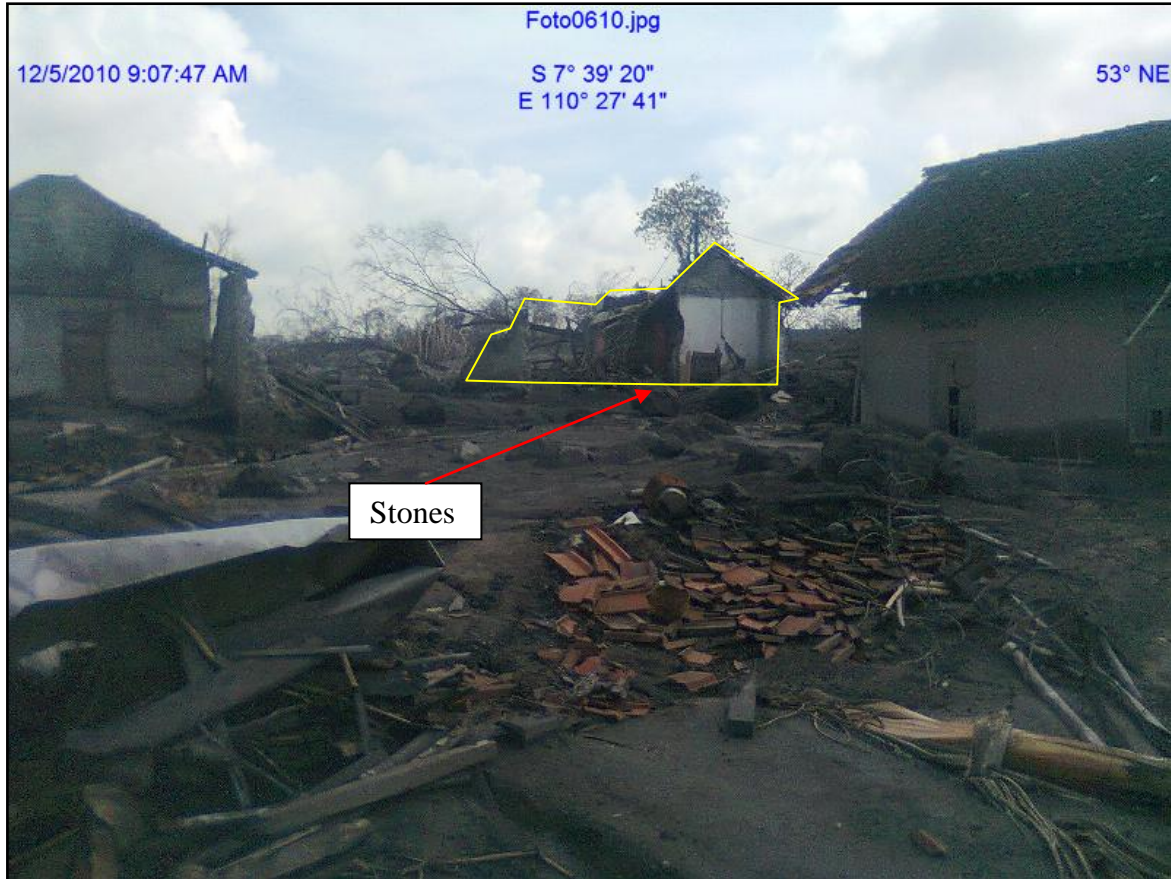
Figure 54. Nearest condition after volcanic disaster 2010 (manually geotagging)

The figure 54 below shows the condition of the current building damage after the eruption in November 2010. Many large stones strewn around the damaged building (damage caused by pyroclastic flow) which is an indication of the cause of damage to the building.

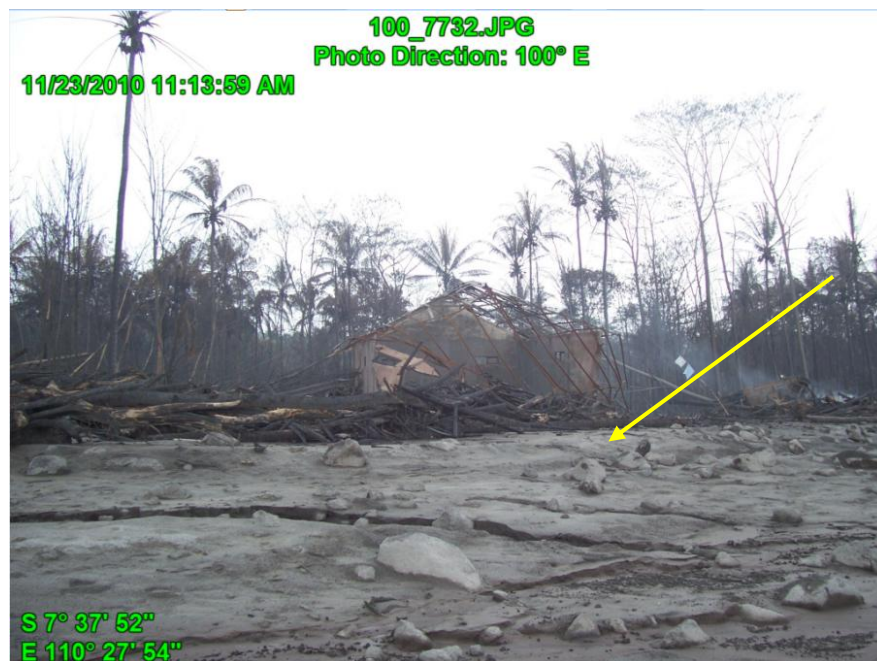
Figure 55. Building that damage by pyroclastic flow and pyroclastic surge
(Photo source: BPBD Sleman)

The damage described in the above description is shown in the figure below 55:

In figure 55 above, half of the building affected by pyroclastic flow until the building is lost. The building that still stands was affected by pyroclastic surges and trees missiles. The structure of the remaining roof made of iron curved because of the heat and trees missiles.

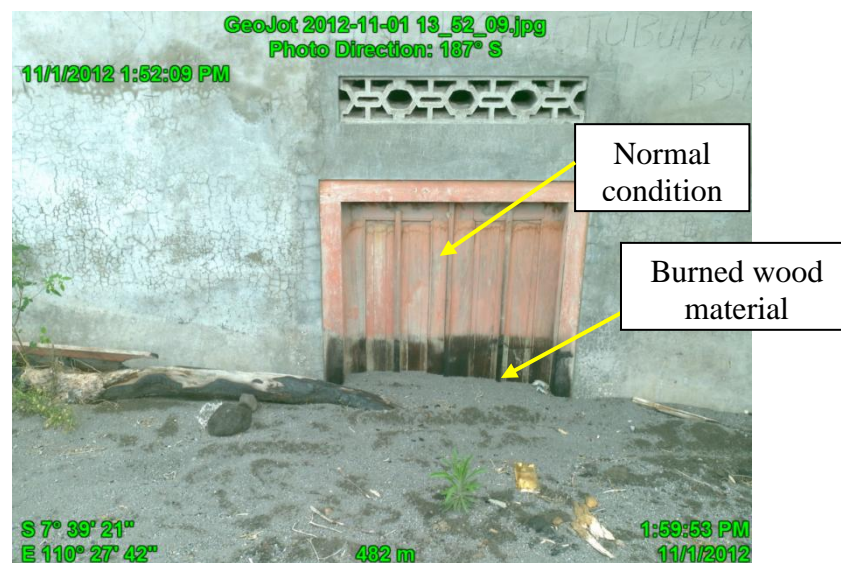
Figure 56. Building that damage by pyroclastic flow with lower intensity

For pyroclastic flow with lower intensity, the material that buried part of the building will have an impact on fire/burned on the windows or doors made of wood because the material is very hot. Figure 56 shows the impact of pyroclastic flow with the lower intensity.

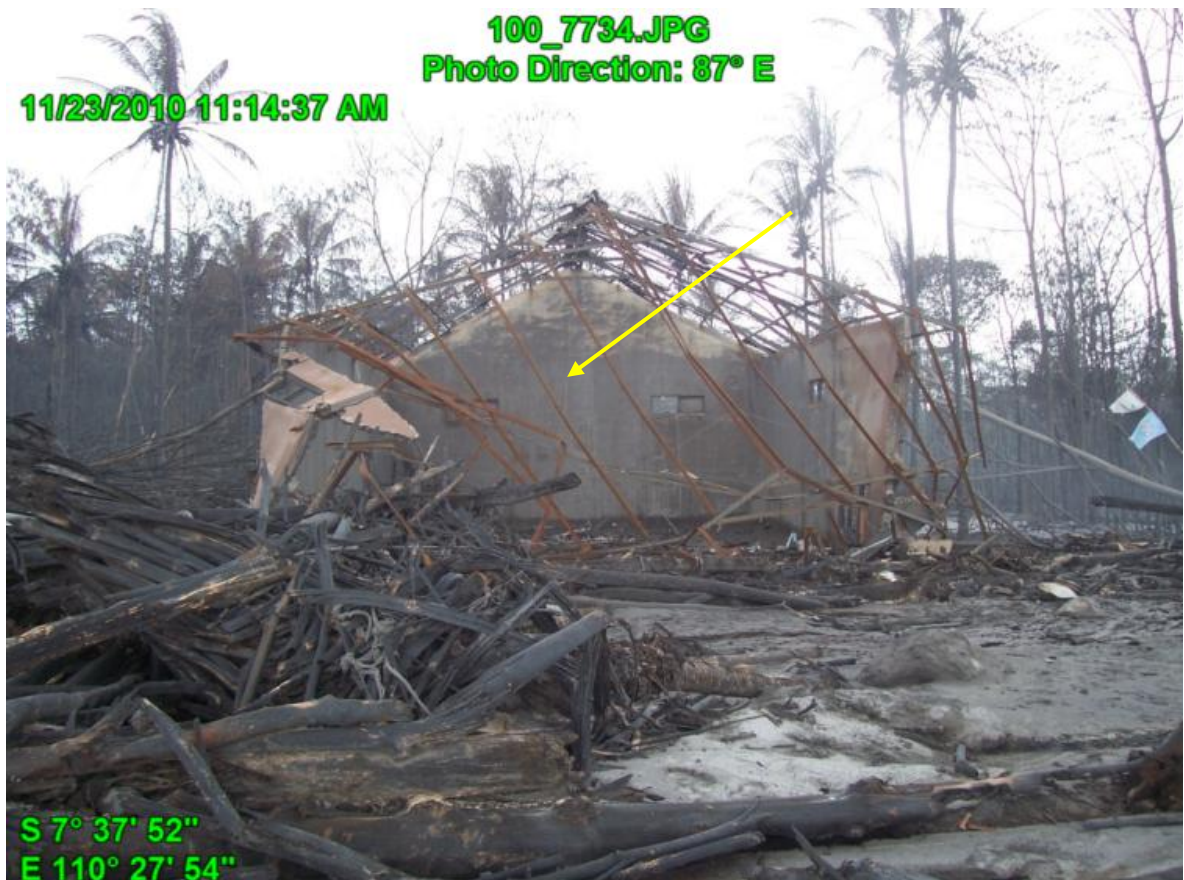
Figure 57. Building that damage by pyroclastic surge (Photo source: BPBD Sleman)

- The building could be lost and buried by a relatively thick material
- The structure of the building that is still standing is characterized by missing or burned window or broken of windows glass, or the frame is still there or burned.
- Missing or damaged roof but the building is still standing
- Most of the building ruins can be found

Damage to buildings due to pyroclastic surges can be described as picture 57 below:

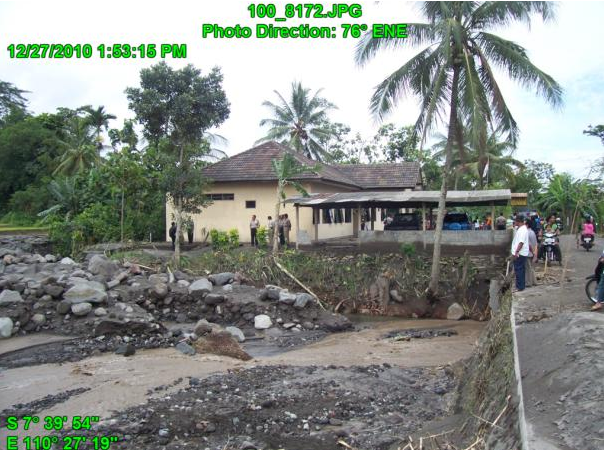
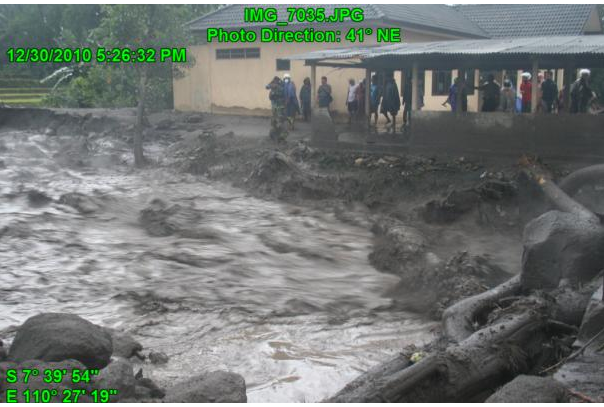
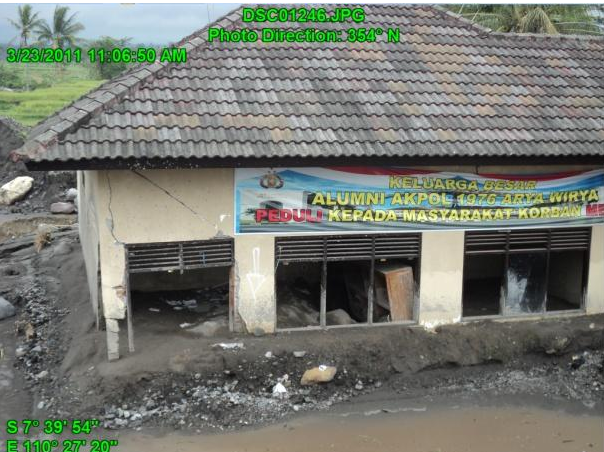
Figure 58. Building that damage by lahars (Photo source: BPBD Sleman)

- The building may be a total float if that is on the main line of lahars
- Building buried by volcanic material, but wood on the windows and doors do not burned
- The building is still standing, no damage on roof
- The wall of the building partially lost

Figure 58 below illustrates the damage caused by lahars:

Based on the figure 58 above, after the lahars hit the building, the walls of the building partially lost in one corner of the building and surrounding suffered cracks, structural columns at the corners of the building was large damaged, missing window glass, sand piles in buildings up to a half meter. Damage is caused by lahars that bring large boulders and tree trunks that hit the wall so that the wall cavities.

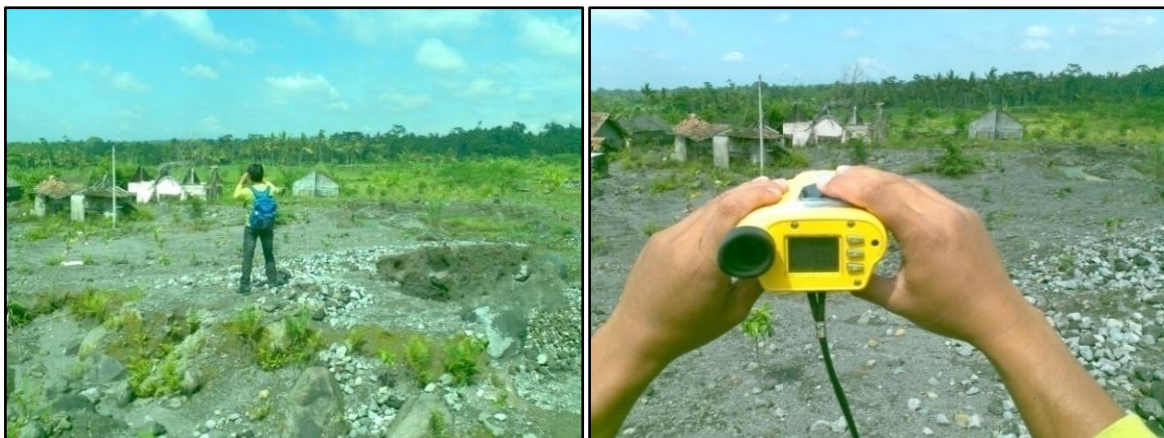
Figure 59. Measuring the distance between camera position and the object photographed with Laser Distance Meter (Laser Ace 300)

In GPS Lock-Off scenario, shooting direction becomes a very important factor for the combination with spatial data from remote sensing imagery. With an Android device that has an electronic compass and Geojot software, shooting direction can be recorded on the attributes of the photo. Distance data between the camera and the object being photographed is also important. Relatively accurate distance measurements can be performed using a laser distance meter. In this study, Laser Ace 300 is used to calculate distance between camera and the object being photographed which can measure distances up to 300 meters. Distance information is filled in on the attributes of the geotagged photograph. Geojot provides facilities for reading Laser Distance Meter with Bluetooth technology if Laser Distance Meter that is used also has bluetooth facility. Figure 59 below shows distance measurement between camera position and the object photographed with Laser Distance Meter.

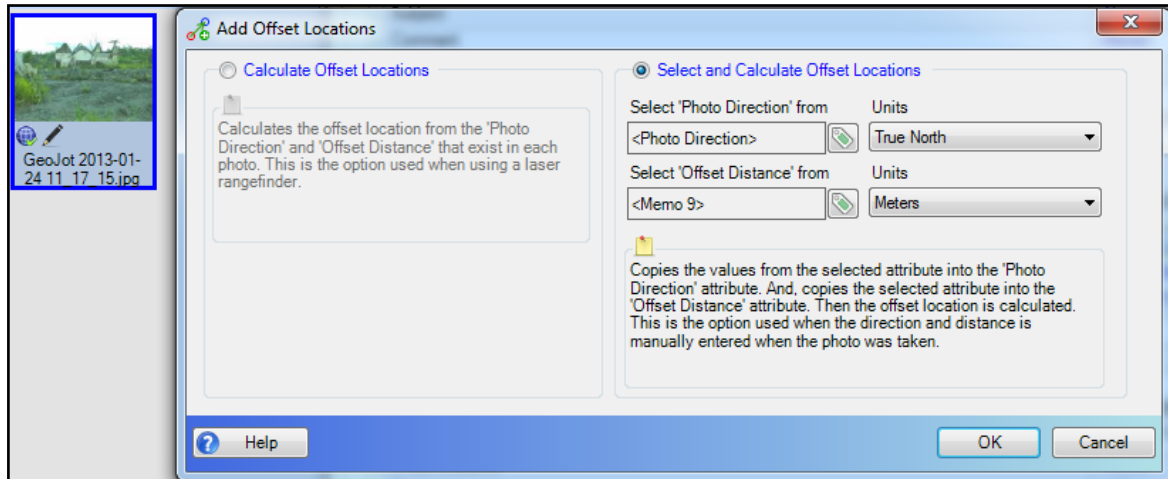
Figure 60. Calculation offset location by photo direction and offset distance in GPS Photo Link

If there is no distance information, the direction of the shooting information and camera position is used as the basis for determining which objects are photographed on remote sensing imagery. By the direction and distance information, panning (offset) camera coordinates into object coordinates can be done as shown in figure 60. Right or not the result of the coordinates shifting will be affected by the GPS accuracy when shooting and the accuracy of distance measurement to the object.

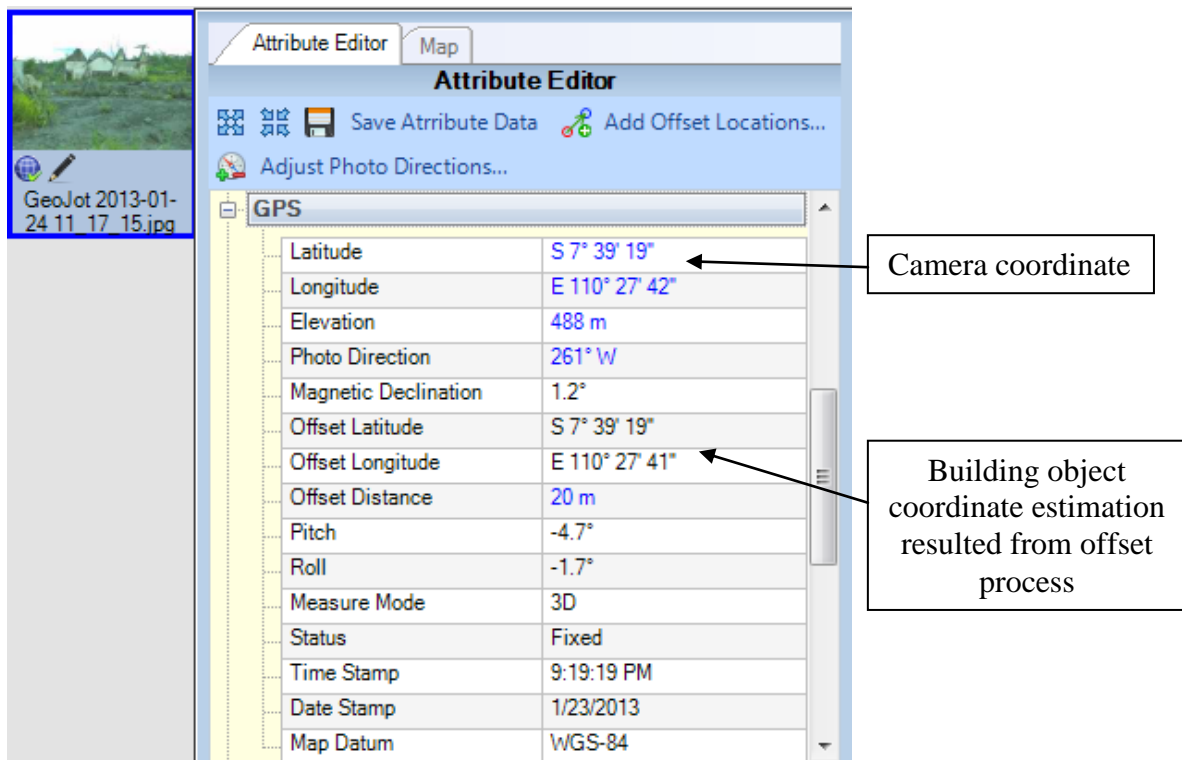
Figure 61. Building object coordinate resulted from offset process in GPS Photo Link

The figure 61 below shows the result of shifting camera coordinate into object coordinate. Camera location coordinates is shifted as far as 20 meters in the direction of 261° W from its original position resulting offset latitude and longitude. Koordinat hasil offset ini adalah koordinat obyek bangunan.

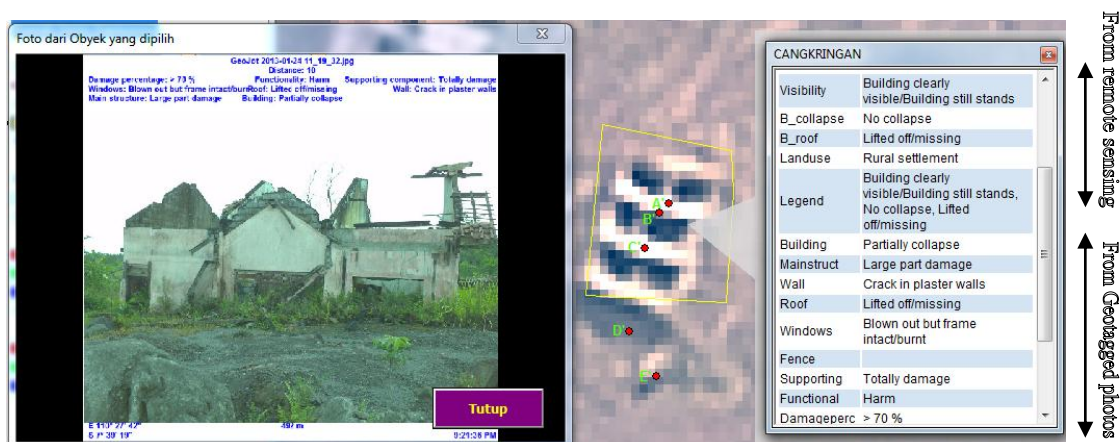
Figure 63. Combine of geotagged photograph attribute and imagery interpretation attribute by mean of GIS (spatial join process)

The incorporation of spatial data structure in which contained the interpretation results and damage attribute to buildings from geotagged photos can be done by using spatial join technique if the photos coordinate is in the building objects. If the results of offset are not in the building boundary, then the provision of common identity between building objects and the point location of the photo on the attribute is another way that can be done to combine attributes. The result of attribute combination is shown in the figure 63.

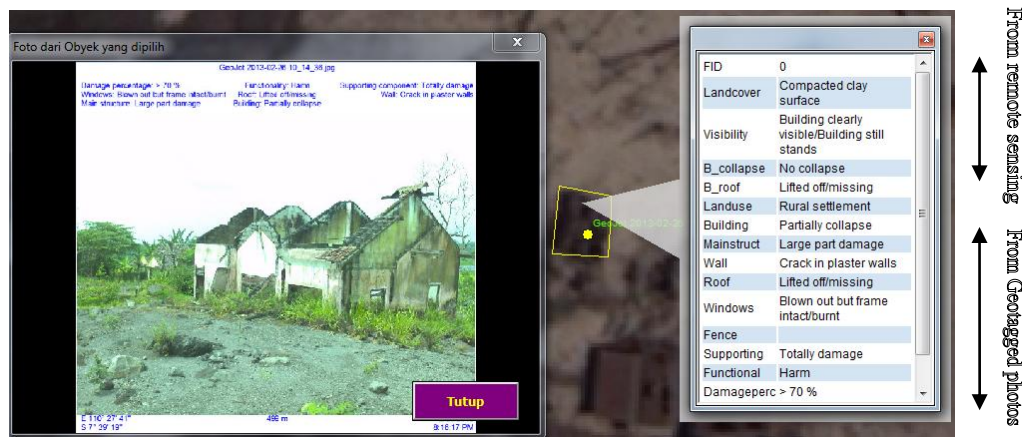
Figure 64. Combine of geotagged photograph attribute and imagery interpretation by GPS Lock-On scenario

The second scenario is to lock the coordinates of geotagged photos with the coordinates of the object to be photographed on Geojoat. Photographer came to the location of the object photographed building and wait until the GPS accuracy reaches a maximum. This method will produce photographs with the same coordinates. The downside of this method is the photographer may not be able to enter the building at the building that can not be approached / entered because of certain conditions. The results of GPS-Lock On scenario is shown in the figure 64 below.

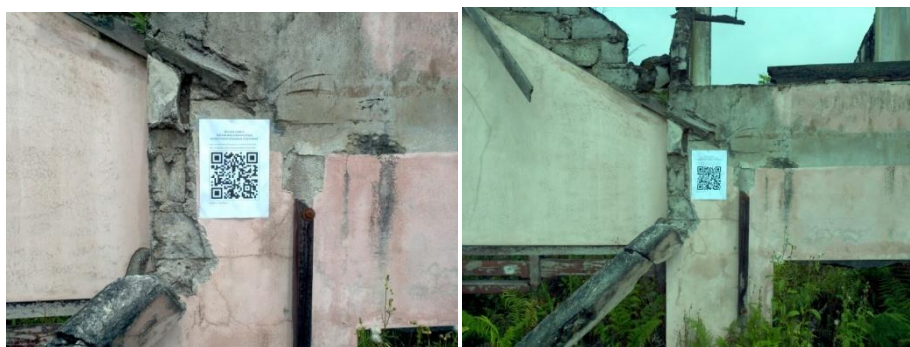
Figure 65. QR Code scenario on building

Each object of a particular building should have a unique identity. Identity can be used to identify the building and match them with a database building. QR Code / Barcode is a unique code that can be used for identity building. QR code can be read by using the camera on the Android Barcode Scanner software. Barcode scanner software has been integrated with Geojoat so that it reads QR code that can be stored in the attribute of geotagged photos. QR code scenario in the building sample of Cangkringan Sub-district is shown in the figure 65 below.

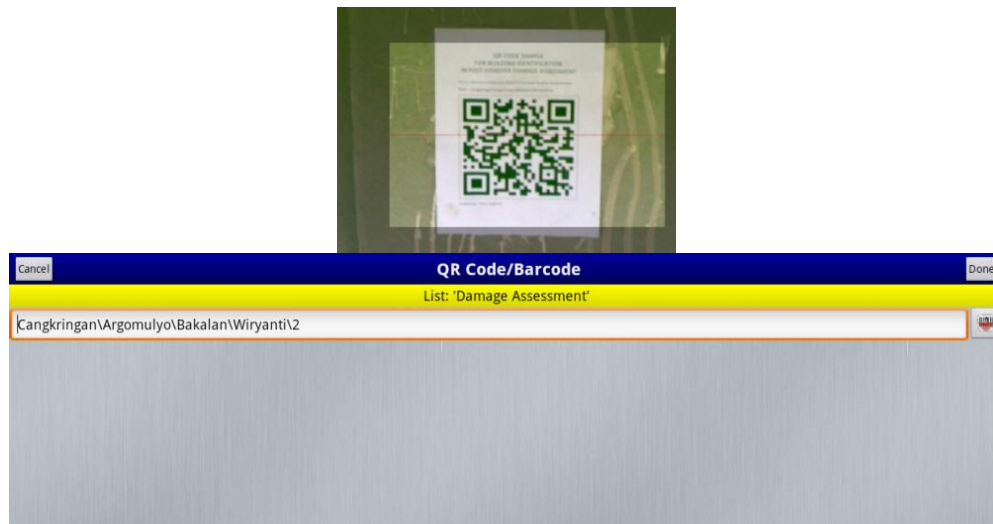
Figure 66. Building QR Code read and entry in Geojot

In normal conditions, QR Code with size 15 cm x 15 cm can be read by a Barcode Scanner camera at a distance of ± 2 meters. Read and entry of Building QR Code in Geojoat is shown in the figure 66.

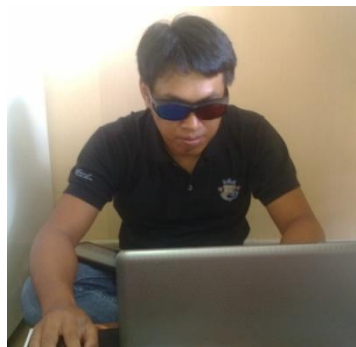
Figure 71. 3D Anaglyph photograph observation

3D Anaglyph photograph is created from a pair of 2D geotagged photograph treated with Anaglyph Maker that can be observed by using 3D glasses to observe the visual appearance of an object in three dimensions as shown in figure 71 below.

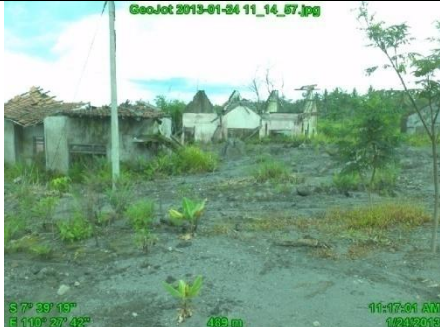
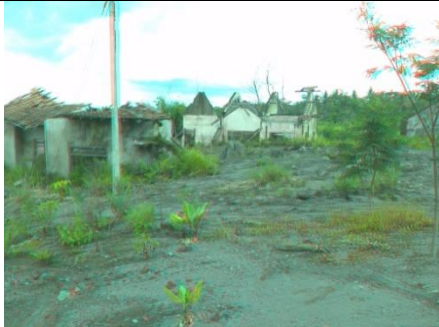
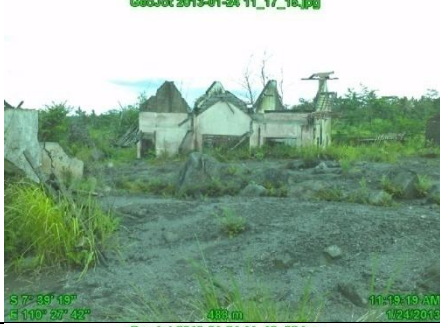
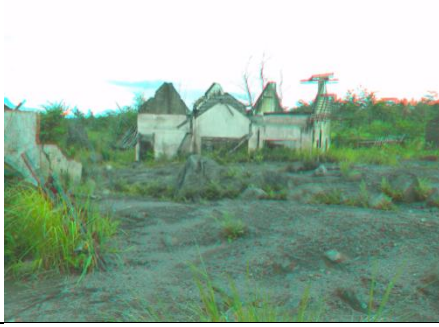
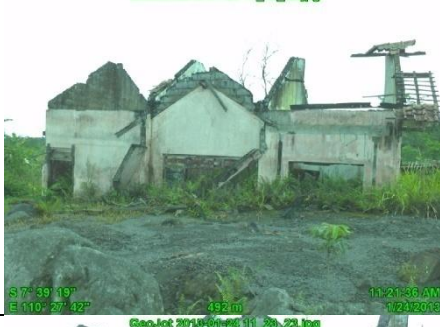
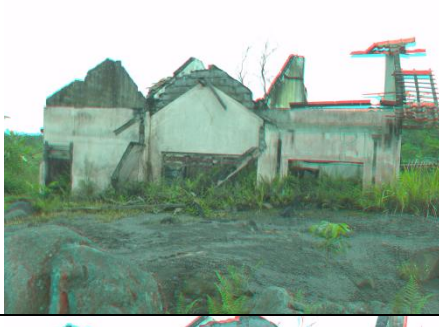
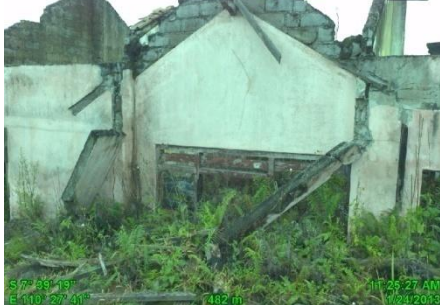
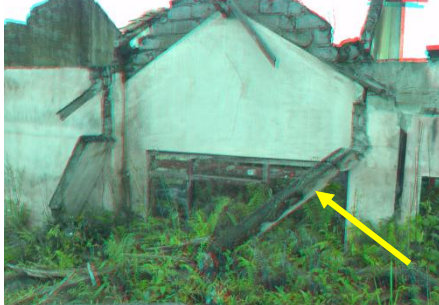
Figure 73. 2D and 3D geotagged photograph visual comparison based on distance variation on Building sample 1

For the nine scenarios distance as above, comparison of the visual appearance of 2D and 3D geotagged photos are shown in Figure 73 below.

Based on the observations of building damage in a variety of scenarios within 2D and 3D geotagged photos above, observations of building damage at a distance closer to the object it is better to look at structural damage, damage on roof and damage on windows. Observation of structural damage to buildings, roofs and windows more clearly and accurately use 3D Anaglyph photos instead of using 2D geotagged photos for depth perception obtained. At relatively far distance (80 meters), structural damage such as beam damage as shown in figure 73 above by yellow arrow are more clearly observed in 3D Anaglyph photos.
