THESIS

UTILIZATION OF GEOTAGGED PHOTOGRAPH, REMOTE SENSING AND GIS FOR POST-DISASTER DAMAGE ASSESSMENT IN CANGKRINGAN SUB-DISTRICT, SLEMAN, YOGYAKARTA AS VOLCANIC DISASTER-PRONE AREA

Thesis submitted to the Double Degree M.Sc. Programme, Gadjah Mada University and Faculty of Geo-Information Science and Earth Observation, University of Twente in partial fulfillment of the requirement for the degree of Master of Science in Geo-Information for Spatial Planning and Risk Management

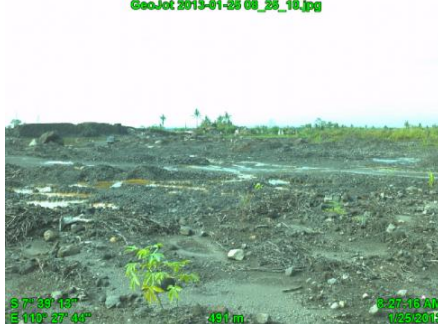
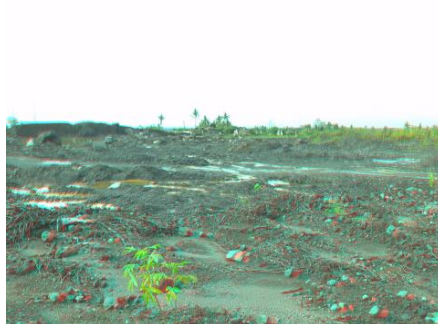
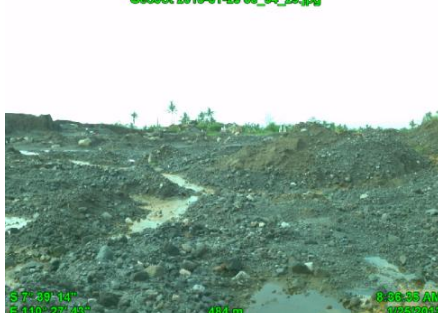
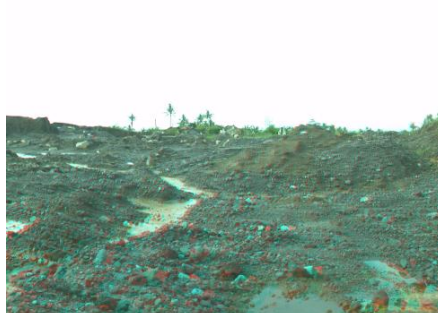
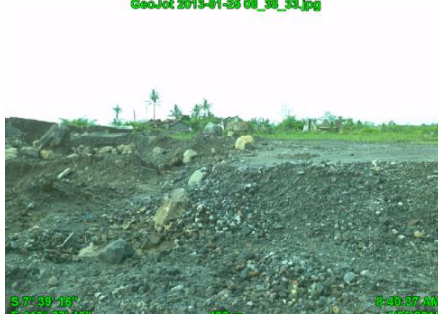
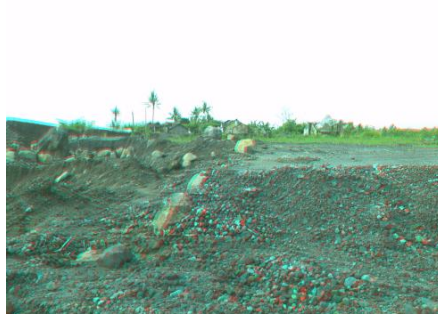
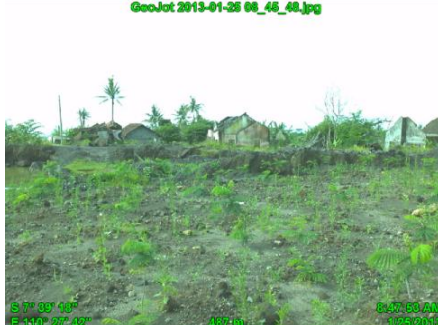
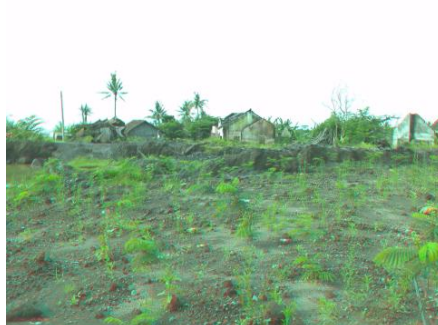
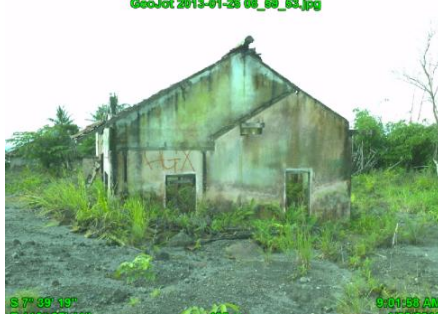
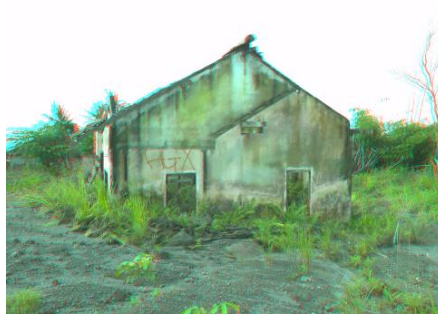
Figure 75. 2D and 3D geotagged photograph visual comparison based on distance variation on Building sample 2

Comparison of visual appearance of 2D and 3D geotagged photos are shown in the figure 75 below. When making comparisons, photos can be enlarged so that the object of the building can be seen more clearly.

Based on the figure 75 above, at a distance of 250 meters from the building objects, building damage particularly damage to roofs and structures can still be tapped with a clear picture both 2D and 3D, but the condition of the windows can not be observed. 3D Anaglyph photos provide the capability of building damage observations better than the 2D photos because of the depth perception to building object and surrounding of buildings.

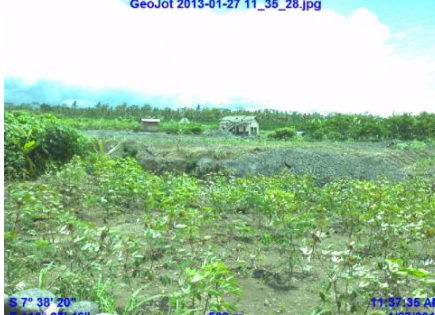
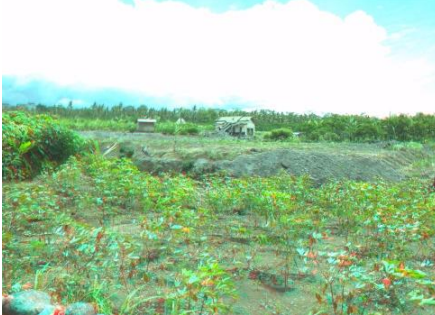
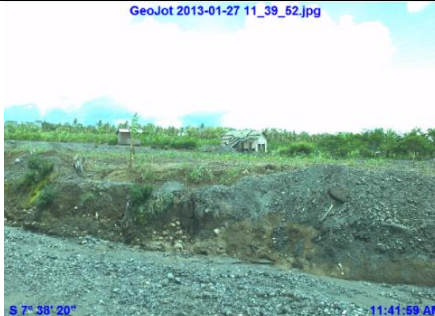
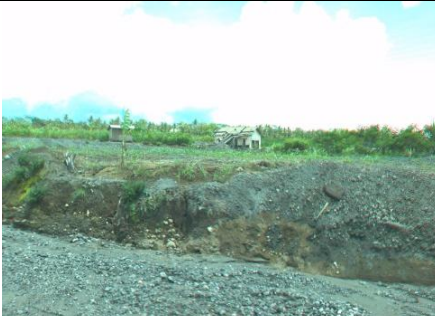
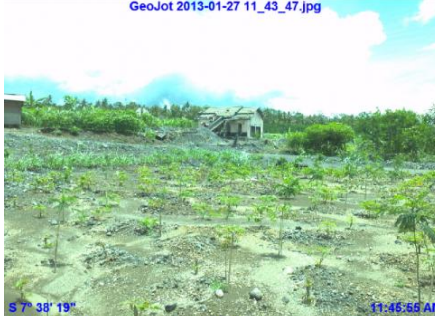
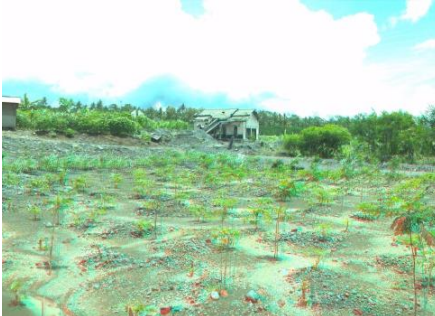
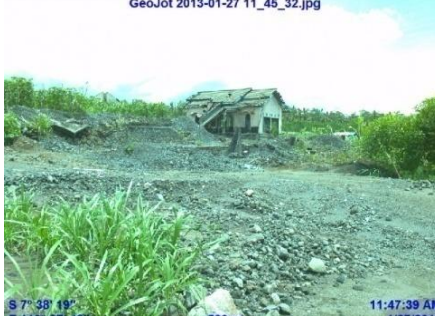
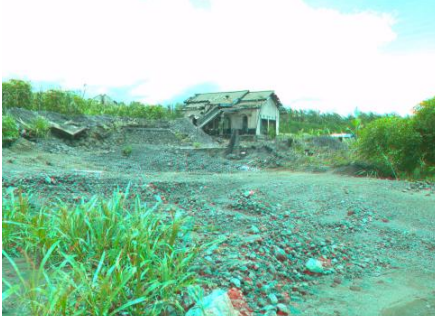
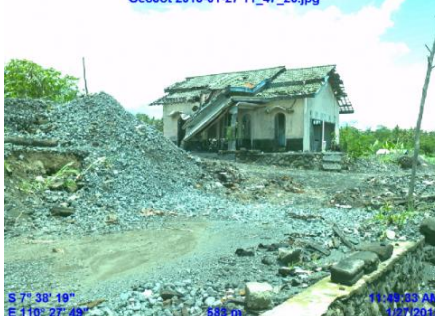
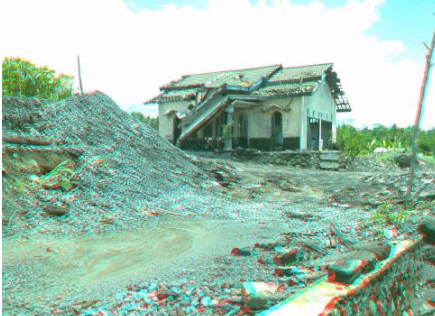
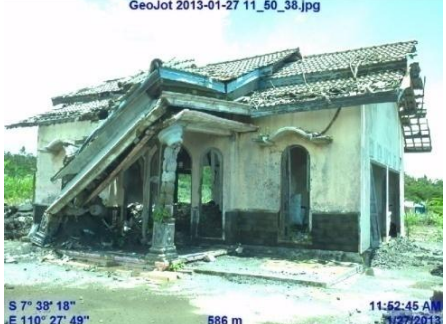
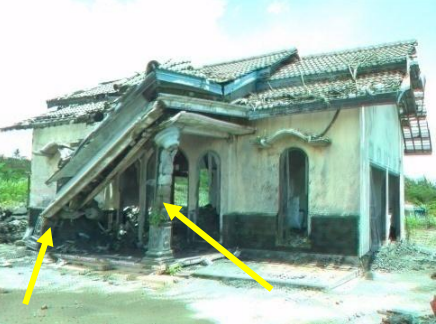
Figure 77. 2D and 3D geotagged photograph visual comparison based on distance variation on Building sample 3

Comparison of visual appearance appearance 2D and 3D geotagged photos depicting damage to buildings based on variations in the distance is shown in Figure 77 below.

Based on figure 77 above, 3D Anaglyph geotagged photograph can illustrate more clearly of building damages such as damage to structures in the form of a column structure that collapsed on one side and severe cracking in the column on the other pole as shown by yellow arrow. In addition, the damage to the roof tiles and the windows is very visible and more clearly with 3D Anaglyph photograph than 2D geotagged photograph. The closer distance from the shooting position of geotagged photograph with the object to be photographed, then the more obvious 3-dimensional effects of the building structure so it can make the clearer observations of building damage that occurs.

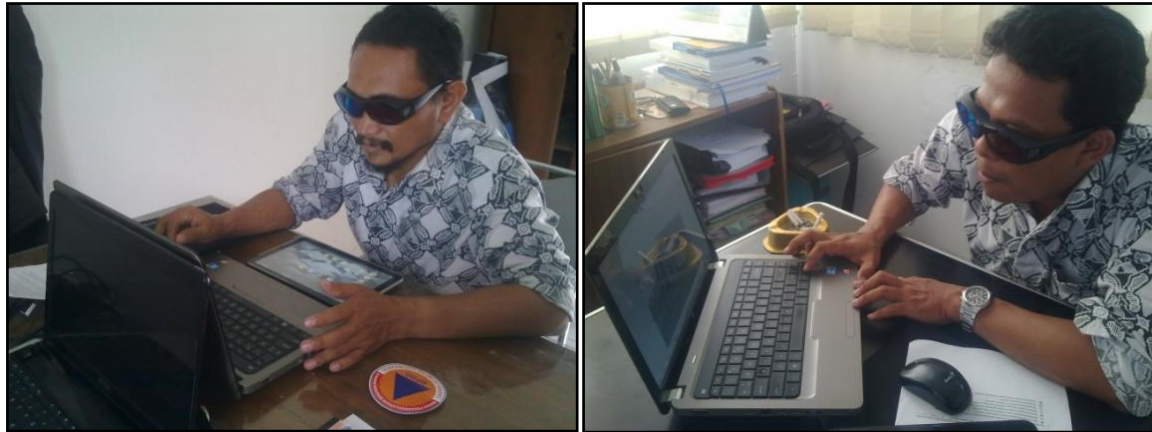
Figure 78. Testing of 2D and 3D geotagged photograph by Disaster Management Agency of Sleman and Public Works Department of Sleman

Test conducted by the Disaster Management Agency and the Public Works Department of Sleman district includes assessing building damage using 2D and 3D geotagged photos on several buildings in the Bakalan sub-village, Argomulyo village, Cangkringan that was affected by Merapi eruption in 2010. Figure 78 shows the testing process of 2D and 3D geotagged photo interpretation for building damage assessment.

Based on the test results obtained, the 3D Anaglyph geotagged photograph more clearly to observe damage to buildings rather than 2D geotagged photograph. Damage to buildings equally can be interpreted from 2D and 3D geotagged photograph, but 3D Anaglyph geotagged photograph provide better level of clarity for better observation of structural damage to the building.
