3D scene reconstruction and structural damage assessment with aerial video frames and drone still imagery

JOHNNY CUSICANQUI Enschede, The Netherlands, 2016

Thesis submitted to the Faculty of Geo-Information Science and Earth Observation of the University of Twente in partial fulfilment of the requirements for the degree of Master of Science in Geo-information Science and Earth Observation. Specialization: Applied Earth Sciences

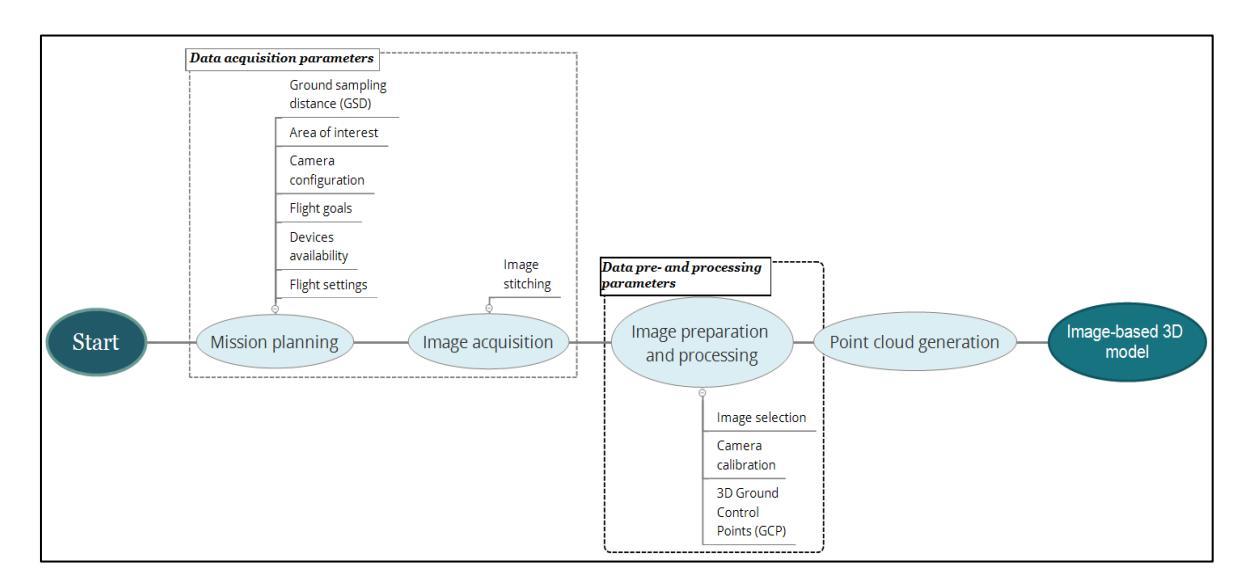
Figure 3. Image Based Modelling quality parameters (modified from: Nex & Remondino (2014))

Different kinds of parameters can affect 3D model quality and its application accuracy. Parameters can broadly be grouped in data acquisition and pre-processing stages (*Figure 3*). Data acquisition parameters (e.g. Ground Sampling Distance, Area of interest, etc.) are related to mission planning and data acquisition process. Thus, they must be wisely defined since there is no way to modify them farther. Data pre- and post-processing parameters (e.g. Image selection, Ground Control Points, etc.) are more flexible and can be used to solve errors caused during the data acquisition process (e.g. The use of accurate GCPs in IBM would lead to a better stabilization of the 3D model geometry) (Nex & Remondino, 2014; Remondino et al., 2014). IBM errors in image matching processes are mainly related to data quality (e.g. resolution, blurriness, etc.) and scene characteristics (e.g. smooth textural objects, transparent objects, etc.). In the case of SfM models, IBM errors are considered more as a black box, since they can be related to bundle adjustment divergences or geometric deformations in the process (Remondino et al., 2012). Data acquisition parameters are relevant, since although some data quality pre- and processing parameters can be modified, some of them such as resolution cannot. Hence, the priority must be given to an appropriate selection of data acquisition parameters to impede error propagations on pre- and processing steps.

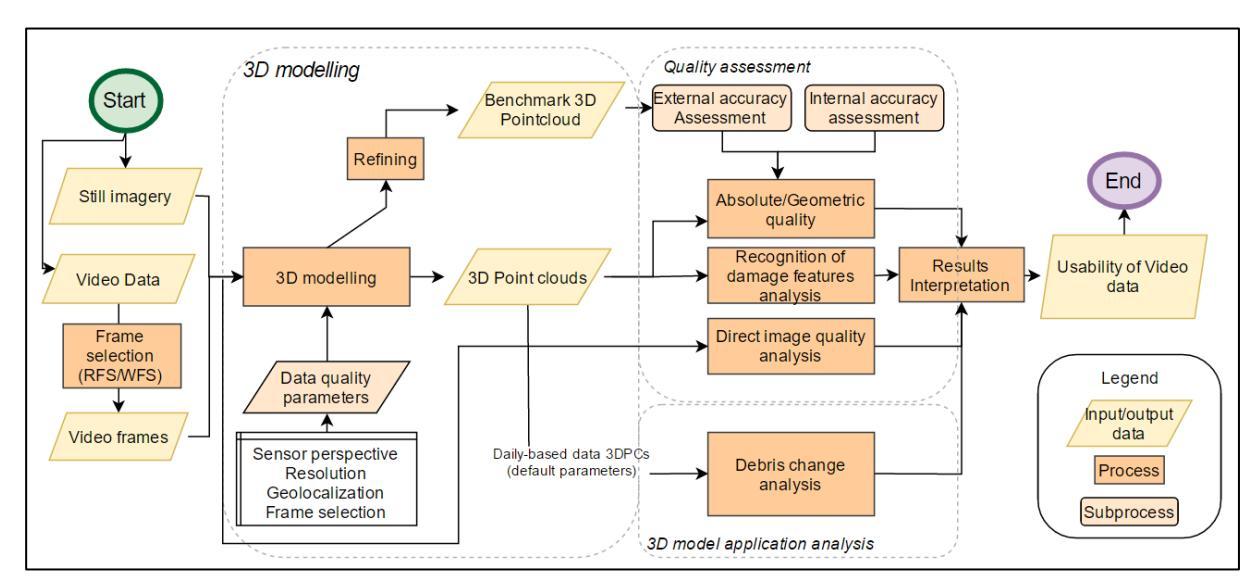
Figure 6. Research flowchart describing the main three stages: 3D modelling, Quality assessment and Application analysis

The flowchart implemented for this research is shown in *Figure 6*. In broad, the research can be divided in three main stages: 3D modelling, quality assessment and 3D model application analysis. As a first step however video data was processed to generate multi-perspective imagery for 3D modelling. Then these data processing is grouped inside the 3D modelling stage; here both data types are processed using different quality parameters. From this procedure, many 3D point clouds will be generated, their quality characteristic will depend on the data type (i.e. video or still images), study area, and the quality parameter used. Also during this stage a benchmark 3DPC will be generated using a refining procedure with the Tainan still imagery and default parameters. Hereafter all the 3DPCs generated will pass through a quality assessment phase, in which all of them will be tested by different means in relation to their geometric or absolute quality, their capability to represent damage features for SDA and a direct image quality index using blur and texture metrics. Once finished this process the usability of Video data for 3D modelling and SDA can be determined during a general objective results interpretation procedure.

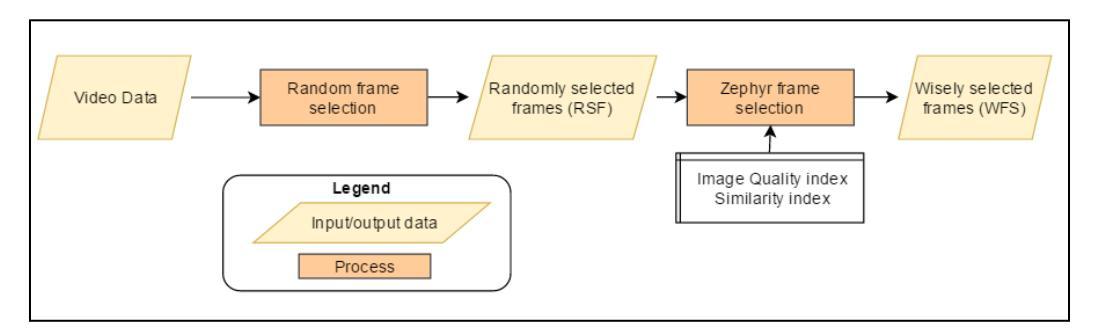
Figure 7. Flowchart for Wise Frame Selection approach for video frames extraction using Zephyr image quality and similarity indices.

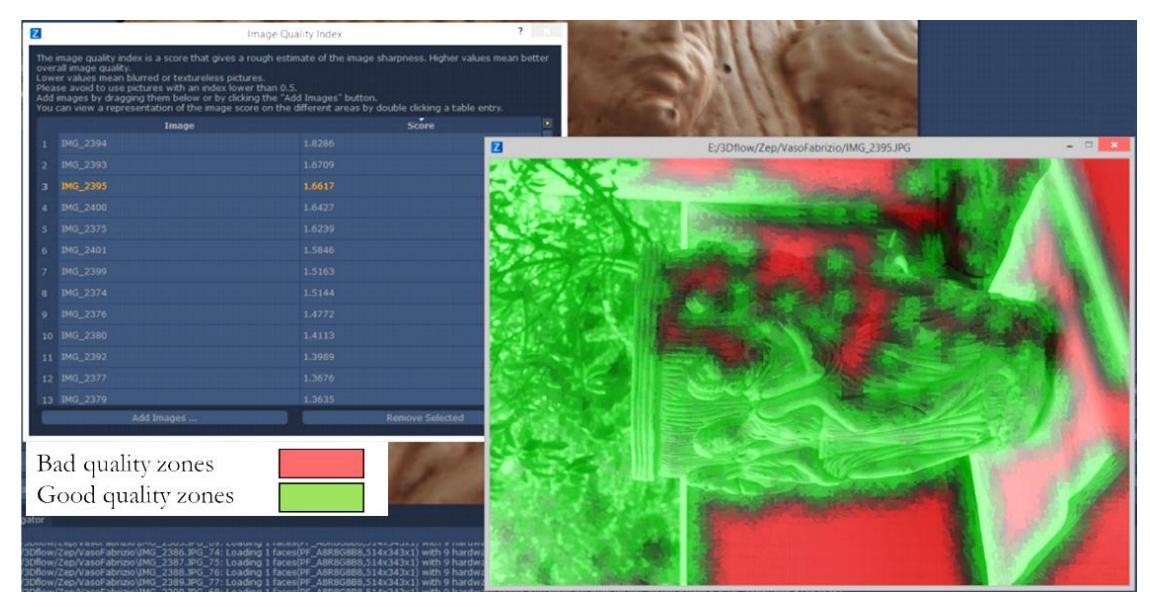
Figure 8. Image quality index tool in 3D Zephyr user interphase. Left: Image quality calculation, right: image quality map

For this analysis, unprocessed data (i.e. still images and extracted video frames) were analysed using a quality index developed by 3D Flow (2017). This index allows to measure blurriness and texture homogeneity of every single image, and also displays a map to check what parts of the image may present problems in 3D IBM (*Figure 8*). Still images were directly used; whereas for video data, a subset was generated using RFS, explained in the previous section. This analysis is very practical and by statistical means describes roughly data quality for 3D modelling of all the datasets used. Quality index is a unit-less value, with no maximum or minimum boundaries. When images below a quality index value of 0.5 should be filtered out, since usually they are too blurred and do not have texture information. This index represents still images and video frames characteristics by a single image-based examination, based on a multiscale approach with frequency analysis. This index is also able to generate a graphical representation of low and good quality maps (3D Flow, 2017).

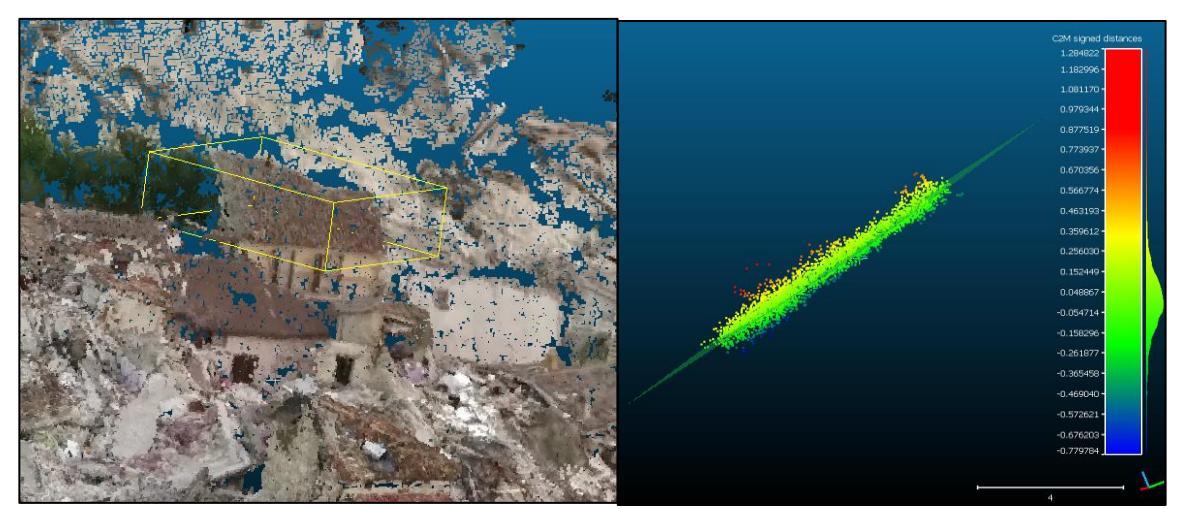
Figure 9. Planar fitting analysis example. Left: subset of a plane surface, Right: distances from point clouds to a theoretical flat surface (fit plane).

First planar fitting was applied to the different generated 3DPCs models. This measurement reflects 3DPCs distribution and noise, it is based on the analysis of objects that should be flat, therefore by fitting a plane from the 3DPC, the distribution of every single 3D point along this plane can be analysed (*Figure 9*). Plane objects were first identified for every study area. In this research house roofs were used as reference plane surfaces, since also at-nadir imagery precision will be tested at this analysis, subsets from every 3DPCs were extracted based on this planar objects. A plane section was created using Cloud Compare software (CC)(Girardeau-Montaut, 2017) along the extracted 3DPC subset. In theory, the 3D points will fit this plane in case the model is precise, but in reality, a refined model should have some deviated points (i.e. model noise). Therefore, some statistical indicators (e.g. mean distance to the plane and standard deviation) of how each generated 3DPC fits this theoretical plan will be computed and analysed to determine model precision.

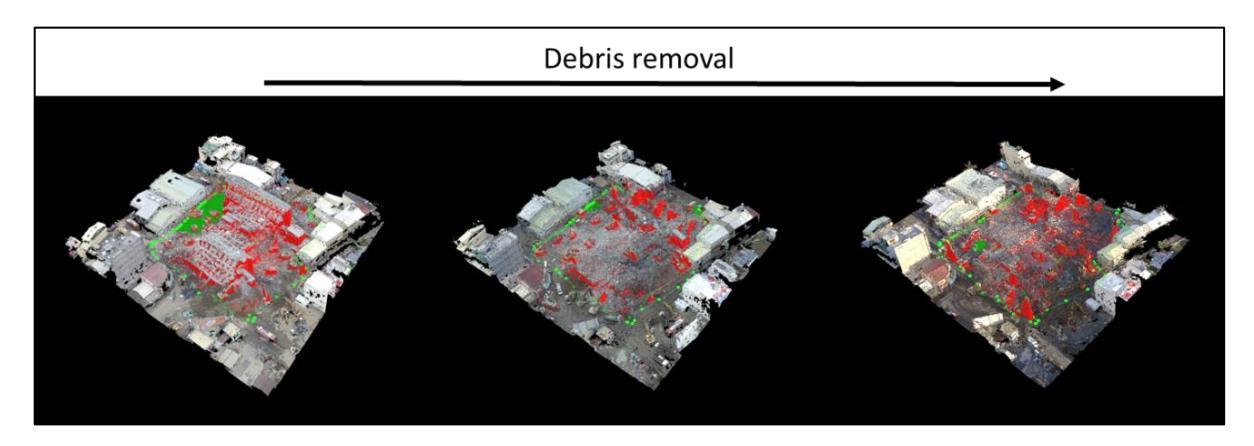
Figure 10. Debris volume calculation at different time steps. Green areas represent the base of the calculation polygon, red are the volumes calculated.

With the availability of post-disaster daily-based still imagery data, several 3DPCs were generated during the 3D modelling stage (*Figure 10*). These then were used to perform a temporal analysis of change on debris volumes for Tainan study area. 3D models along with their respective STMs and one polygon to delimit computational area, were used to estimate debris volume for every model and every day (e.i. February 7, 10, 11, 12, 13 and 14<sup>th</sup>, 2016) in Pix4d software (Pix4d, 2016a). In parallel an additional 3D model was generated from video RFS frames to make a valid comparison of results. The exact date when the aerial footage was executed is unknown, but most likely it was recorded the same day of the earthquake (February 6<sup>th</sup>, 2016); the scene present a lot of smoke, and there is a lot of movement of SAR teams working on the buildings searching for victims. Therefore, the estimations obtained with these data should be correspondent with the still imagery ones of the first collecting date (February 7<sup>th</sup>, 2016). It is also important to mention that with the aim making a consistent analysis, the same 3D vector was at the ground level used in all calculations. Finally, these estimations were plotted and analysed.

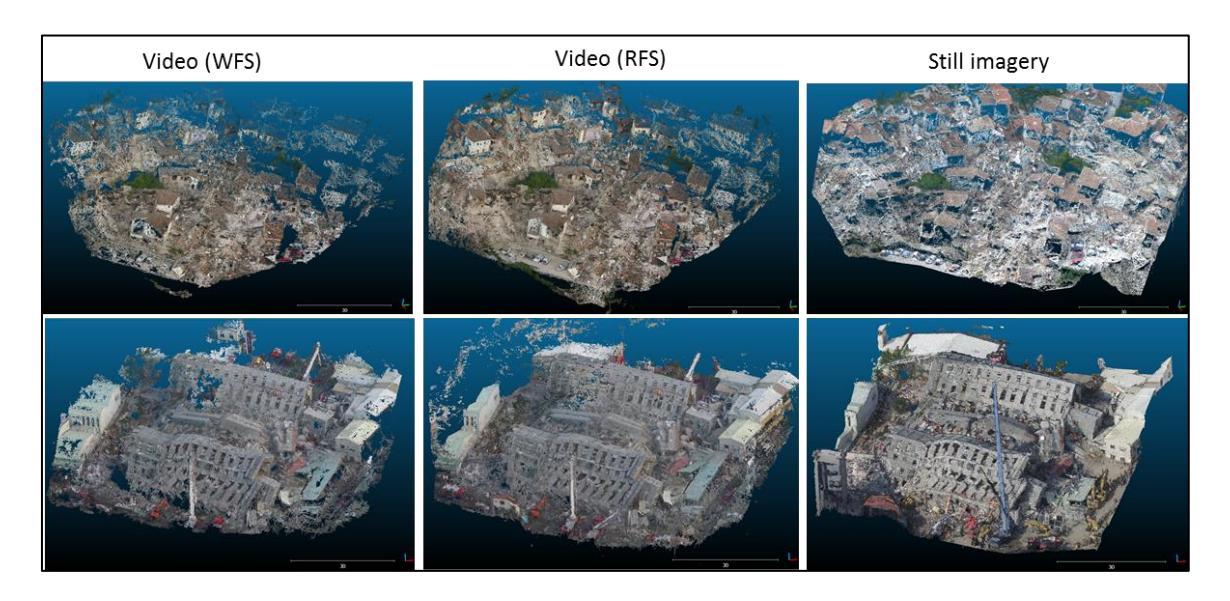
Figure 11. General visualization of some 3DPCs generated for Tainan (up) and Pescara del Tronto (down). Datasets used: Video Wise Frame Selection (WFS), Random Frame Selection (RFS) and Still imagery. Some noise on Video (RFS) due to smoke.

There are three remarks related to quality to denote from this process already. First, a lot of noise is produce for the video RFS model; this is clearly sign of smoke perturbation, which is instead removed in video WFS one (see also Appendix 1). Second, without refining 3DPCs of Tainan still imagery presented a clear displacement of features, or a sort of duplication (Figure 12). Second, for WFS approach proposed using Zephyr3D software tools did not give appropriate results; too many frames were filtered out and initial identification of key points was not satisfactory or even not possible (Figure 13). In the first case, it may be that the absolute orientation of the model was not accurate, since all 3D GCPs used were uniquely identified on the at-nadir images and they were almost at the same plane; there are only 2 m of elevation difference between all Tainan 3D GCPs. This is supported by the fact that also the 3DPC generated with oblique imagery presented a similar displacement, which was then corrected using 3DCPs form the reference model. Besides, in case of WFS approach, the proposed procedure using Zephyr did not succeed. Many thresholds were tested for image quality and similarity index, however most of relevant sections were lost and initial image matching was not possible to make or resulted in a very poor 3D key point structure. Therefore this approached was modified and only image quality index was used as a guide to manually select video frames from the rayCloud of a rough 3DPC created using a random selection of video frames (Figure 14); the same values of RFS approach were used here (45 for Tainan and 25 for Pescara del Tronto). RayCloud was analysed by sections and frames were manually selected considering two aspects: Not having to many overlapping images per section and keeping the minimal number of overlapping images to cover a section.

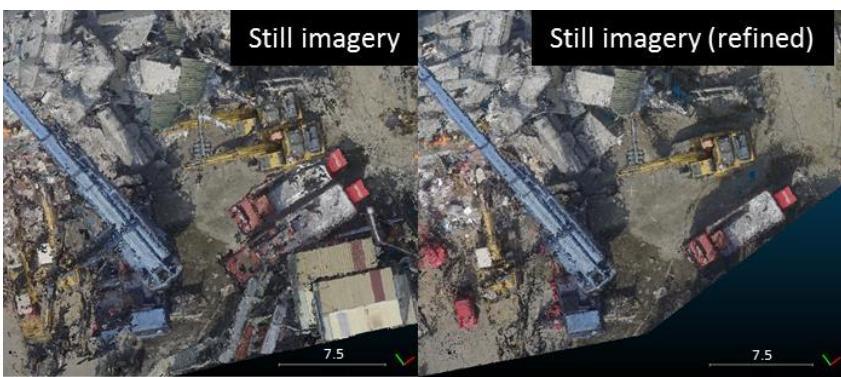
Figure 12. Duplication effects due to displacement caused by wrong model orientation using the complete still imagery dataset (not refined)

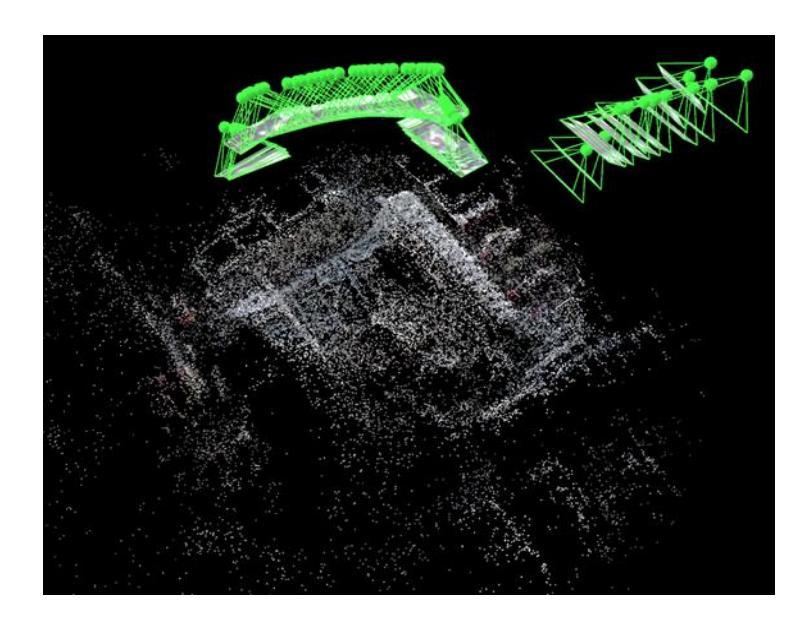
Figure 13. Unsatisfactory Wise Frame Selection (WFS) model using Zephyr similarity index tool, lack of frames for some sections in the 3DPC. Still some similar overlapping frames are selected.

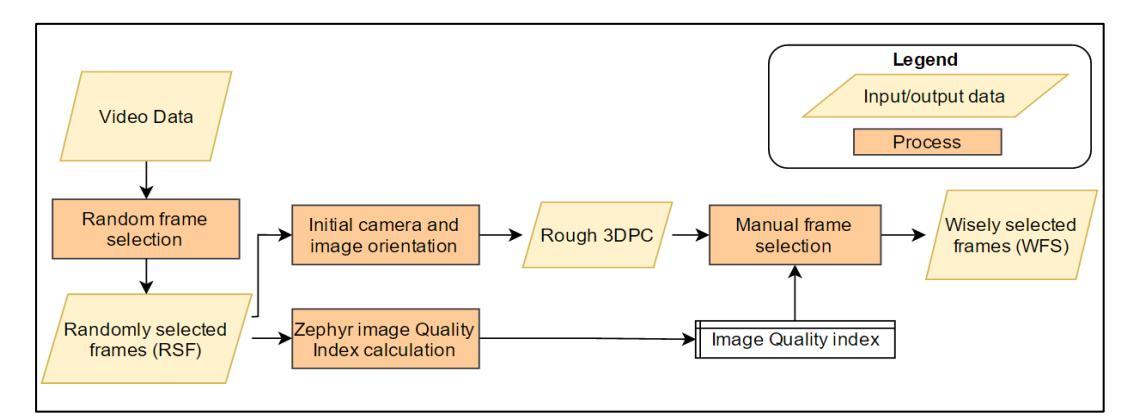
Figure 14. WFS: Wise Frame Selection modified approach using rayCloud of the Rough 3DOC and image quality index as guide.

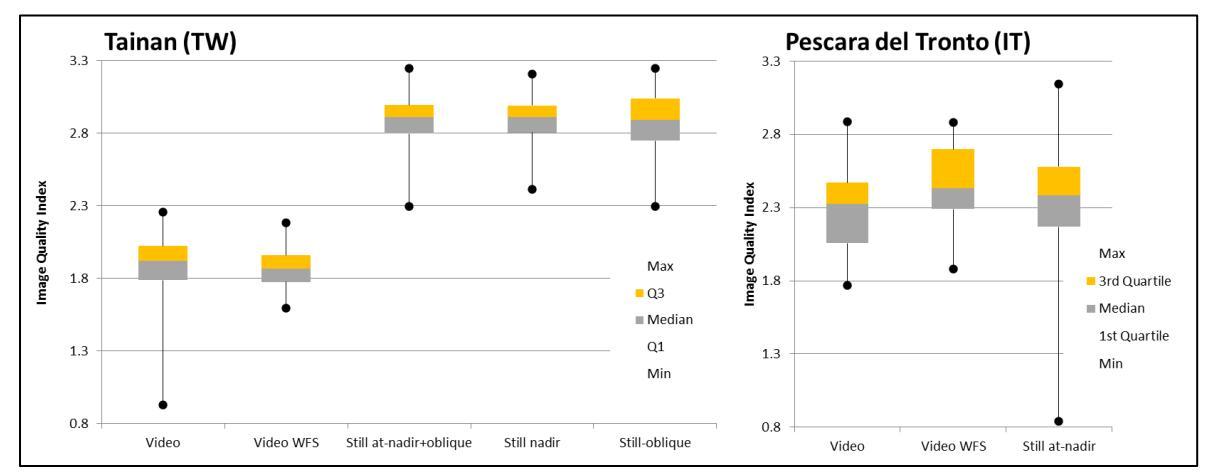
Figure 15. Image quality index distribution boxplots

is more stable than the other data type, and WFS approach instead here did increased image quality rising the 75% of the dataset to values above 2.3.

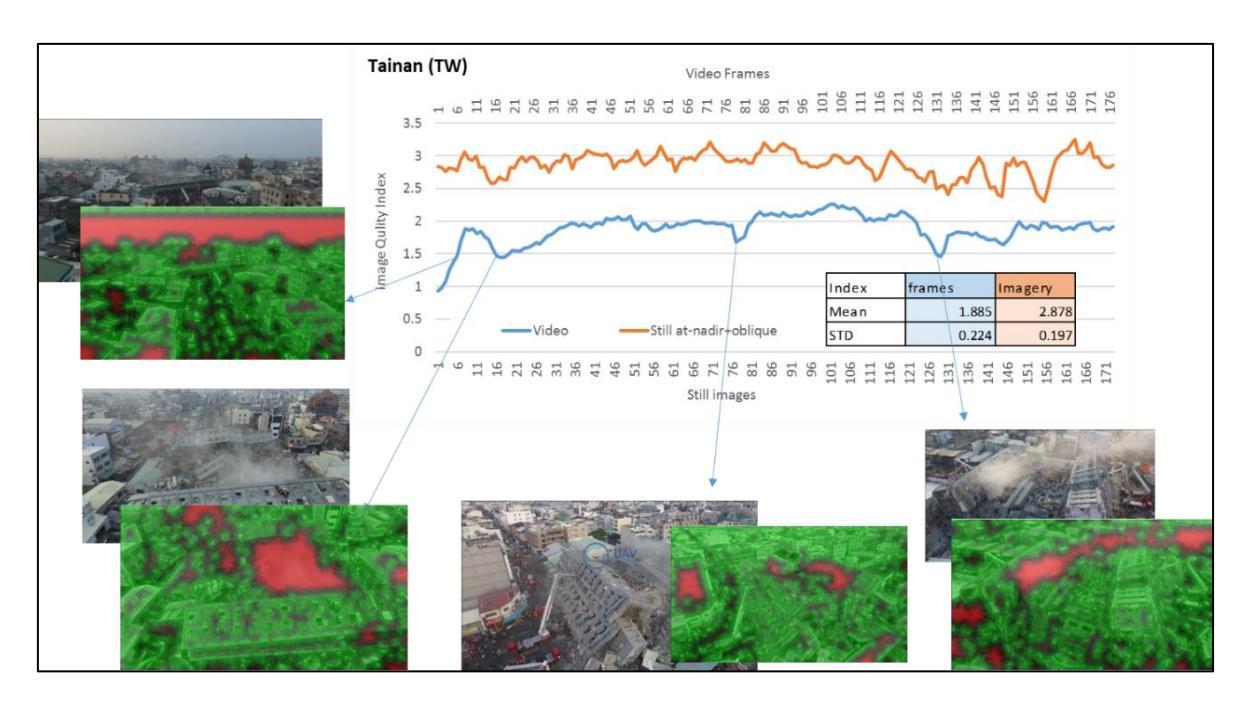
Figure 16. Image quality index series plot and maps for Tainan (TW). In maps red represent areas of low quality. Dips are caused due to smoke (red areas in imager quality maps) in most cases.

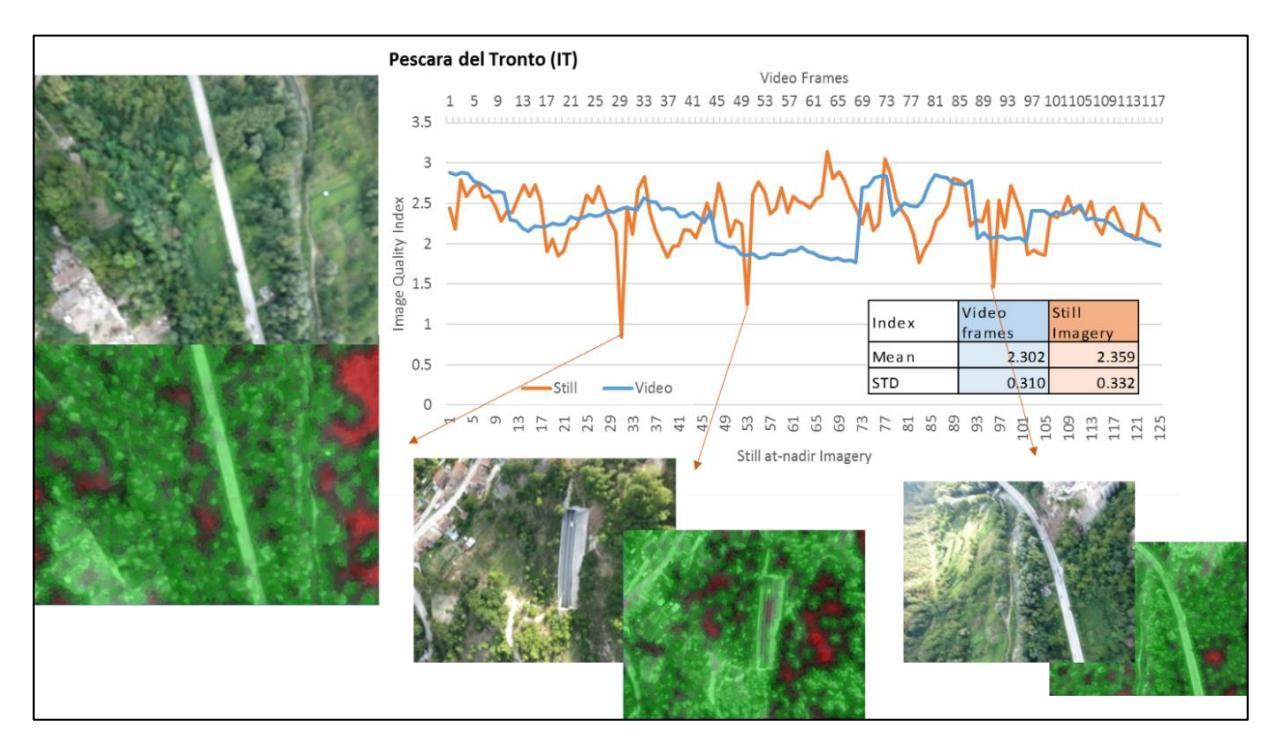
Figure 17. Image quality index series plot and maps for Pescara del Tronto (IT). In maps red represent areas of low quality. Dips are caused due general image blurriness and textural homogenous areas (red areas in image quality maps).

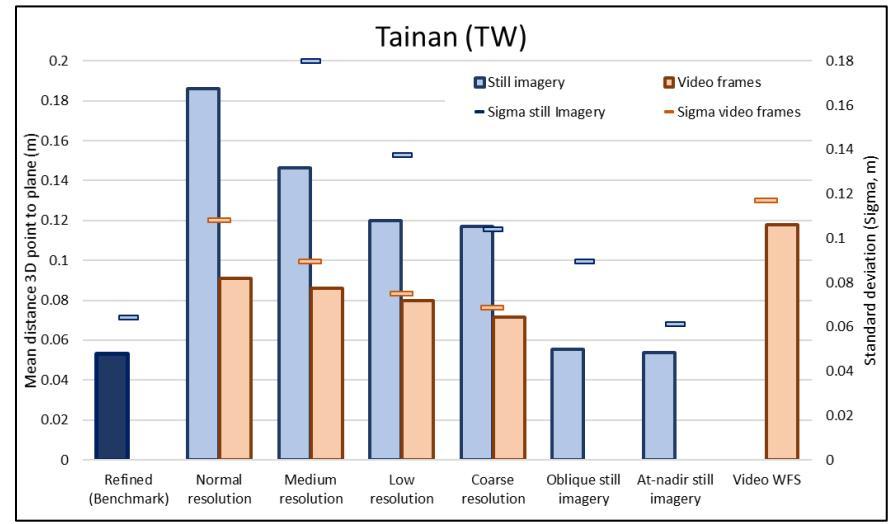
Figure 18. Mean distance (m) to fit plane for Tianan. Distances represent 3DPC precision and standard deviation dispersion. Different resolutions are tested for still imagery complete and video Random Frame Selection (RFS) data sets.

Some arguable results were obtained by this assessment in relation to the study area under analysis. In case of Tainan, a high mean distance to the plane was calculated for still imagery models, with exception of atnadir and oblique datasets, which were also analysed individually (*Figure 18*). Moreover, in relation to resolution an inverse direct relation between resolution and mean distance to the plane can be observed; so more precision when having a lower resolution. On the other hand, opposite and more evident results were observed for Pescara del Tronto data sets (*Figure 19*). First, in this case still imagery present lower mean distance to the plane than video data. Second, resolution more reasonably decreases abreast of mean distance to the plane.

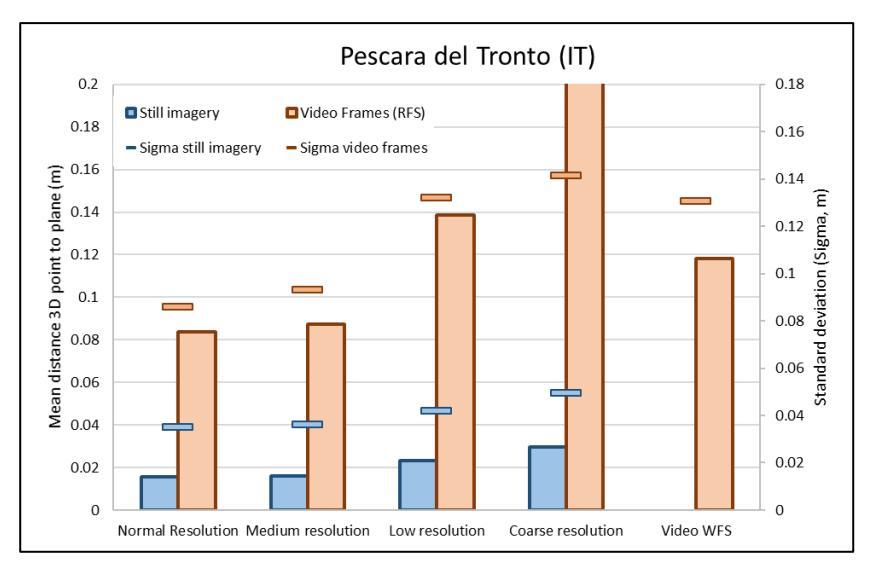
Figure 19. Mean distance (m) to fit plane for Pescara del Tronto. Distances represent 3DPC precision and standard deviation dispersion. Different resolutions are tested for still imagery complete and video Random Frame Selection (RFS) data sets

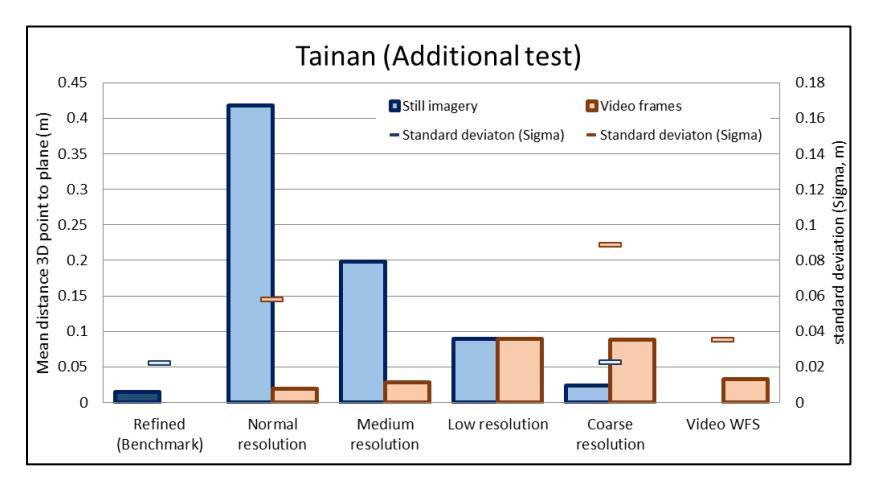
Figure 20. Mean distance (m) to fit plane for Tainan (second test). Distance to plane reduces with resolution (more precision). A more logical trend is presented for video models

Two observations on Tainan results deserve more analysis at this stage: The high mean distances of the models generated using Tainan still imagery (i.e. unrefined) and the unexpected inverse relation between resolution and mean distance to the plane. Regarding the first observation, the low precision of still imagery was caused by the displacement or duplication effect, also discussed in the above subchapter (4.1 3D Modelling, Figure 13). Tainan still imagery-generated 3DPCs are characterized by noise due to several duplicated objects; this was negatively influencing during the planar fitting assessment and varies according to the image resolution. In relation to the resolution issue, this trend may require a deeper analysis and even some extra tests to confirm this particular behaviour; by testing other areas the same characteristic were found, confirming this relation between resolution and 3DPC noise. A probable explanation for this is that at lower resolutions, less 3D points key points are generated, and most of the noise is removed. In case of video data this trend is less significant, although the same could be expected in areas where noise is produced by smoke. An additional test performed shows that precision could tent to increase with resolution as Pescara del Tronto case for video-generated model, however still imagery keeps the same unexpected pattern (Figure 20). Another remark is the low standard deviation of still imagery when is acquired form one perspective (i.e. at-nadir or oblique), which reflects its precision in comparison to video data. Within these single-perspective data sets, however oblique still imagery generates noisier 3DPCs compared at-nadir images, expressed by their standard deviation.

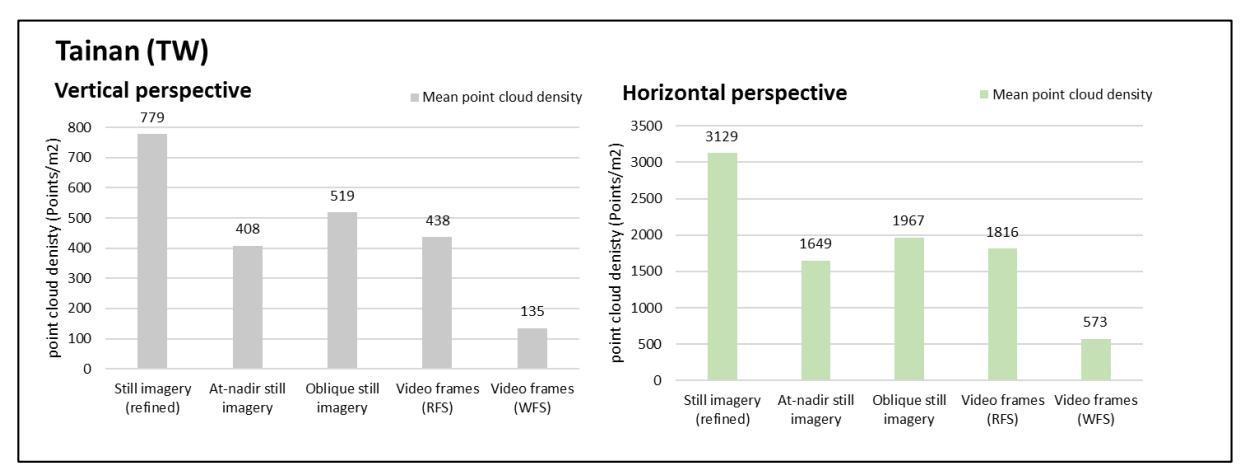
Figure 21. 3D Point cloud density (points/m<sup>2</sup>) from vertical and horizontal perspective for Tainan (TW)

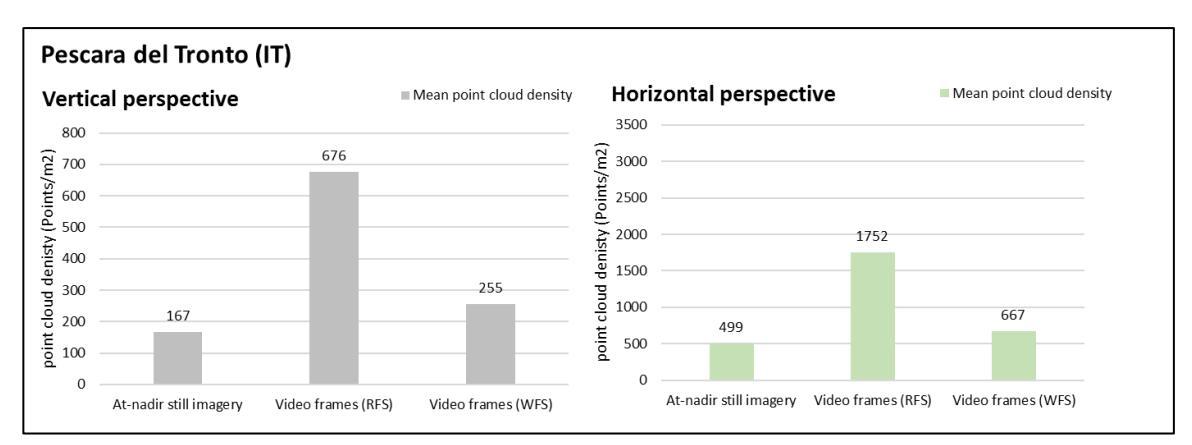
Figure 22. 3D point cloud density (points/m<sup>2</sup>) from vertical and horizontal perspectives for Tainan

sets compared to at-nadir still imagery considering both perspectives (*Figure 22*). This is related to the same aspects of Tainan and especially has to do with the limitation of at-nadir still imagery: high elevation above the ground and lack of vertical information. The same patterns can be seen for both study areas, excluding Tainan video WFS, which instead was not able to generate highly dense 3DPCs as the other data sets.

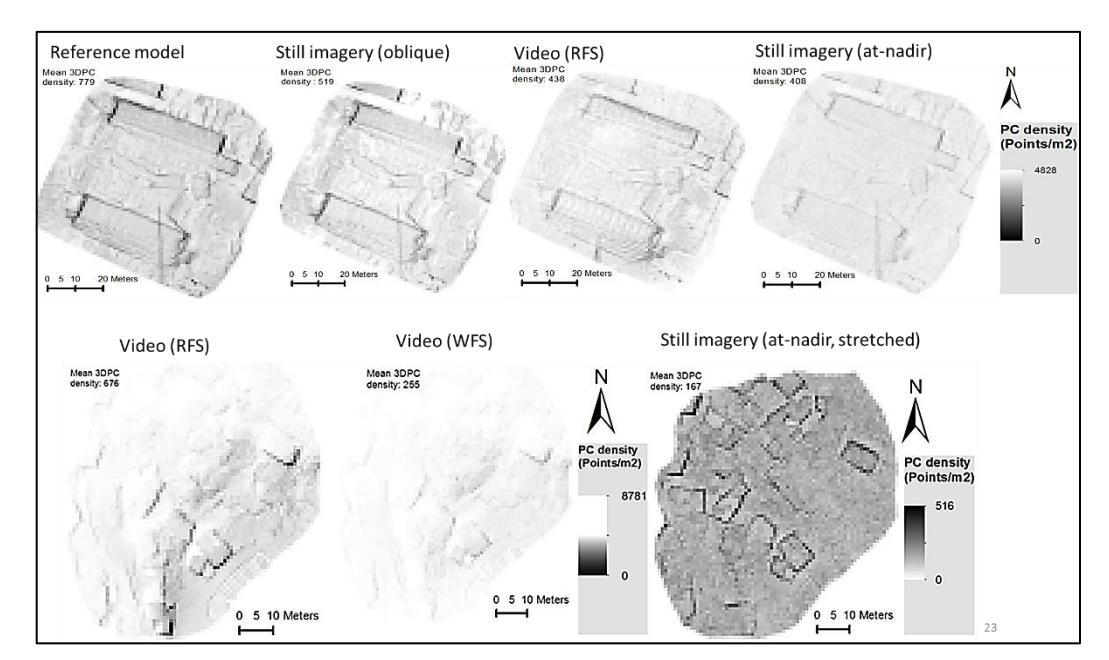
Figure 23. 3D point cloud density maps (up: Tainan, down: Pescara del Tronto). RFS: Random Frame selection, WFS: Wise Frame Selection.

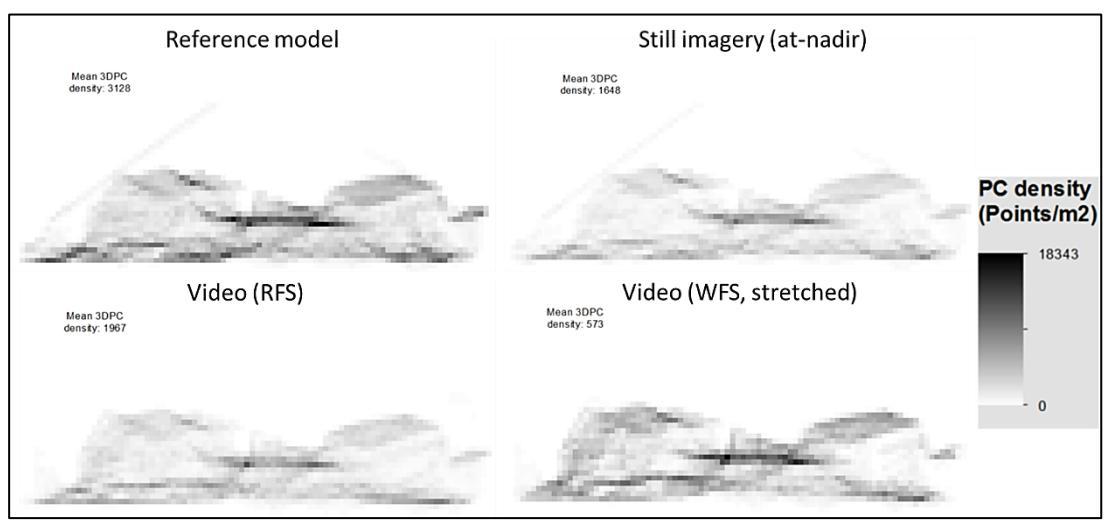
Figure 24. 3D point cloud map (Tainan, horizontal perspective). RFS: Random Frame Selection. WFS: Wise Frame selection.

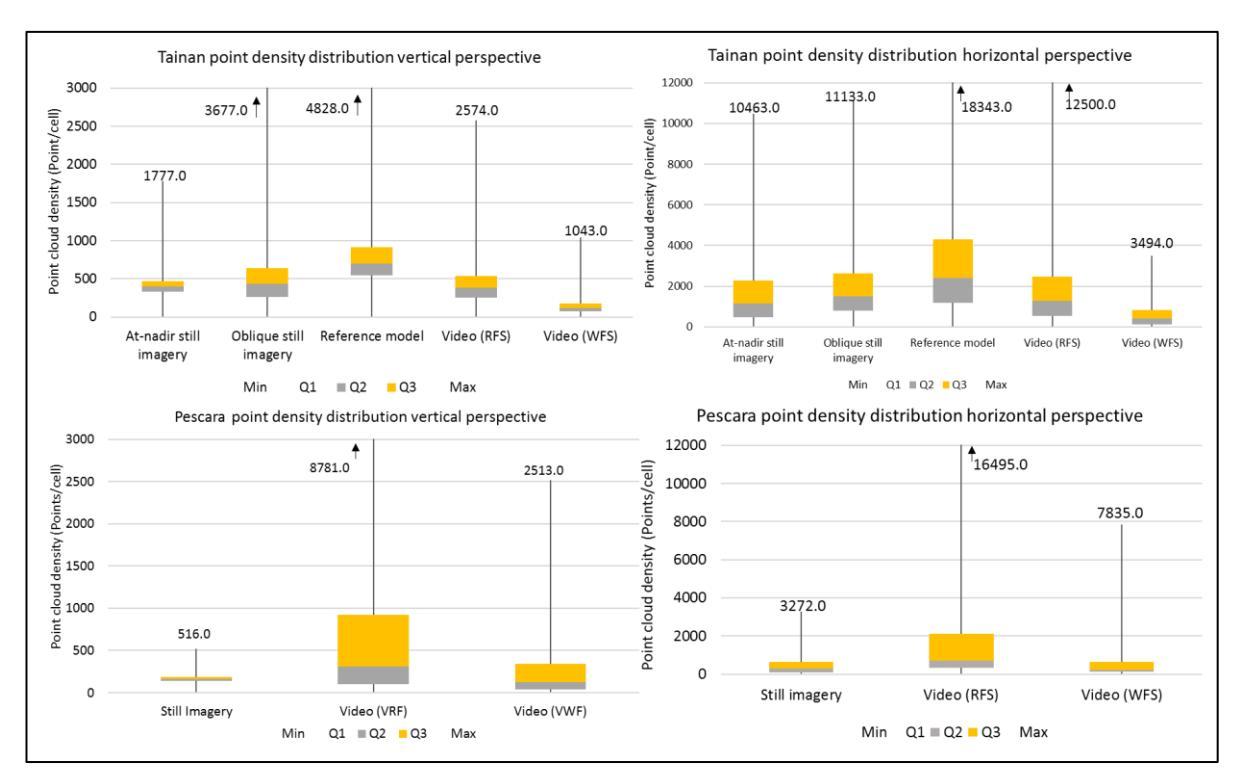
Figure 25. Point density distribution boxplots. Maximum values are labelled for every 3DPC. Every data set is divided in four quartiles (Q) and the distribution of every quartile is presented by the box heights.

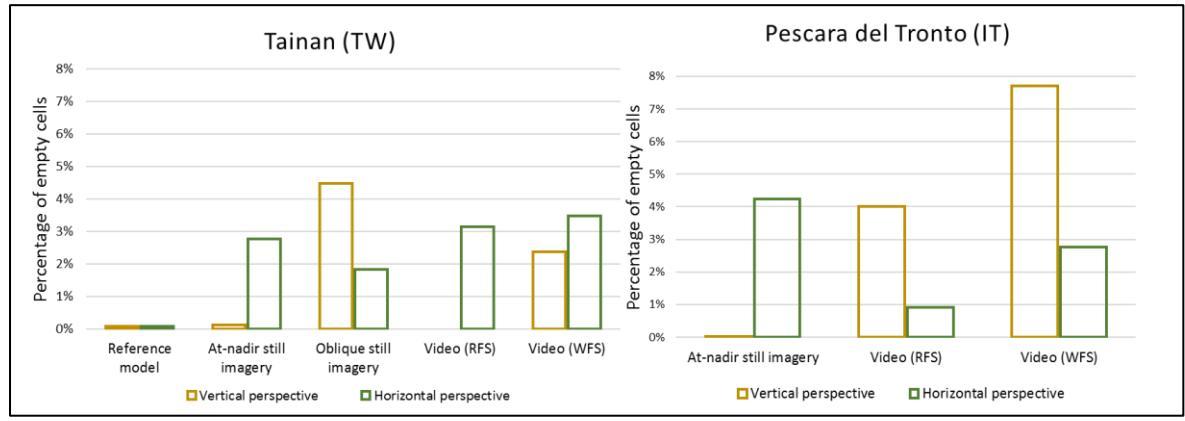
Figure 26. Percentage of gaps from vertical and horizontal perspectives. From vertical perspectives oblique and video WFS (Wise Frame selection) models present more gaps, from the horizontal at-nadir and also WFS model

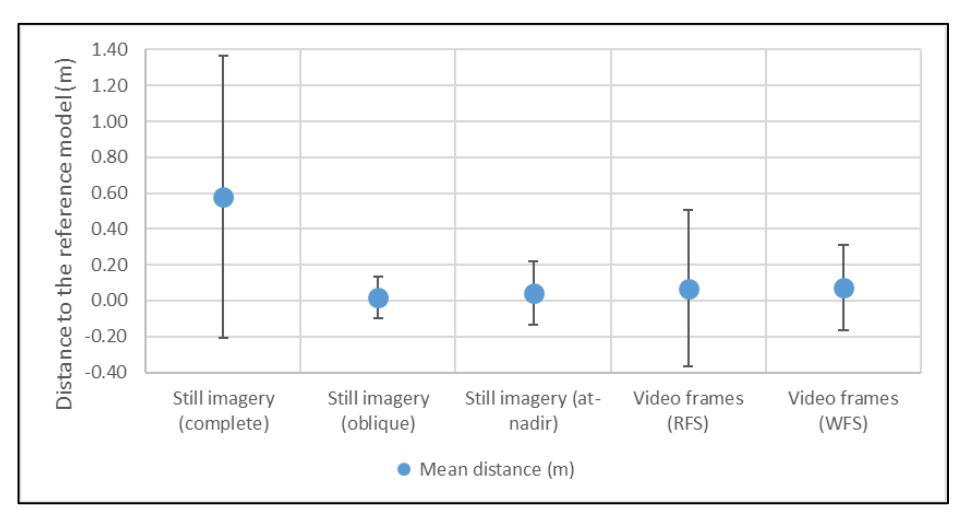
Figure 27. Mean distance to the reference model (external accuracy). The closer to the reference the higher the accuracy, Still imagery complete (oblique and at-nadir) 3D model presents high deviation and the lowest accuracy due to model orientation errors

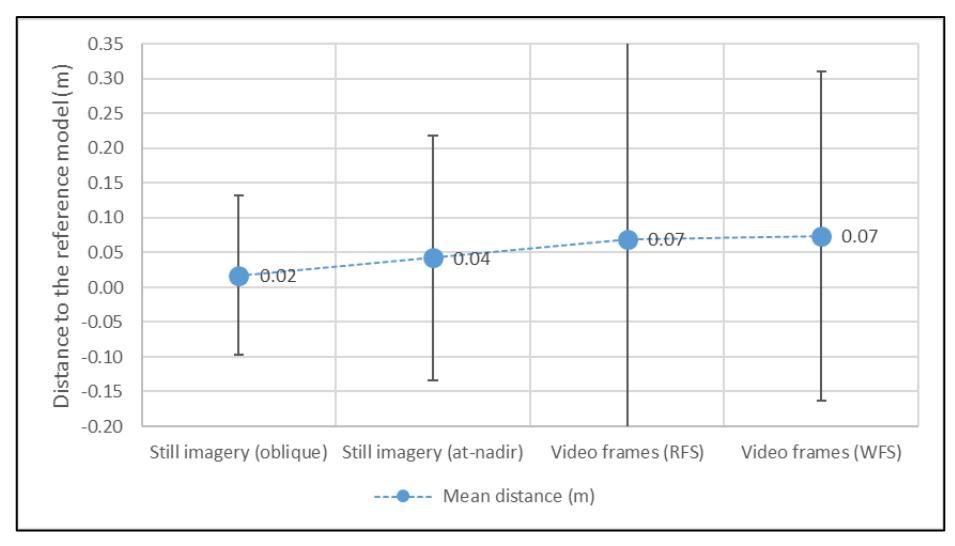
Figure 28. Mean distance to the reference model (close up). Video 3D models achieved 7cm accuracy, not that far from still imagery ones, however precision is high due to noise generated from smoke and frame redundancy.

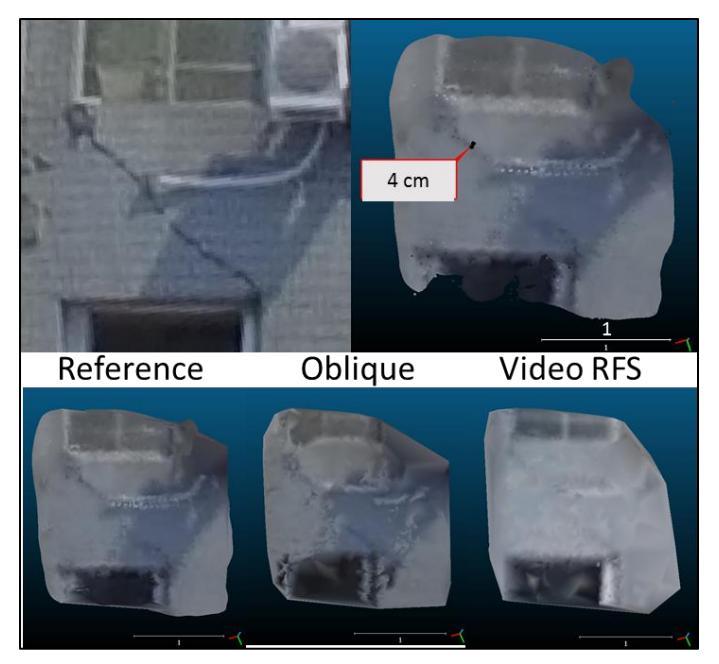
Figure 29. Cracks recognition for Tainan. The crack can be identified in the oblique model, video (WFS Wise Frame Selection) model is not able to represent this feature

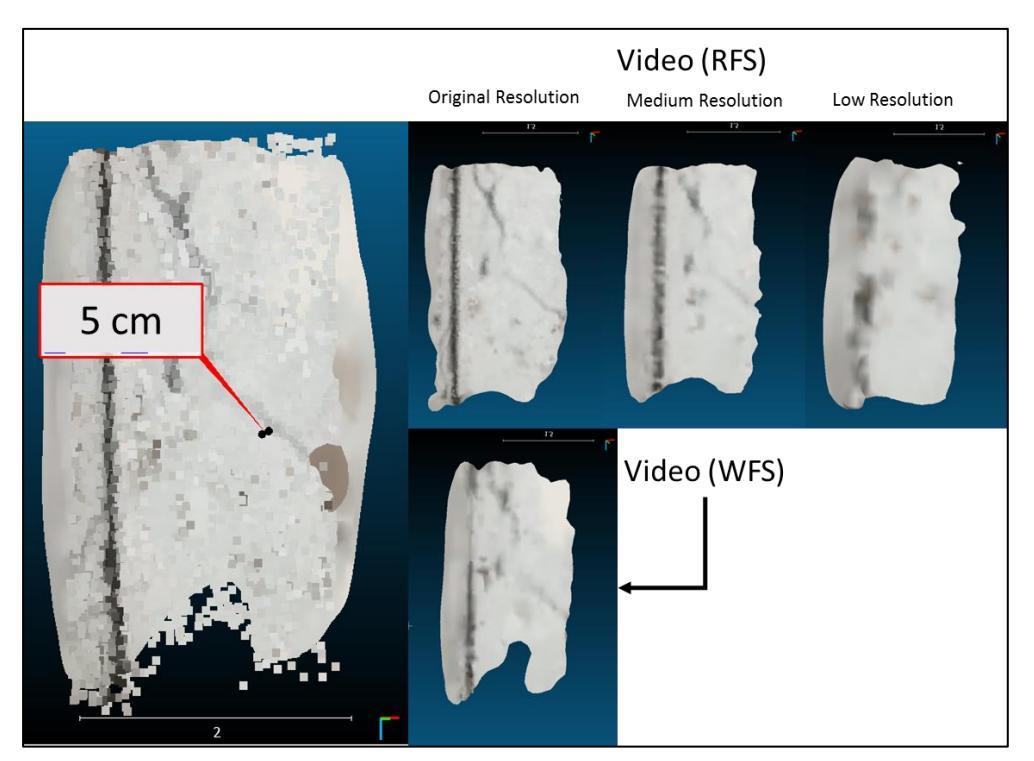
Figure 30. Cracks recognition for Pescara del Tronto. The crack can be identified up to video RFS (Random Frame Selection) medium resolution and video WFS (Wise Frame Selection) original resolution models.

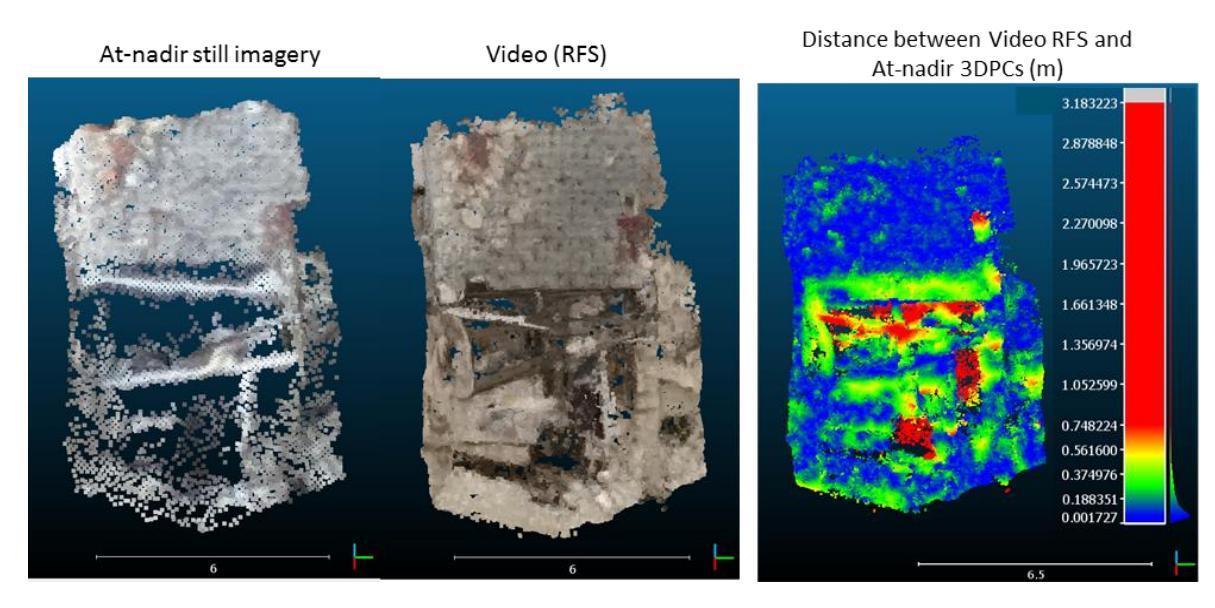
Figure 31. Left: Structural failure recognition (Pescara del Tronto). Right: Distance between Video Random Frame Selection (RFS) and at-nadir still imagery models (m).

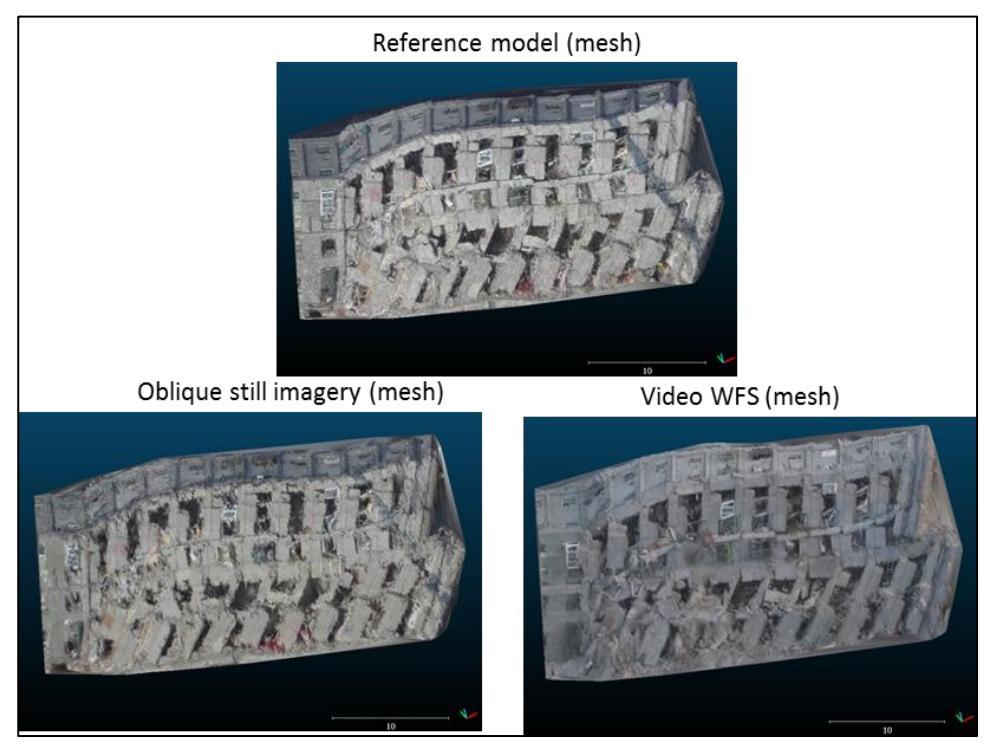
Figure 32. Structural failure recognition (Tainan). RFS: Random Frame Selection. WFS: Wise Frame Selection

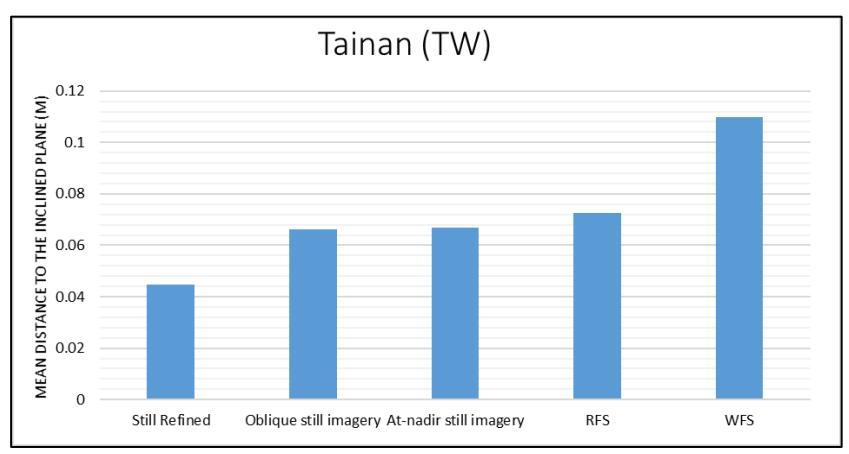
Figure 33. Left: Inclined wall representation and comparison of oblique and video model fitted planes. Right: mean distances to reference model plane

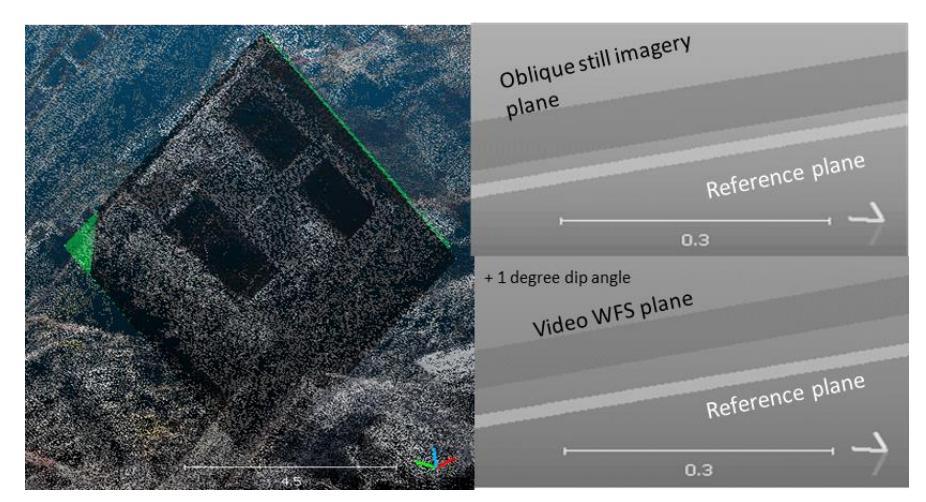
Figure 34. Left: Inclined wall analysed. Right: Differences between inclined walls using oblique and video WFS (Wise Frame Selection) 3DPCs
