3D scene reconstruction and structural damage assessment with aerial video frames and drone still imagery

JOHNNY CUSICANQUI Enschede, The Netherlands, 2016

Thesis submitted to the Faculty of Geo-Information Science and Earth Observation of the University of Twente in partial fulfilment of the requirements for the degree of Master of Science in Geo-information Science and Earth Observation. Specialization: Applied Earth Sciences

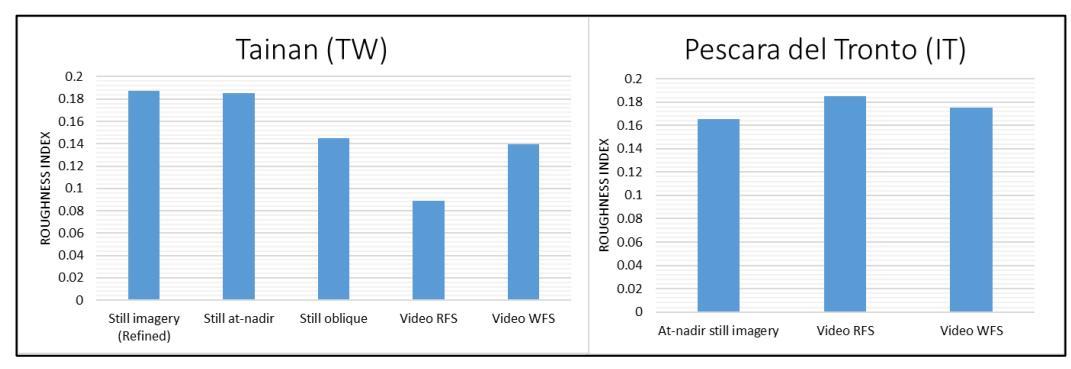
Figure 35. Roughness indices as an indicator for debris representatibility

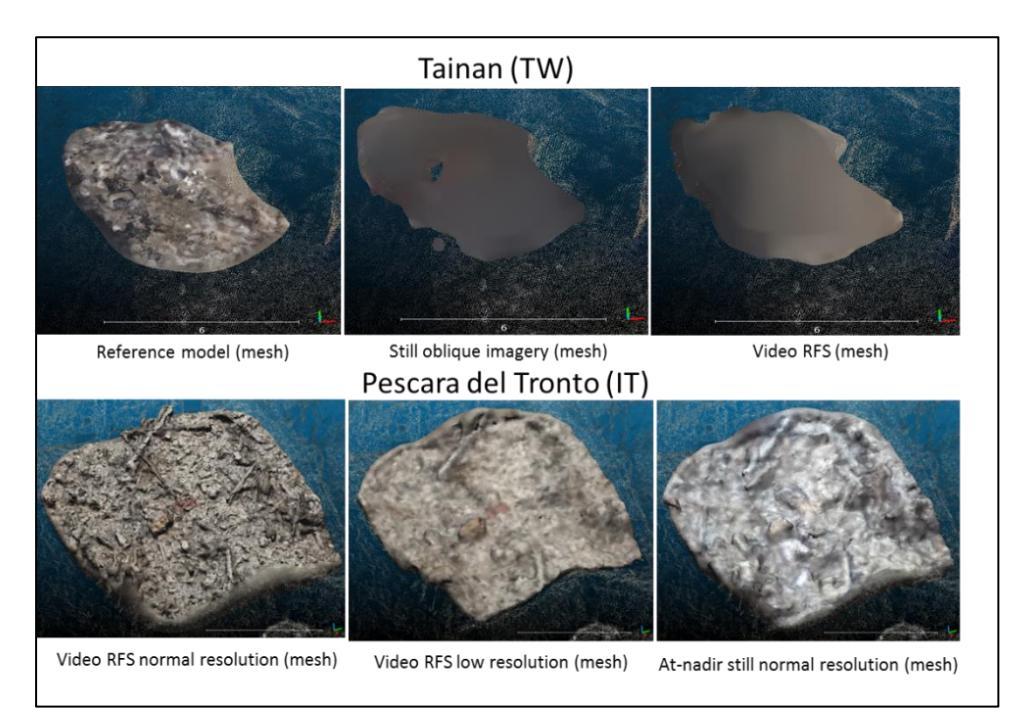
Figure 36. Mesh models of debris areas from different 3DPCs for visual analysis of debris features representability. Video RFS (Random Frame Selection) 3DPCs are able generate clear debris areas even at low resolutions.

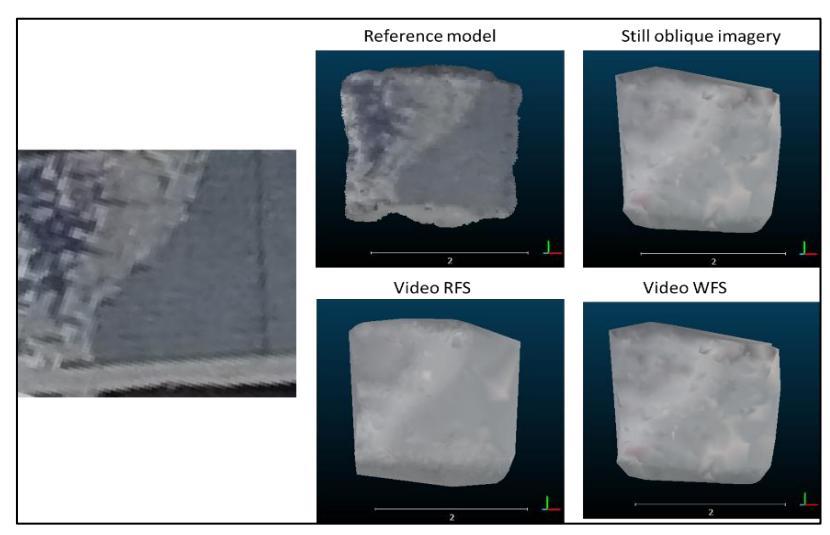
Figure 37. Spalling feature mesh models for visual recognition (Tainan). RFS: Random Frame Selection. WFS: Wise Frame Selection

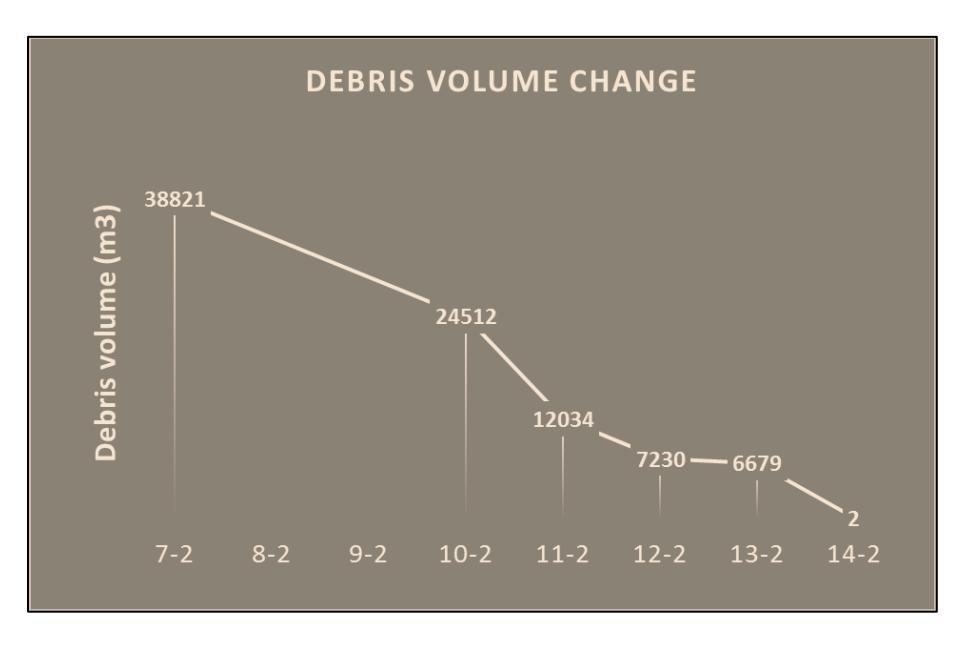
Figure 38. Debris volume change estimations for Tainan computed with the complete (oblique and at-nadir) still imagery-based models.

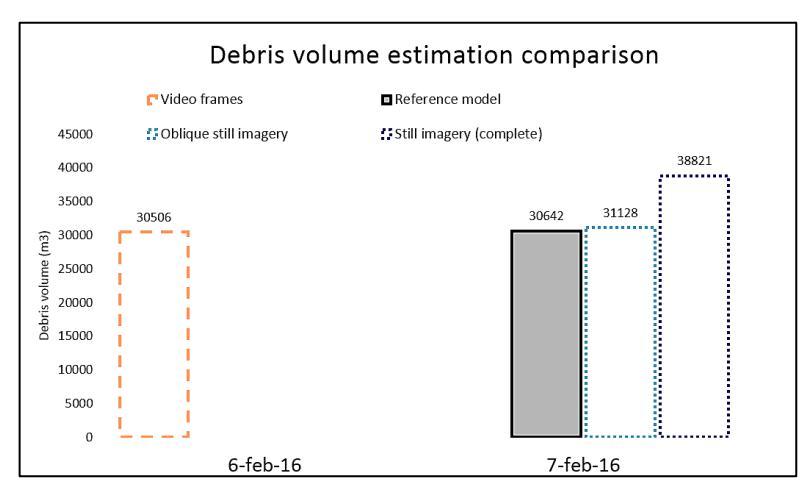
Figure 39. Debris volume comparison analysis. video model volume estimation is closer to Reference volume than the other models.

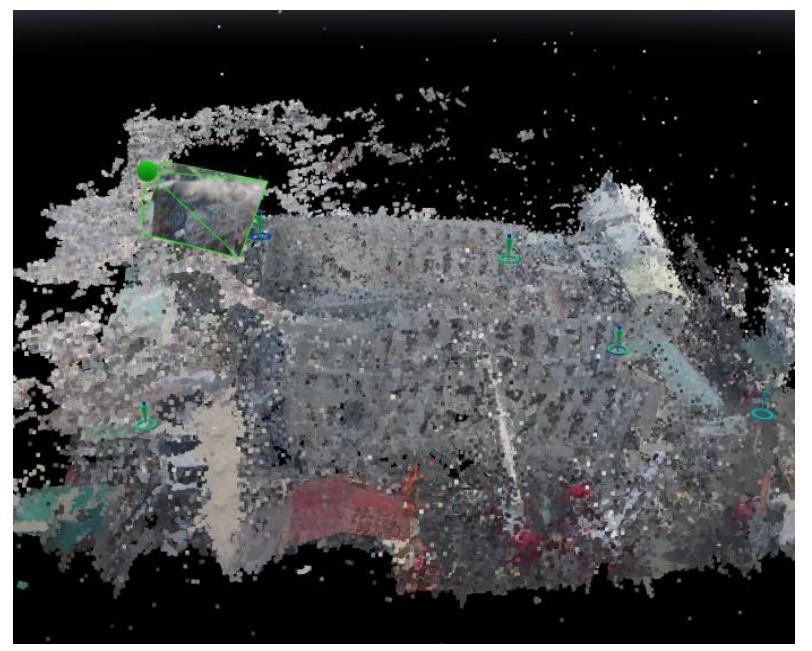
Appendix 1. Noise due to smoke in video-generated 3DPC

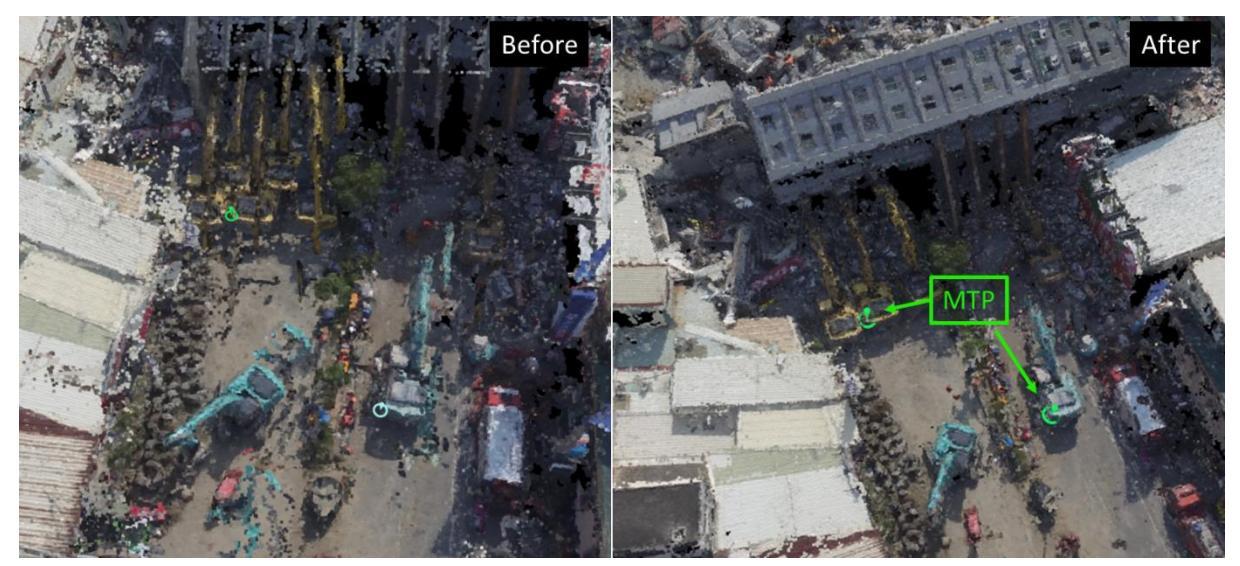
Appendix 2. MTP selection for refining procedure (Befor and after refining)

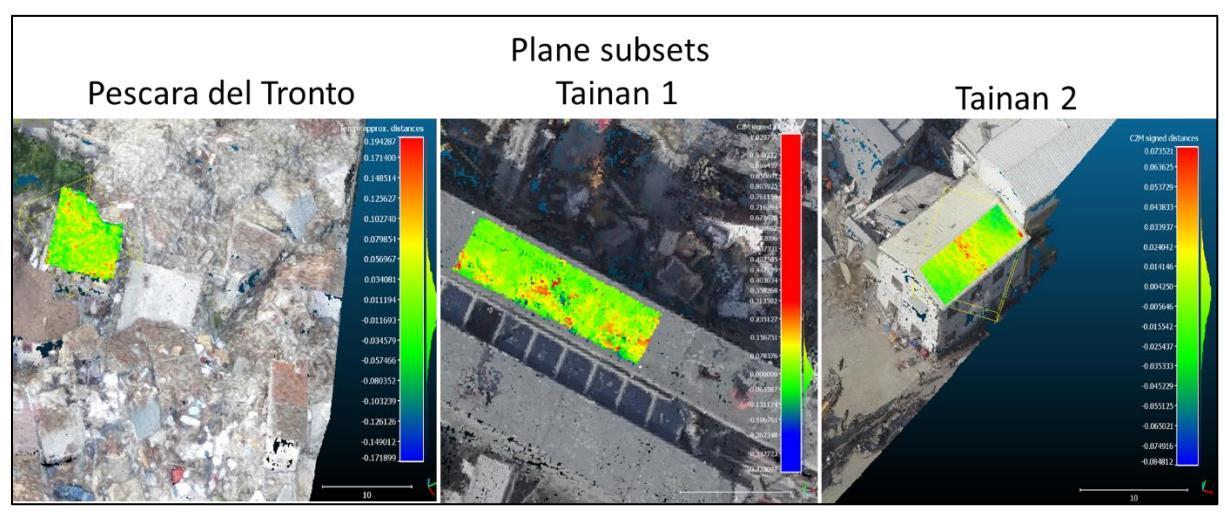
Appendix 3. Plane surfaces used for planar fitting analysis

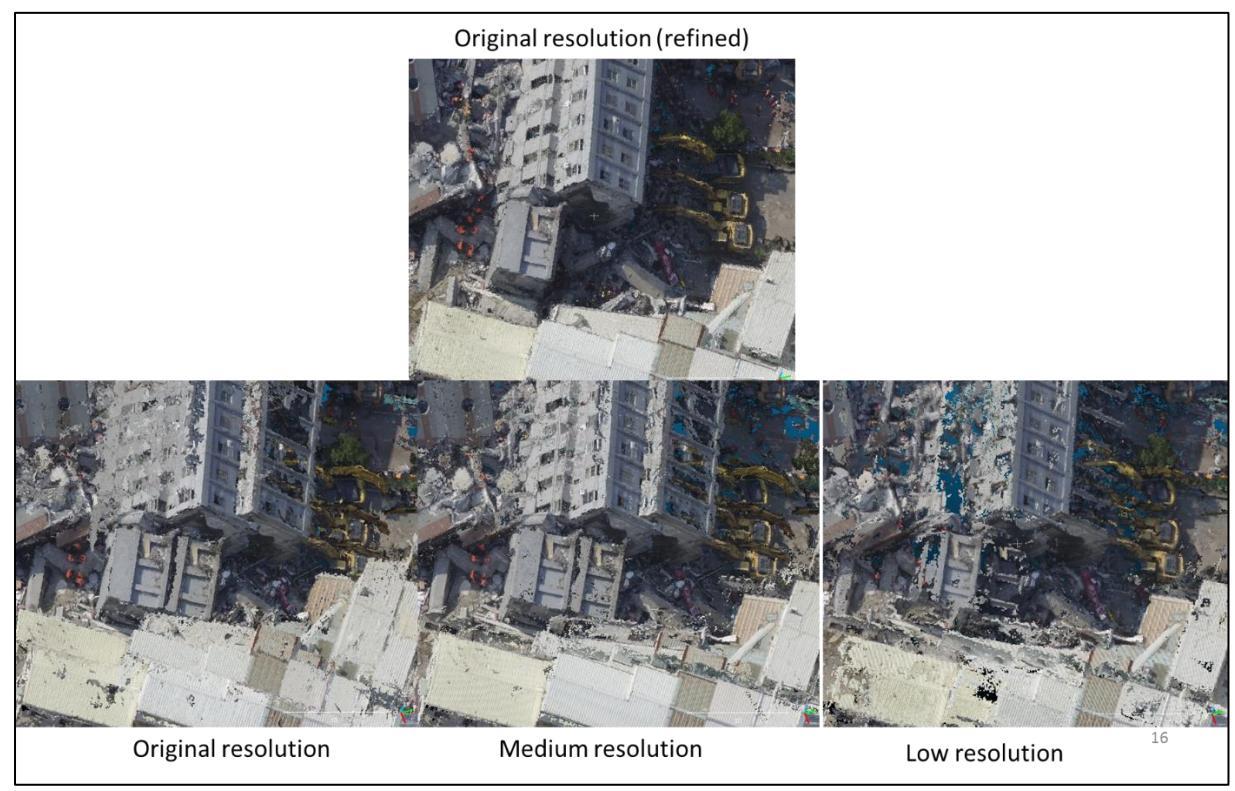
Appendix 4. Noise reduction with resolution degradation (medium resolution) for still imagery model. Low resolution instead loses also essential information

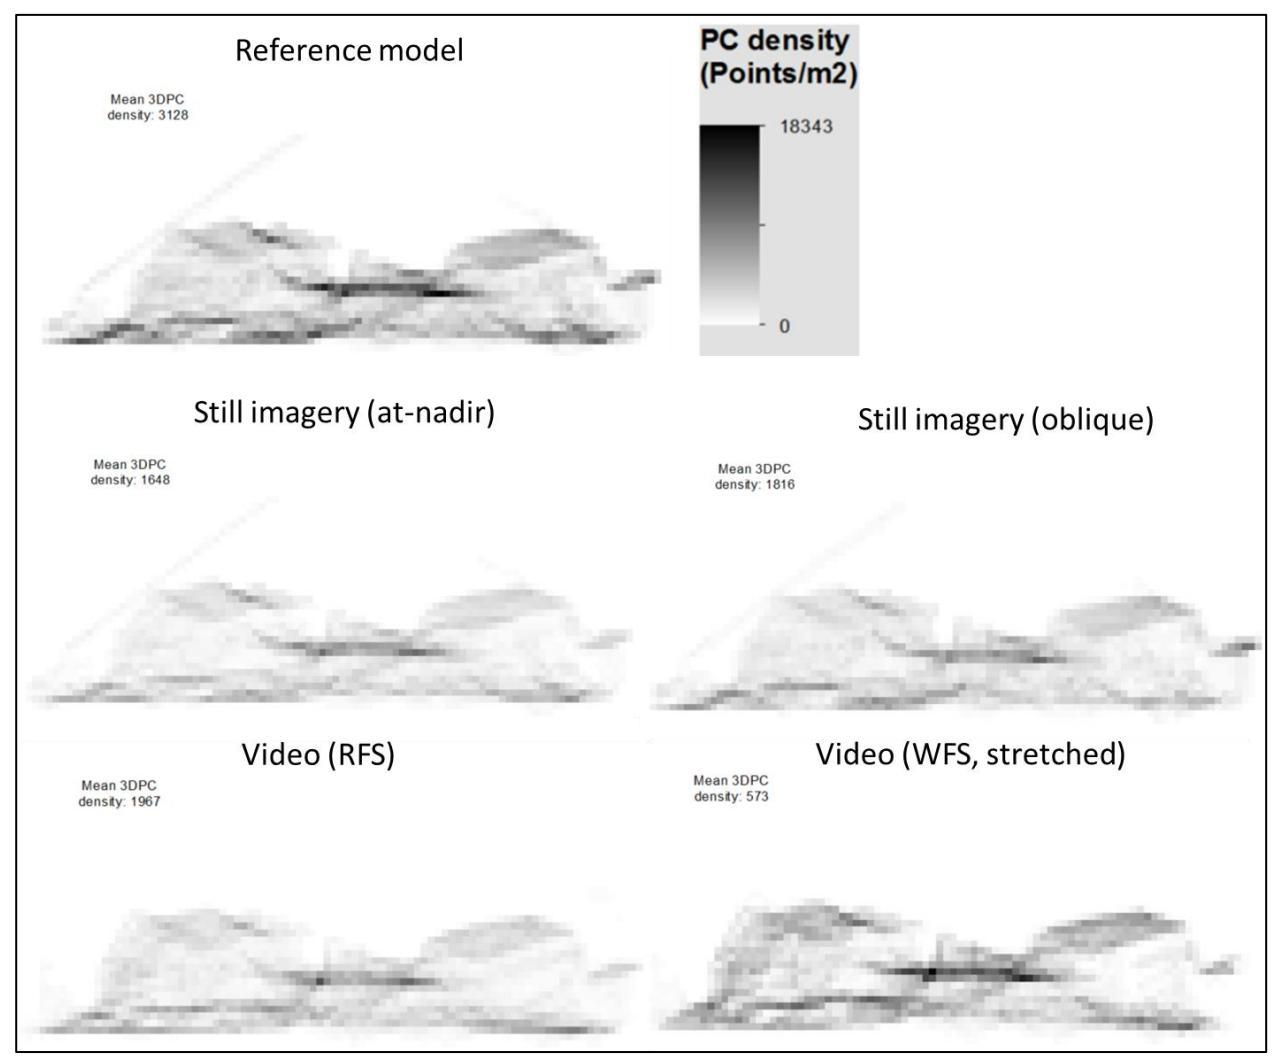
Appendix 5. Horizontal point cloud density maps for Tianan datasets

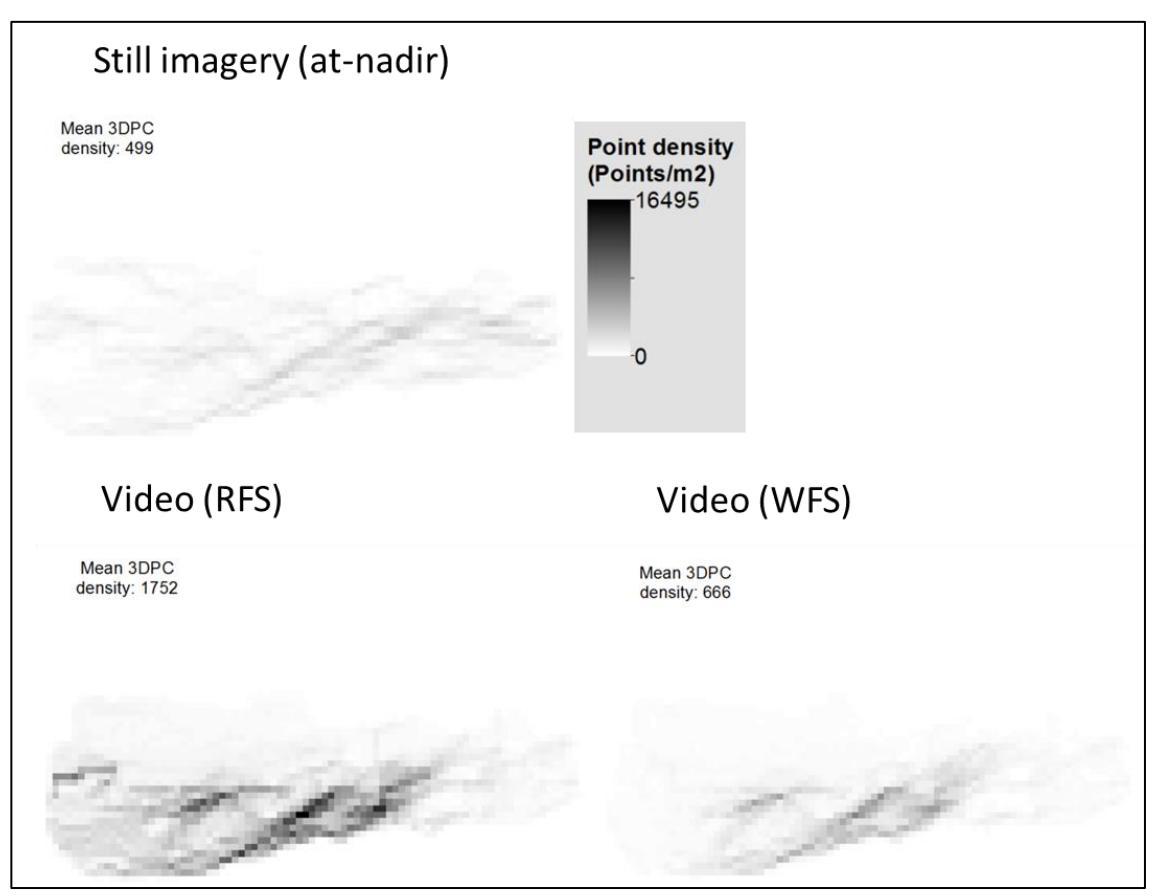
Appendix 6. Horizontal point cloud density maps for Pescara del Tronto datasets

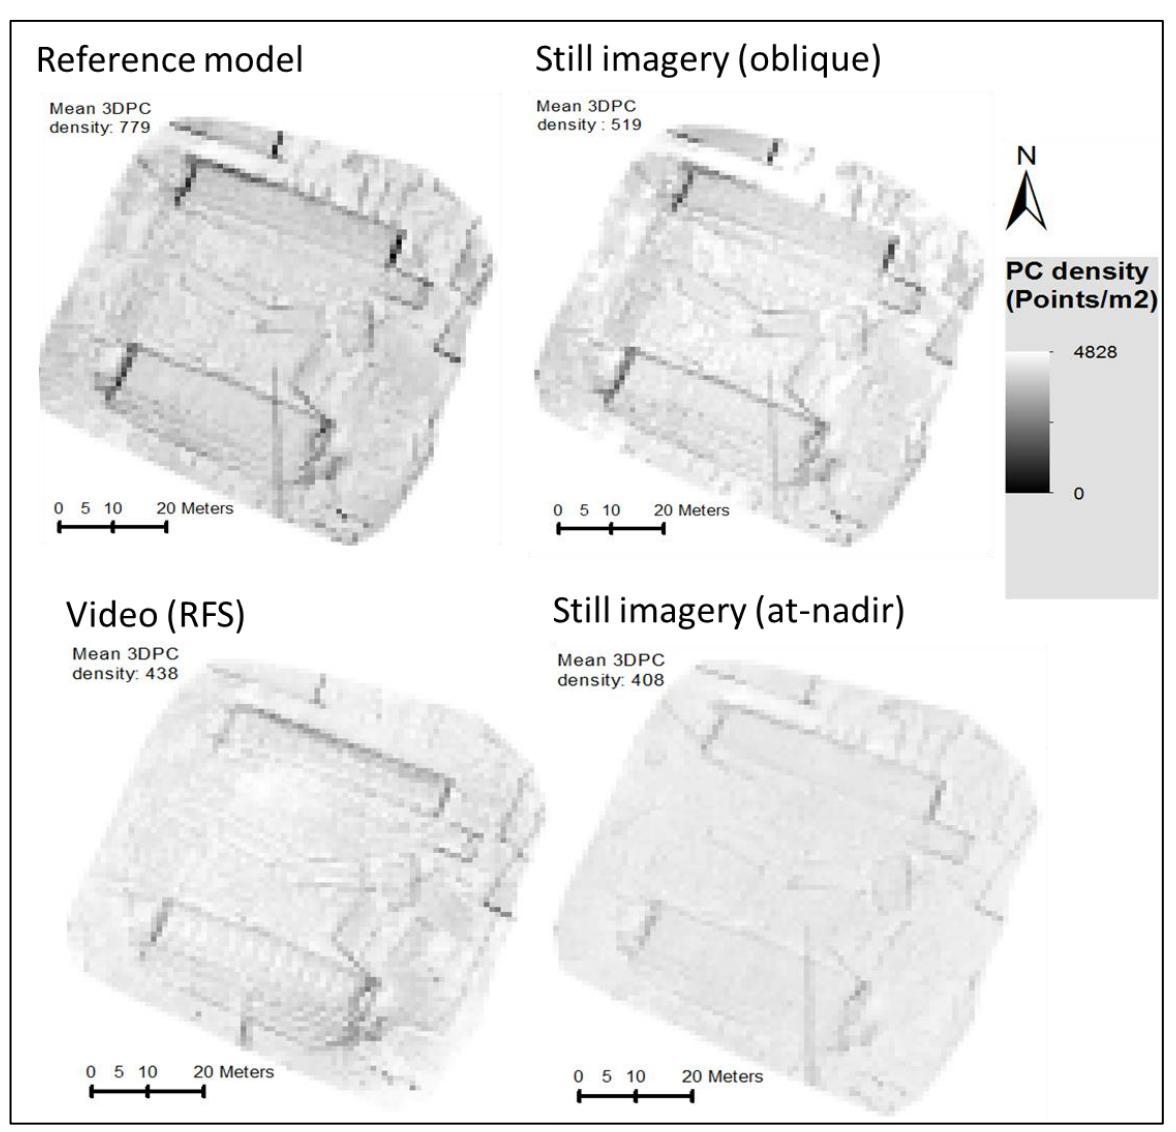
Appendix 7. Vertical point cloud density map for Tainan datasets

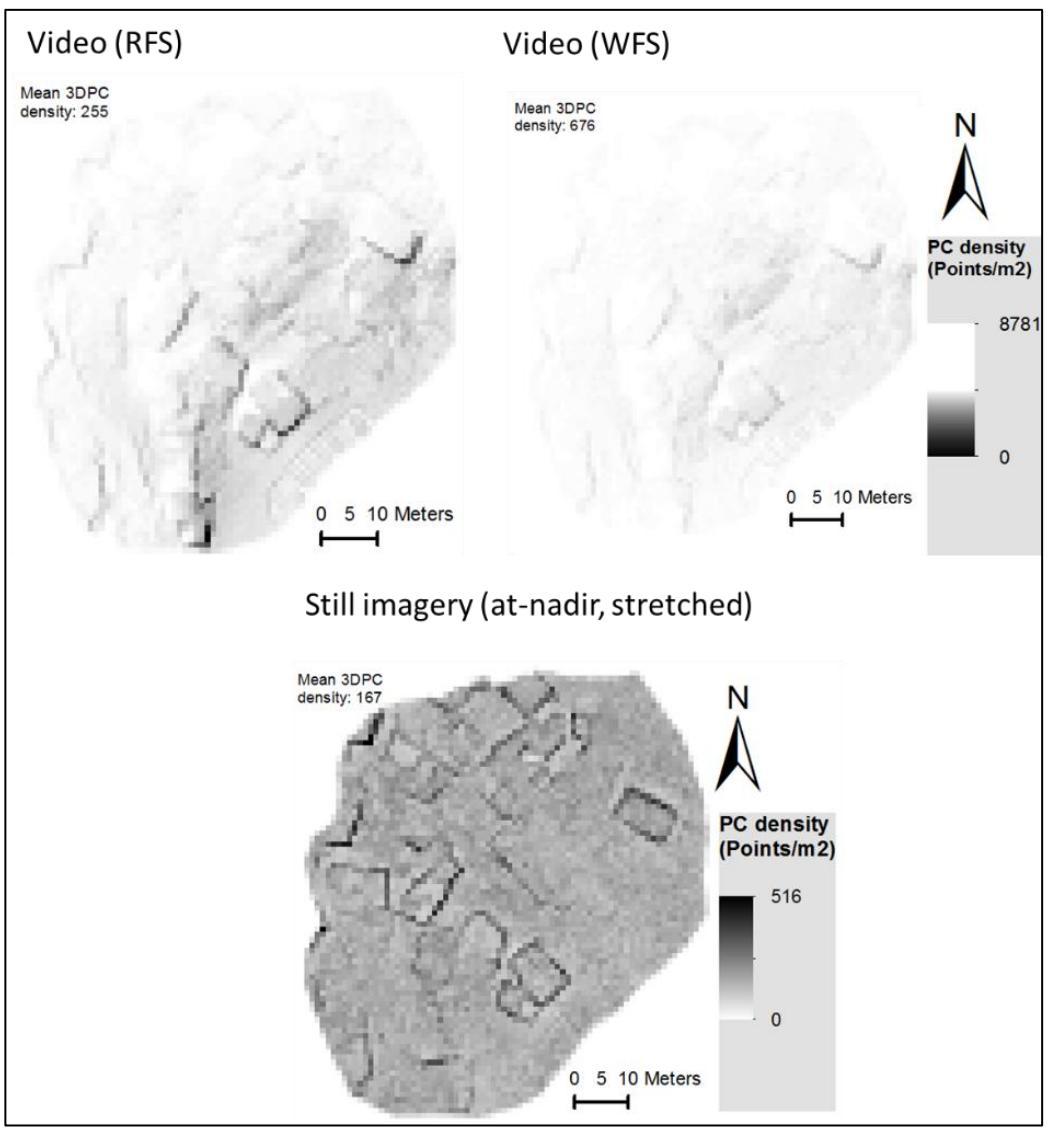
Appendix 8. Vertical point cloud density map for Pescara del Tronto dataset

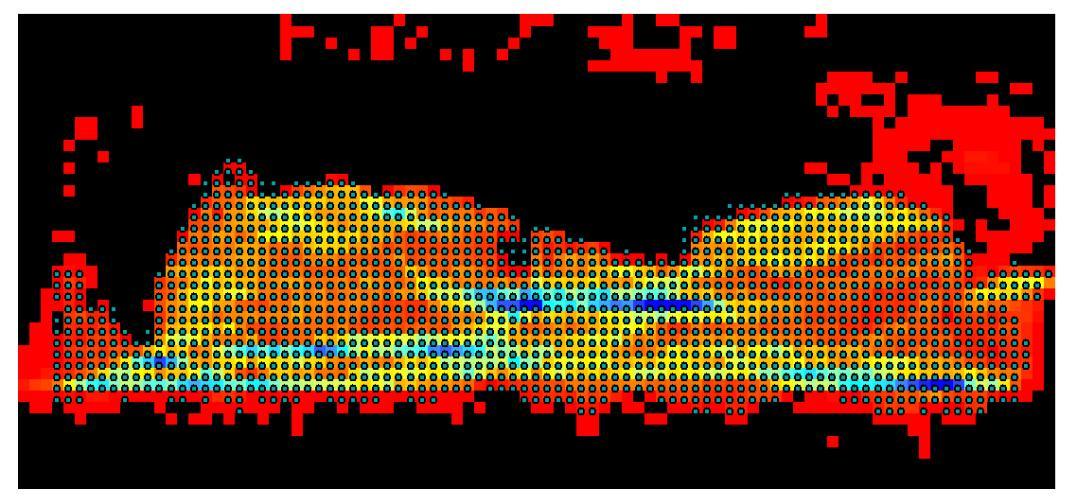
Appendix 9. Dots used as mask for point density distribution and empty cells proportion estimations

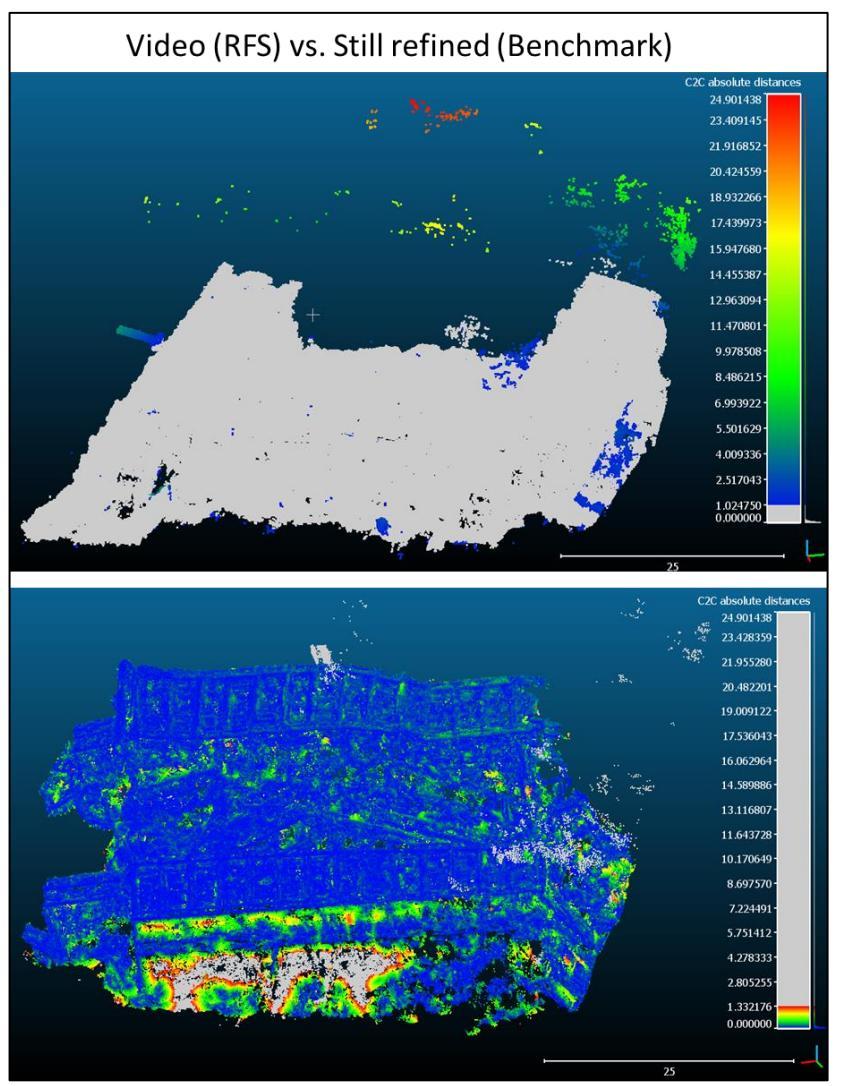
Appendix 10. Video main differences with reference model. Up: noise due to smoke perturbation. Down: Occlusion zones

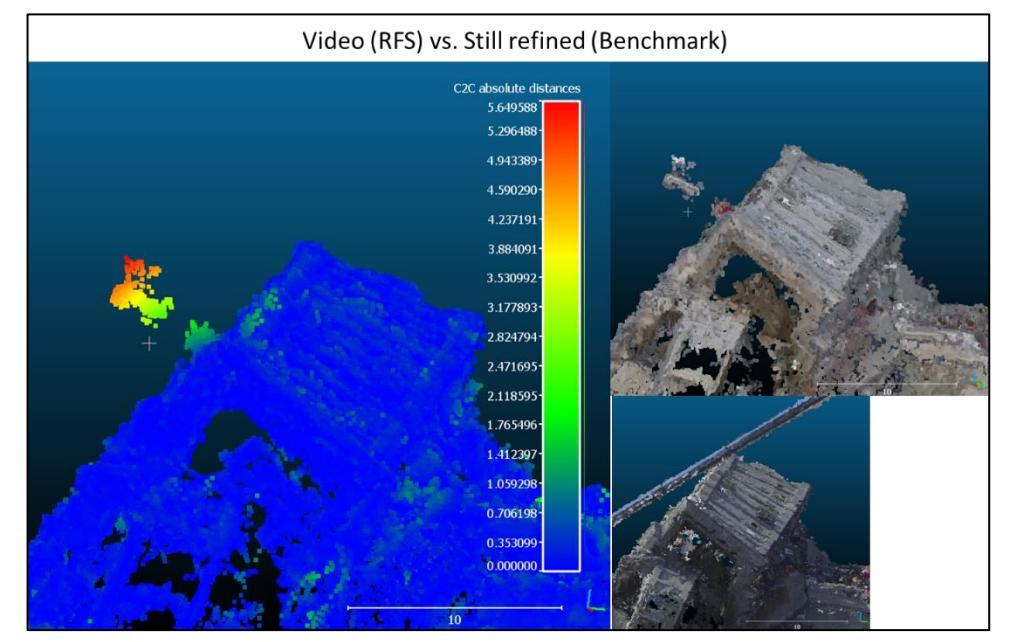
Appendix 11. Differences due to changes in scenario settings. A crane was mistakenly modelled only for one data set.

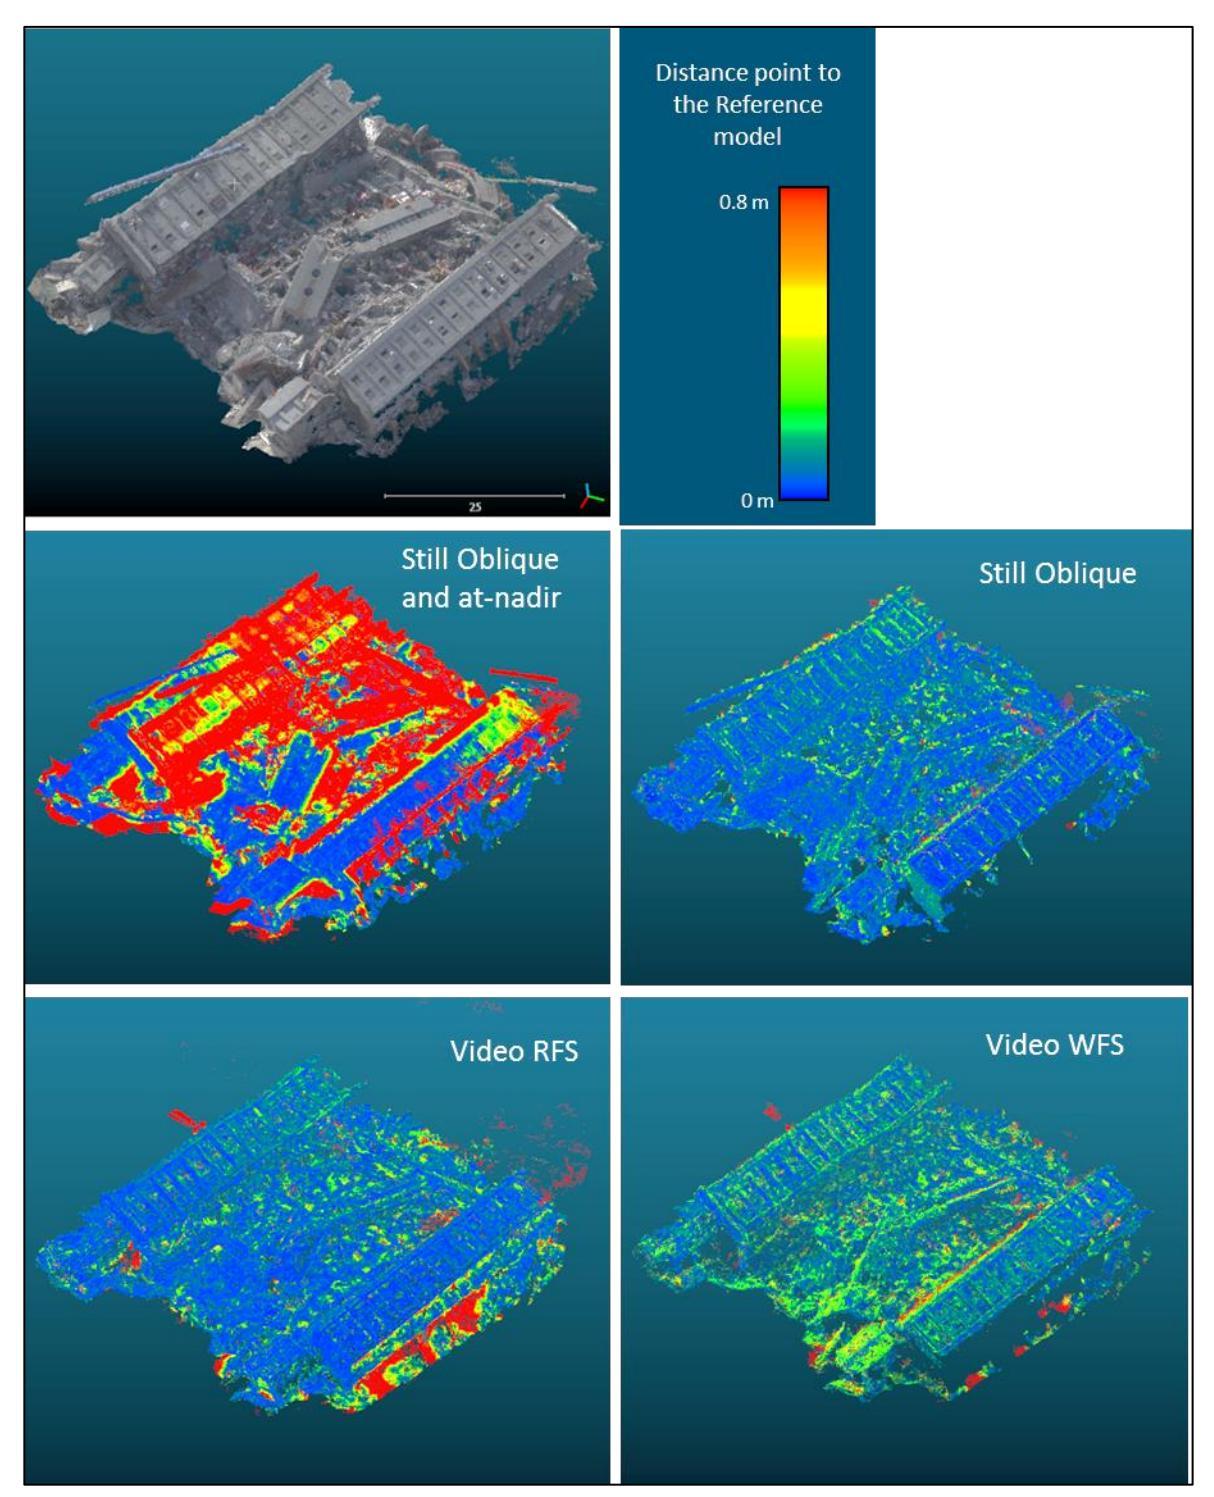
Appendix 12. Point cloud distance to the reference model for most video and still imagery generated models. Problems such as occlusion, changes in scenario settings and smoke perturbations, causes the main differences for video data.

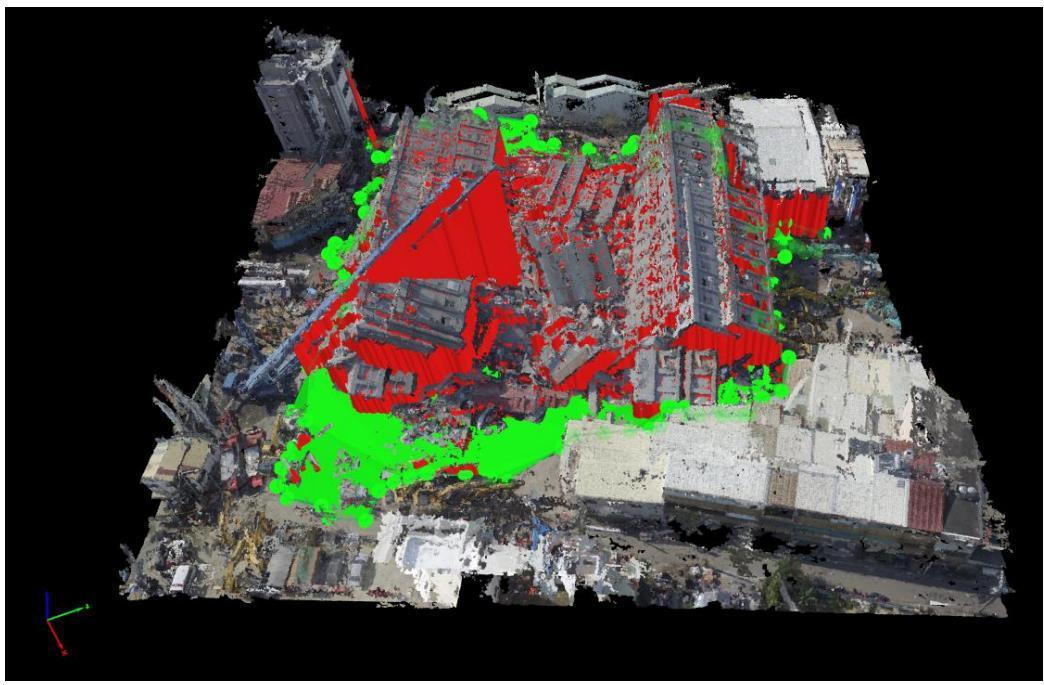
Appendix 13. Volume calculation overestimation example, made by blue crane.
