# NATIONAL SCALE LANDSLIDE SUSCEPTIBILITY ASSESSMENT FOR DOMINICA AND SAINT VINCENT

Thesis submitted to the Faculty of Geo-Information Science and Earth Observation of the University of Twente in partial fulfilment of the requirements for the degree of Master of Science in Geo-information Science and Earth Observation.

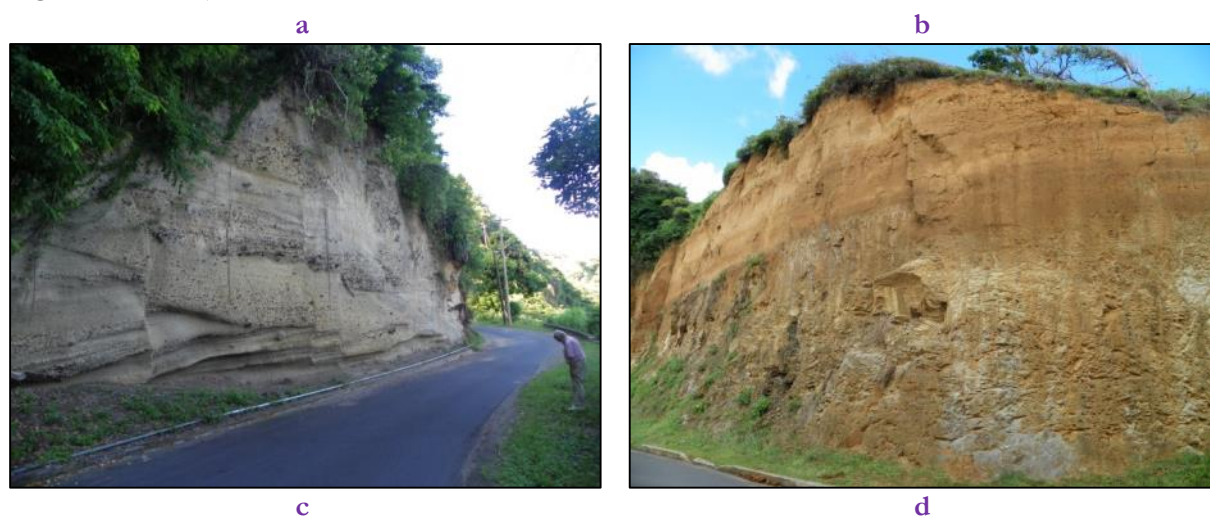
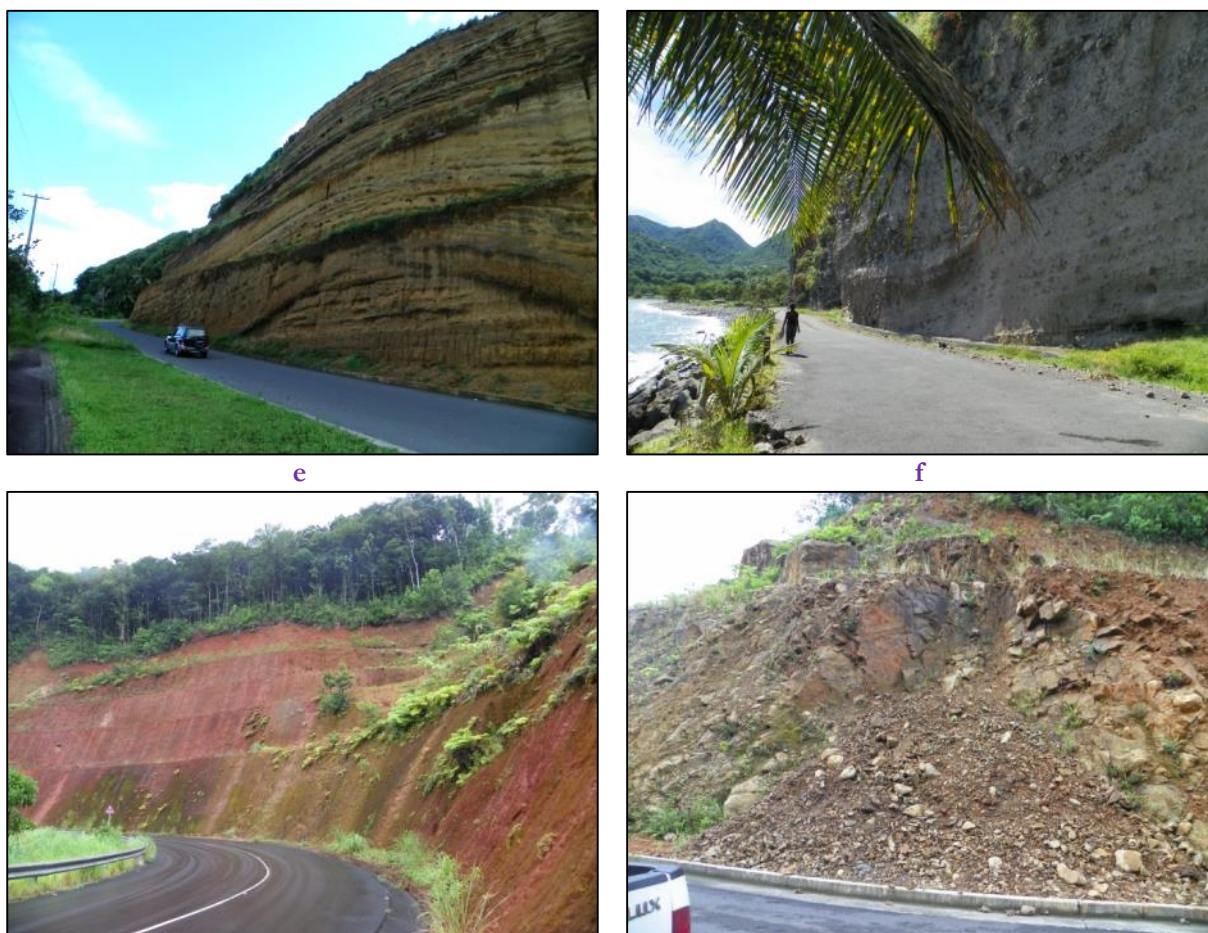
**Figure 3.** Examples of outcrops in volcanic deposits. *a, b and c in Saint Vincent: d, e and f in Dominica.*

As it could be seen during the fieldwork, the difference between rocks and soils is not clear in engineering terms, due to the relative degree of consolidation of the volcanic deposits, their heterogeneity and the effect of weathering. These volcanic deposits are usually very thick; they may sustain vertical road-cuts, however, after weathering processes take place such road-cuts may cause problems, as seen in Dominica **Figure 3e and 3f**.

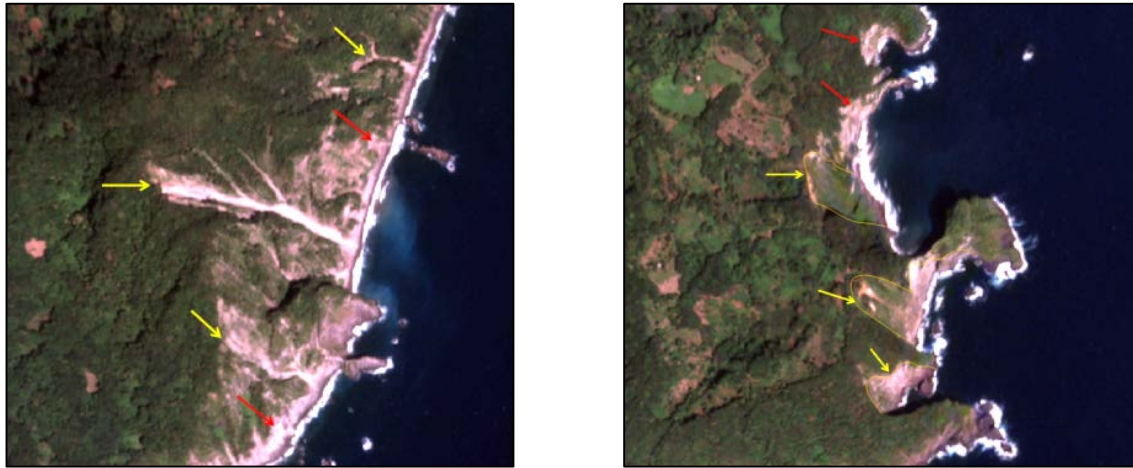
**Figure 13.** Examples of Landslide image interpretation in Dominica. A. The yellow arrows indicate Debris Slides (Left) and B. Rockslides (Right). The red arrows show areas of Rockfall.

Debris Flows (**Figure 12**) usually start with the arcuate scar (indicated by the yellow arrows) where movement was initiated extending downslope to the natural channel. Sometimes it is possible to observe faint lines showing fluvial erosion (**Figure 13**) of the bare soil exposed by the debris flows passage. Occasionally there may be a small amount of deposit at the very bottom next to the channel, but it is very often transported downstream. Debris slides are usually shallow, elongated and narrow, and lack of resistant escarpments (**Figure 13**). Rockslides have a square or circle geometry and the presence of a resistant escarpment (**Figure 13**).

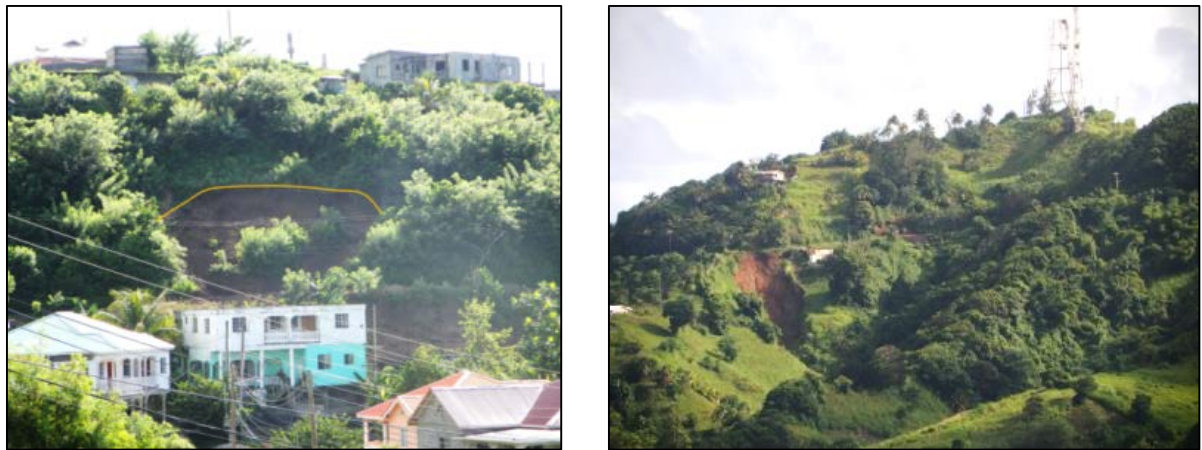
**Figure 17.** Landslides in Saint Vincent. Belmont Landslide (right). It is possible to identify the changes in morphology and vegetation on the slopes.

Landslides were identified where there was a presence of hummocky and irregular slope morphology, or a change on the morphology, vegetation or drainage of a slope (**Figure 17**). We identified the basic landslides features: crown or scarp, body and deposit. Most of the landslides identified were shallow landslides affecting the top layer of soil (usually 1m thick) on steep slopes (around 60 to 80 degrees) leaving an area without vegetation corresponding to the crown of the landslide; in some places, this shallow landslides could be debris-flow or debris-slides.

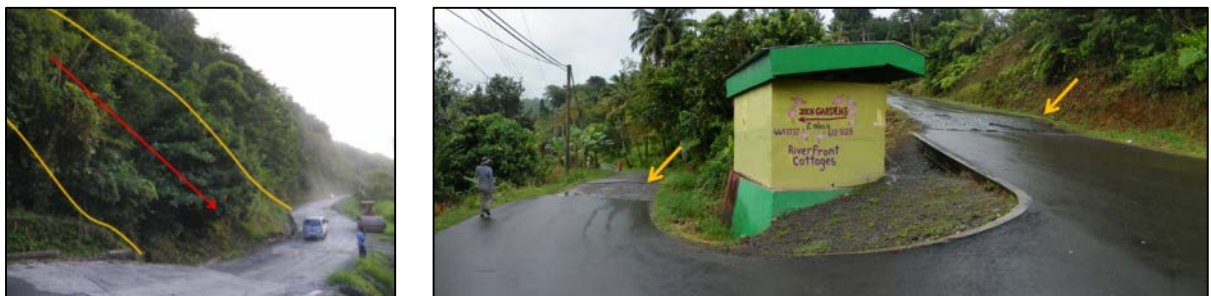
**Figure 18.** Landslides identified on fieldwork in Dominica. Deux Branch Area (Left), and Belle Wet Area Junction (Right).

There were also some rare deep-seated landslides, which affected the roads through displacements and subsidence, which was in the most extreme case up to 2 meters (Deux Branch area); the biggest one is located in Dominica on the Layou River (**Figure 18**).

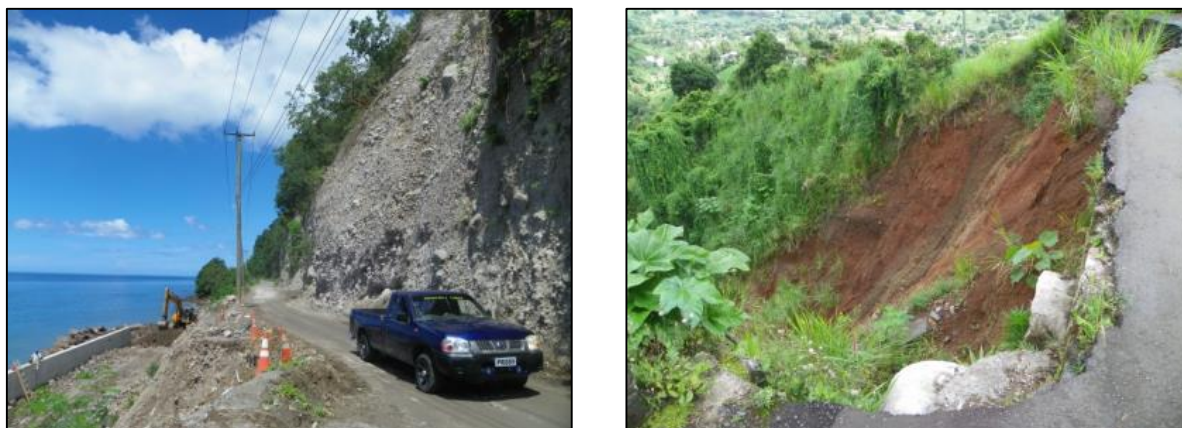
**Figure 19.** Rockfall and embankment failure in Dominica - Champagne beach area (Left), and Embankment failure in Saint Vincent – Belmont Landslide (Right).

Along the road network, landslides are common (**Figure 19**), in most of the cases they were related to cutslope failures (e.g. Rockfall in Stowe area in Dominica) or embankment failures. (E.g. Champagne beach area in Dominica, or Belmont Landslide in Saint Vincent).

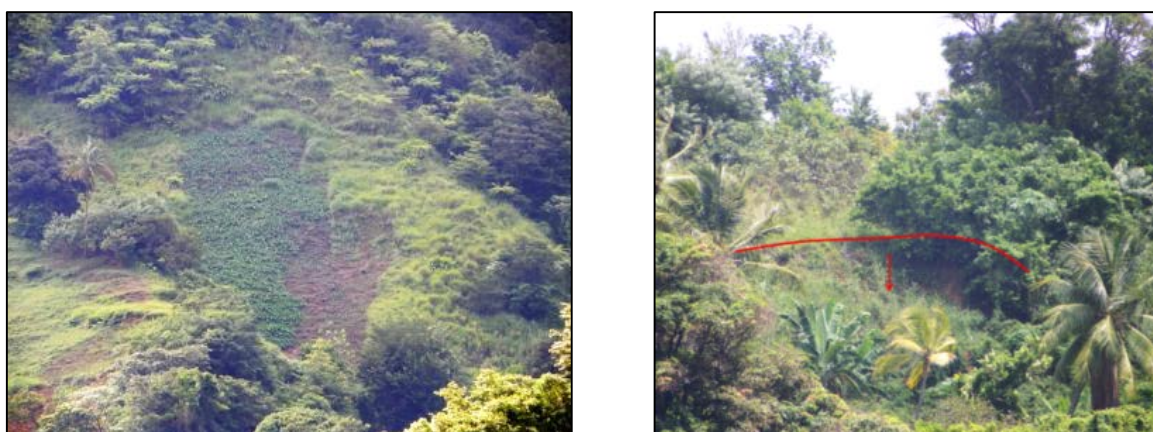
**Figure 20.** On the left: Arrowroot crops on top of a possible old landslide. On the right it is possible to observe a sugar Cane crop on top of a landslide deposit.

Being in the field it became obvious that many of the points identified as landslides on the previous image interpretation, were not landslides but cropland. It is possible that the date of the satellite images matches to the time when the farmers are preparing the land to plant the seeds of the new crops, which makes easy to confuse bare soil (with elongated shapes parallel to the length of the slope) with fresh landslides, this is the case of the Arrowroot plant, which harvesting time is from October to May, and as the satellite images are from February, then most of the fields where arrowroot is cultivated will look like bare soil or fresh landslides.

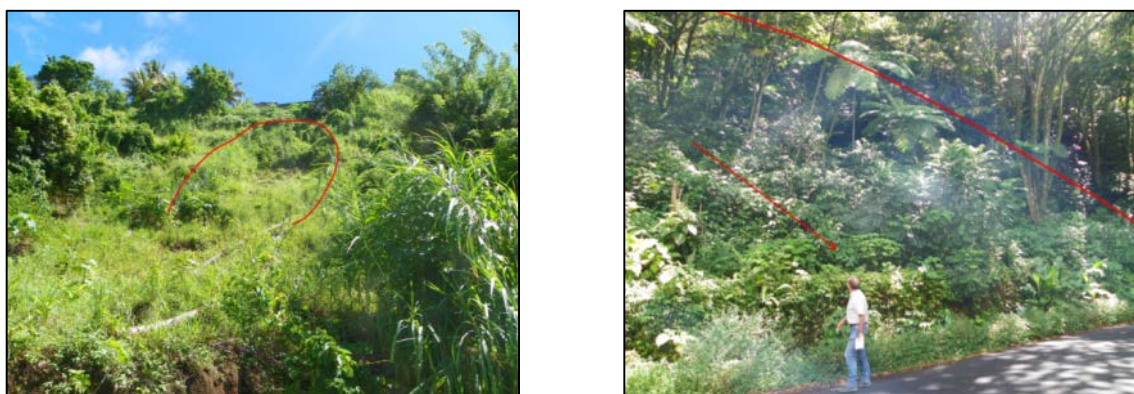
**Figure 21.** Manning Village landslide (left) and Belle-vue Landslide (Right)

This has several reasons, the first one is that the fieldwork were made along the roads, and most of DeGraff inventory comprises landslides occurred in the middle of the island. Another reason is that due to the tropical weather, the vegetation grows really fast, covering completely any evidence of landslides (i.e. in Saint Vincent, Manning village landslide occurred in December 2013, was already completely vegetated by September 2014), actually the location of most of the DeGraff landslides identified on the field, were indicated by the government officers (i.e. Bagatelle or Belle-vue Landslide in Dominica). This is one of the major obstacles in the landslide inventory mapping from images. Unless the images are taken within a few months after the triggering event, it becomes very difficult to recognize them as such (*Figure 21*).
